Central Police Station Conservation
and Revitalisation Project:
77th Monthly EM&A Report
(1 March to 31 March 2018)

Issue Date: April 2018

Reference 0095646

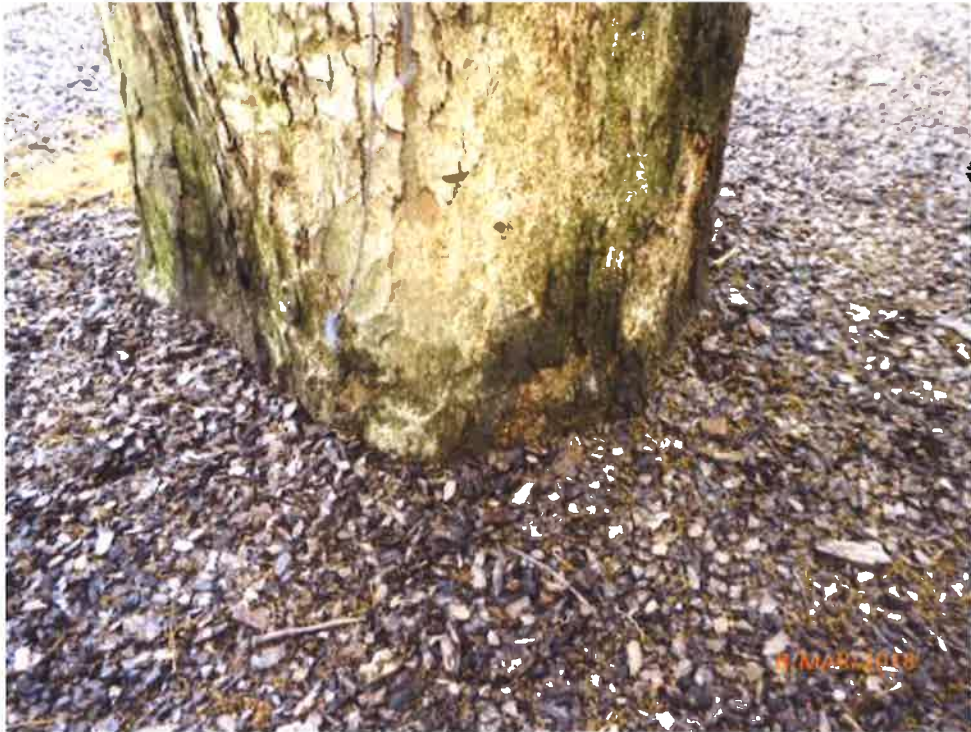
Fig 2. The root collar is normal. The planter is covered with small pieces of pine bark.

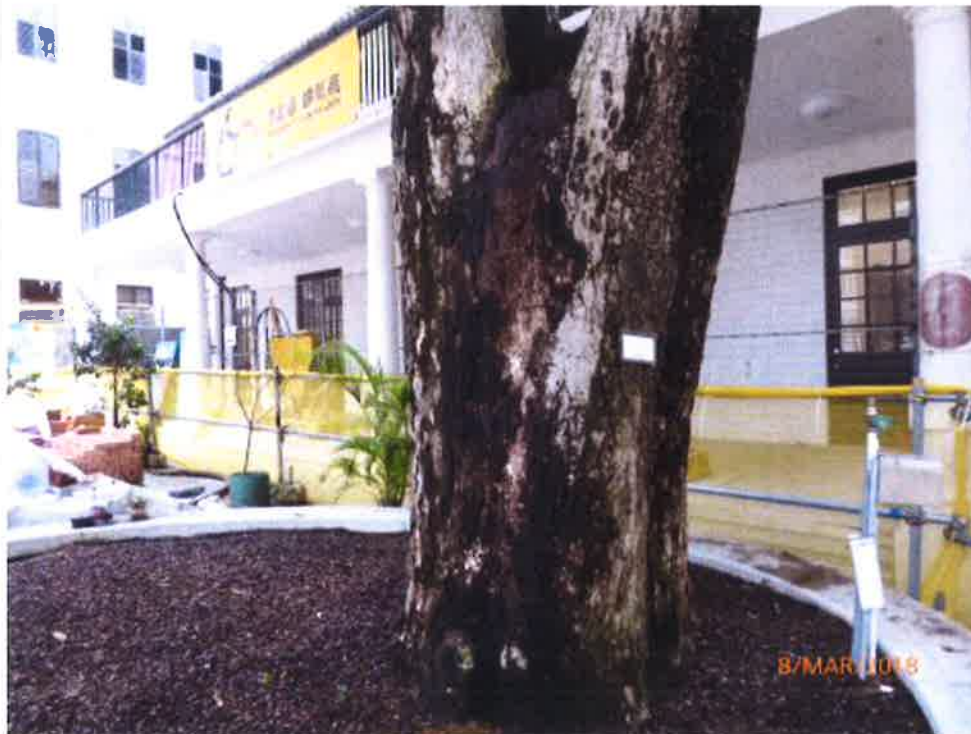
Fig. 3 Health condition of the lower trunk is fair.

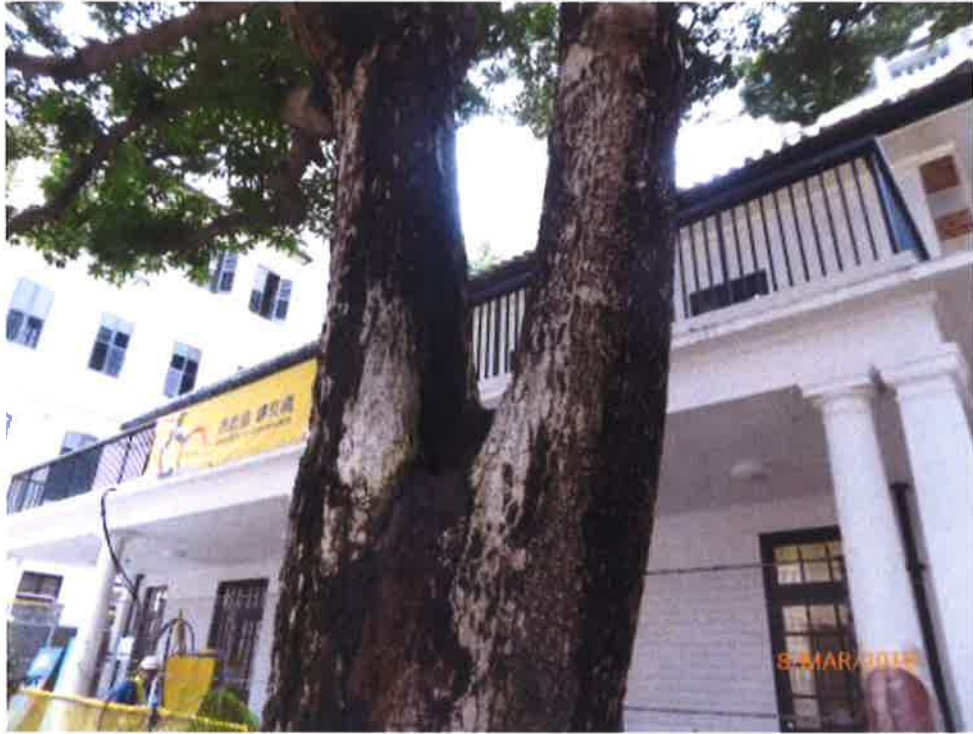
Fig. 4 Health condition of the mid trunk is fair.

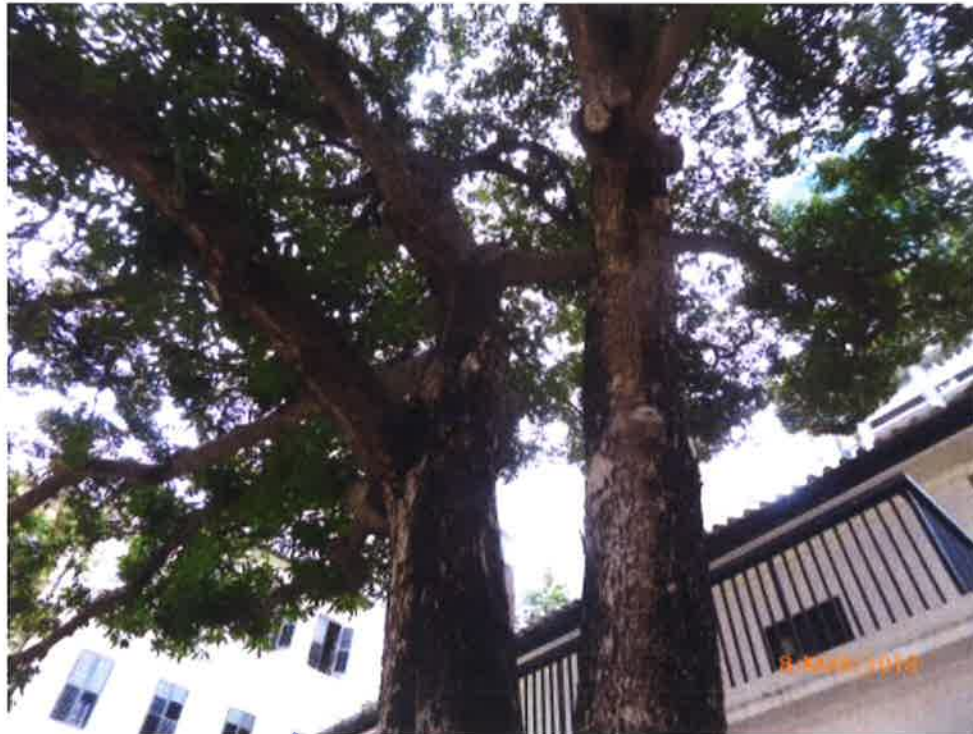
Fig. 5 Health condition of the upper trunk also is fair.

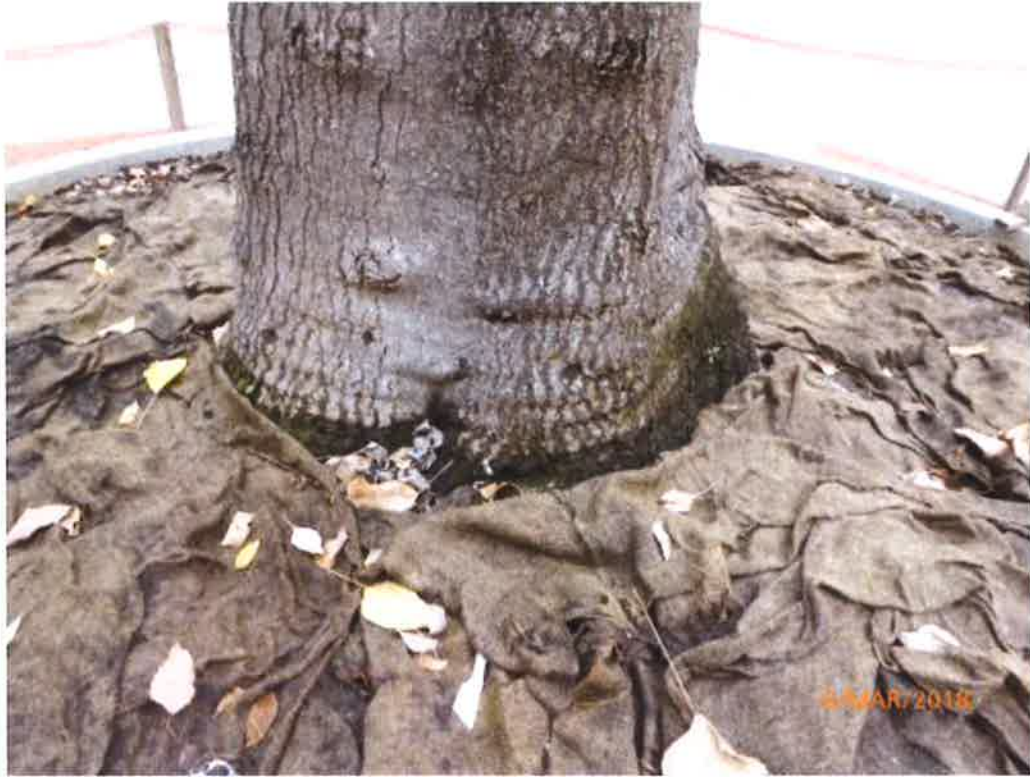
Fig 2. Root collar is normal. The planter is covered with wet hessian clothes.

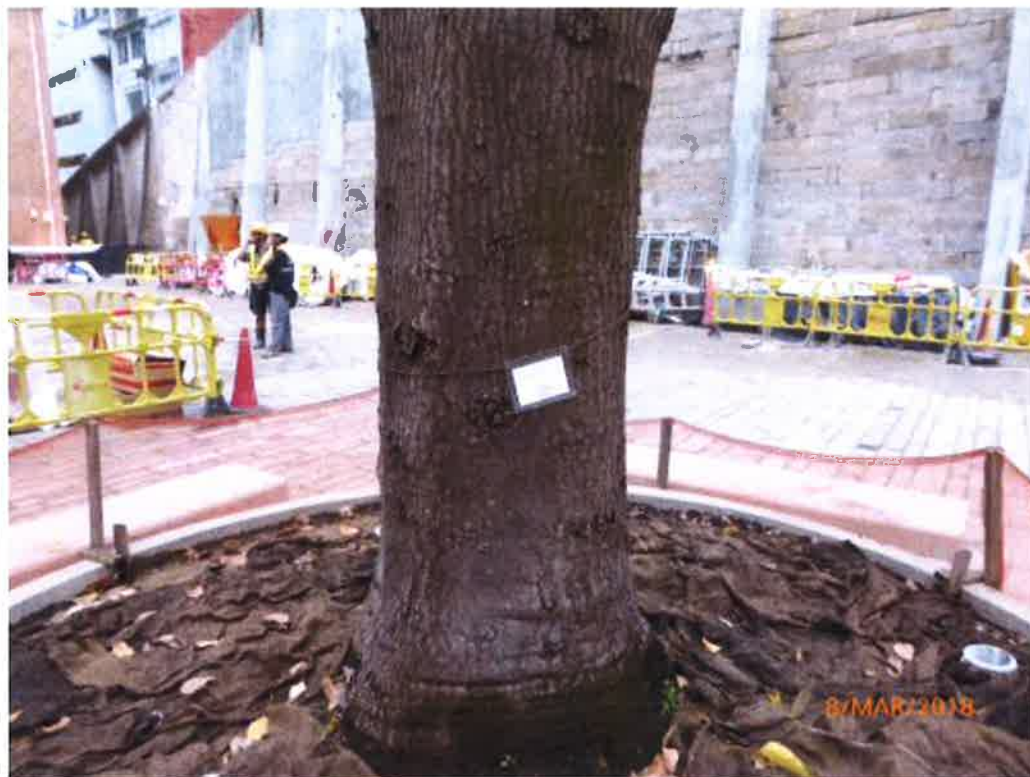
Fig 3. Health condition of the lower trunk is fair.

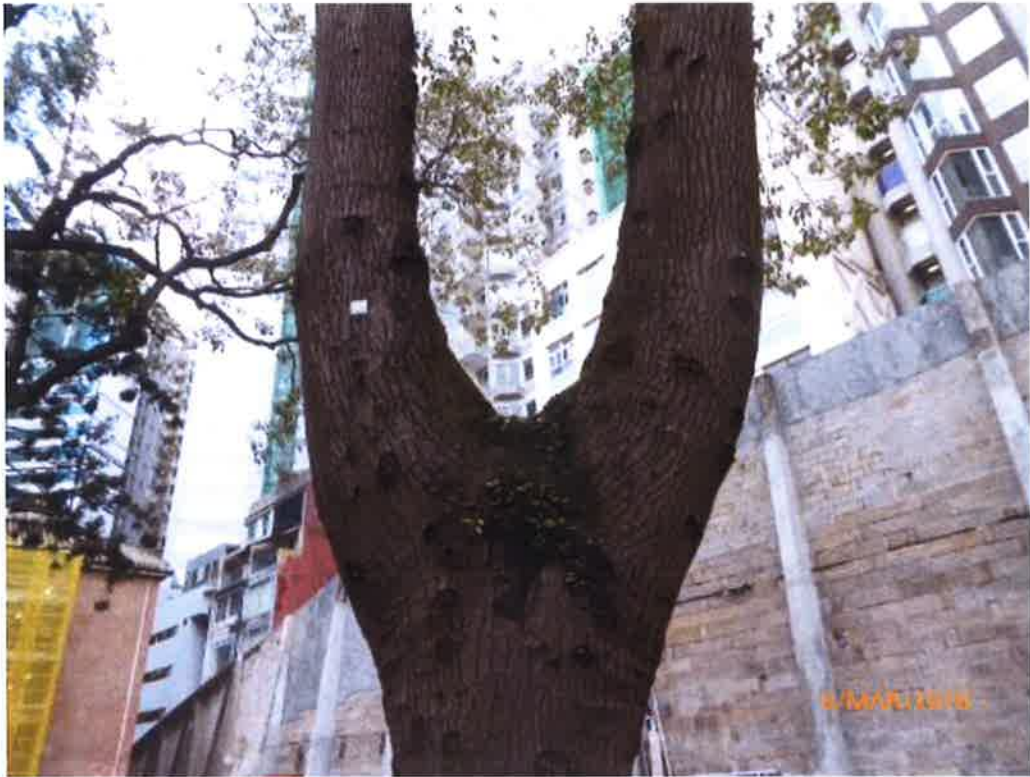
Fig. 4 Health condition of the mid trunk is fair.

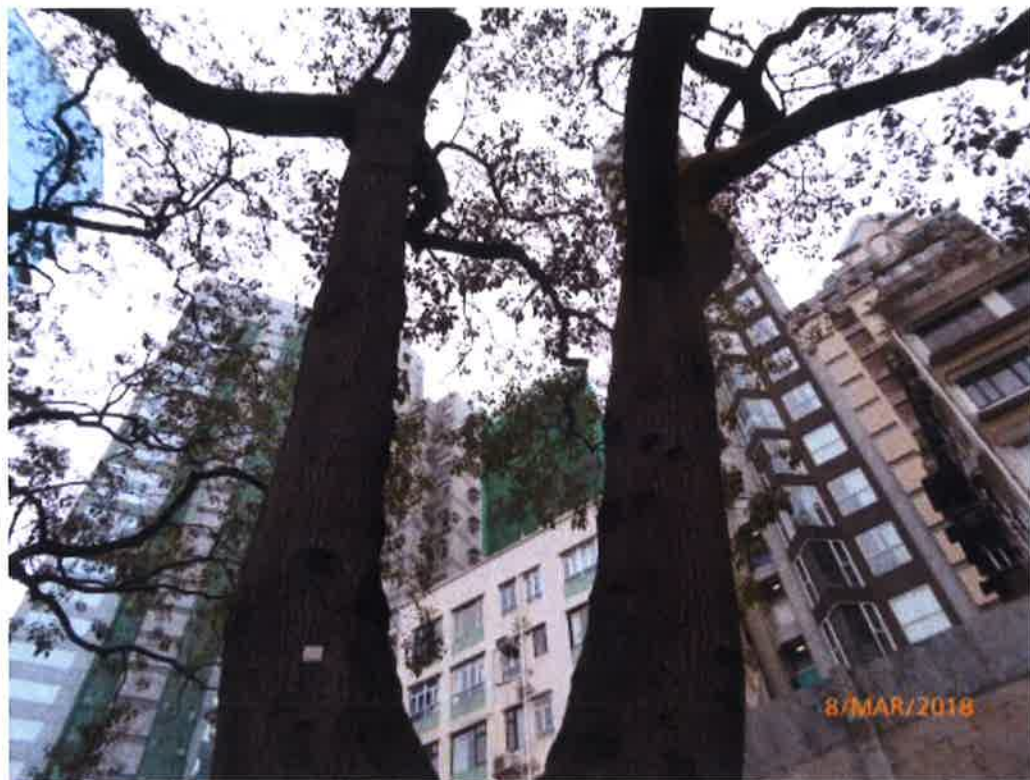
Fig. 5 Health condition of the upper trunk also is fair.

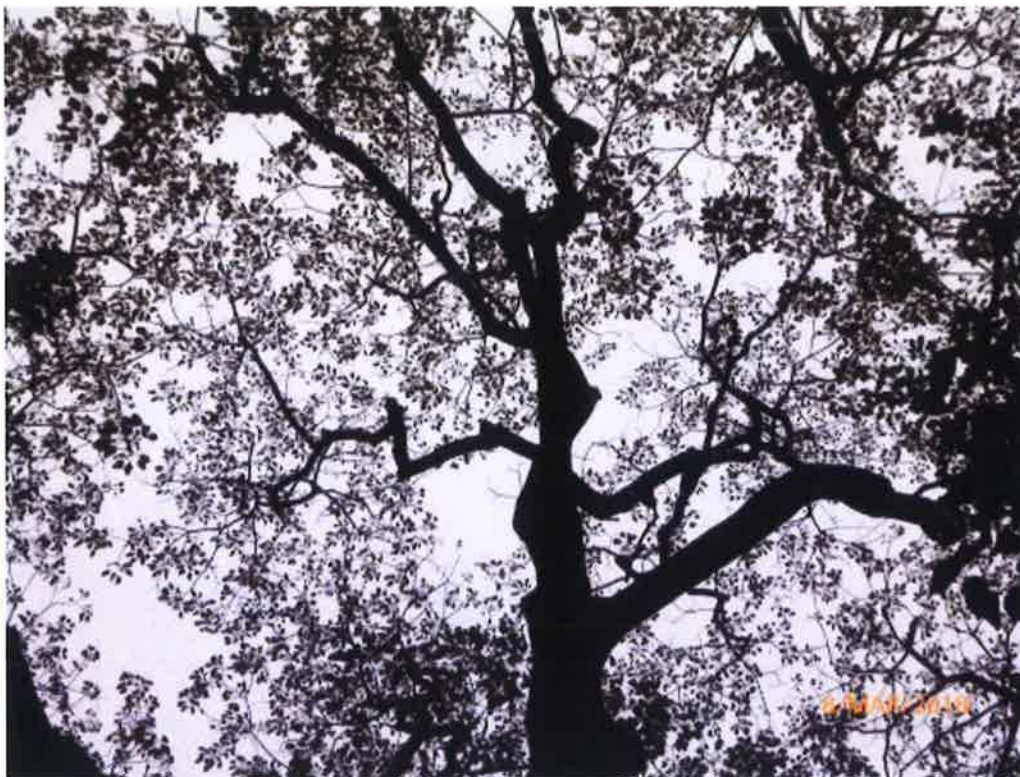
Fig. 6 Leaves on the crown are rather sparse.

1. Keep monitoring on the growth of the tree.

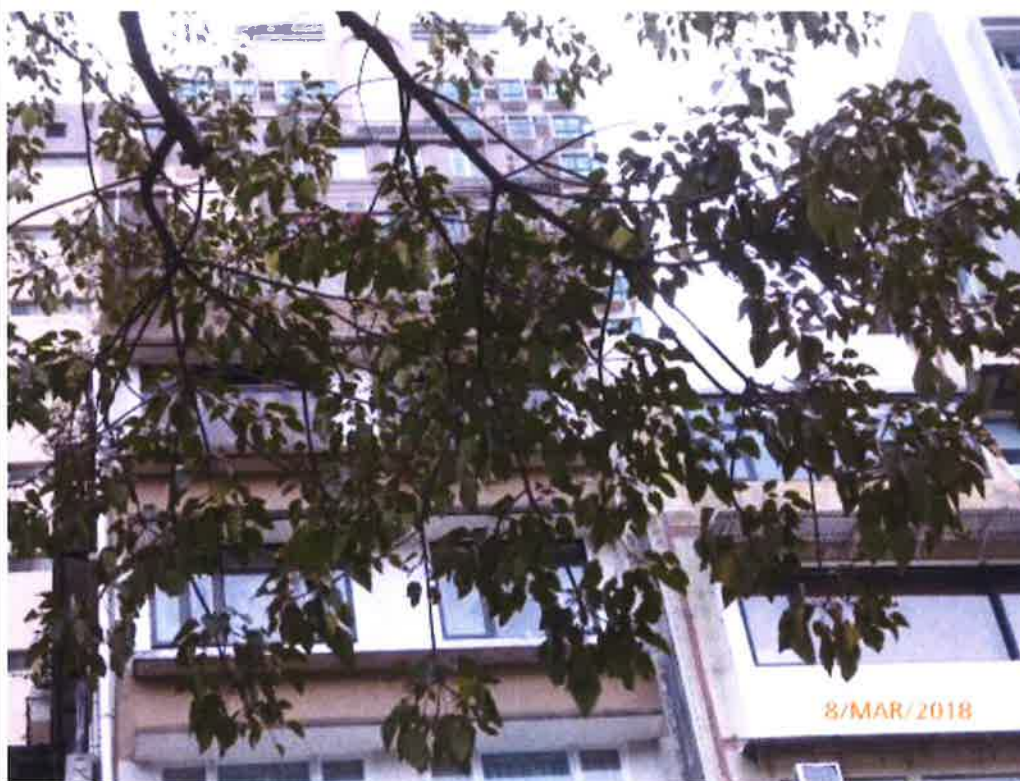
Fig. 7 Leaves on the lower branches are normal.

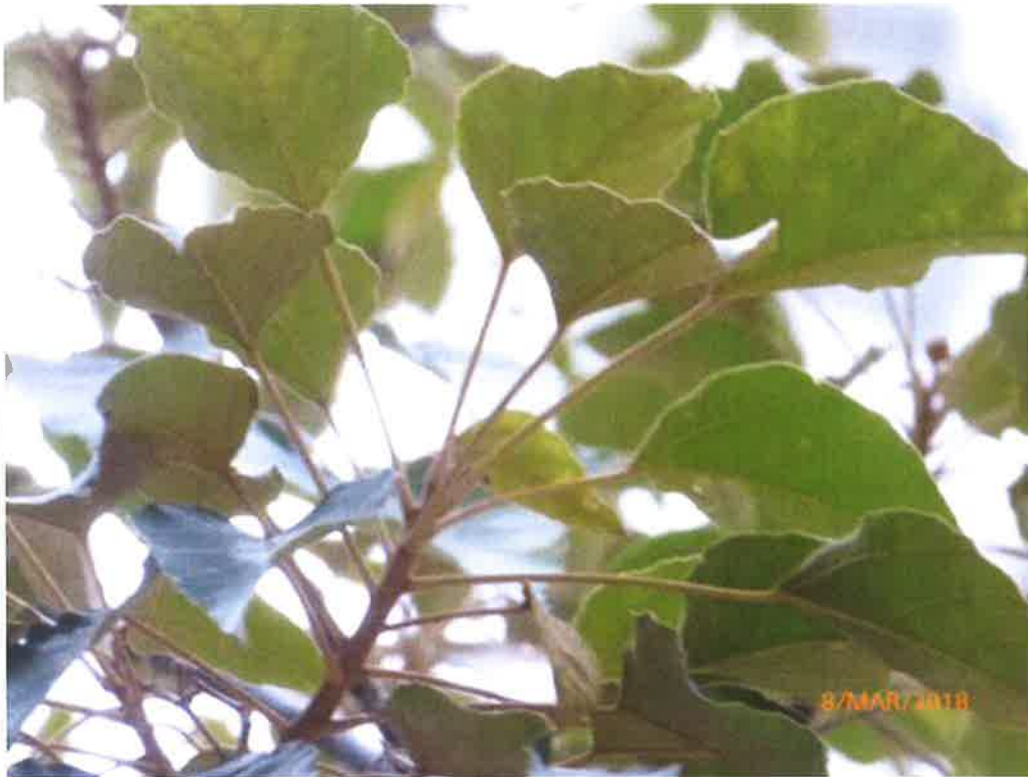
Fig. 8 Some young and green leaves appear on the tree.

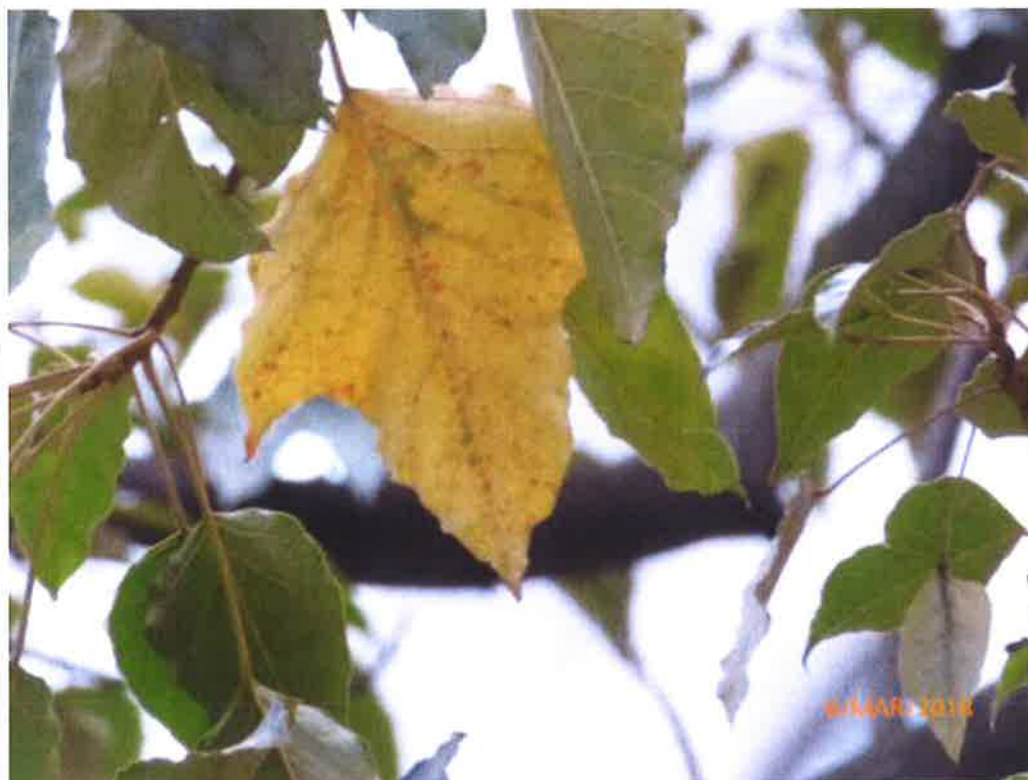
Fig. 9 A few faded leaves still remain on the tree.

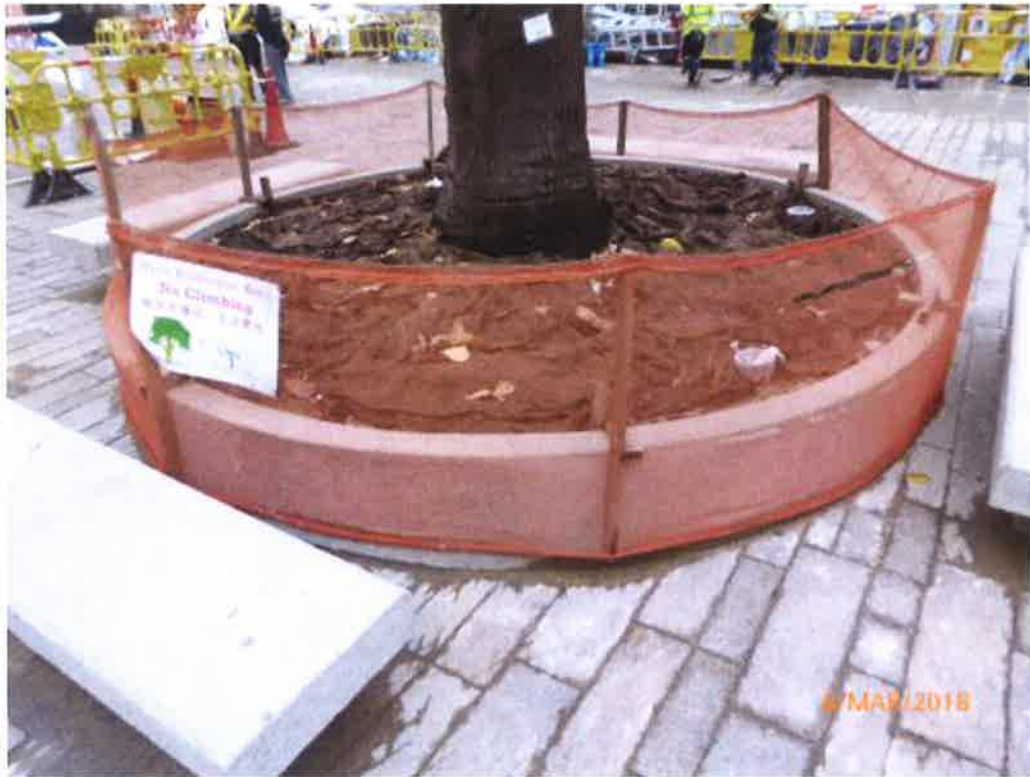
Fig. 10 The tree protection zone is in good order.

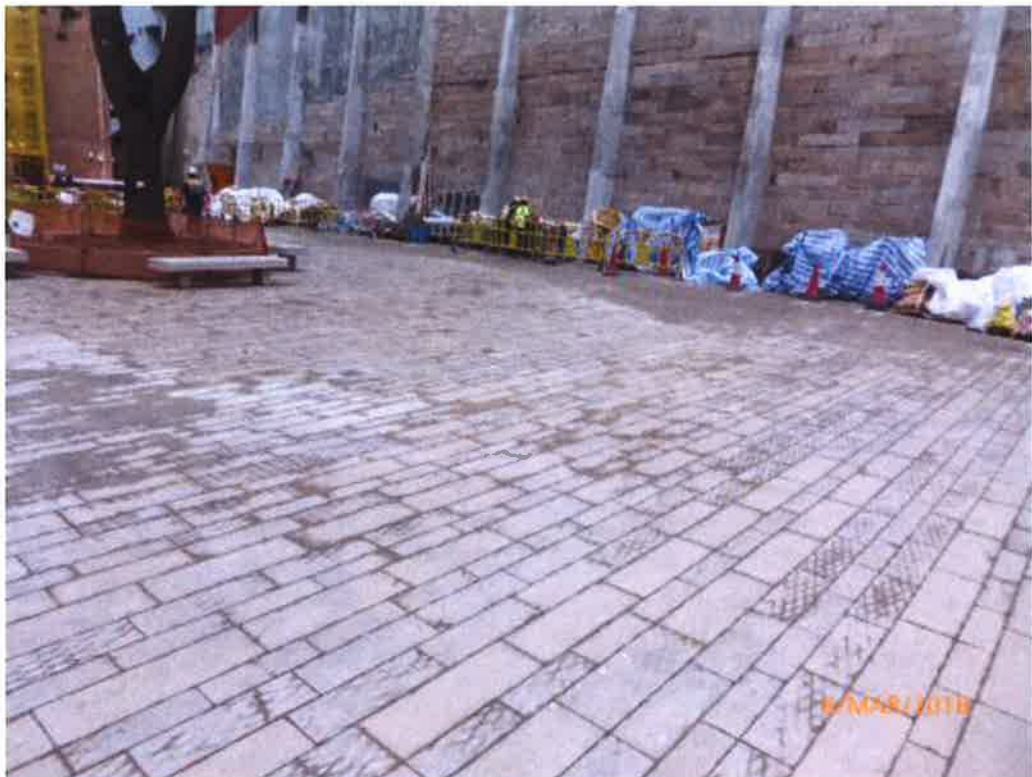
Fig. 11 The site near Tree-6 appears clean and tidy.

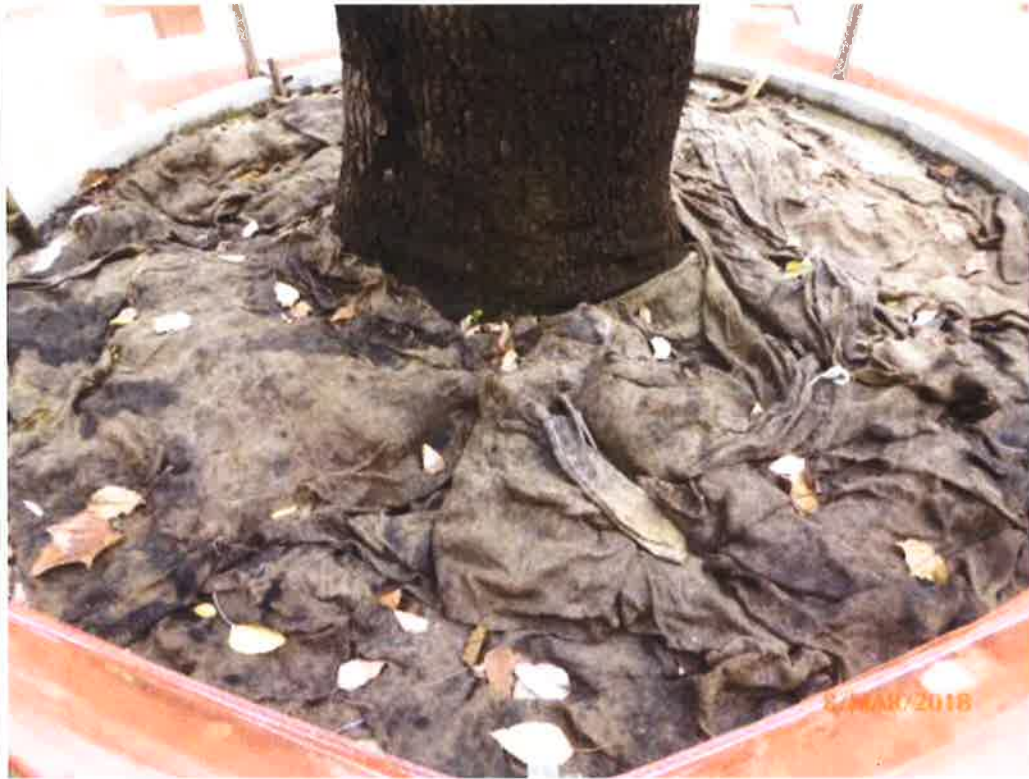
Fig. 2 Root collar is normal. The planter is covered with wet hessian clothes.

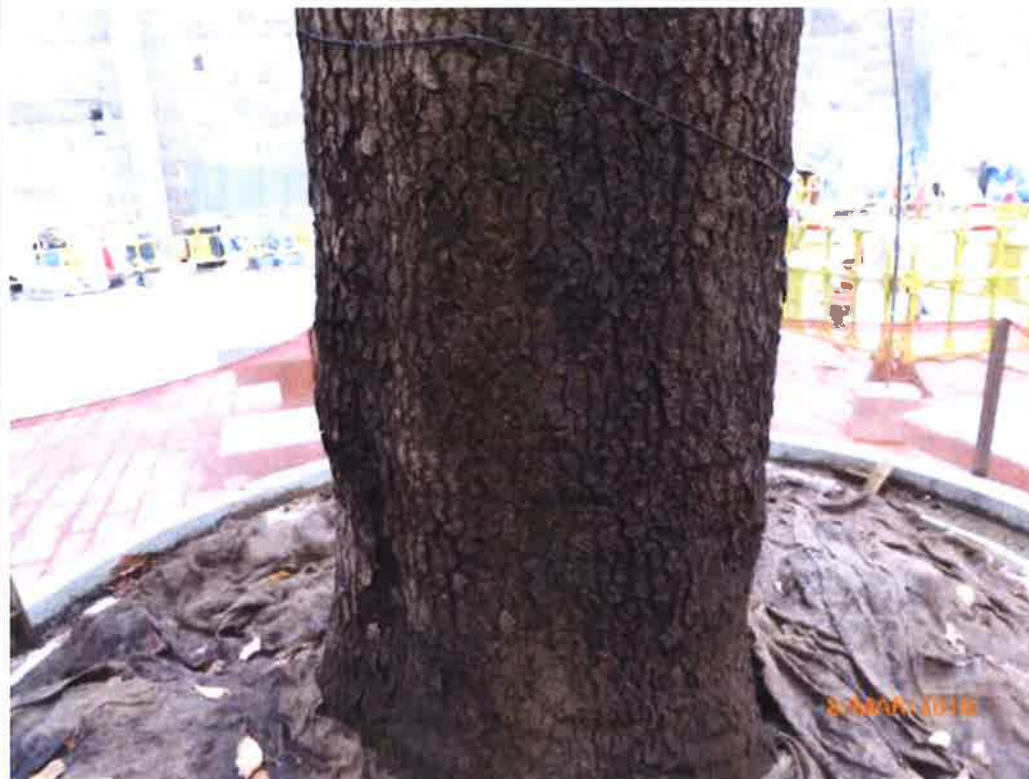
Fig 3. Health condition of the lower trunk is fair.

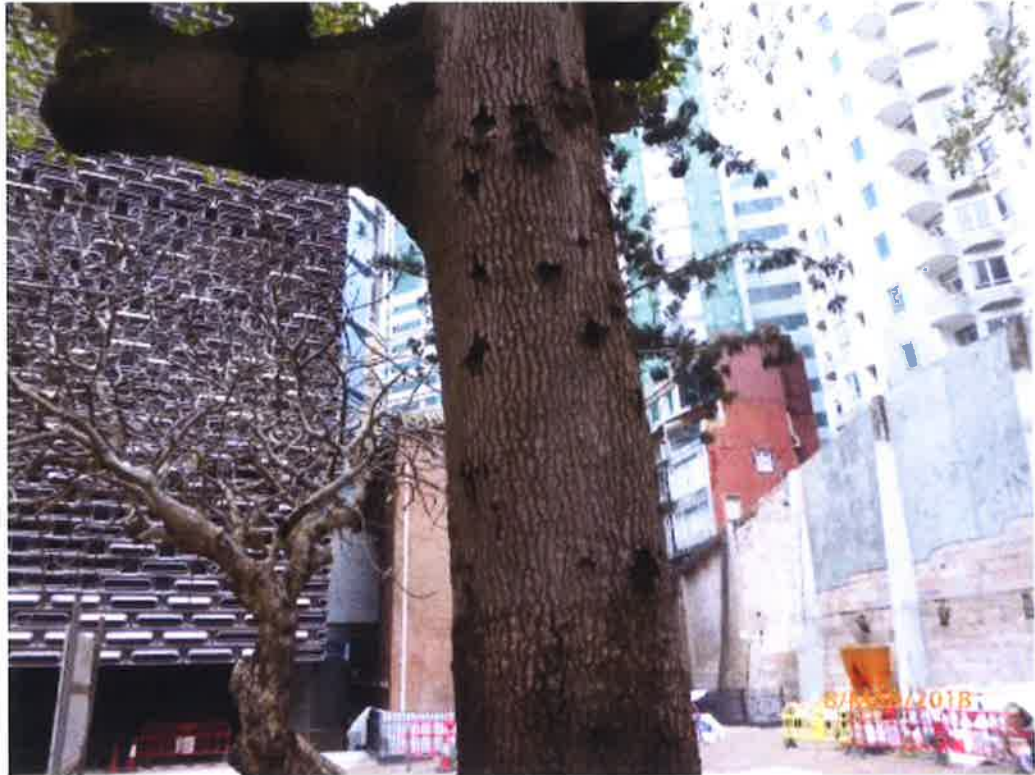
Fig. 4 Health condition of the mid trunk is fair.

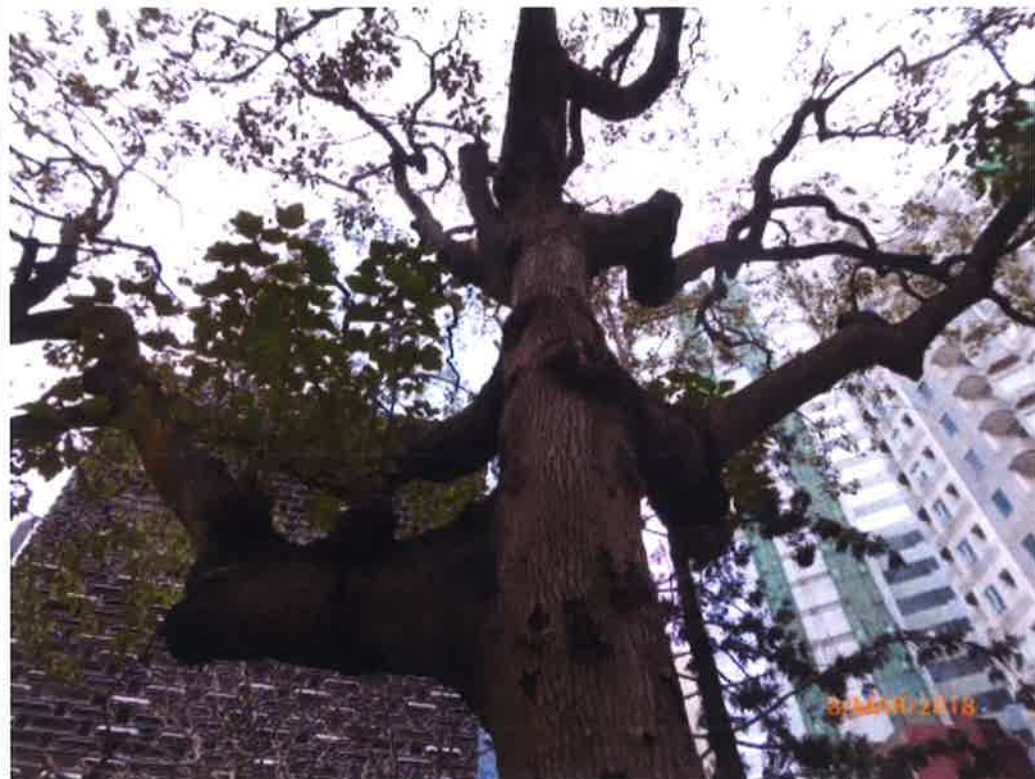
Fig. 5 Health condition of the upper trunk also is fair.

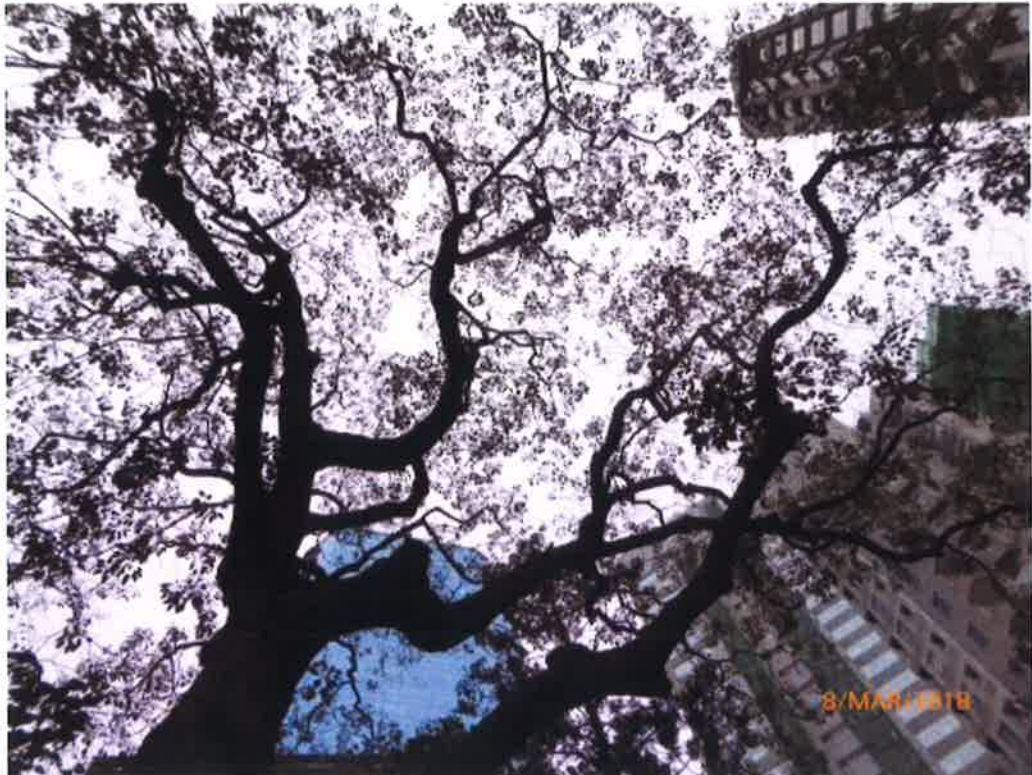
Fig. 6 Leaves on the crown are rather sparse.

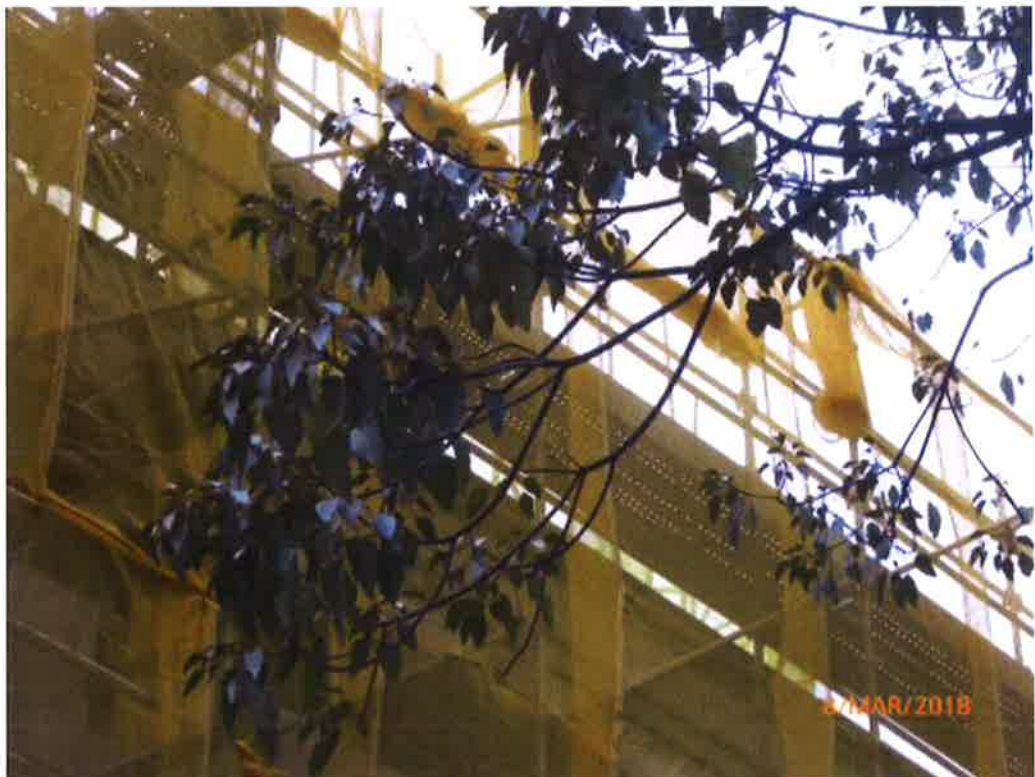
Fig. 7 Leaves on the lower branches are normal.

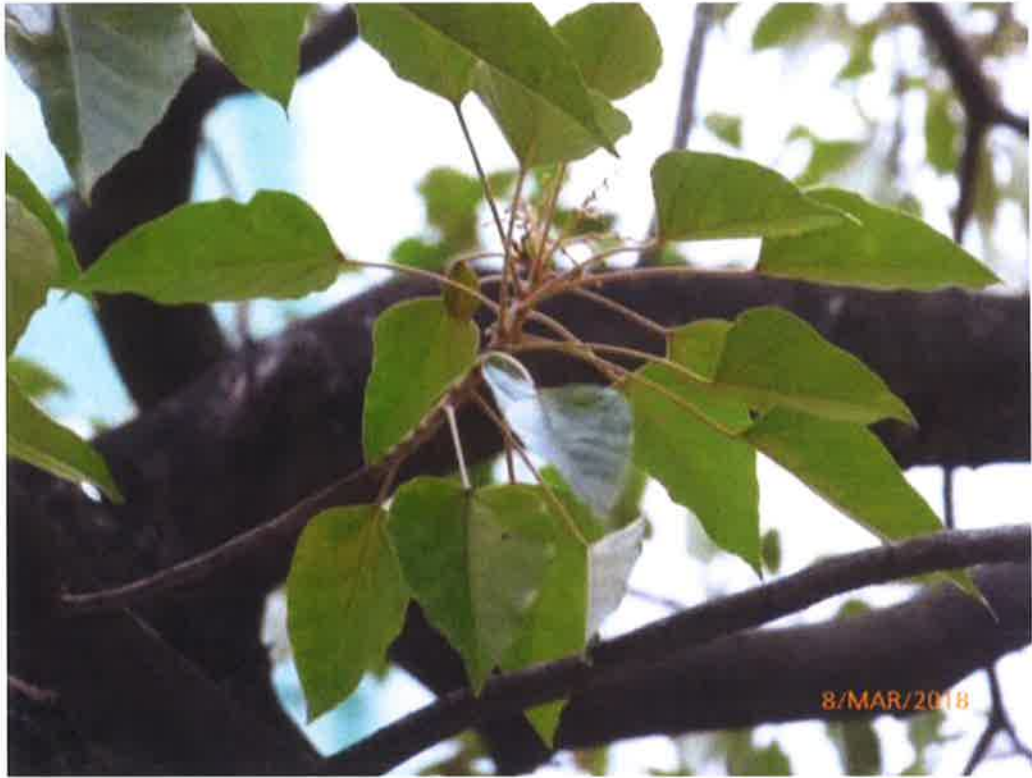
Fig. 8 Some young and green leaves appear on the tree.

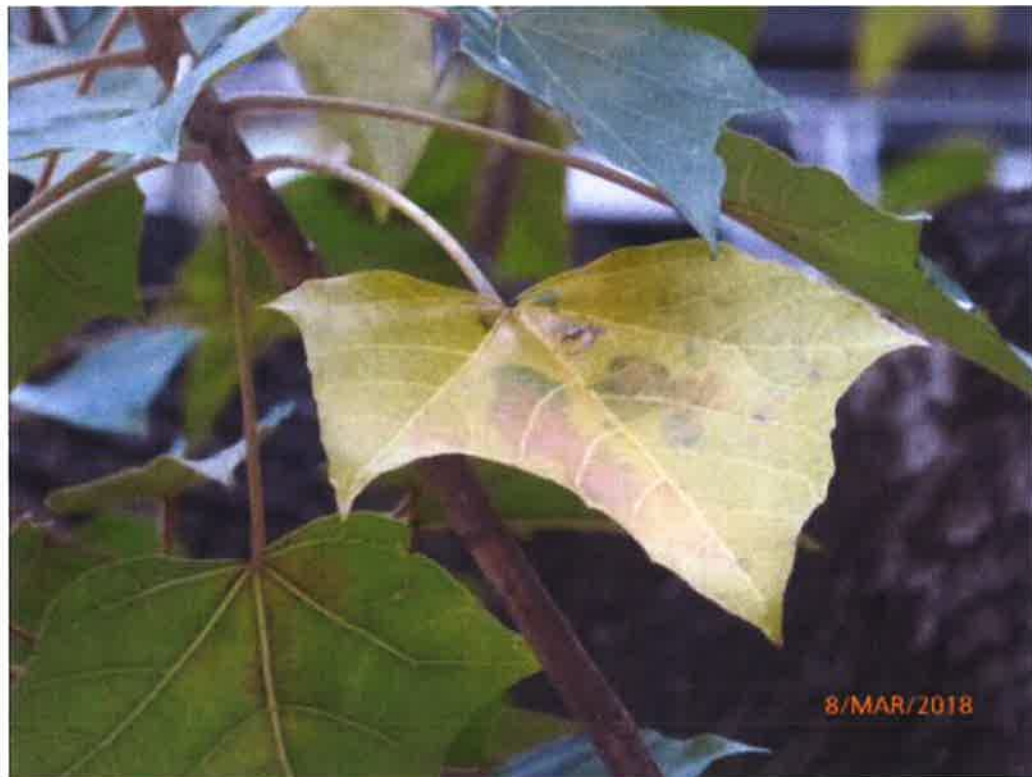
Fig. 9 A few faded leaves still remain on the tree.

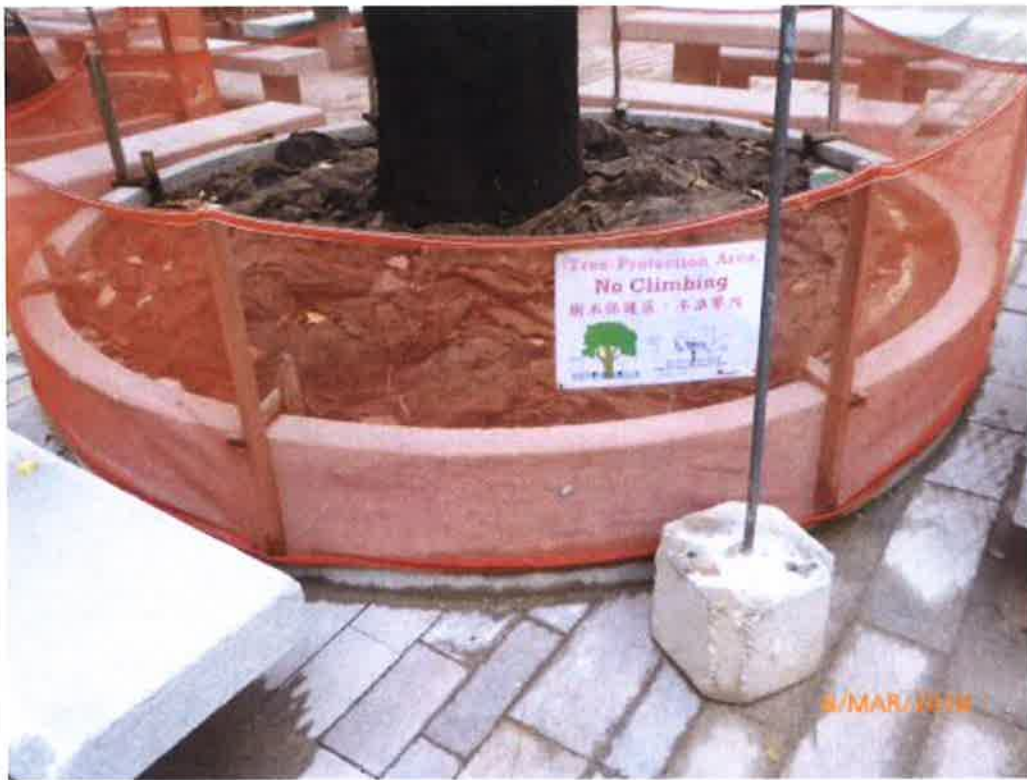
Fig. 10 The tree protection zone is in good order.

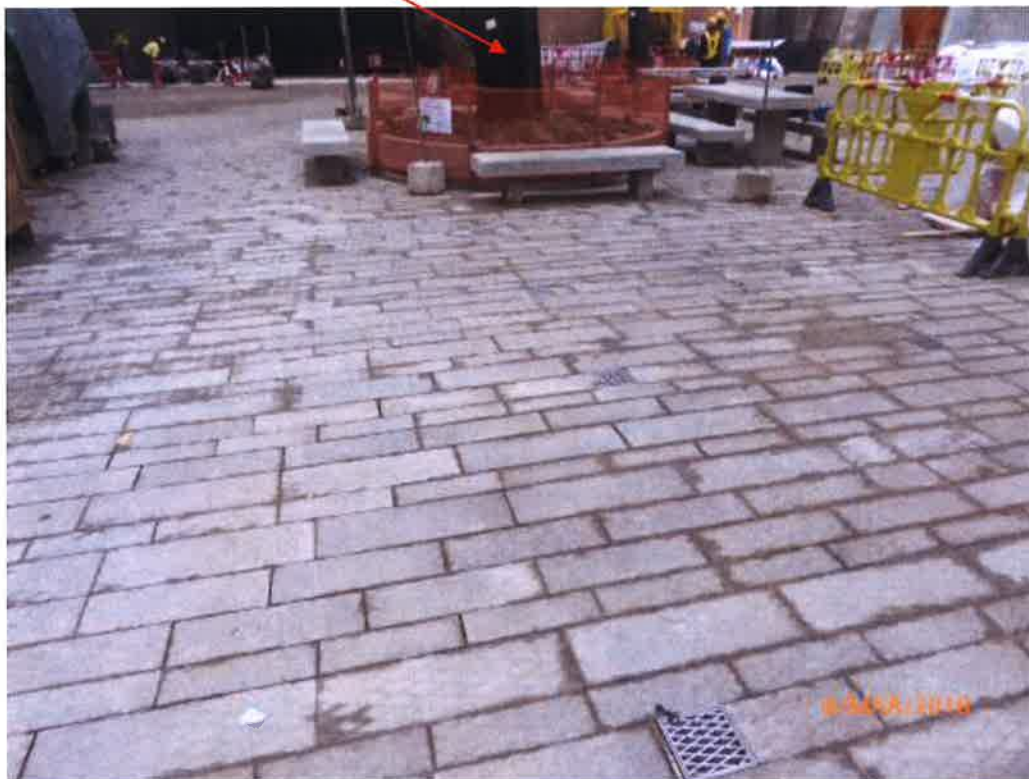
Fig. 11 The site near Tree-7 appears clean and tidy.

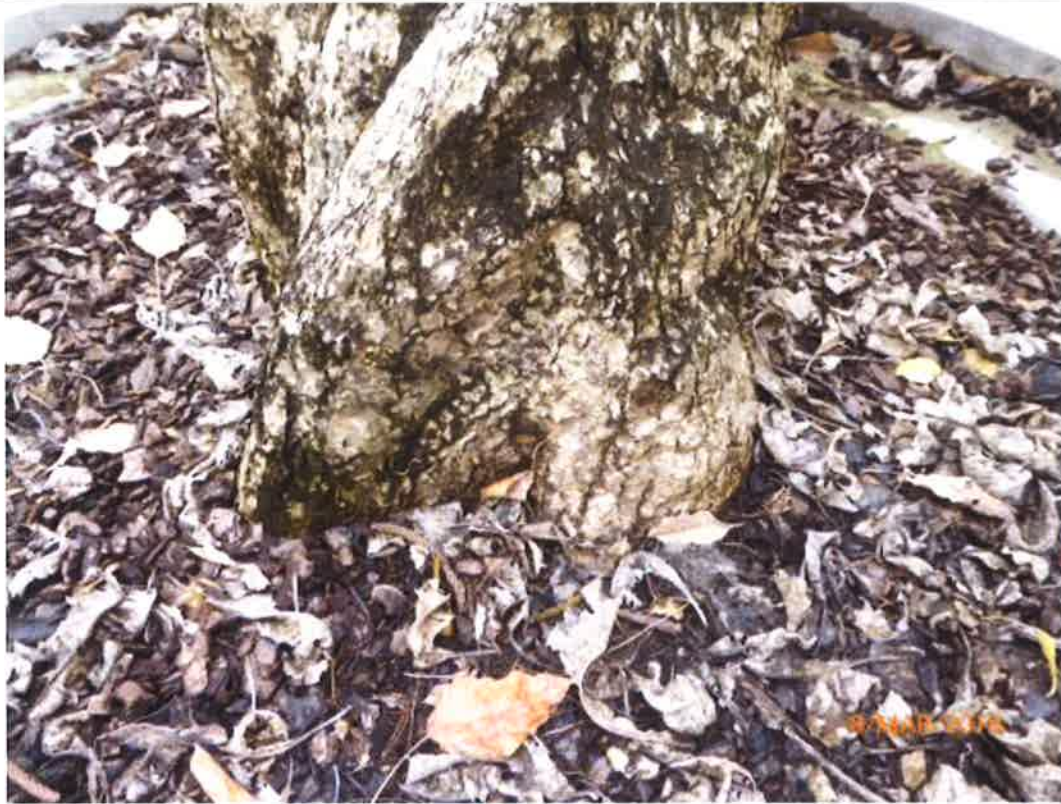
Fig. 2 Root collar is normal. The planter is covered with mulch and dry leaves.

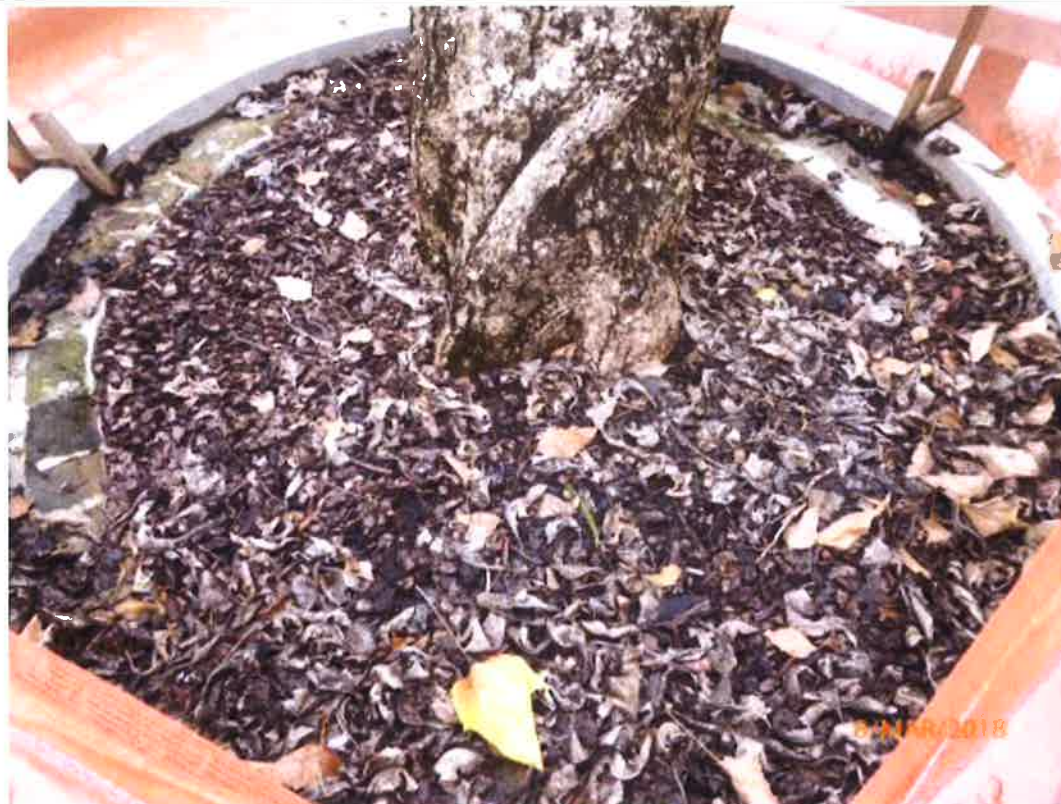
Fig. 3 The planter is covered with mulch and dry leaves.

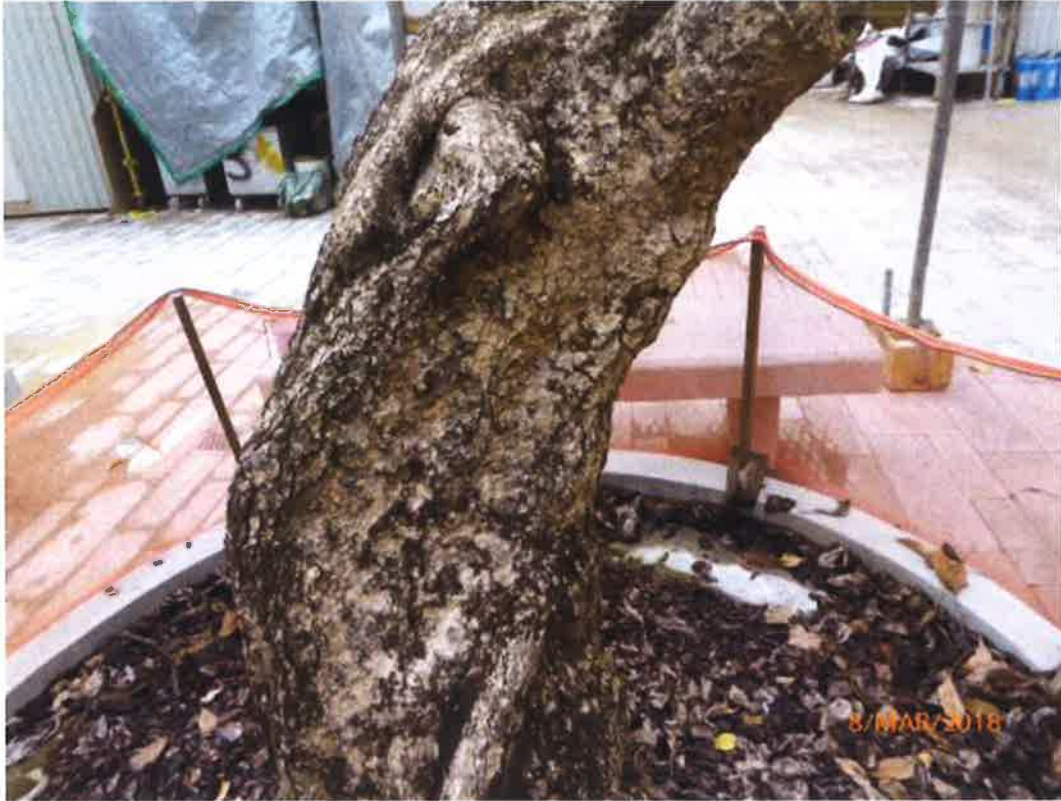
Fig. 4 Health condition of the lower trunk is fair.

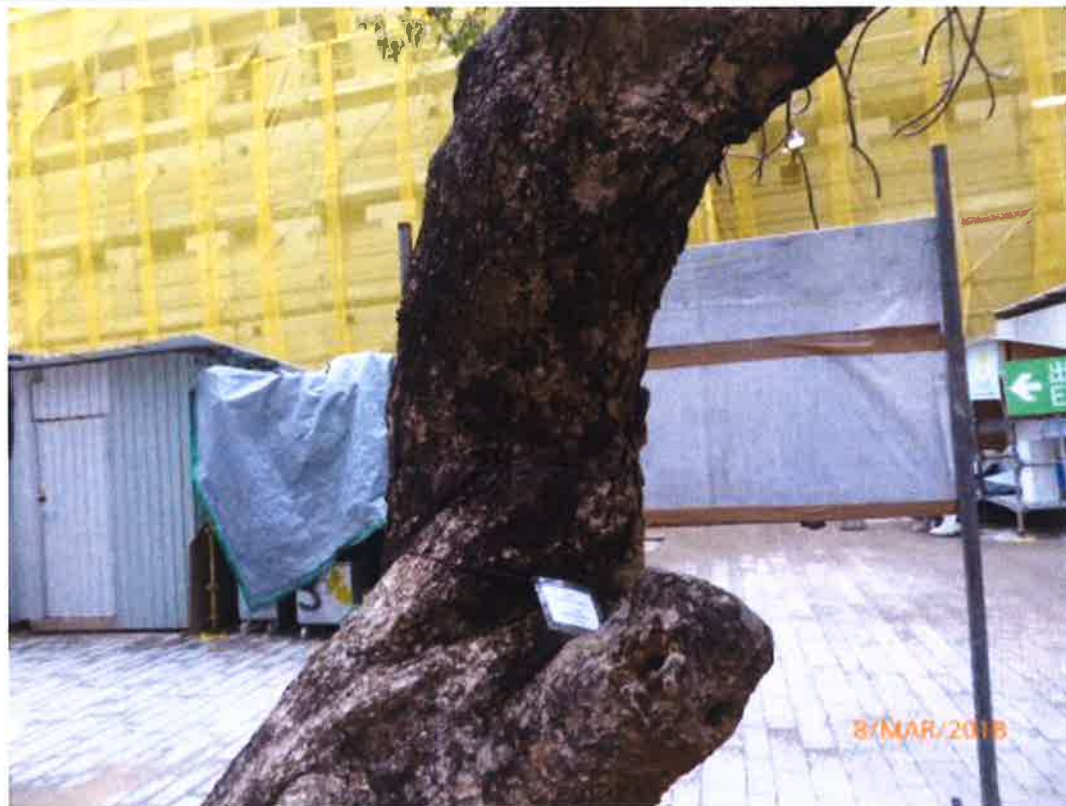
Fig. 5 Health condition of the mid trunk is fair.
