Central Police Station Conservation
and Revitalisation Project:
77th Monthly EM&A Report
(1 March to 31 March 2018)

Issue Date: April 2018

Reference 0095646

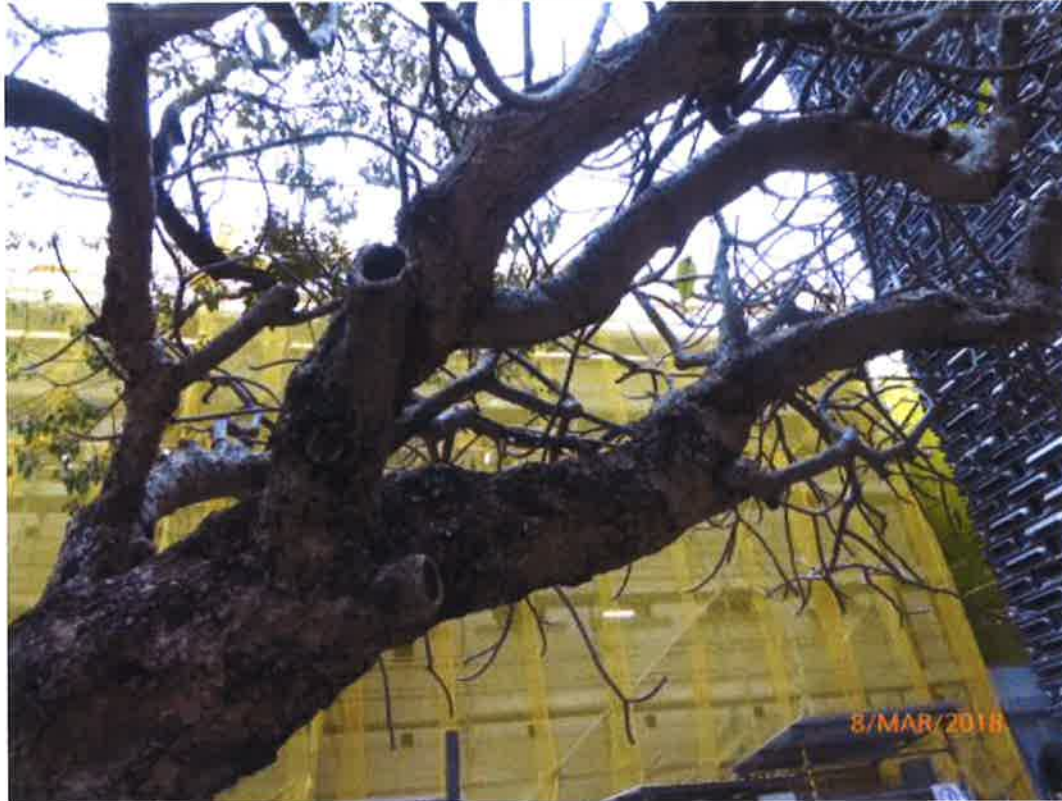
Fig. 6 Health condition of the upper trunk also is fair.

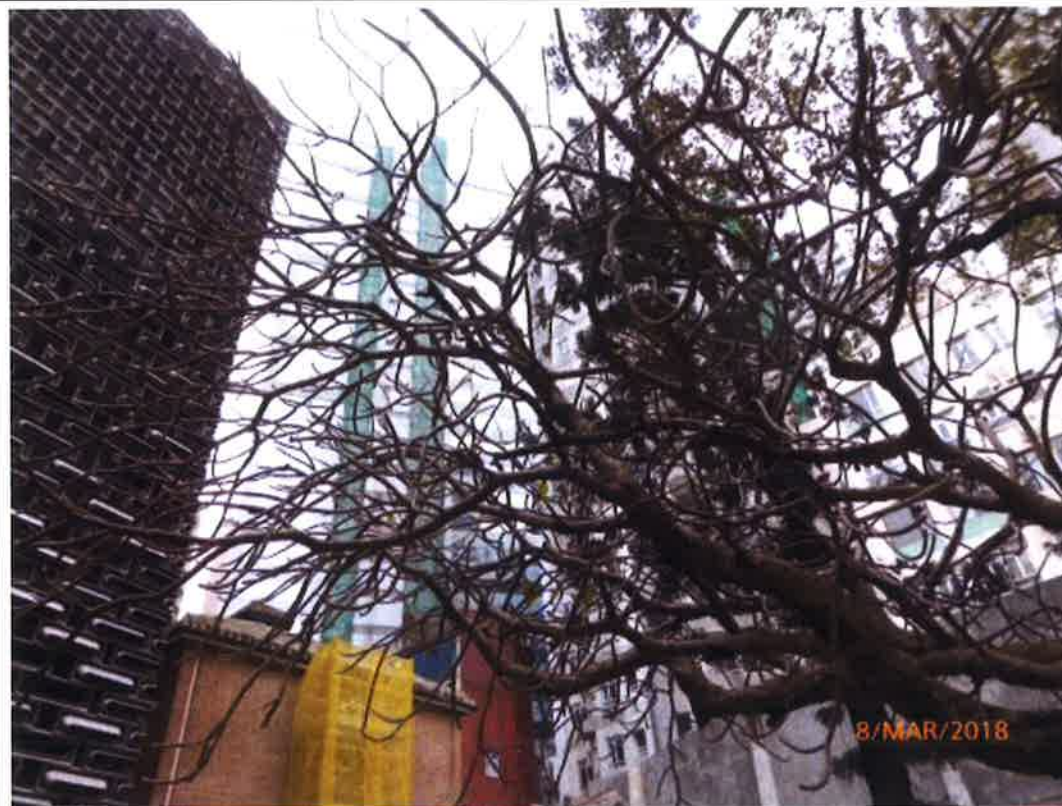
Fig. 7 As dry season has come, leaves are sparse on the tree.

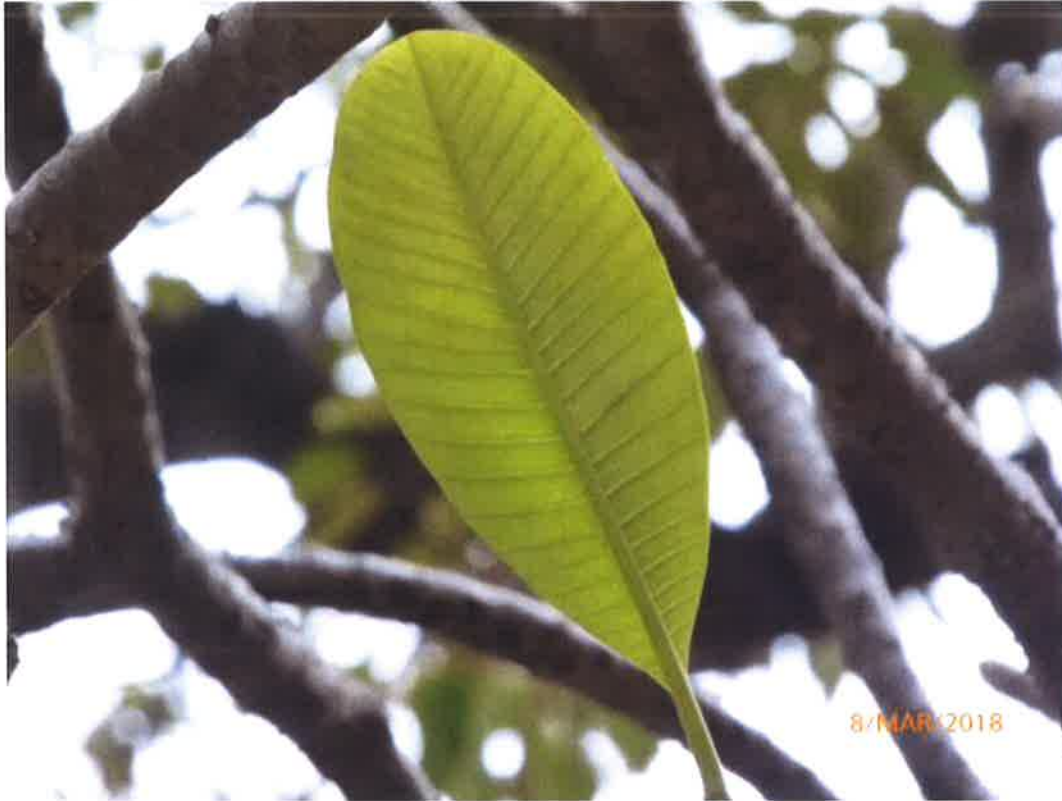
Fig. 8 Only a few leaves still remain on the lower branches.

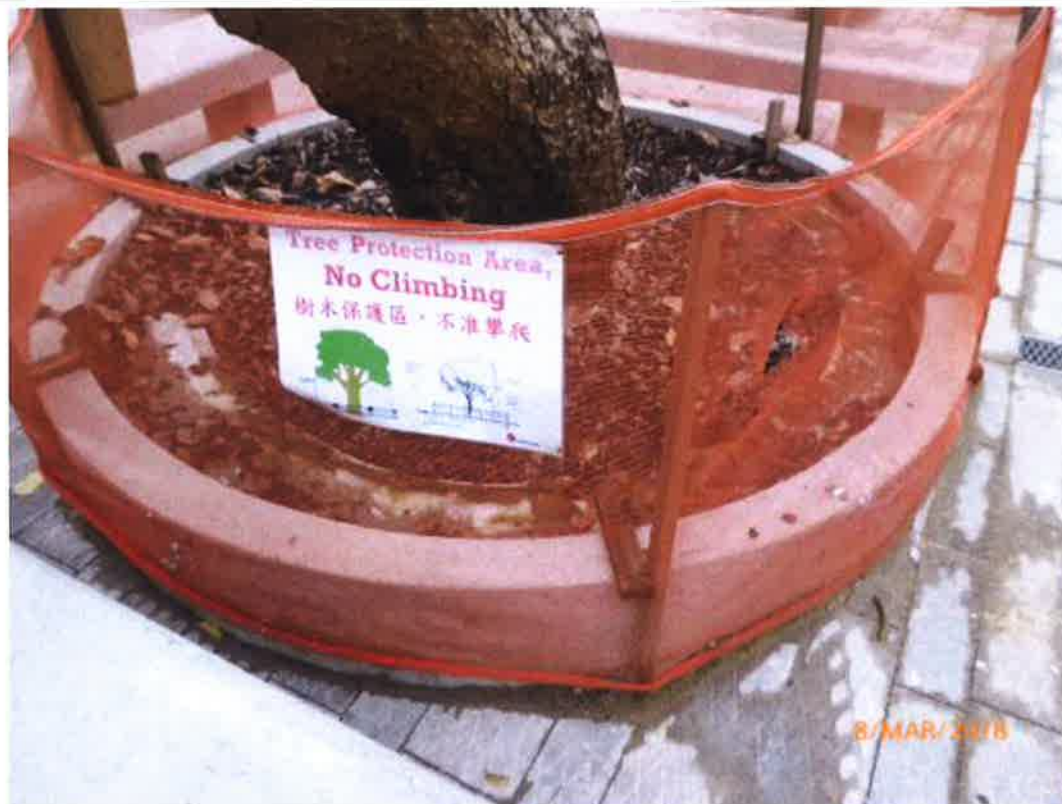
Fig. 9 The tree protection zone is in good order.

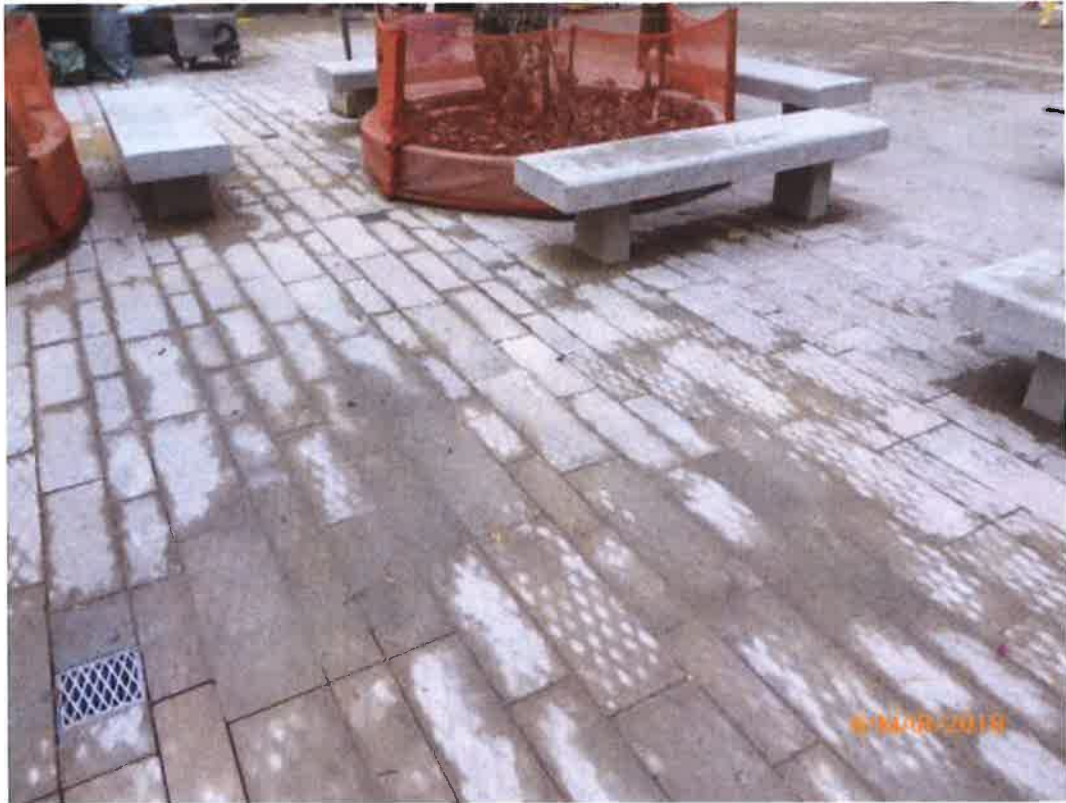
Fig. 10 The site near the planter appears clean and tidy.

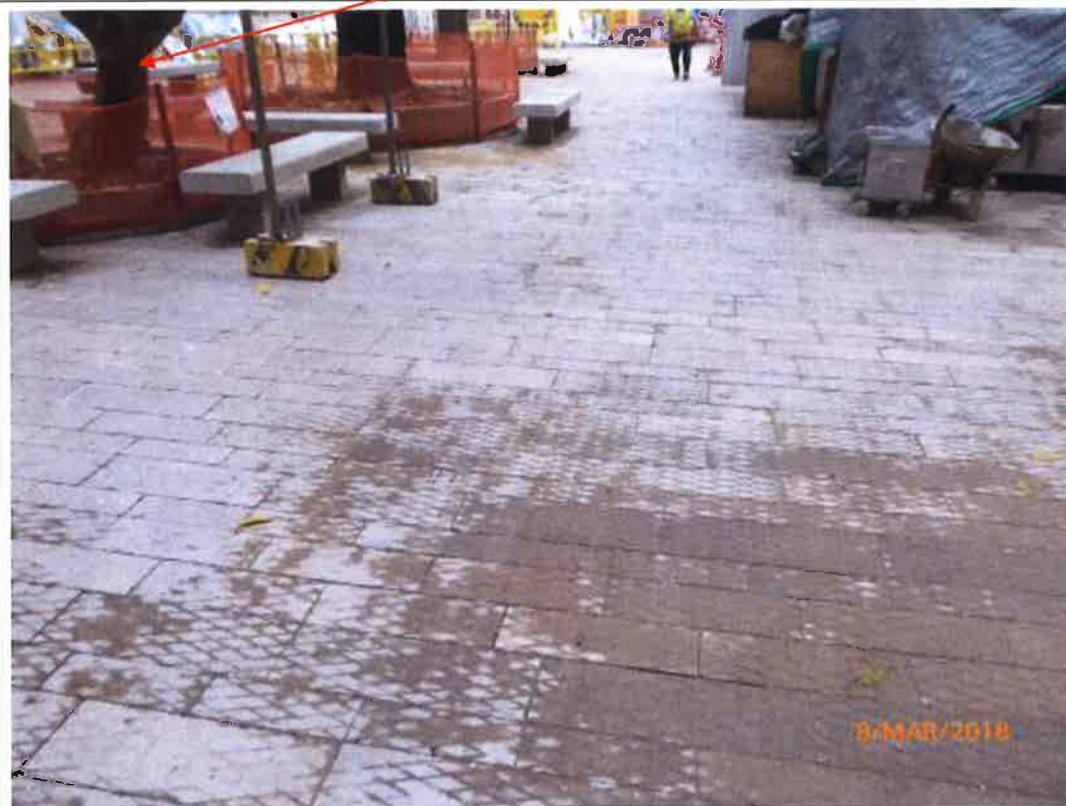
Fig. 11 The access near Tree-8 also is clean and tidy.

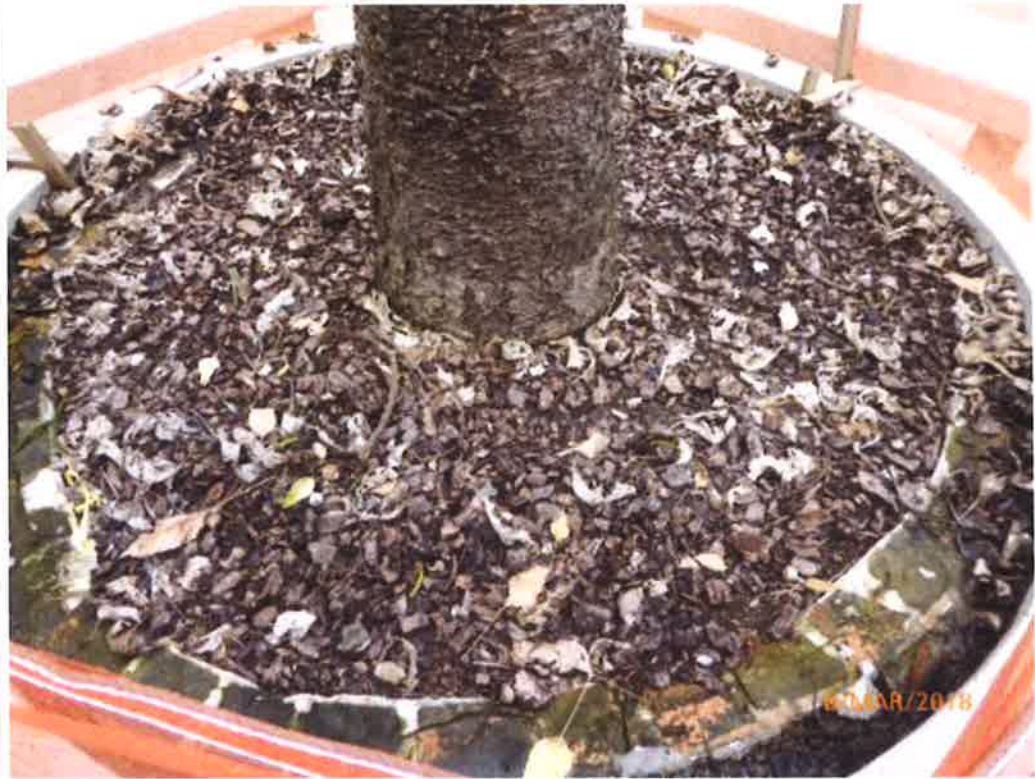
Fig. 2 Root collar is normal. The planter is covered with mulch and dry leaves.

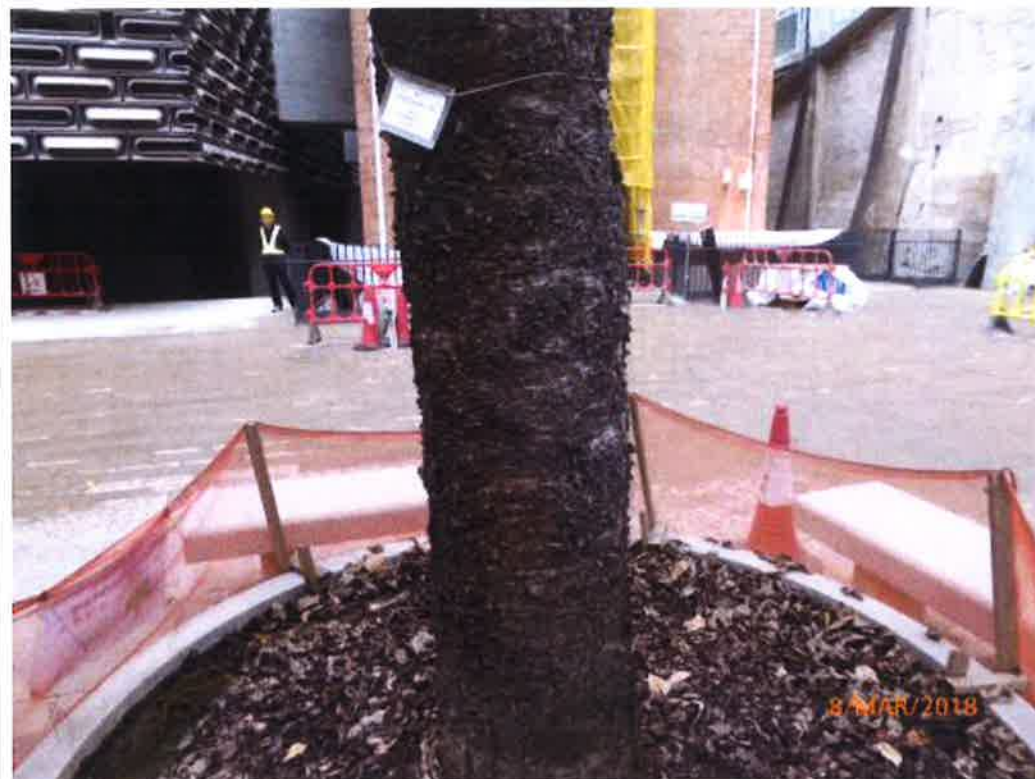
Fig. 3 Health condition of the lower trunk is fair.

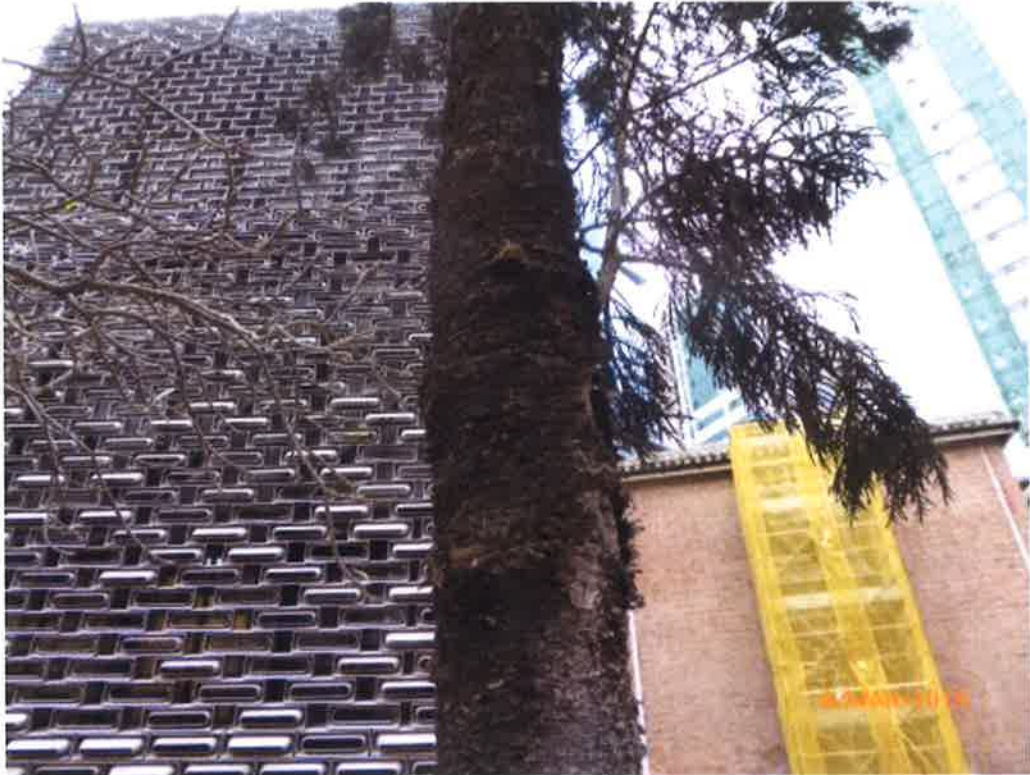
Fig. 4 Health condition of the mid trunk is fair.

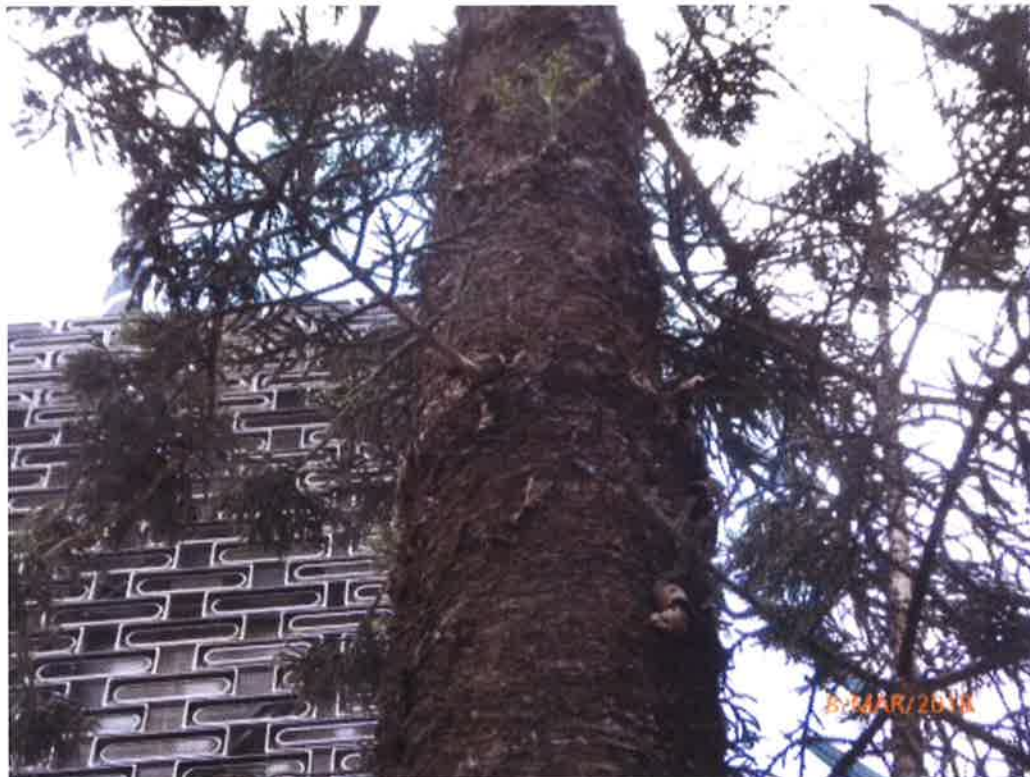
Fig. 5 Health condition of the upper trunk also is fair.

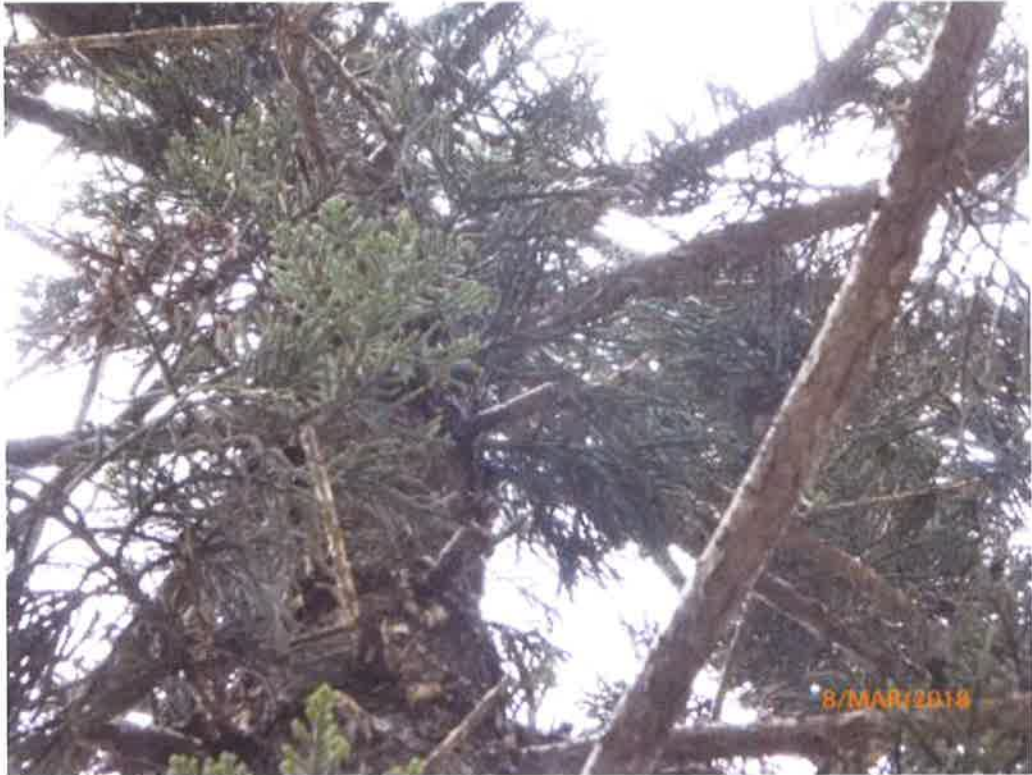
Fig. 6 The crown is full of vigorous and green leaves.

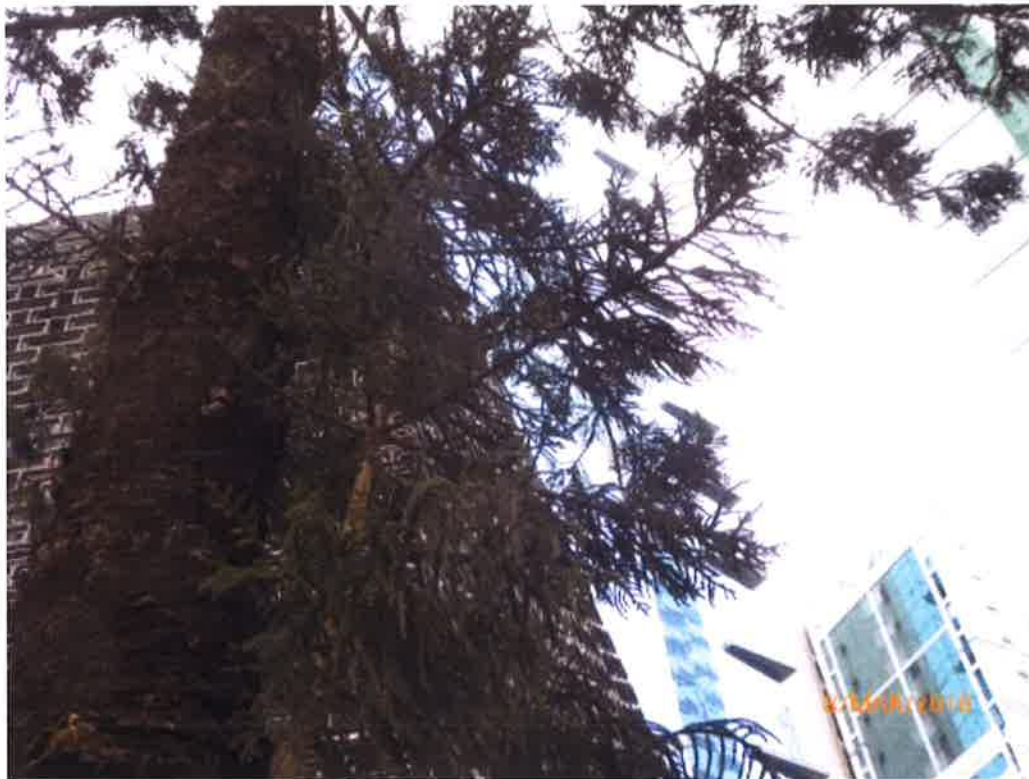
Fig. 7 Vigorous and green leaves also are growing on the lower branches.

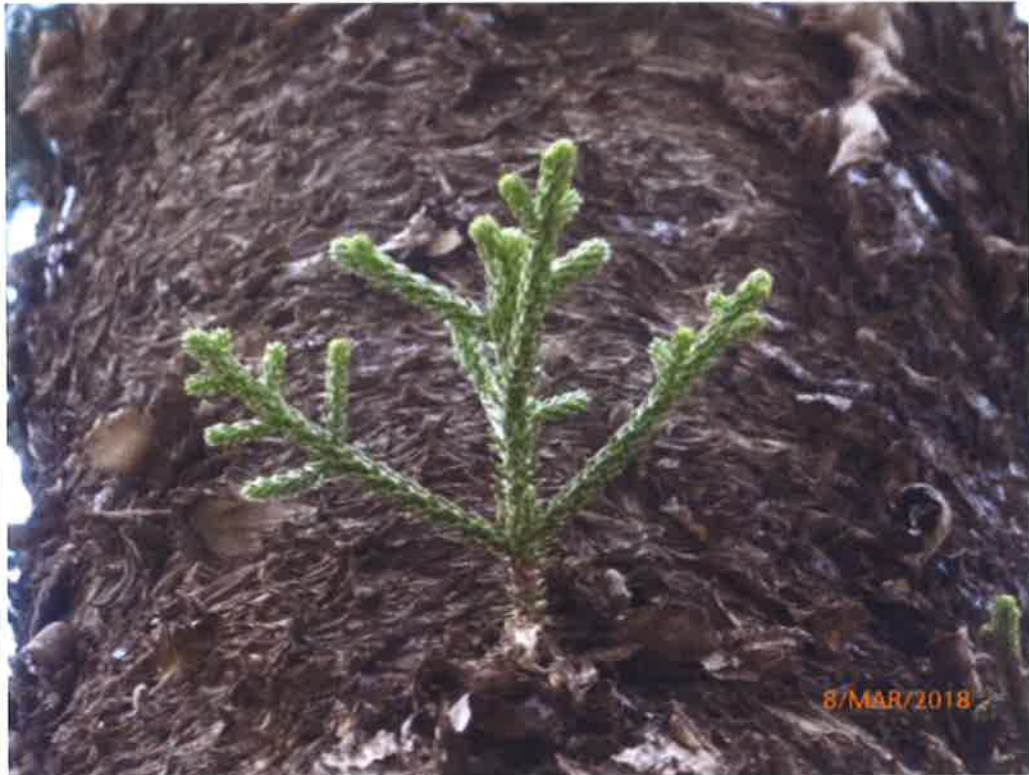
Fig. 8 Some young and green leaves appear on the mid trunk.

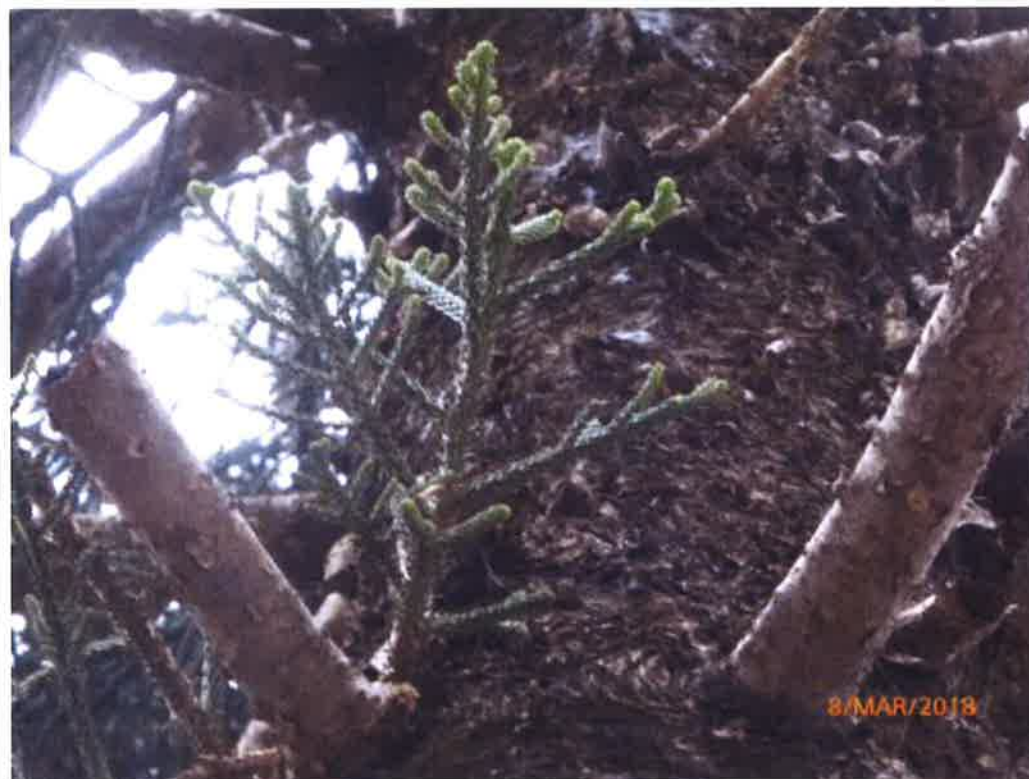
Fig. 9 A few young and green leaves also appear on the upper branches.

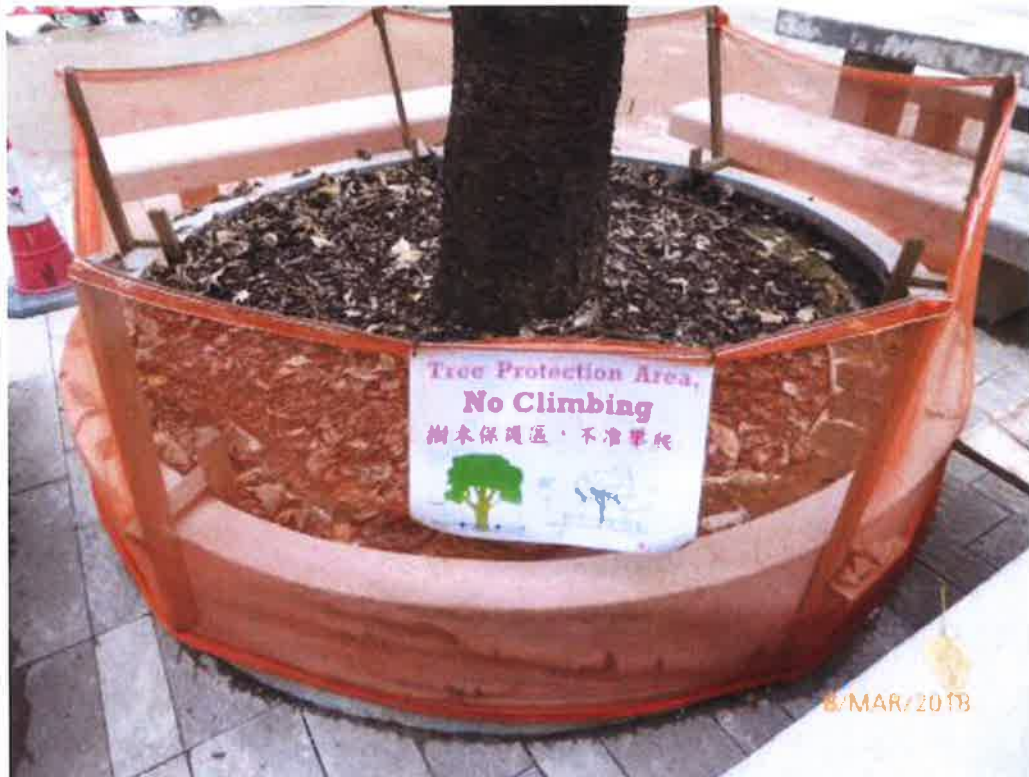
Fig. 10 The tree protection zone is in good order.

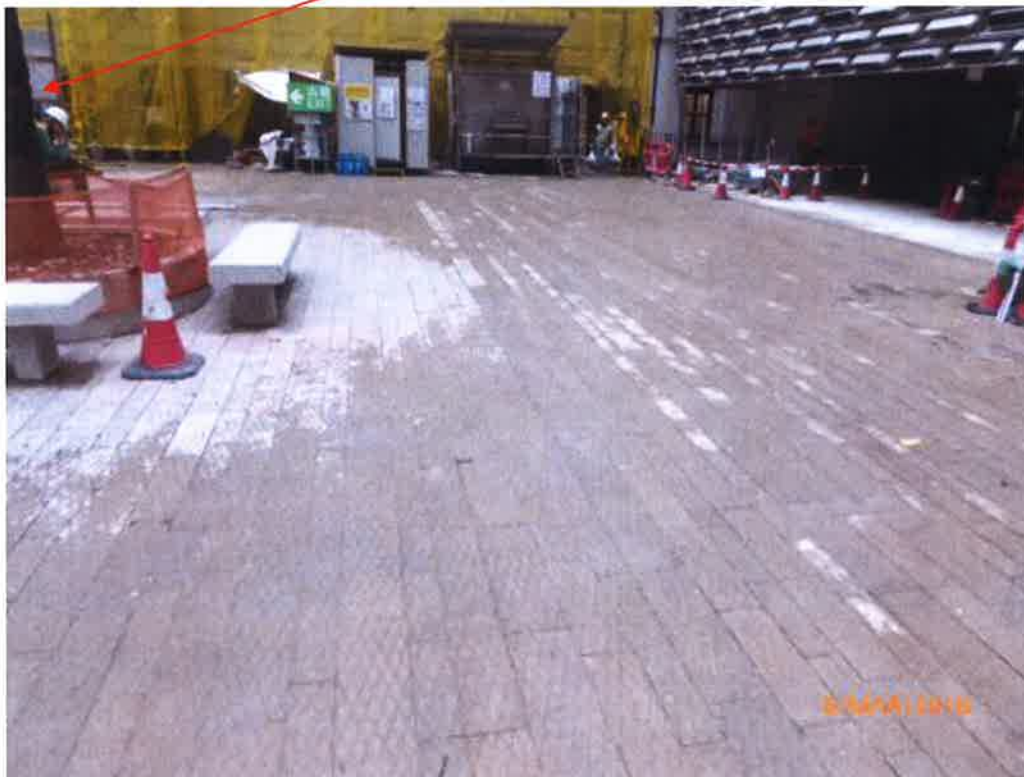
Fig. 11 The site near Tree-9 is clean and tidy.

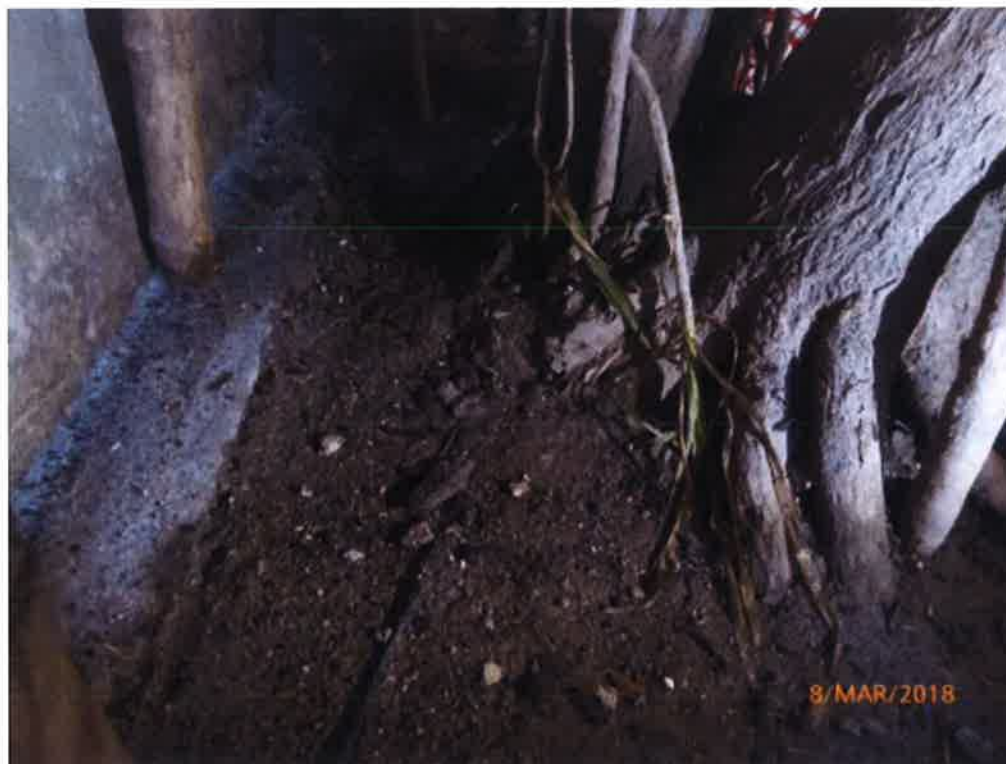
Fig. 3 Cleanliness of the planter is acceptable.

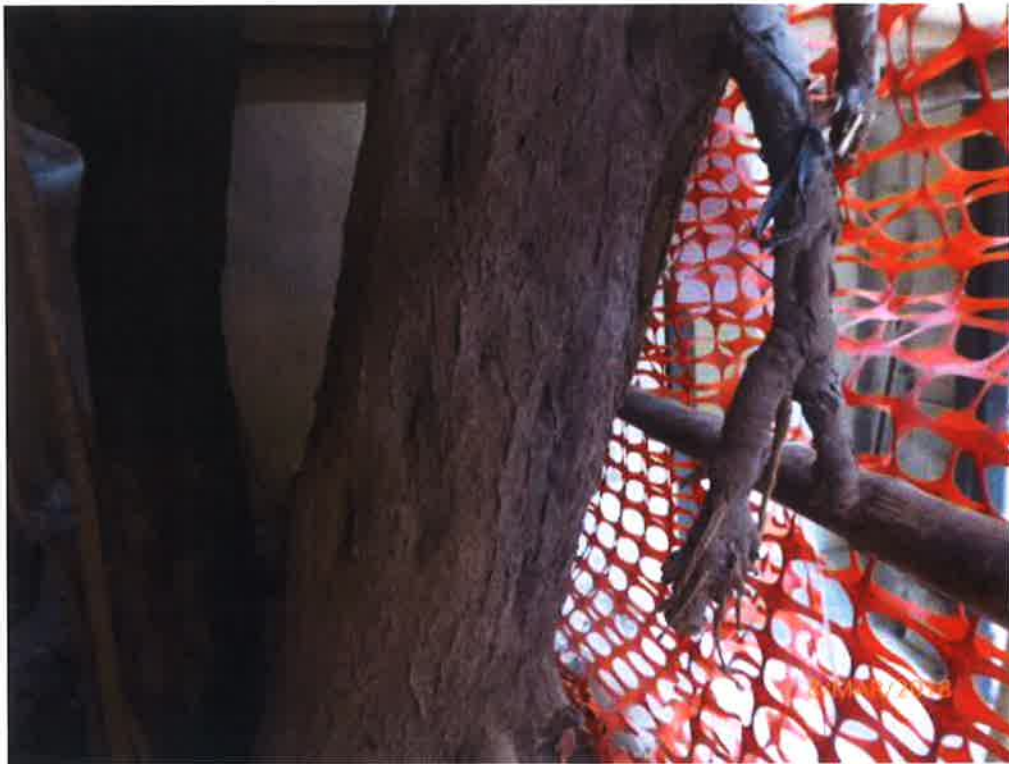
Fig. 4 Health condition of the lower trunk is fair.

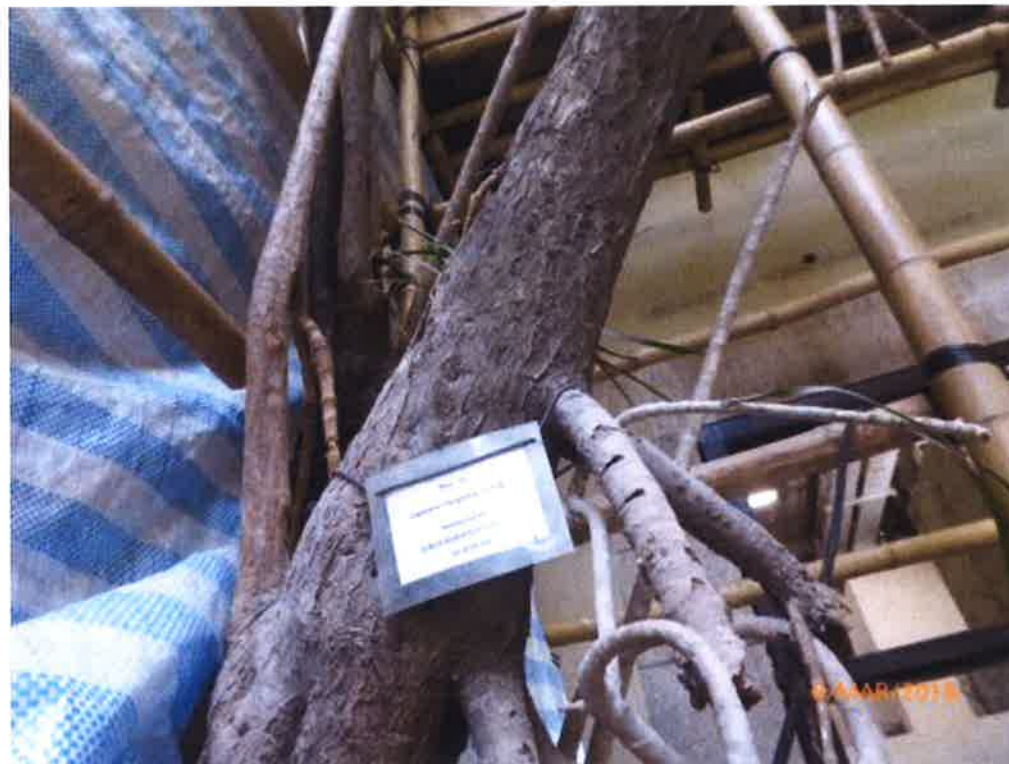
Fig. 5 Health condition of the mid trunk is fair.

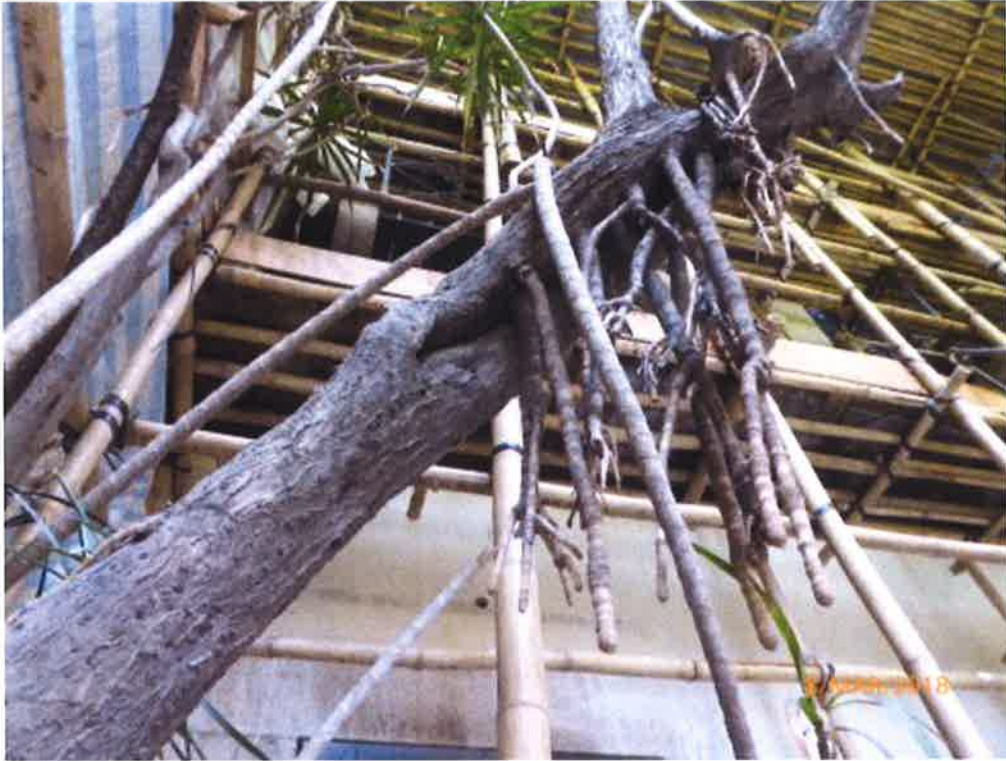
Fig. 6 Health condition of the upper trunk also is fair.

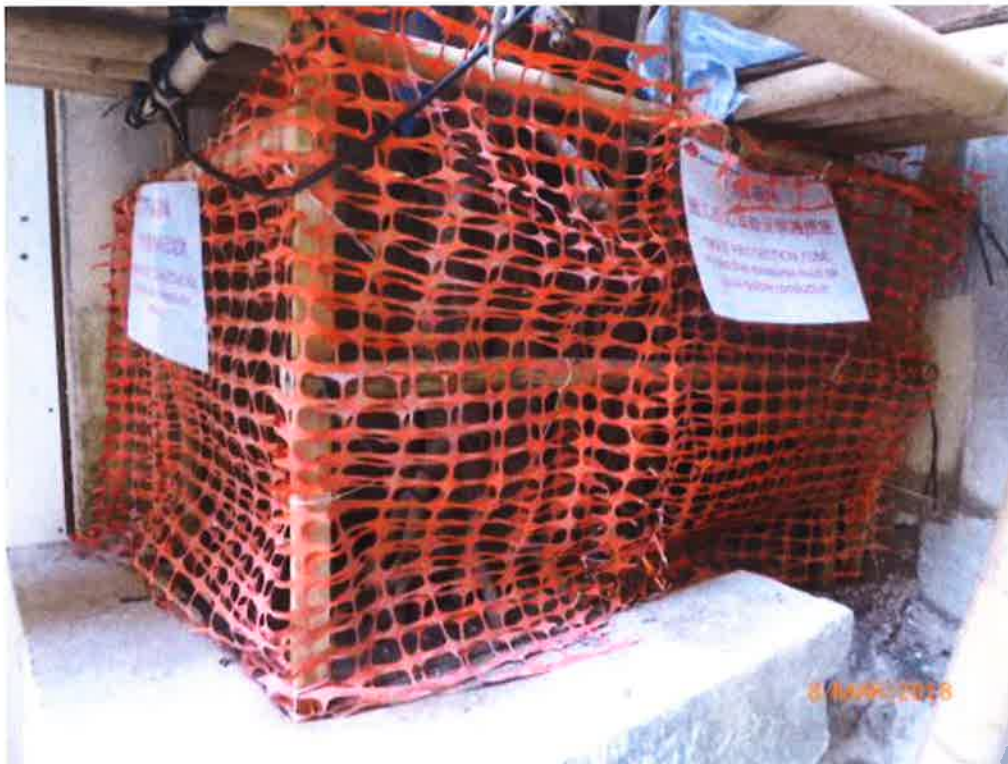
Fig. 9 The tree protection zone is in good order.

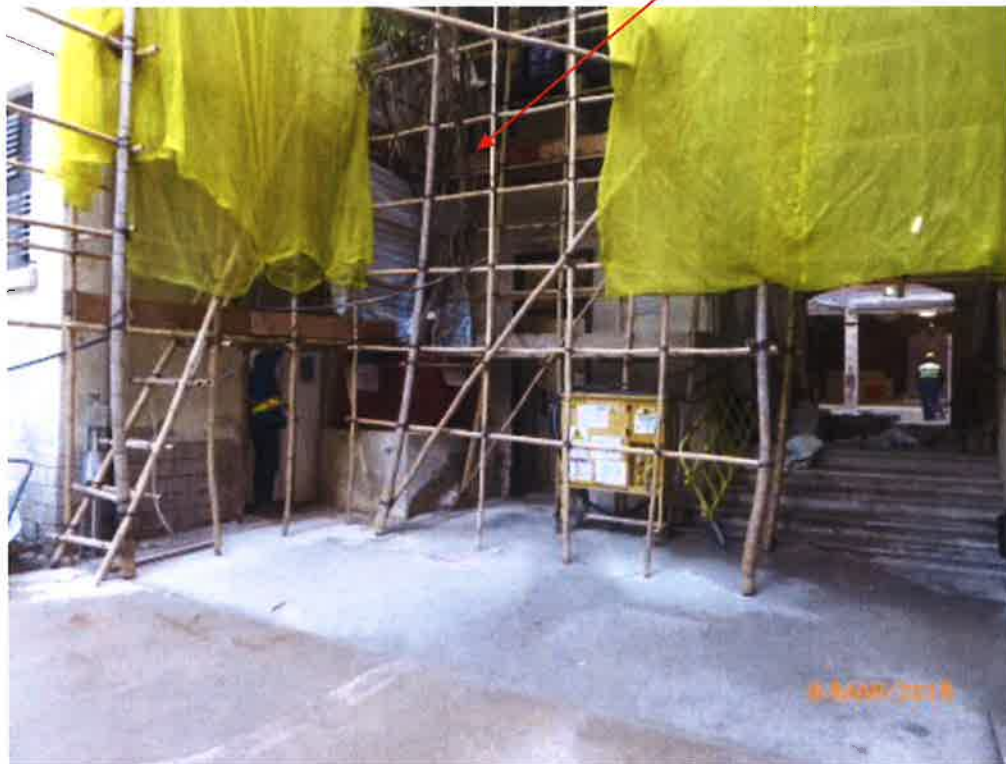
Fig. 10 Renovation works are in progress near Tree-11.

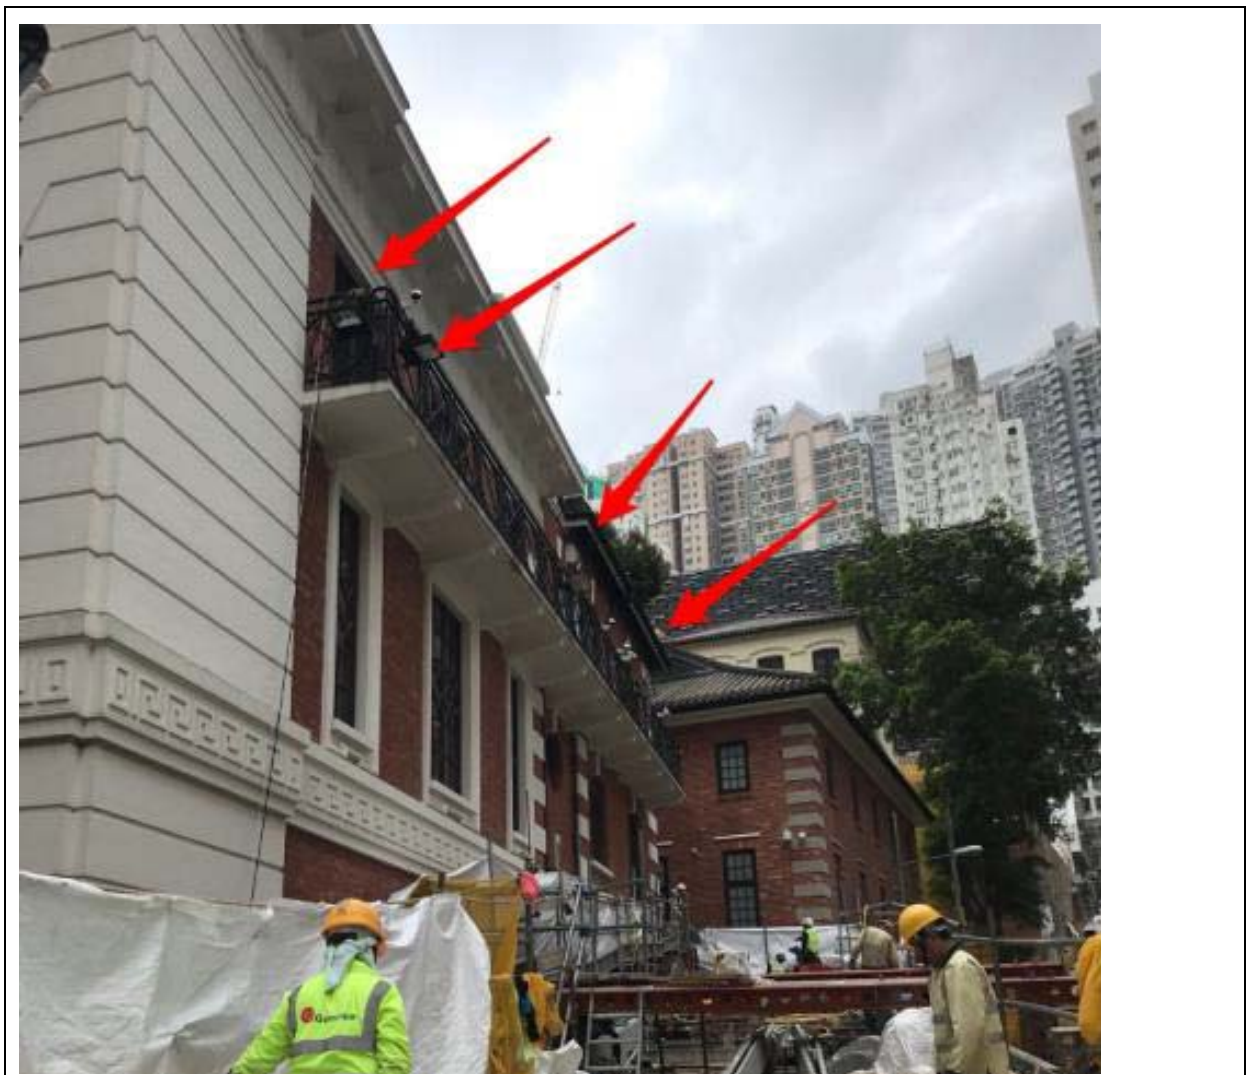
Photo 1: Four Light fittings on the external façade of Block 1 facing Old Bailey Street
