**FINDINGS ON THE
PARTIAL COLLAPSE OF THE MARRIED
INSPECTORS QUARTERS AT
THE CENTRAL POLICE STATION
COMPOUND ON 29 MAY 2016**

Independent Review Panel

31 October 2016

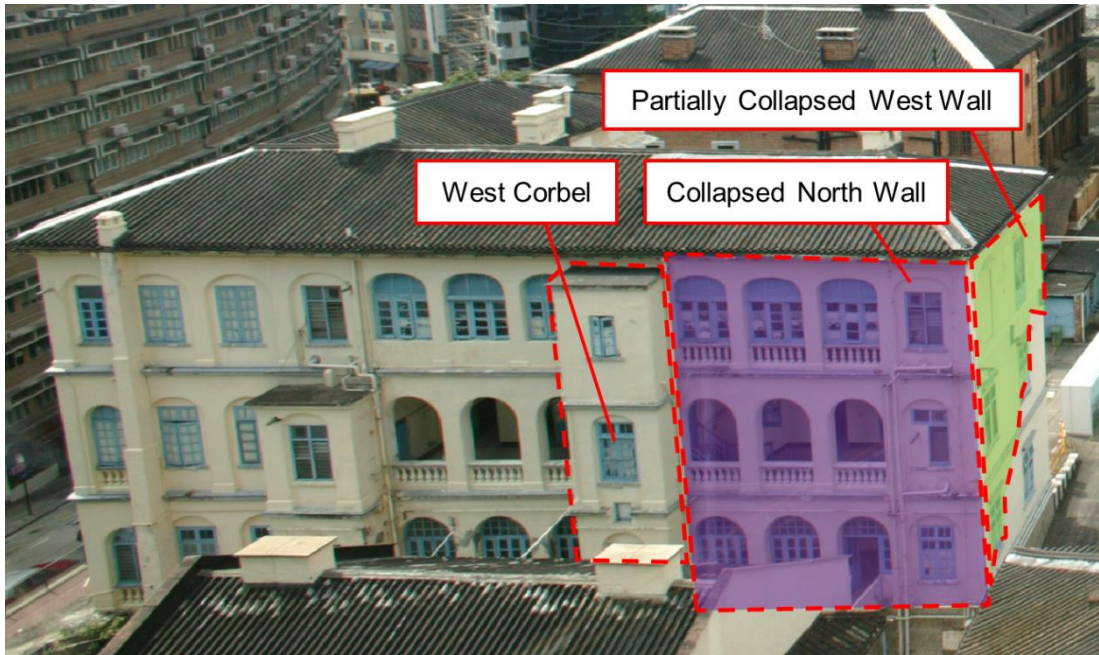
4. The Panel's view is that the collapse most likely initiated at the north façade ("**North Wall**", see Figure 1) under a "curtain fall" mode, as a result of the failure of one or more of the three brick columns at a point between the ground floor and the second floor, causing the entire section of the North Wall to collapse. This in turn pulled down the upper triangular section of the adjoining West Wall, as revealed in the photograph in Figure 2b below.

Figure 1: View of MIQ Building from the north

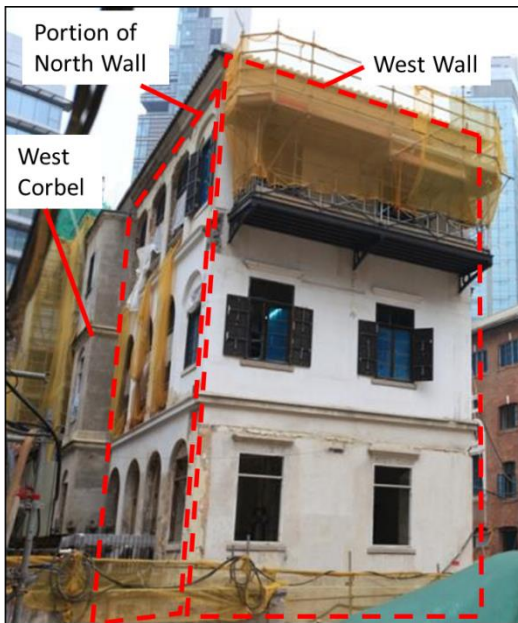
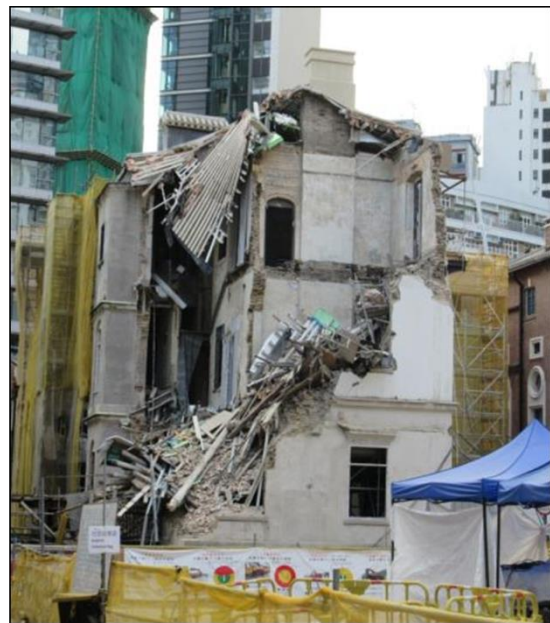
Figure 2a: Before the incident (March 2016)

Figure 2b: After the incident (31 May 2016)

Figures 2a and 2b: Views of MIQ Building from the northwest before and after the incident

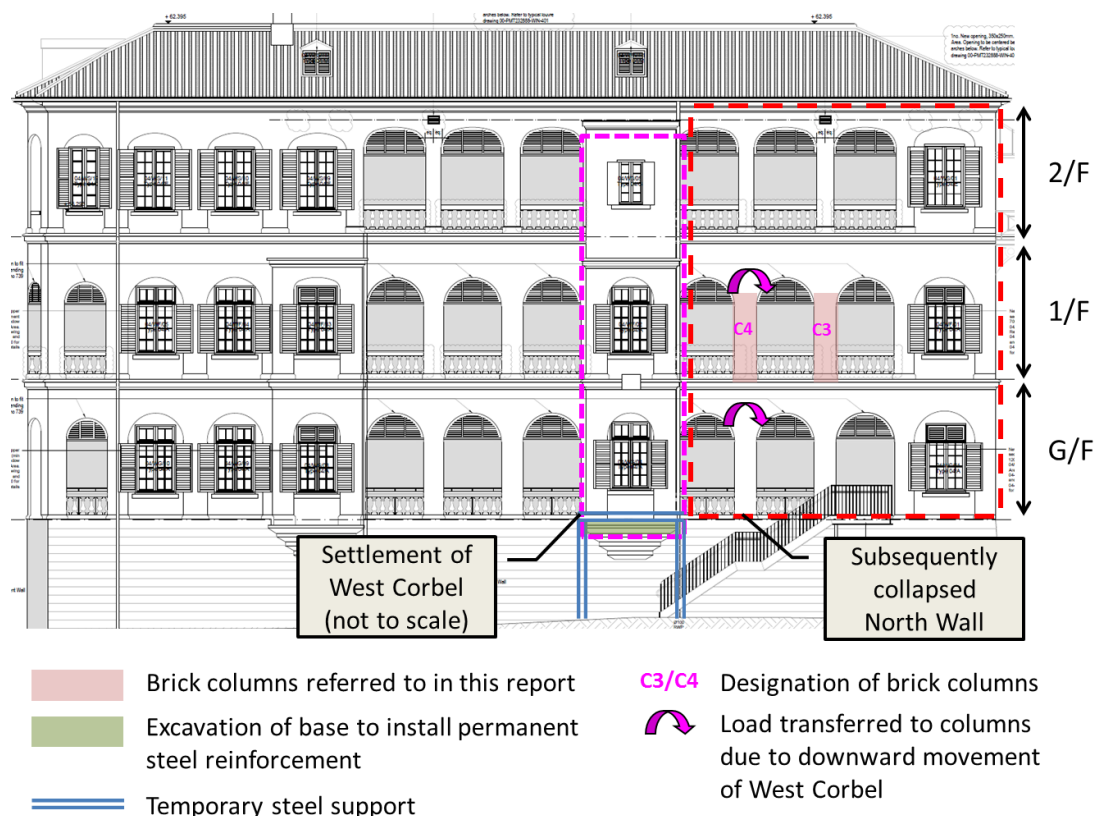
5. The Panel's view is that the three likely causes of the partial collapse are:
 - (a) In March 2016, the West Corbel was temporarily supported by steel support while excavation was carried out at its base for the purpose of installing permanent reinforcement as part of the strengthening works on the west bay window on the North Wall. The temporary steel support would have deflected as a result of carrying the weight of the West Corbel, causing settlement of the West Corbel, which in turn would have caused stress to increase in the adjacent brick columns C4 and C3 of the North Wall (see Figure 4a). Whilst the increase in the stresses in those brick

columns in March 2016 was not large enough to cause failure, it might have reduced the ability of those columns to take any additional load in subsequent stages of the construction works and made the columns C3 and C4 more vulnerable to collapse in the future.

Figure 4: North elevation illustrating West Corbel strengthening works

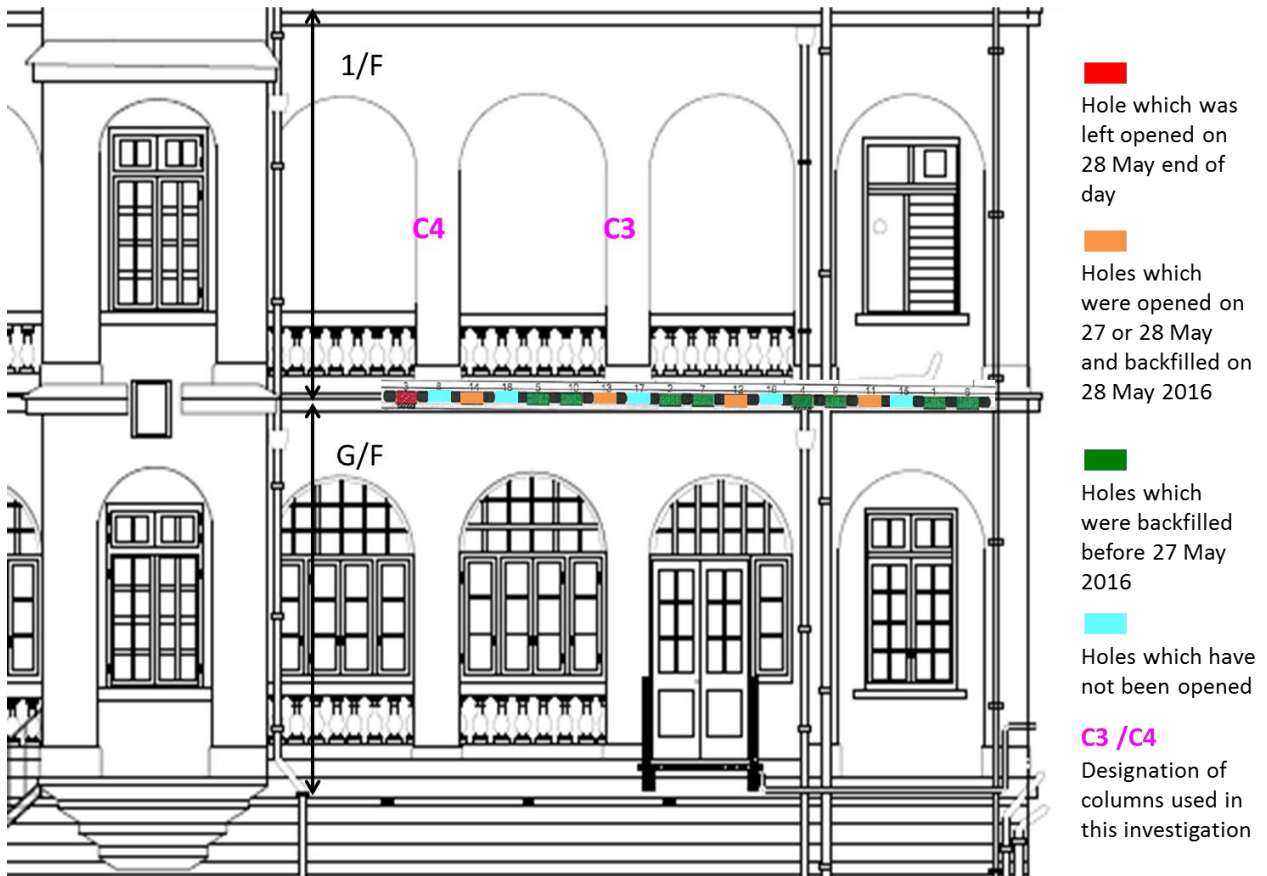
(b) Since the commencement of the project, the only construction works that have been performed on the collapsed North Wall was carried out between 20 May 2016 and 28 May 2016. Such works were part of the first floor timber floor strengthening and fire resistance works and involve the

excavation of 18 holes on the North Wall to pocket certain steel square box sections into the North Wall. Generally speaking, workers would backfill the holes with bricks bonded with lime mortar and cement grout the remaining gaps on the day of the excavation or on the next day after the excavation. The dimensions of the holes were approximately 350mm wide, approximately 200mm high and 200mm to 300mm deep, and were beneath the first floor level. Eight of such holes had been backfilled by 27 May 2016. On 27 May 2016 and 28 May 2016, four further holes were excavated, including two holes that were close to the bases of brick columns C3 and C4. A worker reported that those four holes were backfilled with bricks and grouted late in the afternoon of 28 May 2016. Further, there was another hole at the base of brick column C4 near the first level floor which had remained open since 20 May 2016. Some of the holes were located beneath and were very close to the base of columns C1 to C4, which support the North Wall from the second floor to the roof above. These brick columns collapsed on 29 May 2016. The excavation of the holes in the North Wall before the collapse is most likely to have been the immediate cause of the collapse.

Figure 5a: Illustration of holes formation on the collapsed North Wall

- (a) The Panel, through its investigation, has identified that, in planning for the timber floor strengthening and fire resistance works, any holes for pocketing the square steel box sections which were located within the brick columns base width should have been avoided and an alternative reinforcement detail, which did not involve cutting into the zone immediately below the brick columns, should have been adopted.

- (b) Shoring and propping of the arches and floors should have been installed prior to the cutting of any holes into critical load bearing areas, including the brick columns, in substitution of the function of the brick columns. The Panel notices that these have now been carried out in the remaining parts of the MIQ Building after the incident.

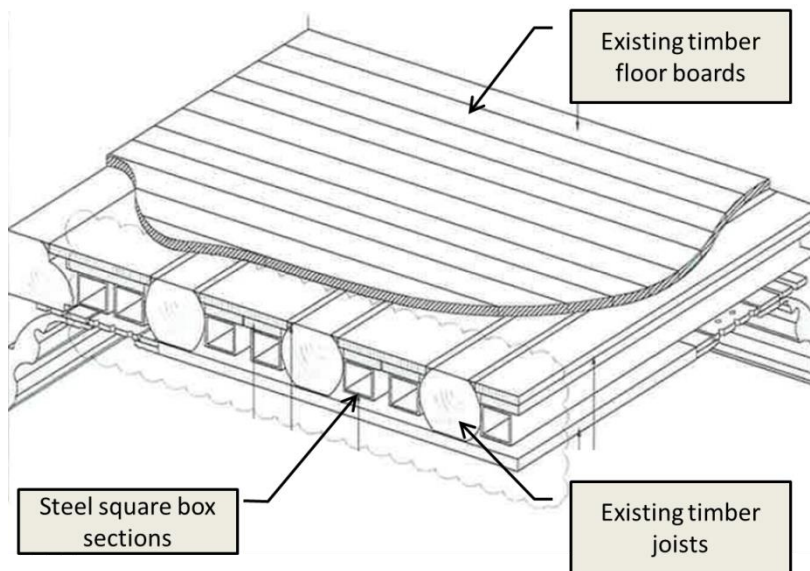
Figure 5b: Illustration of the timber floor strengthening and fire resistance works

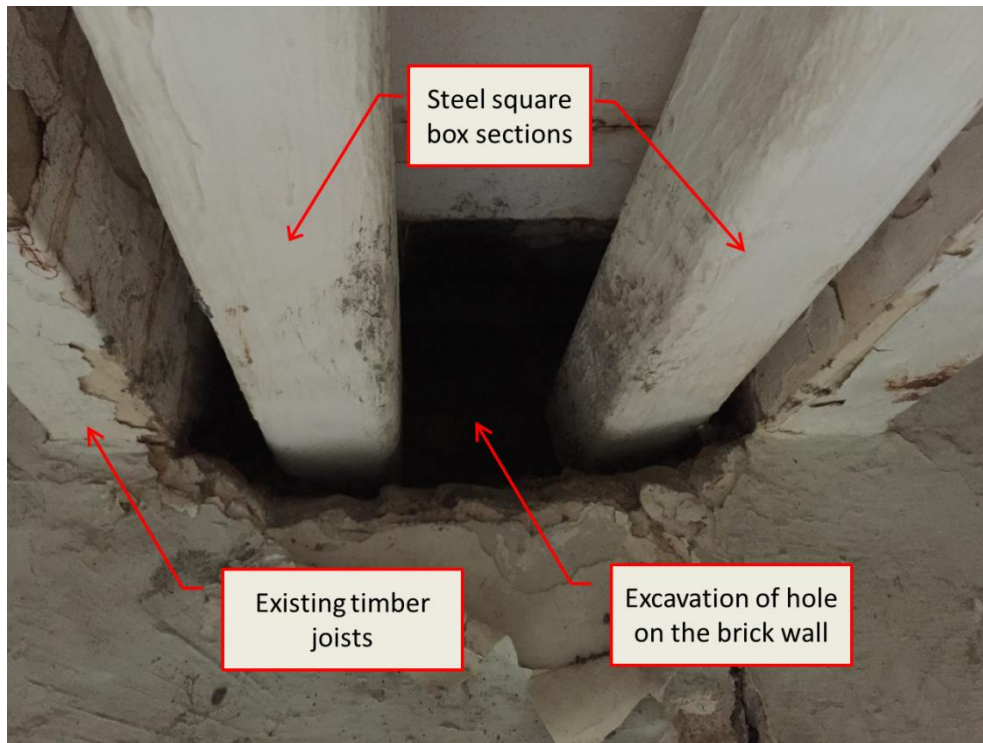
Figure 5c: Photo taken after the incident showing holes excavated in the North Wall

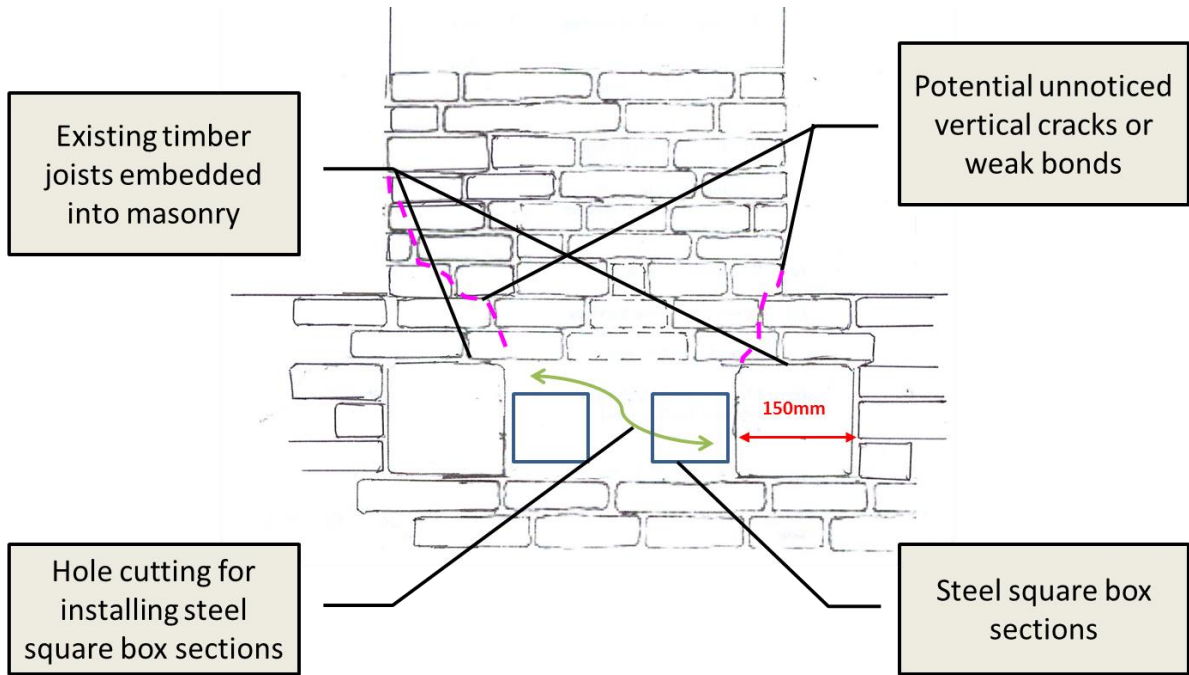
- (c) The final likely contributory cause of the collapse is the combined effect of localised weak masonry and the cutting of holes at the brick columns. Visual inspection of the North Wall columns prior to the hole excavation might have led to a conclusion that the brick columns could have remained stable during the period of the temporary cutting of holes. In reality, the brick columns might have had unnoticed vertical cracks or weak bonding at the first floor near the holes that allowed cracks to propagate during or shortly after the hole excavation and led to the eventual collapse. Fortunately, the cutting of many holes in the masonry walls only occurred in MIQ Building and not in the other buildings at the CPS Compound.

Figure 6a: Combined effect of localised weak masonry and holes formation

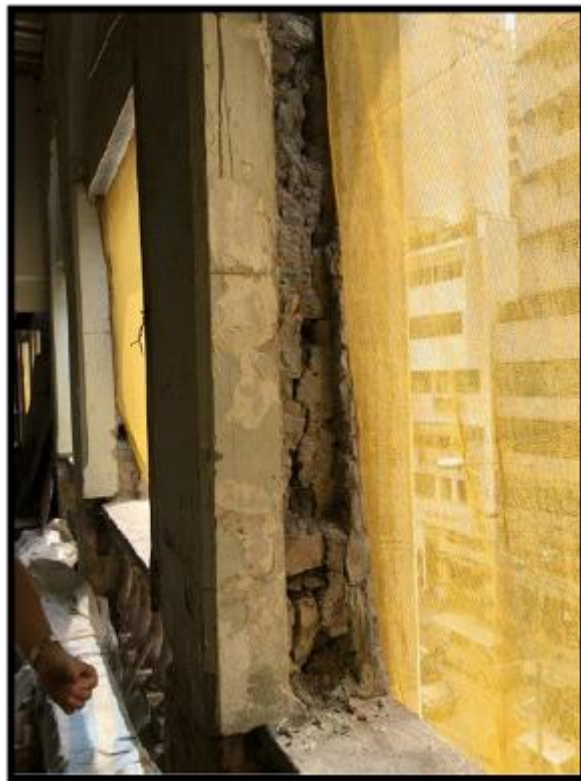
Figure 6b: Example of vertical cracks revealed after removal of rendering at a column in the east wing of the MIQ Building

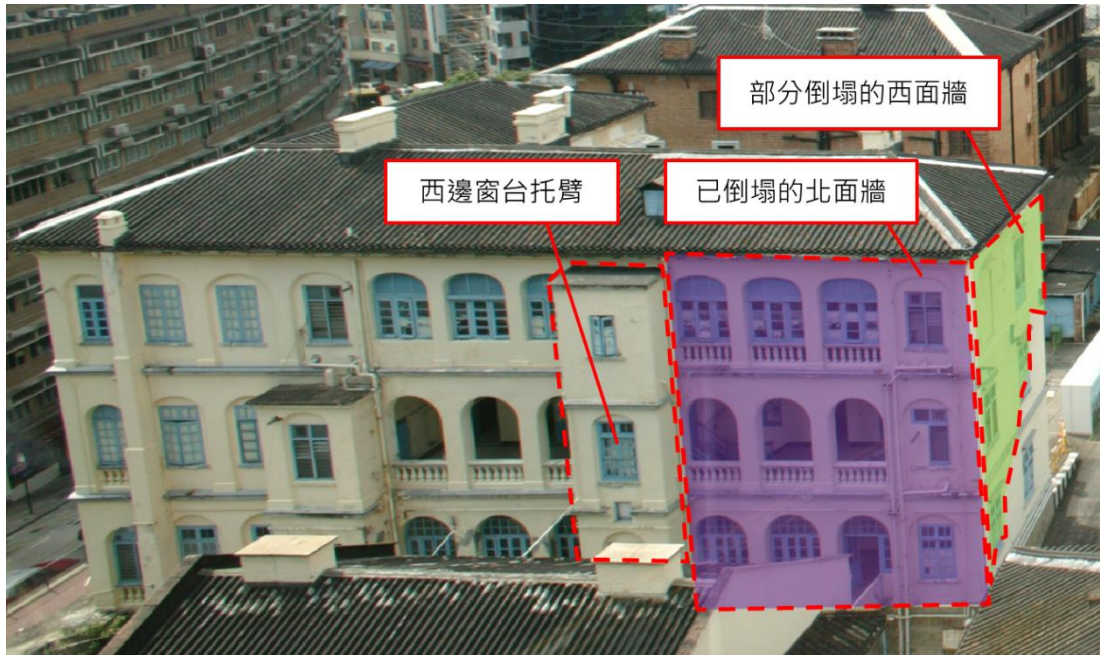
四. 檢討小組認為大樓的部分倒塌，是始於向北的牆(見圖 1 「北面牆」)當中三條磚柱其中一條或多條於地下和二樓之間受到損毀，導致整幅牆發生「幕落模式」倒塌。如下圖 2b 所見，北面牆倒塌亦把相連的西邊牆高處的倒三角部份拉下。

圖 1: 已婚督察宿舍大樓 (北視圖)

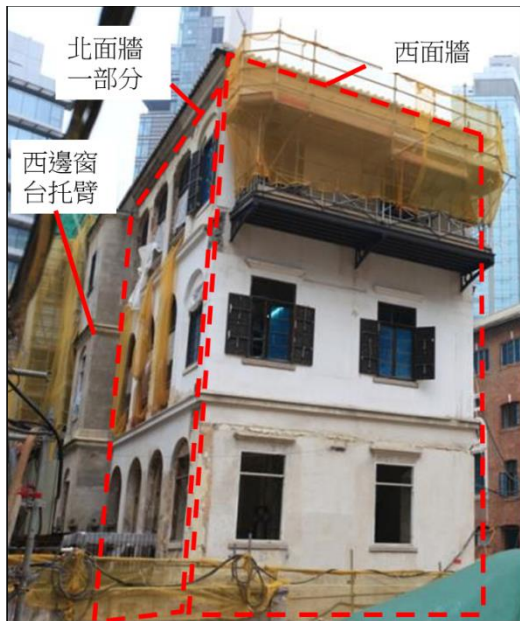
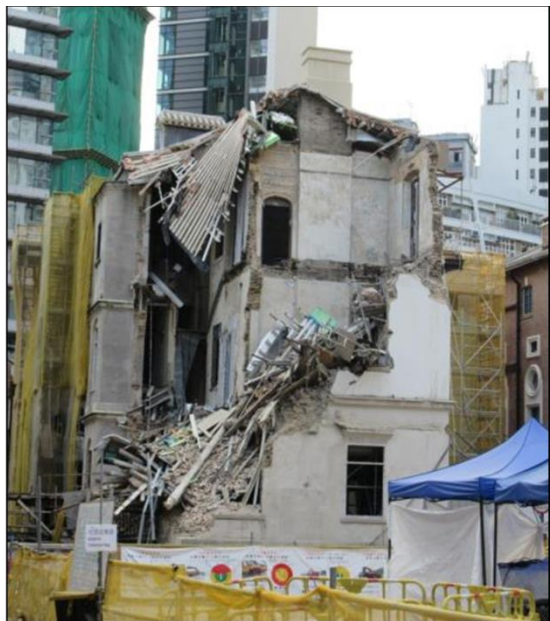
圖 2a: 事件發生前 (二零一六年三月)

圖2b: 事件發生後 (二零一六年五月三十一日)

圖 2a 及 2b: 已婚督察宿舍大樓 (西北視圖) (事件發生前後對比)

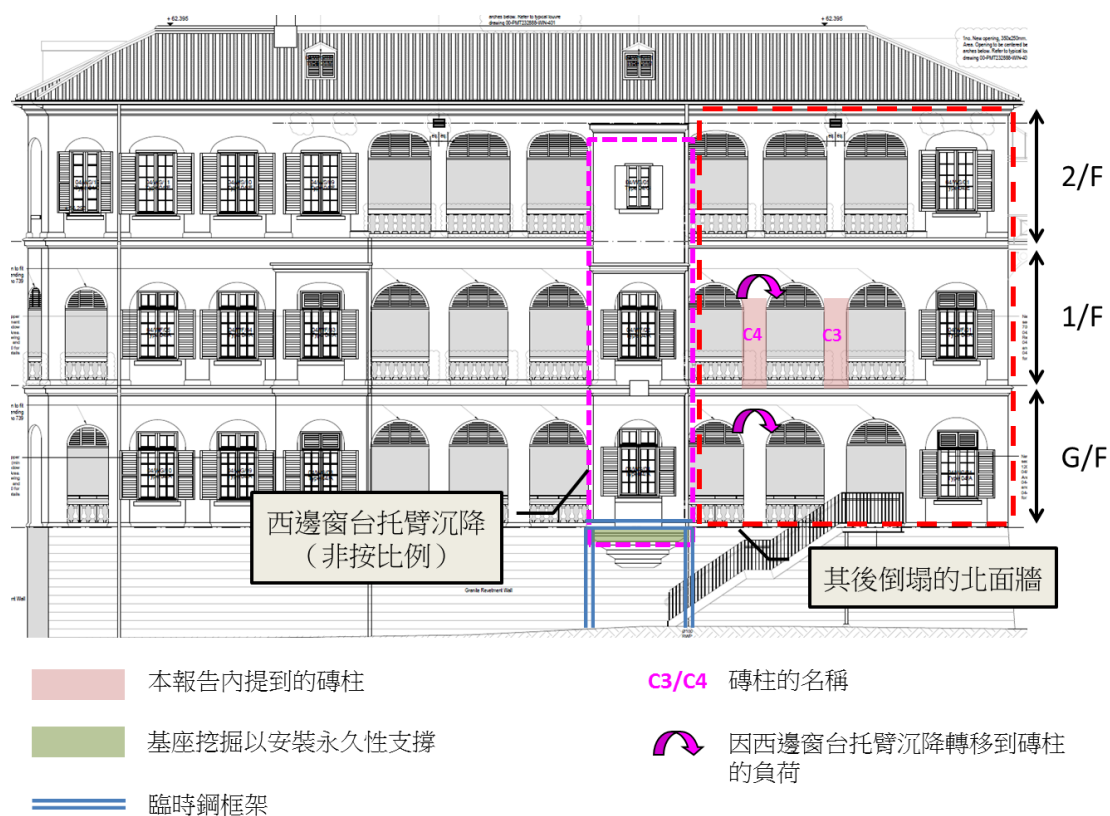
- (一) 在二零一六年三月，北面牆的西邊窗台進行鞏固工程。施工過程中，在西邊窗台托臂下安裝鋼框架作為臨時支撐，以便進行托臂底部的挖掘及安裝永久支撐工序。鋼框架因承托窗台的重量而壓縮，導致托臂及窗台出現輕微沉降。沉降導致鄰近的磚柱 C4 及 C3（見圖 4a）的負荷增加。增加負荷並未足以導

致倒塌，但可能令致 C4 及 C3 磚柱在往後的施工過程中，可以承受的額外負荷減少，因而增加倒塌風險。

圖 4: 西邊窗台托臂鞏固工程 (北視圖)

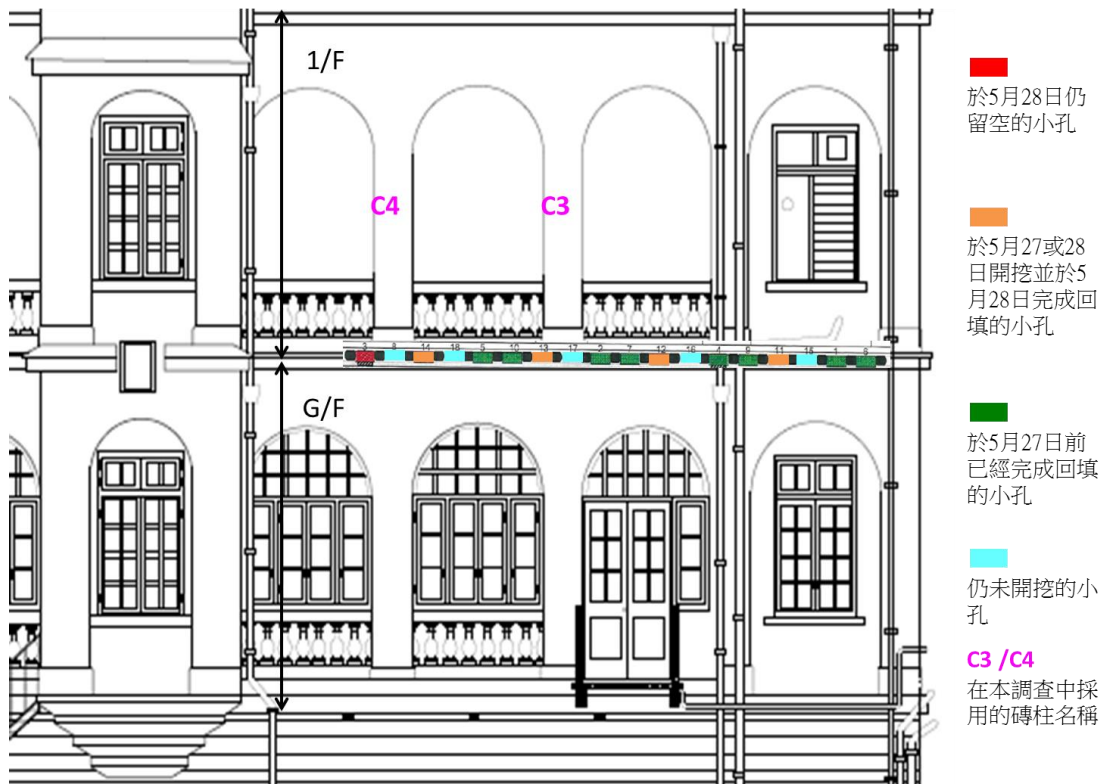
(二)自舊中區警署項目開展後，唯一在北面牆倒塌部分進行過的工程，乃於二零一六年五月二十日至五月二十八日期間進行。是項工程屬於一樓木地板鞏固及防火工程的其中一部份，計劃是在北面牆挖掘十八個小孔，把方形鋼管安放進北面牆。工人一般會於施工當天或翌日以石灰砂漿黏合的磚頭填回小

孔，剩餘的空隙則灌入英泥漿。小孔約 350 毫米闊、200 毫米高、及 200 至 300 毫米深，位於一樓樓面下面。當中八個小孔在五月二十七日前完成回填。另外四個小孔則是在五月二十七日及五月二十八日開挖的，其中兩個小孔接近 C3 和 C4 磚柱底部。據悉工人在二十八日下午較後的時間已用磚頭填回該四個小孔及灌漿。此外，C4 磚柱一樓柱底部另有一個小孔在五月二十日挖掘後一直留空。部份小孔位於北面牆支撐二樓及屋頂的 C1 至 C4 柱的底部，非常接近 C1 至 C4 柱底的範圍內。這些磚柱在二零一六年五月二十九日晚上倒塌。在事故發生前於北面牆挖掘的小孔，是最有可能導致大樓部份倒塌的即時原因。

圖 5a: 在已倒塌的北面牆小孔形成的情況

(甲) 檢討小組經調查後認為規劃木地板鞏固及防火工程，應該避免在磚柱底部下挖掘安放方型鋼管的小孔，而改為採用不涉及於磚柱底部開孔的替代加固工程方案。

(乙) 在主要的結構件，包括磚柱進行挖掘工程之前，應該先在鄰近拱門及地板安裝好足夠的裝頂，代替磚柱的功能。檢討小組注意到，在事件發生後，這些措施已經在已婚督察宿舍的其他部分實施。

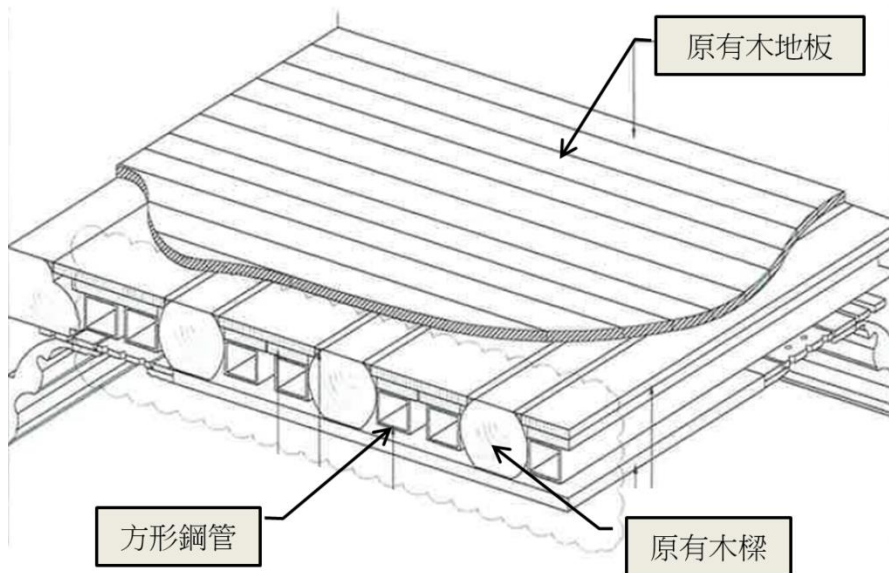
圖 5b: 木地板的鞏固及防火工程

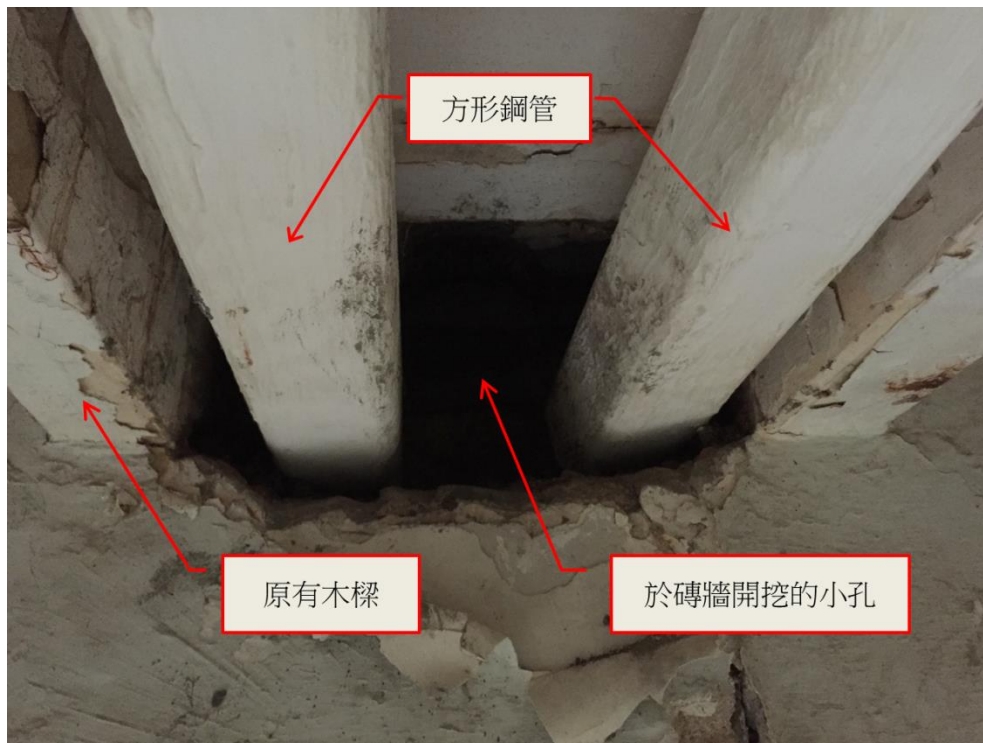
圖 5c: 在北面牆已挖掘的小孔 (事件發生後攝)

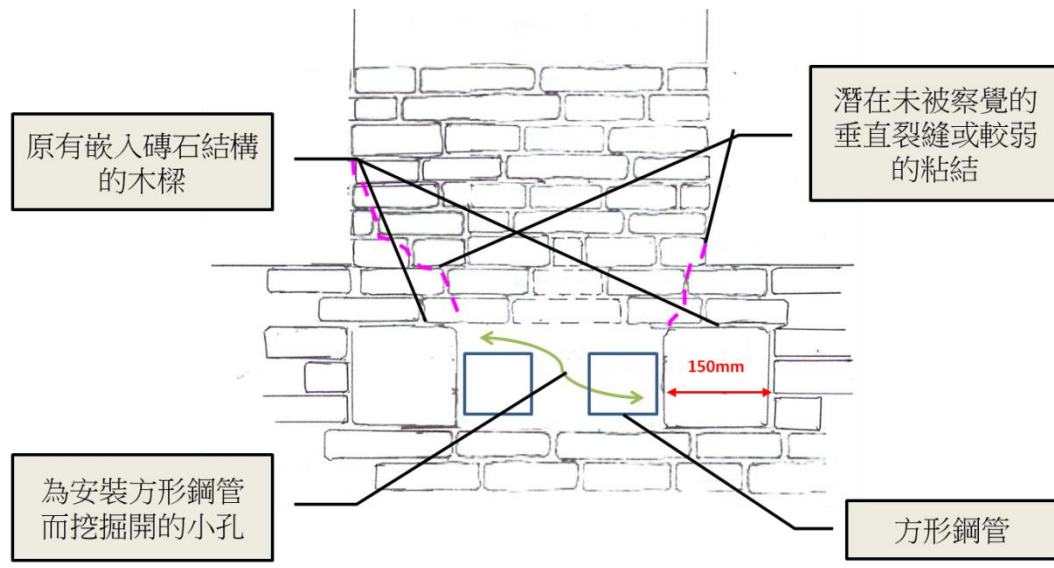
(三)最後一個可能引致倒塌的原因，是大樓內局部較弱的磚石結構與在磚柱開挖小孔的綜合效應。即使在開挖小孔事前目測北面牆磚柱，相信磚柱結構狀況，能夠在短暫的小孔挖掘時段保持穩定。但事實上，磚柱可能在小孔附近內藏未能被察覺的垂直裂縫或較弱的粘結砌體，在開挖期間或稍後，誘發裂縫擴散，最終導致磚柱倒塌。可幸得悉在磚牆挖掘多個小孔的情況，只發生於已婚督察宿舍大樓，而不涉及中區警署建築群的其他樓宇。

圖 6a: 局部較弱的磚石結構與挖掘小孔所造成的綜合效應

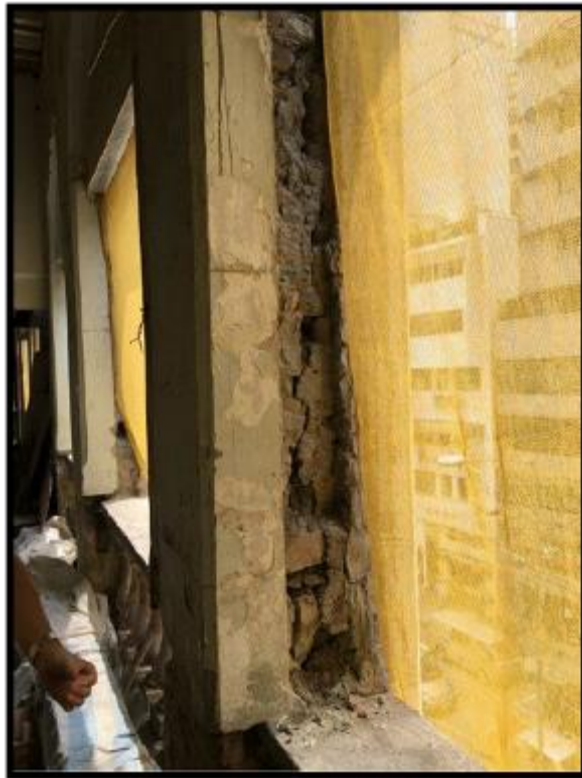
圖 6b: 已婚督察宿舍大樓東翼其中一條磚柱在移除批盪後發現的垂直裂縫
