Central Police Station Conservation
and Revitalisation Project:
63rd Monthly EM&A Report
(1 January to 31 January 2017)

Issue Date: February 2017

Environmental Resources Management

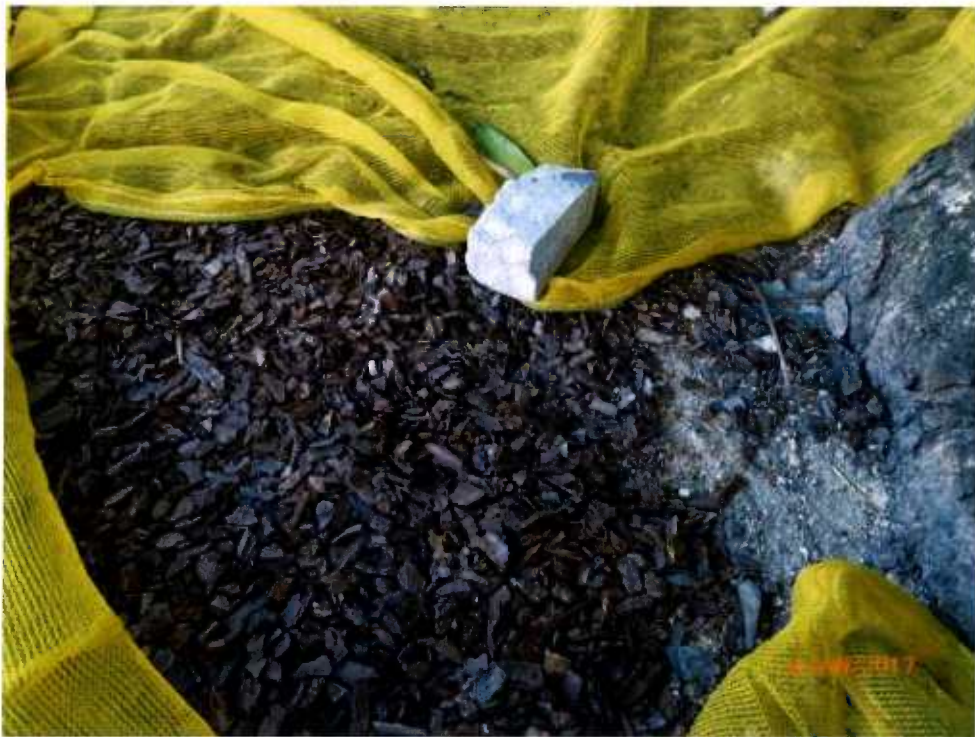
Fig. 12 According to ASD Spec., size of the pine bark mulch should be 20mm to 150mm. Samples are shown on the following photo.

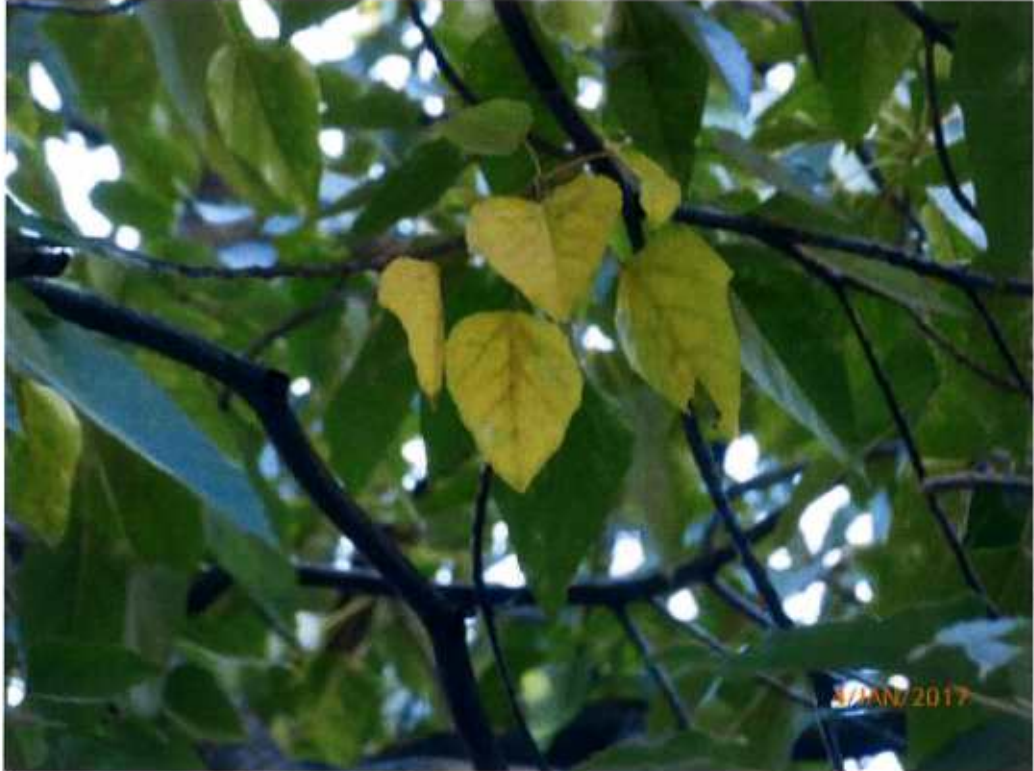
Fig. 9 Signs of Pest (Mealy Bugs 粉狀介殼蟲) are rarely found on the tree due to Pest Control Operation on 25th April 2016.

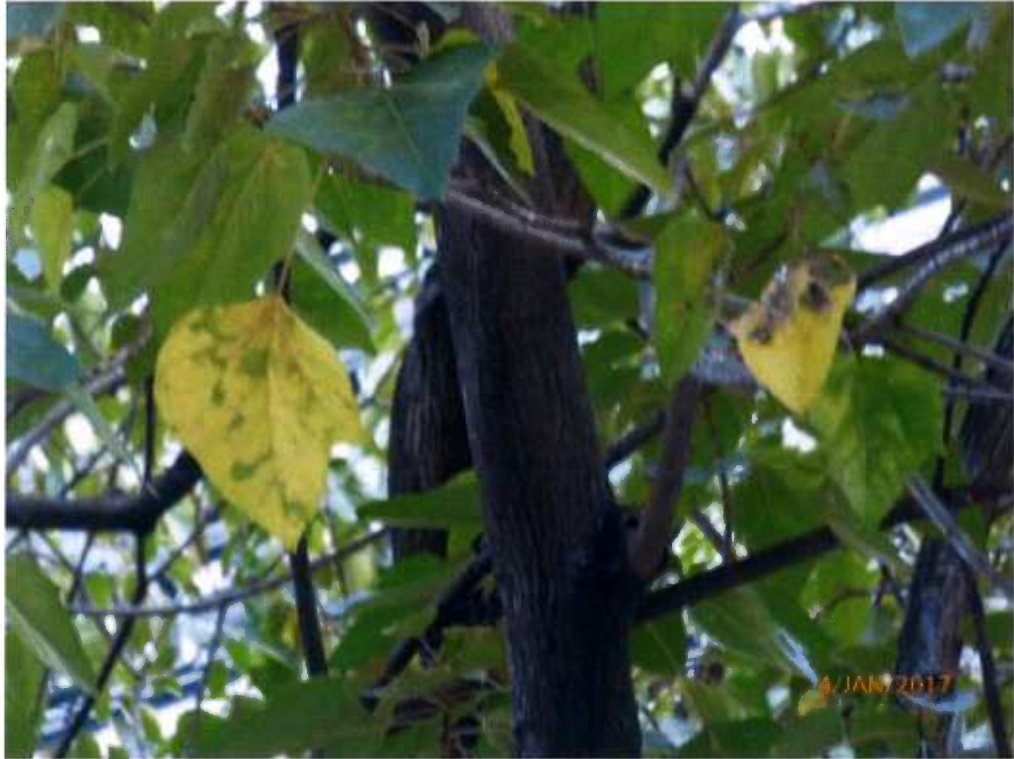
Fig. 9 Signs of Pest (Mealy Bugs 粉狀介殼蟲) are rarely found on Tree-7 due to Pest Control Operation on 25th April 2016.

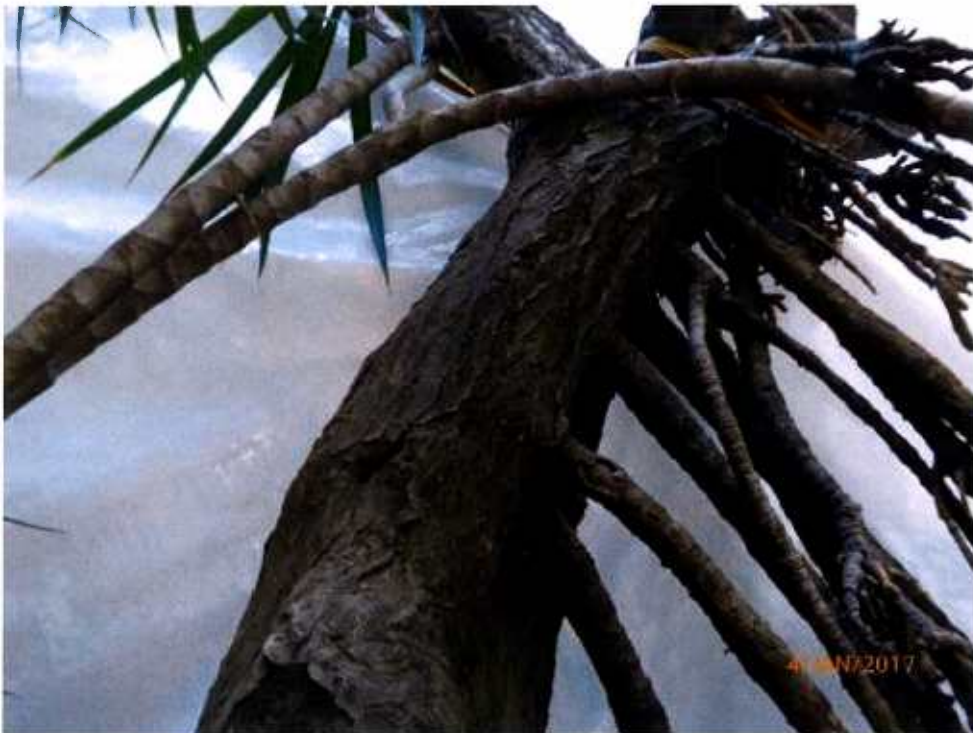
Fig. 6 Withered leaves still appear on the upper branches of the tree.

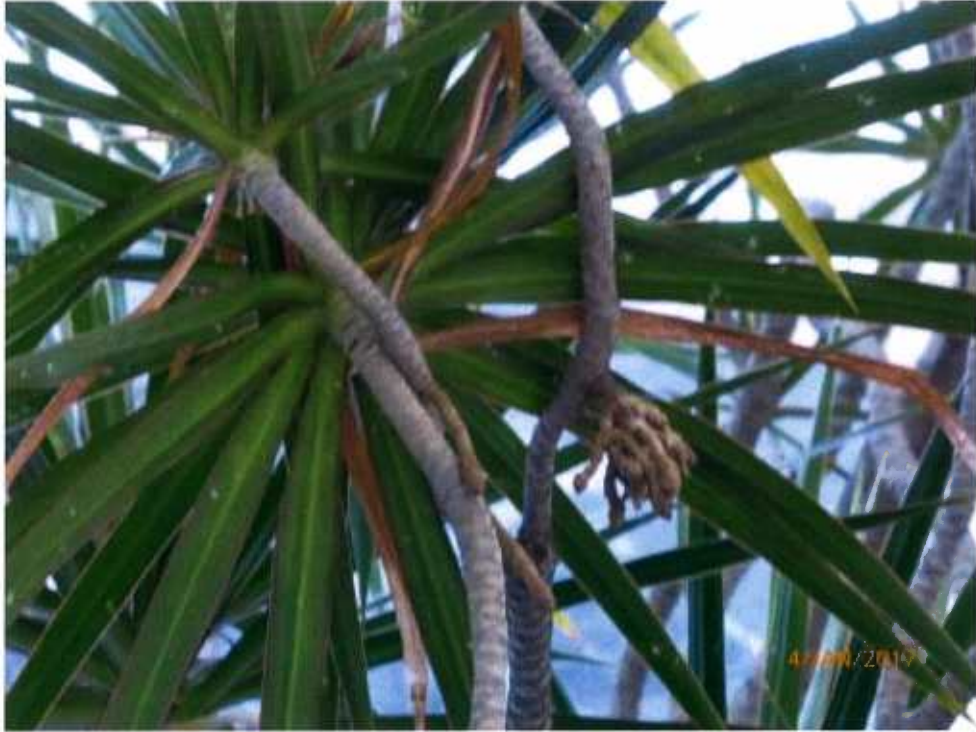
Fig. 7 Some withered leaves also appear on the lower branches.
