The Jockey Club CPS Limited

Central Police Station Conservation  
and Revitalisation Project:  
*70<sup>th</sup> Monthly EM&A Report*  
*(1 August to 31 August 2017)*

Issue Date: September 2017

**Environmental Resources Management**

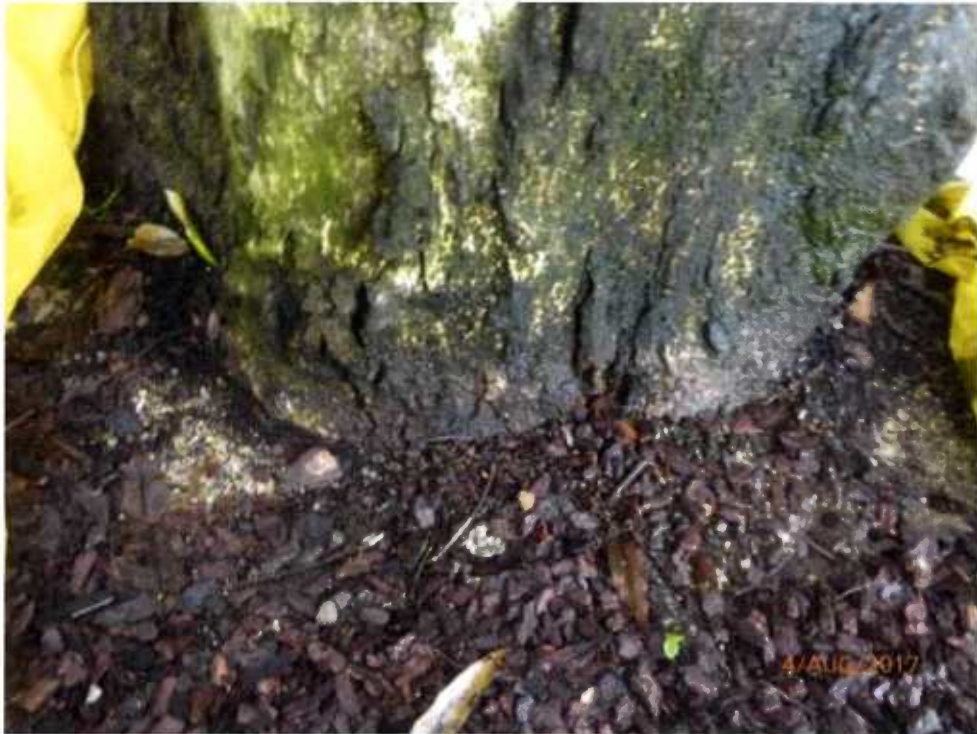
Fig. 3 Health condition of the lower trunk is fair.

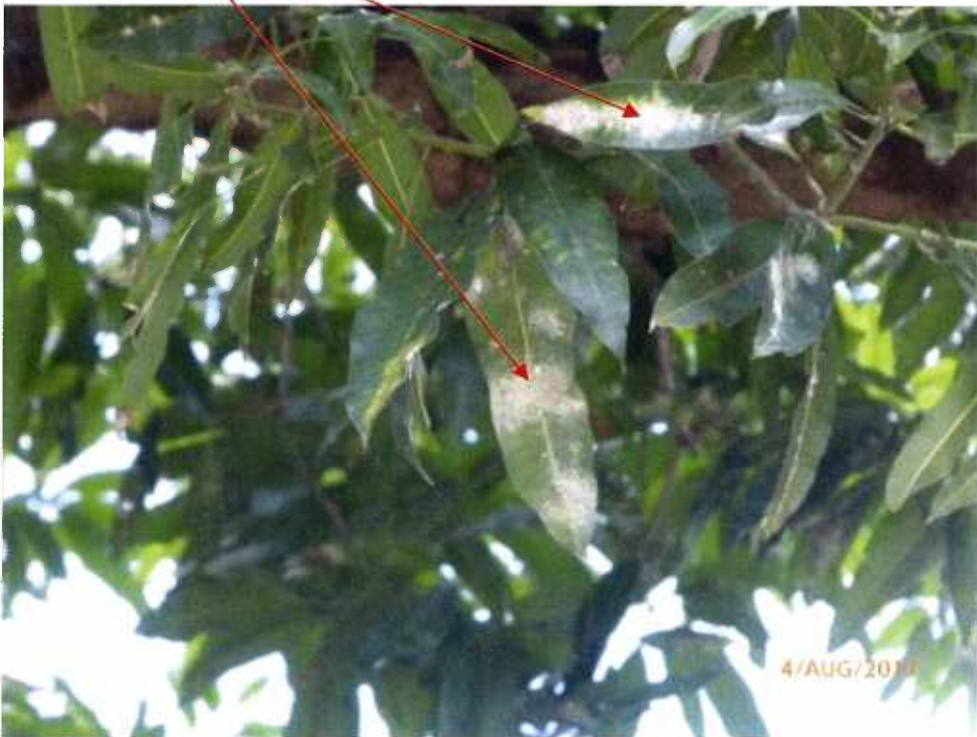
Tree No.	Botanical Name	Overall Health Condition	Arborist's Observations / Recommendations
Tree -5	<i>Mangifera indica</i>	Fair	<ul style="list-style-type: none"> <li>• Signs of pests (Mealy Bugs) were observed on the tree.</li> <li>• Application of pesticides should be carried out as soon as possible.</li> </ul>
Tree -6	<i>Aleurites moluccana</i>	Fair	<ul style="list-style-type: none"> <li>• Signs of pest (<i>Trialeurodes vaporariorum</i>) apparently reduced due to pesticide application on 3 and 4 August 2017.</li> <li>• Leaves on the crown are rather sparse.</li> <li>• Keep monitoring on the growth of the tree.</li> </ul>
Tree-7	<i>Aleurites moluccana</i>	Fair	<ul style="list-style-type: none"> <li>• Signs of pest (<i>Trialeurodes vaporariorum</i>) apparently reduced due to pesticide application on 3 and 4 August 2017.</li> <li>• Leaves on the crown are rather sparse.</li> <li>• Keep monitoring on the growth of the tree.</li> </ul>

Fig. 9 Signs of Pest (Mealy Bugs 粉狀介殼蟲) are found on the tree.

As signs of pests were observed on Tree 5 on 4 August 2017 according to the arborist, the Contractor has arranged pesticide application to be conducted on Tree 5 in September 2017.

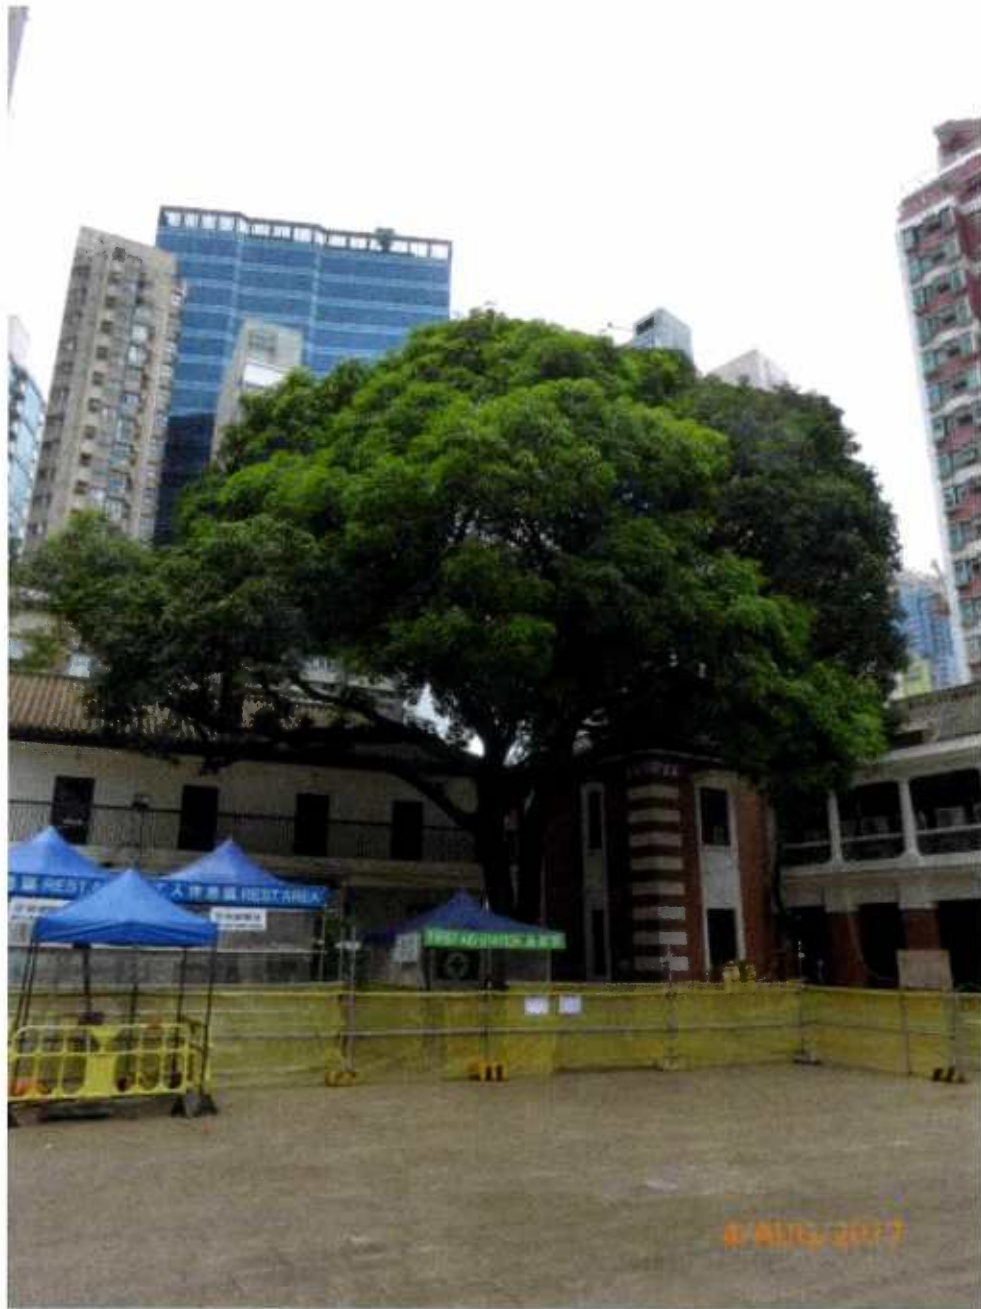
Fig. 12 Overall view of Tree-5 during inspection on 4<sup>th</sup> Aug. 2017.

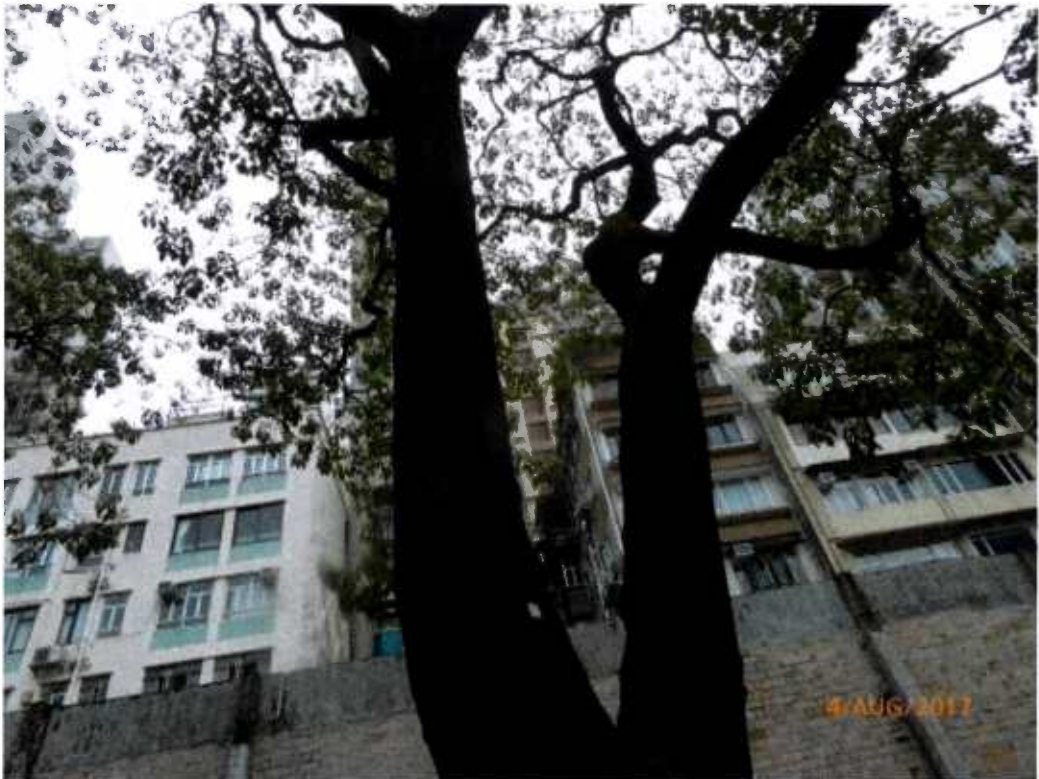
Fig. 6 Leaves on the crown are rather sparse.

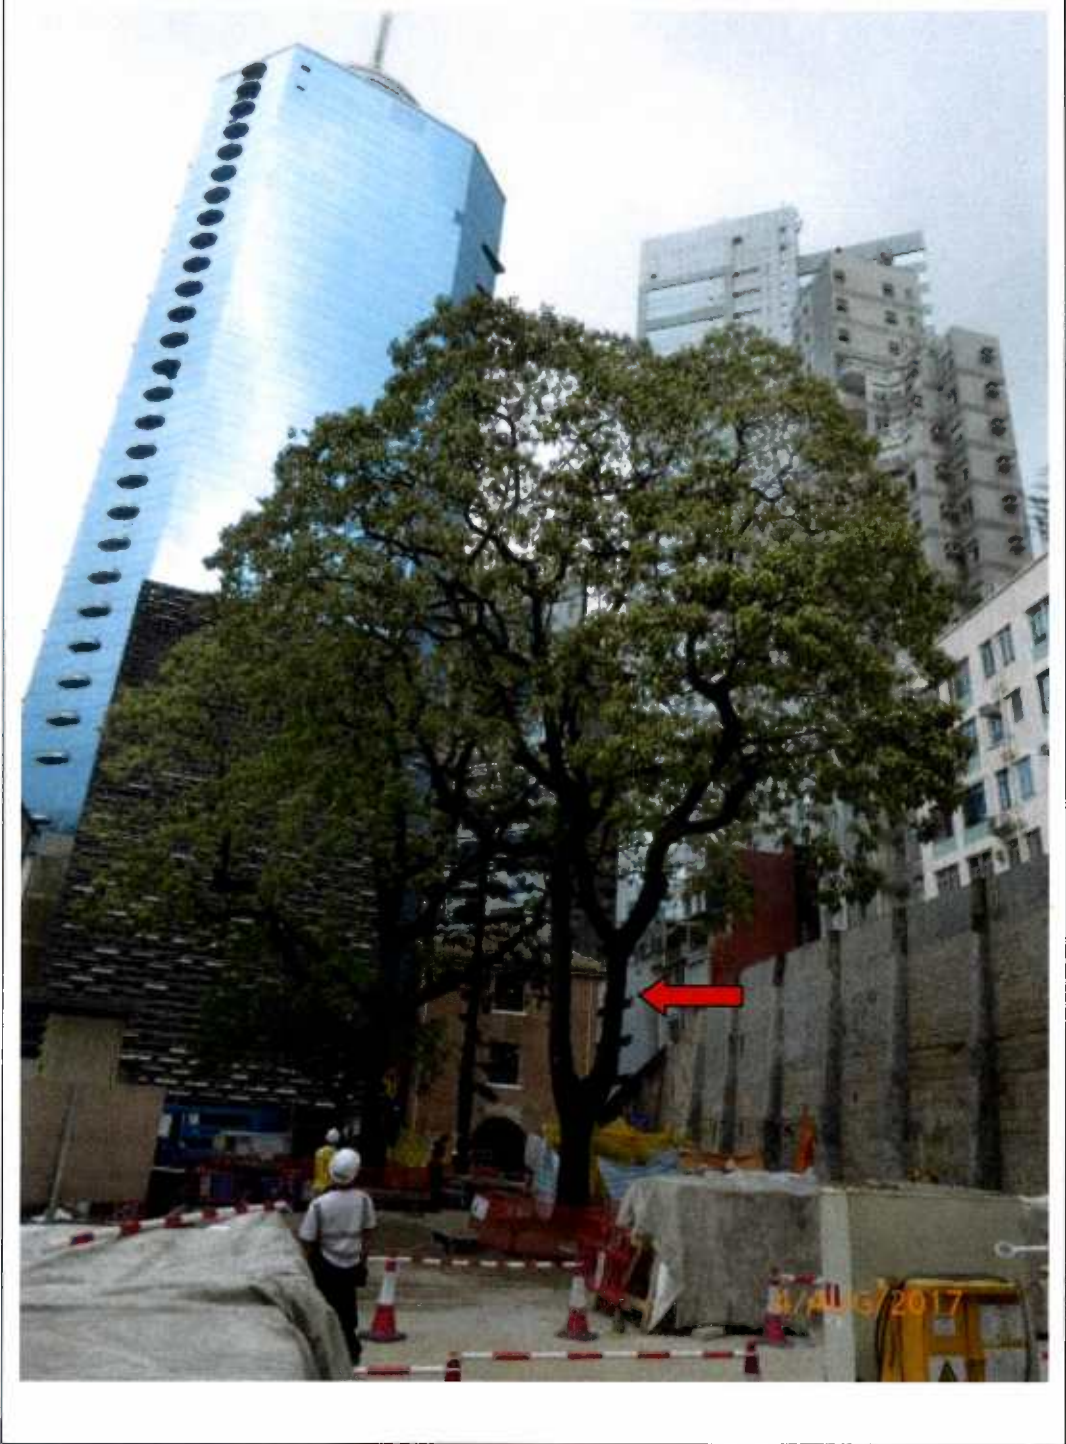
Fig. 12 Overall view of Tree-6 during inspection on 4<sup>th</sup> Aug. 2017.

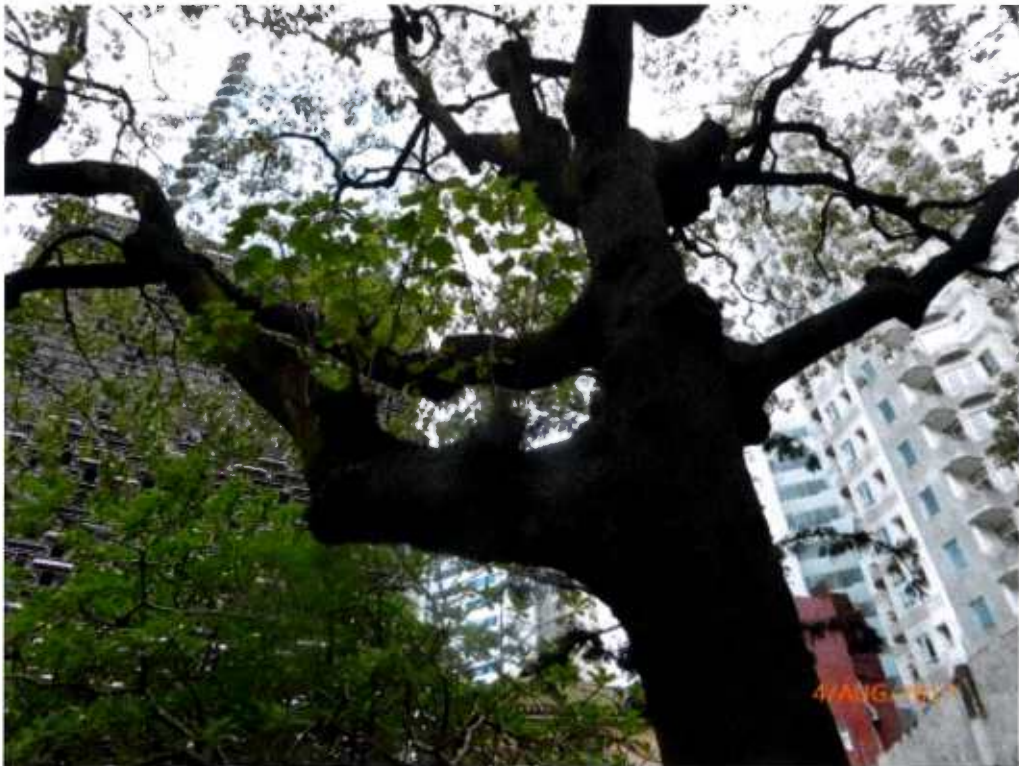
Fig. 6 Leaves on the crown are rather sparse.

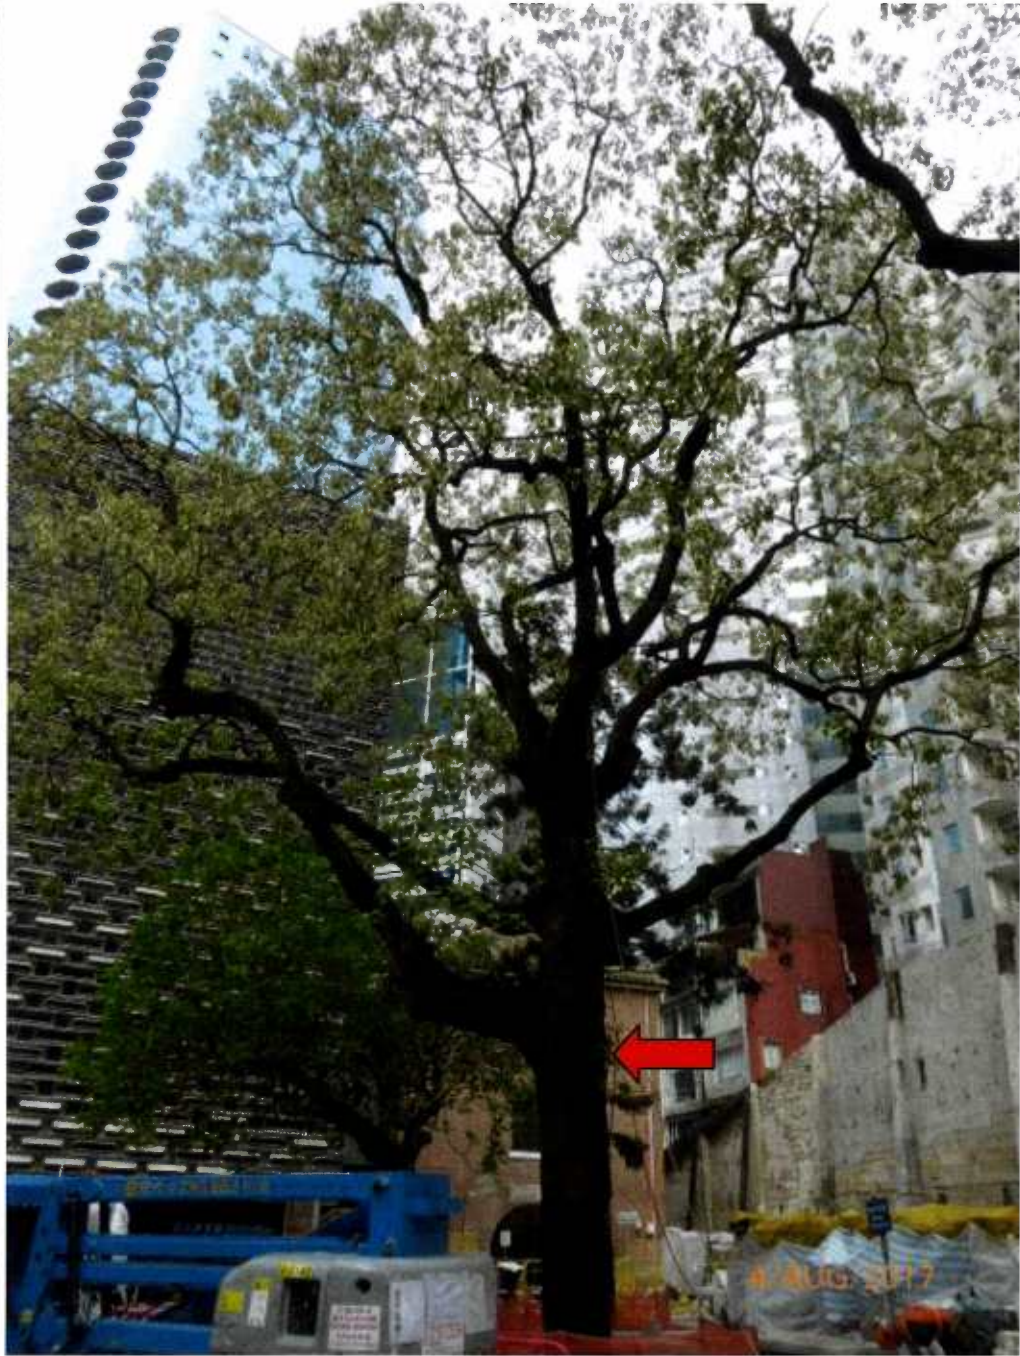
Fig. 12 Overall view of Tree-7 during inspection on 4<sup>th</sup> Aug. 2017.

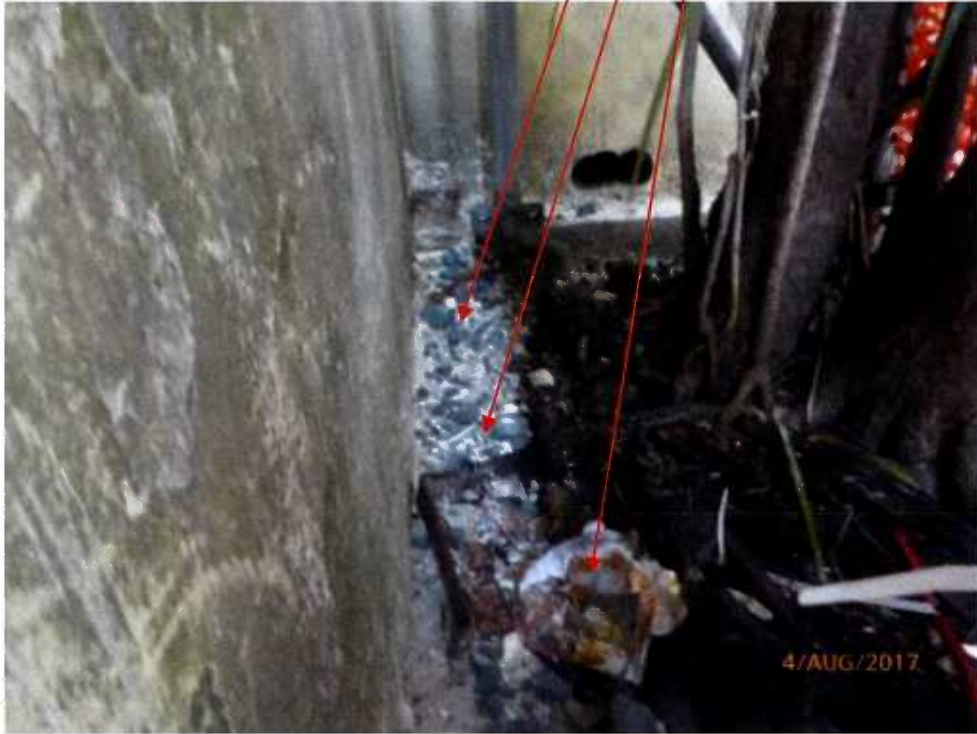
Fig. 2 Root collar is normal. Lots of construction debris remain at the corner of the planter.

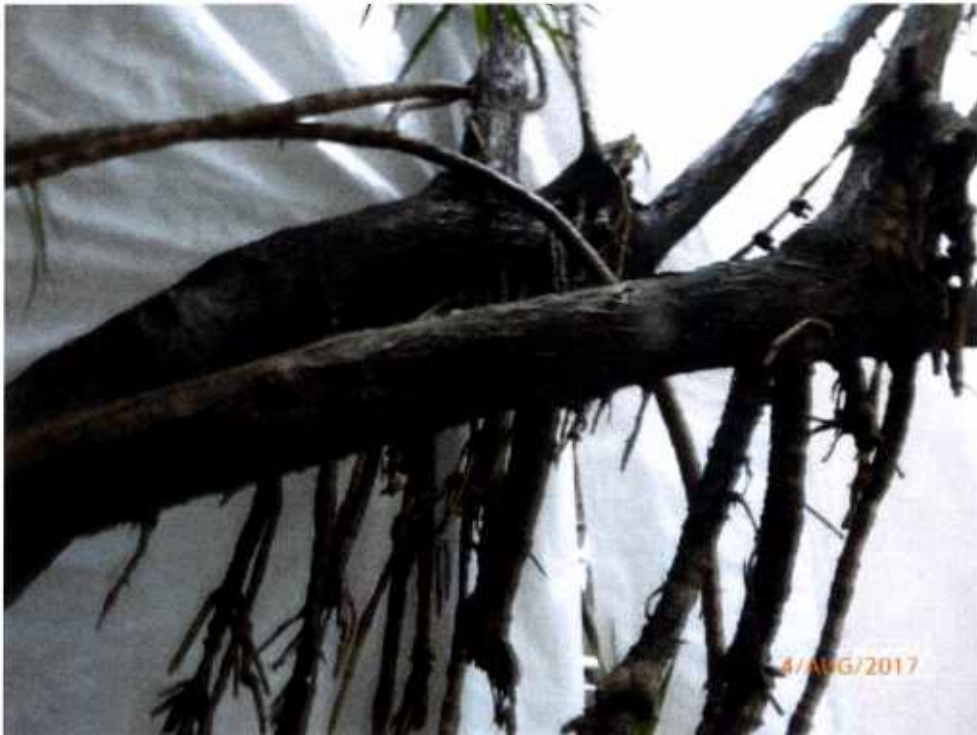
Fig. 6 Withered leaves still remain on the on the tree.

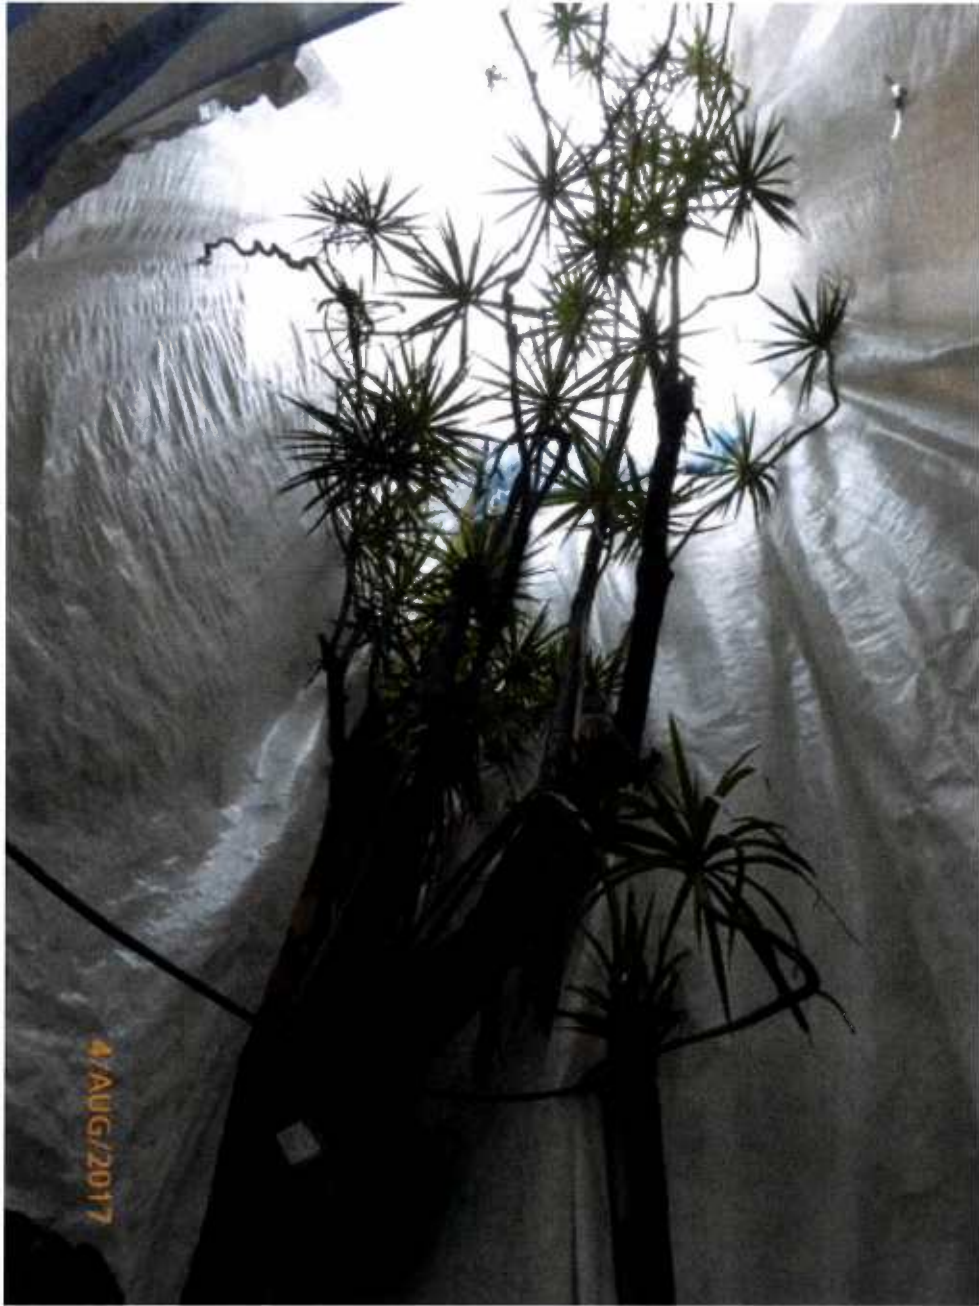
Fig. 12 Overall view of Tree-11 during inspection on 4<sup>th</sup> Aug. 2017.
