# Central Police Station Conservation and Revitalisation Project

*EIA Report:  
Volume II - Annexes*

**Built Heritage Resources within CPS –  
Detailed Baseline Studies and Impact Assessments**

**Annex A1**  
Built Heritage Resources: Baseline Studies and Impact Assessments

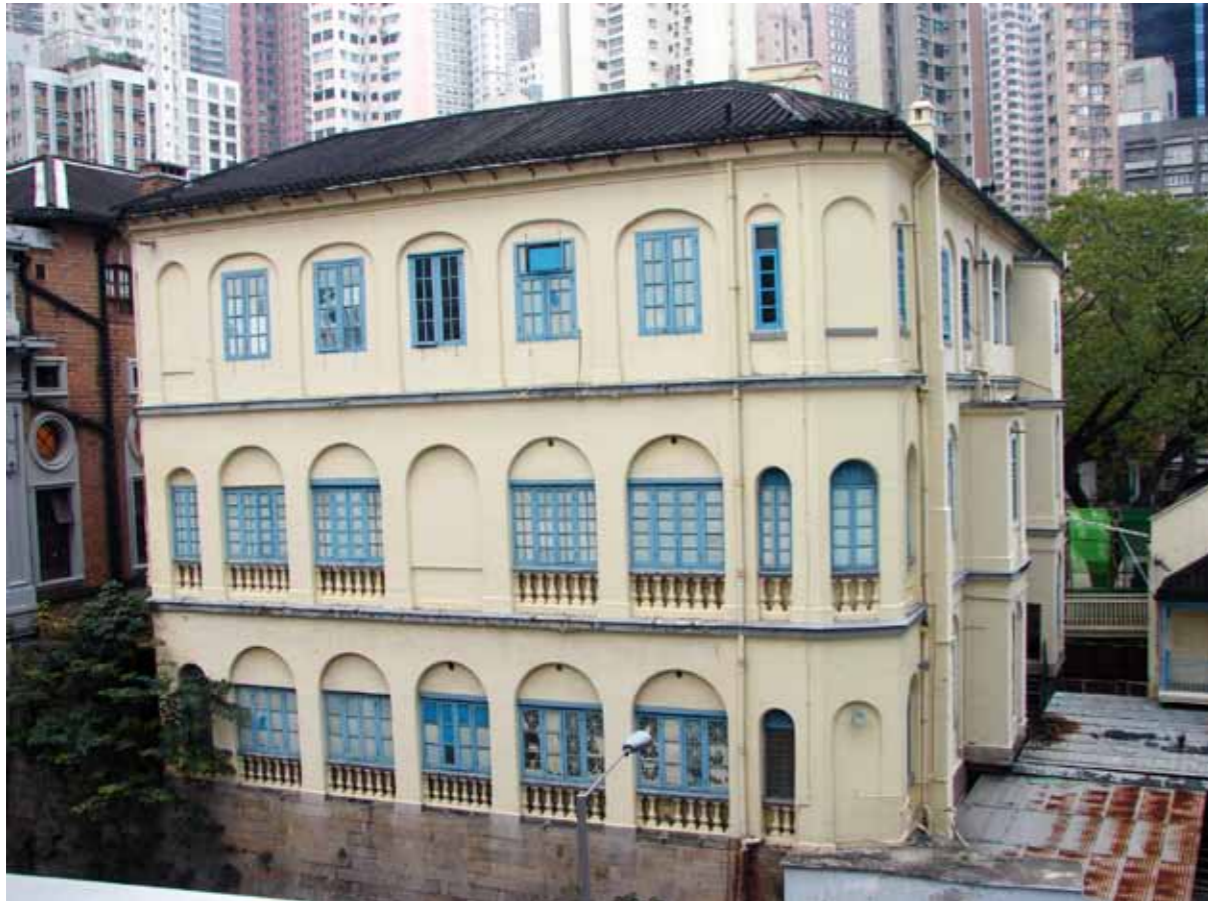
Figure 1 - East elevation overlooking Arbutnot Road; note the ground and first floor verandah infill

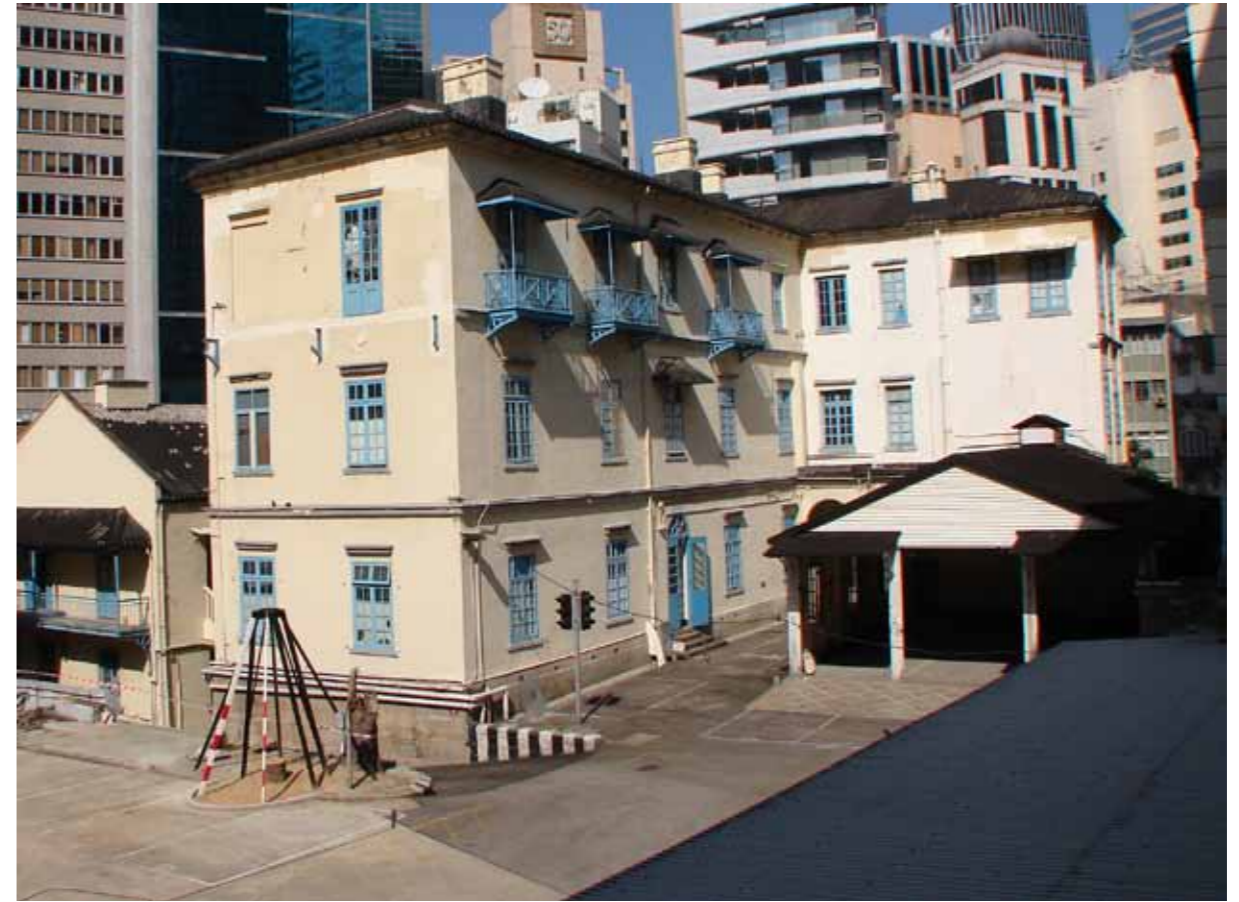
Figure 2 - Southwest elevation; note the missing balcony on the west end, second floor

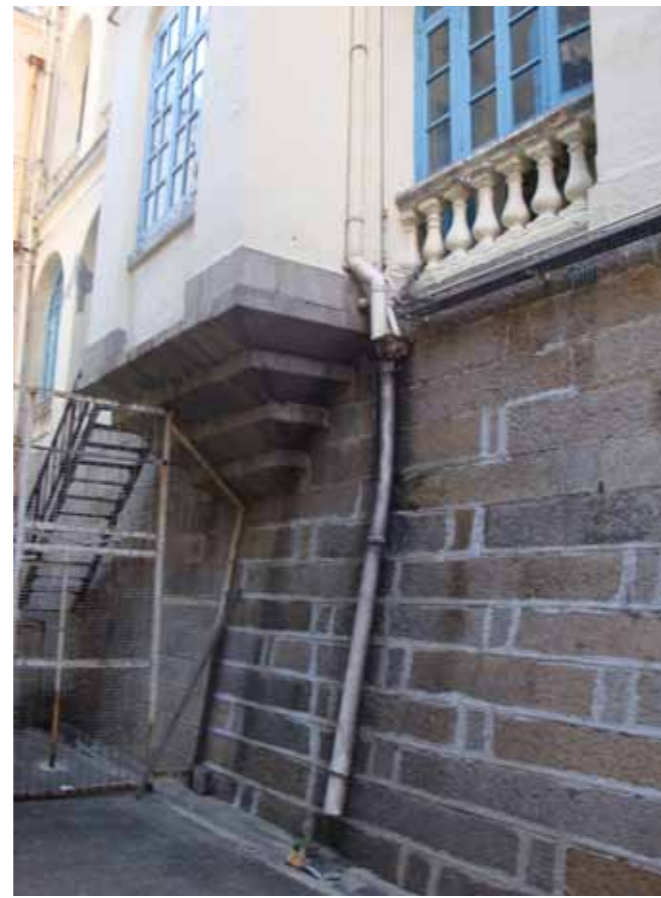
Figure 6 - Granite corbel supporting one of the north projecting bays. The other is in need of urgent repair.

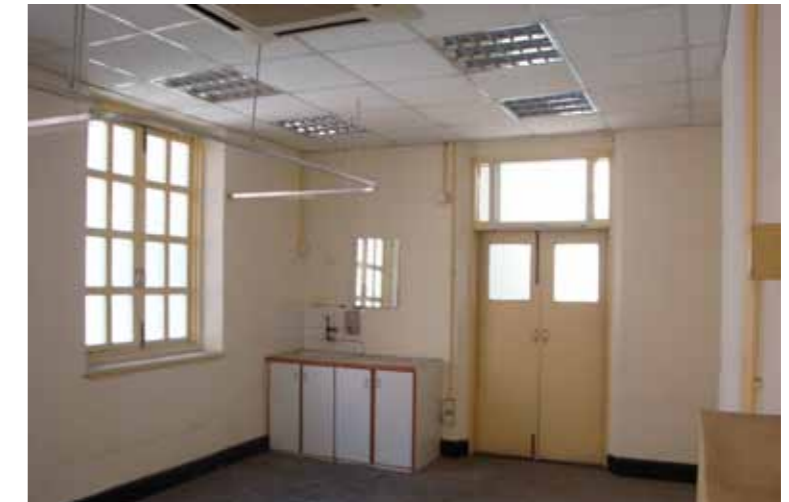
Figure 5 - Typical interior space, with later suspended ceilings and replacement double doors. The fanlight has been altered to accommodate air-conditioning.

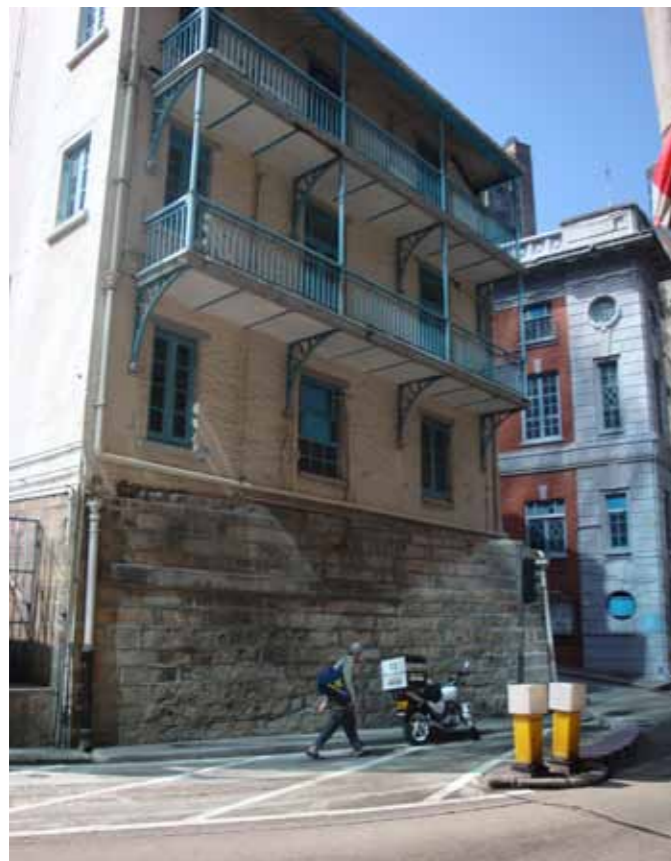
Figure 2 - North elevation of the building overlooking Hollywood Road. The ground floor balcony was removed at an unknown date.

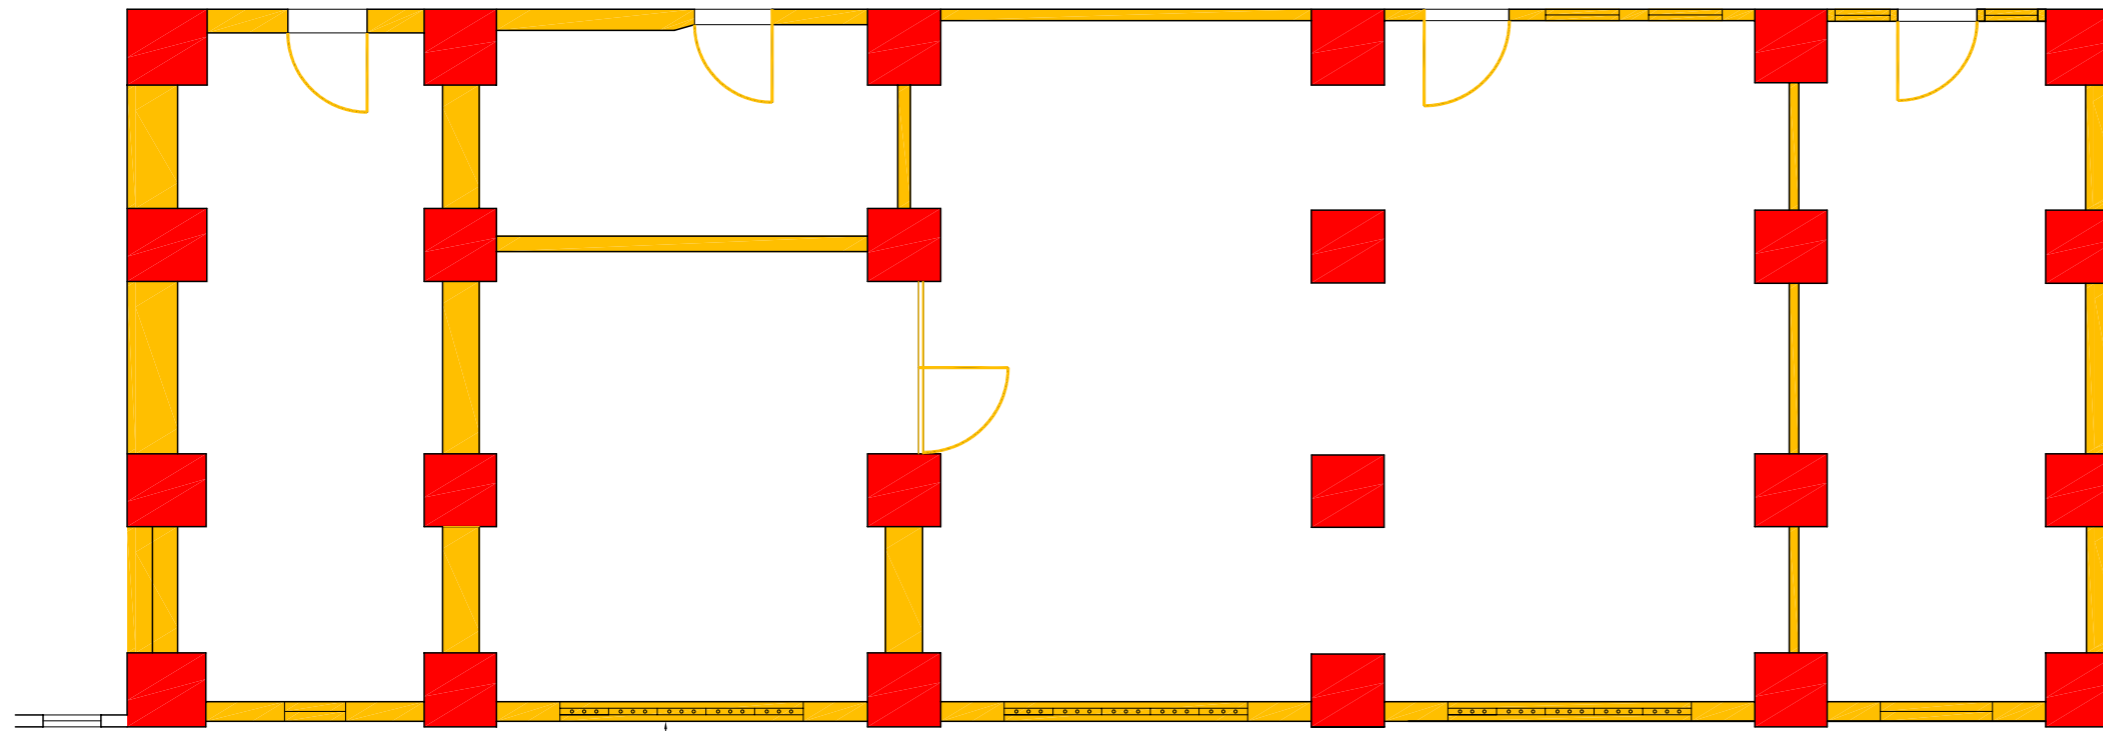
**Building 15. E Hall  
Basement Plan**

Cell windows retain original openings and concrete frames, but the original glass louvre's have been replaced with metal ones and metal wire mesh has been installed on the interior

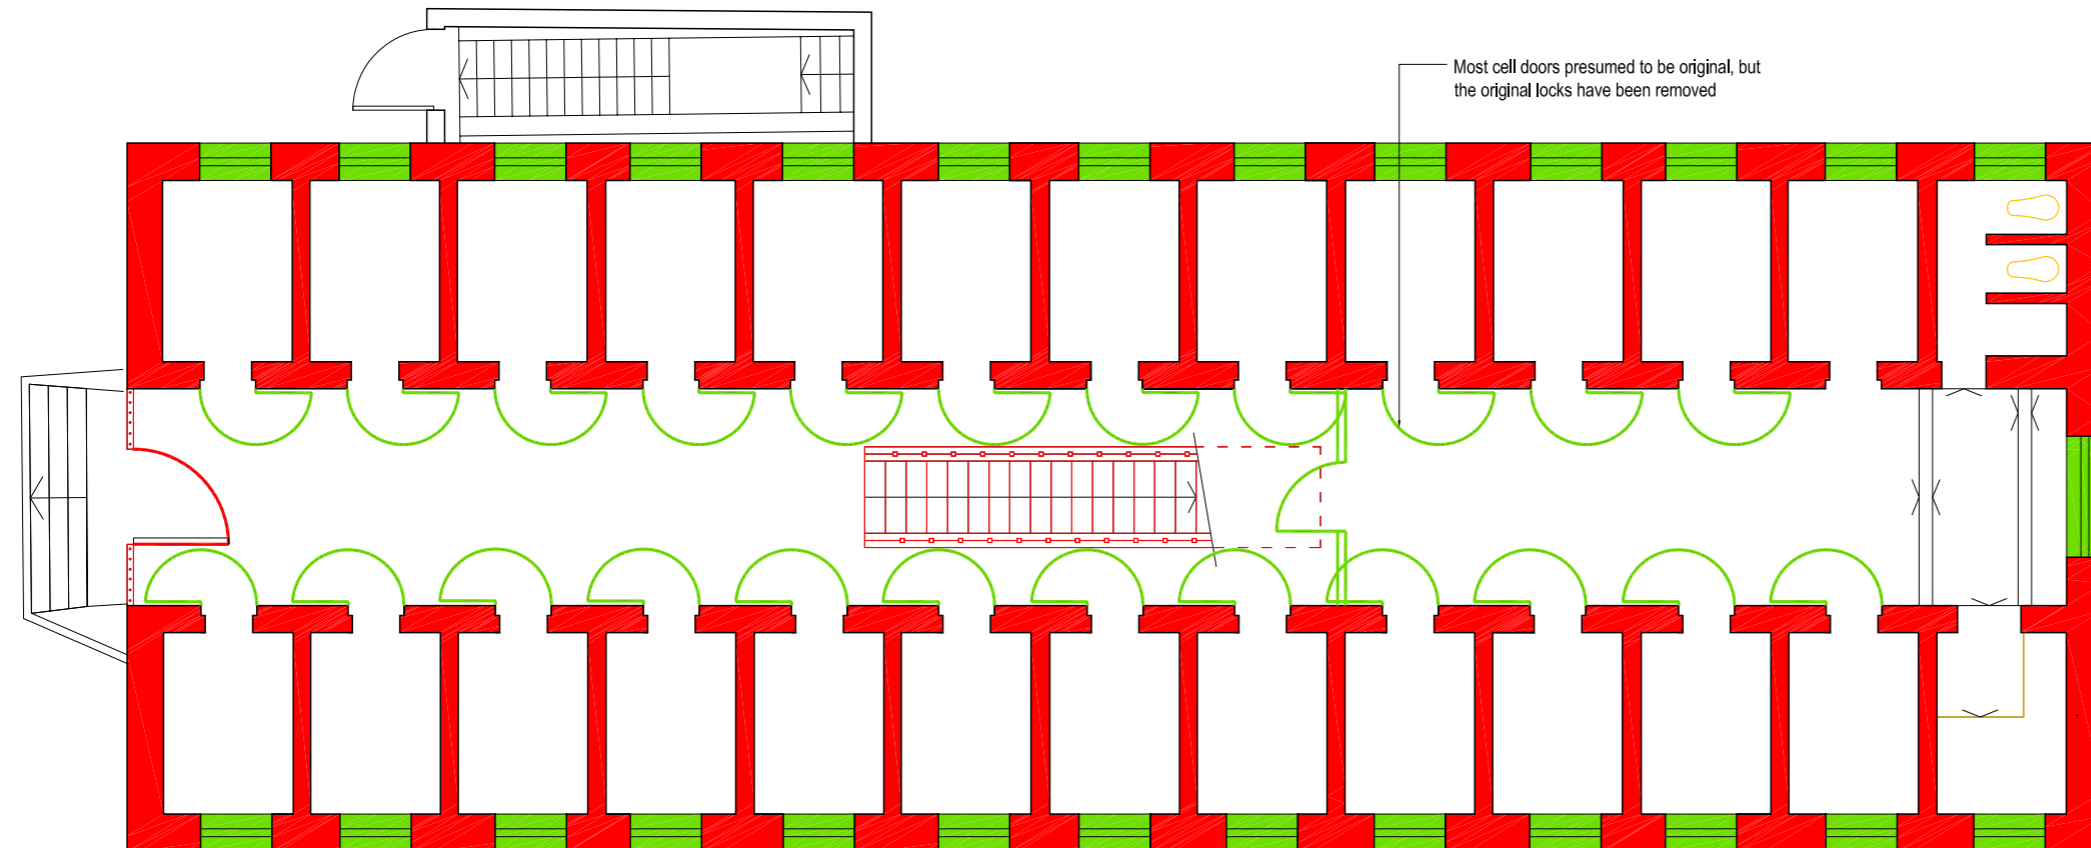
**Building 15. E Hall  
Ground Floor Plan**

Most cell doors presumed to be original, but the original locks have been removed

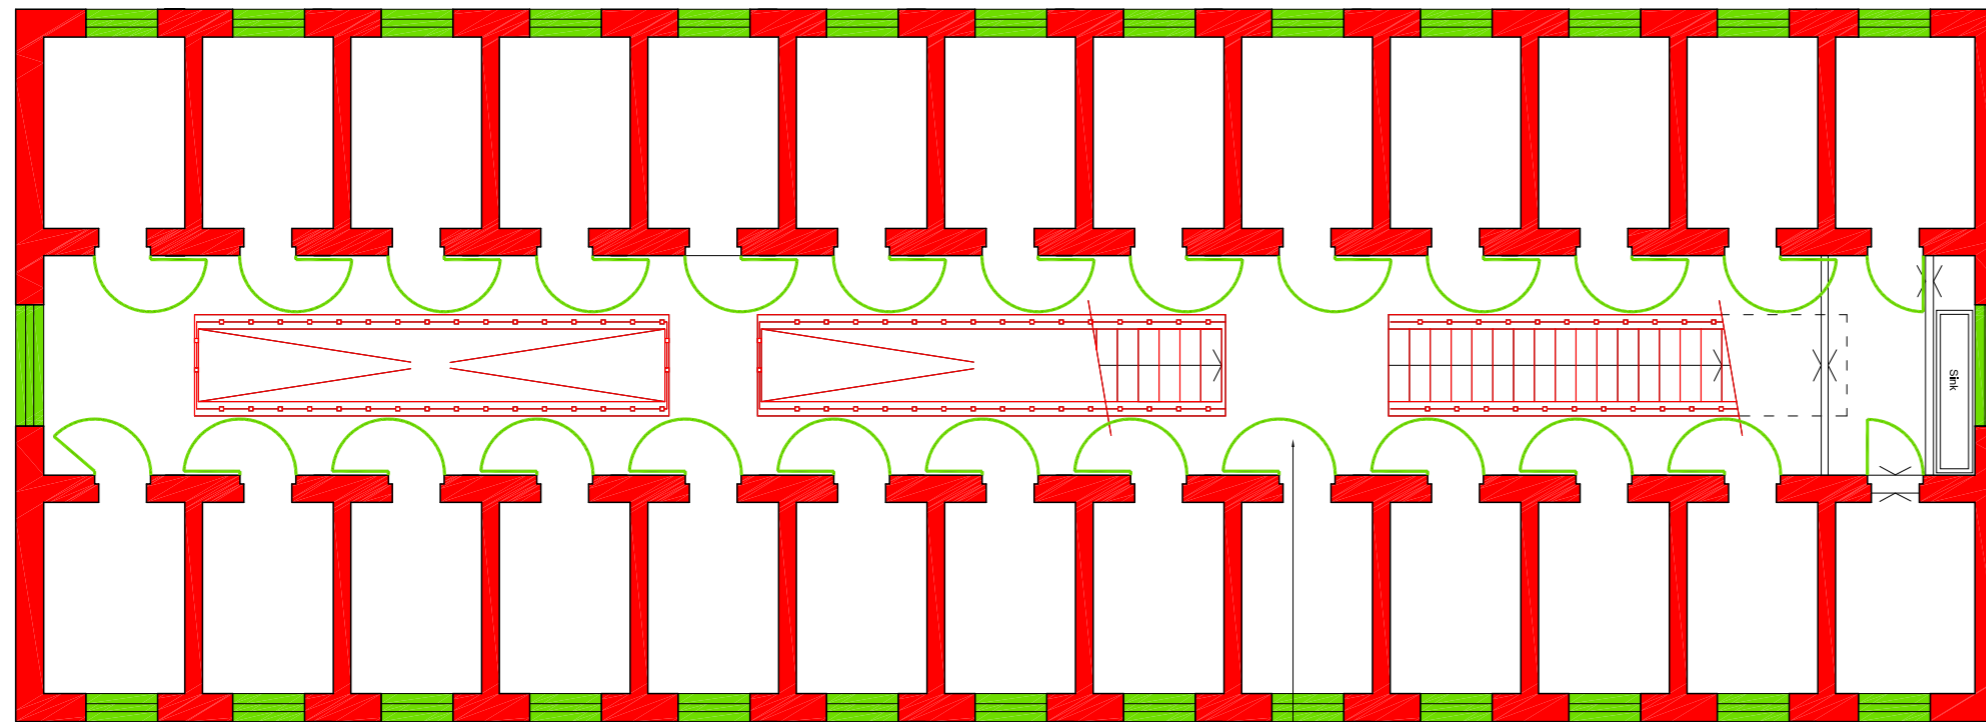
**Building 15. E Hall  
First Floor Plan**

Cell windows retain original openings and concrete frames, but the original glass louvre's have been replaced with metal ones and metal wire mesh has been installed on the interior

Most cell doors presumed to be original, but the original locks have been removed.
