Central Police Station Conservation
and Revitalisation Project:
Thirty-sixth Monthly EM&A Report
(1 October to 31 October 2014)

Issue Date: November 2014

Environmental Resources Management

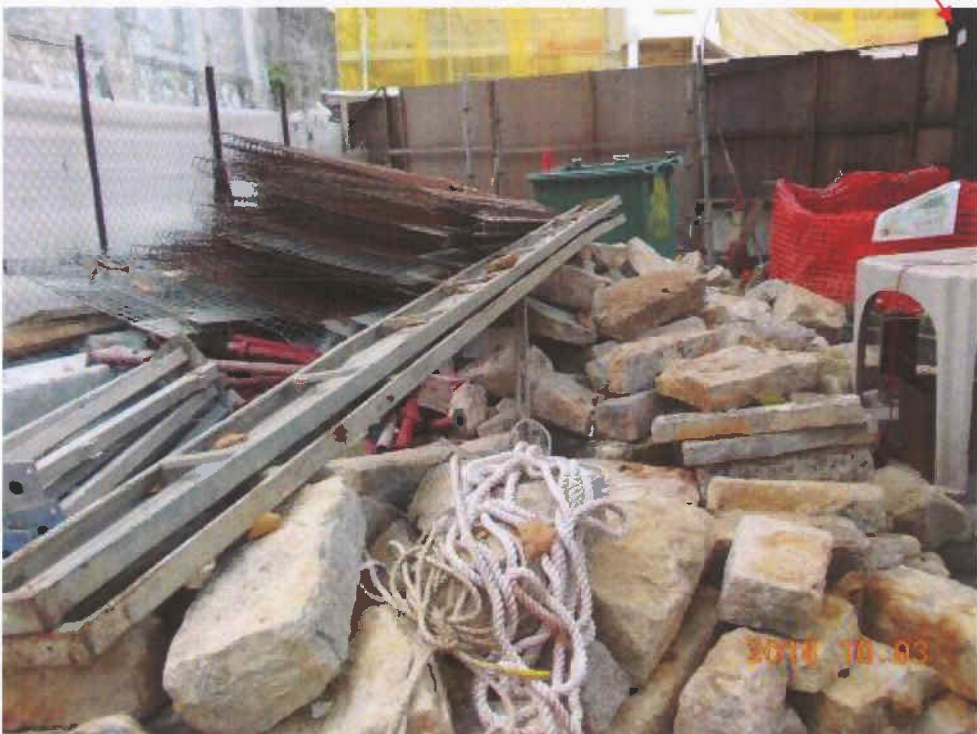
Fig. 7 Many construction items are placed near the planter. Tree-6

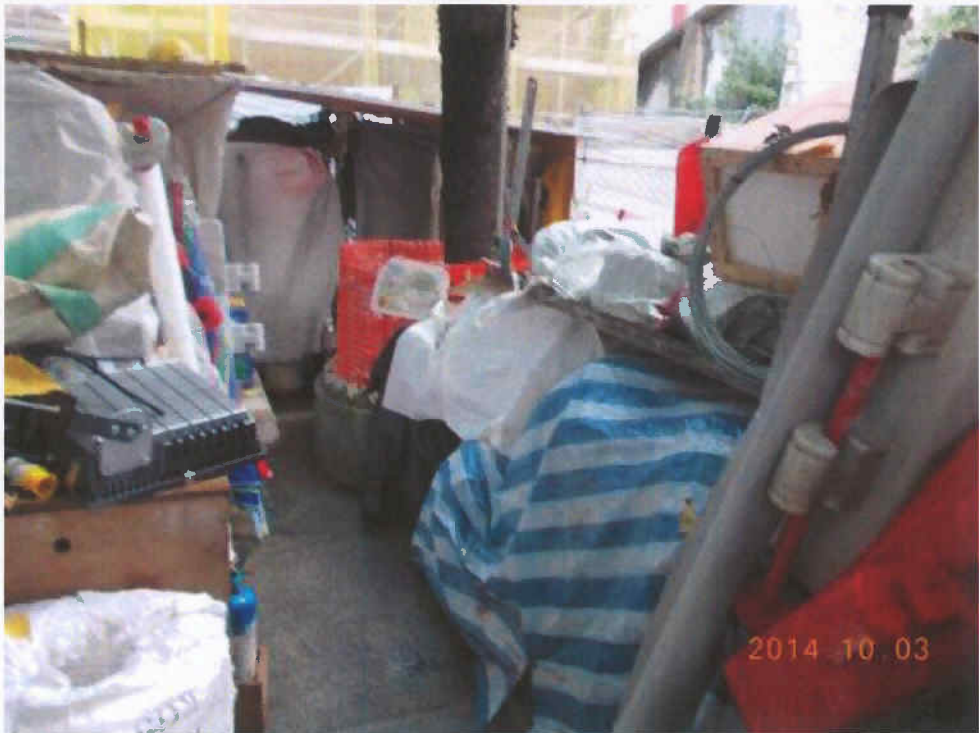
Fig. 7 Many bulky items are placed near the planter.

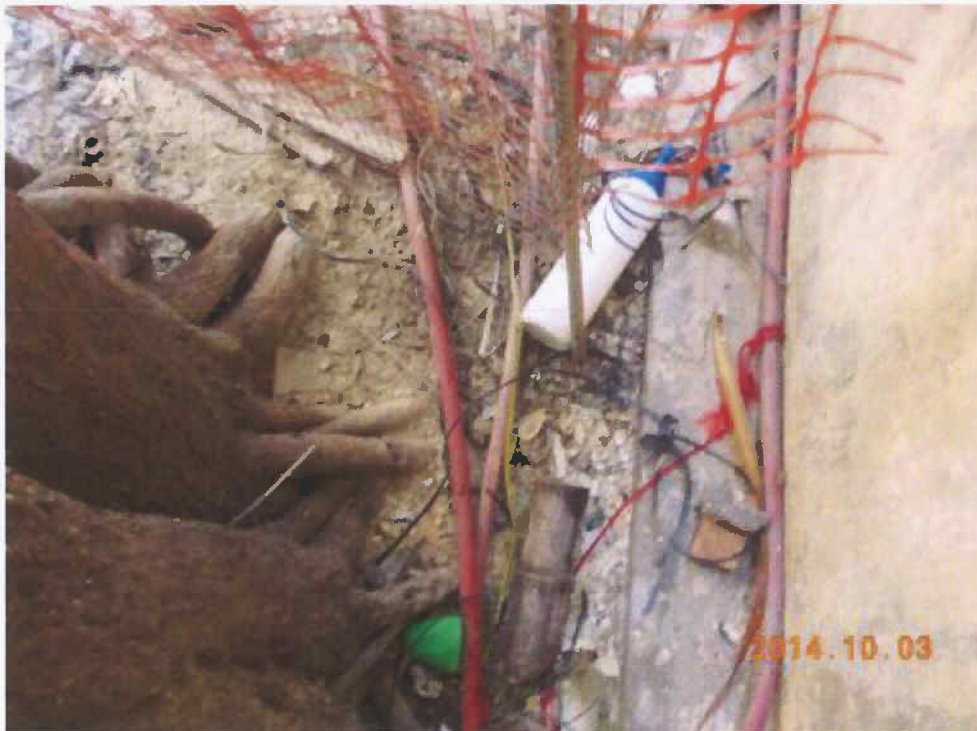
Fig. 3 Other side view of the planter. The top-soil near Tree-11 has been seriously polluted by the construction debris and litter.

1. To take immediate mitigation measures against the land pollution.
