The Jockey Club CPS Limited

Central Police Station Conservation
and Revitalisation Project:
66th Monthly EM&A Report
(1 April to 30 April 2017)

Issue Date: May 2017

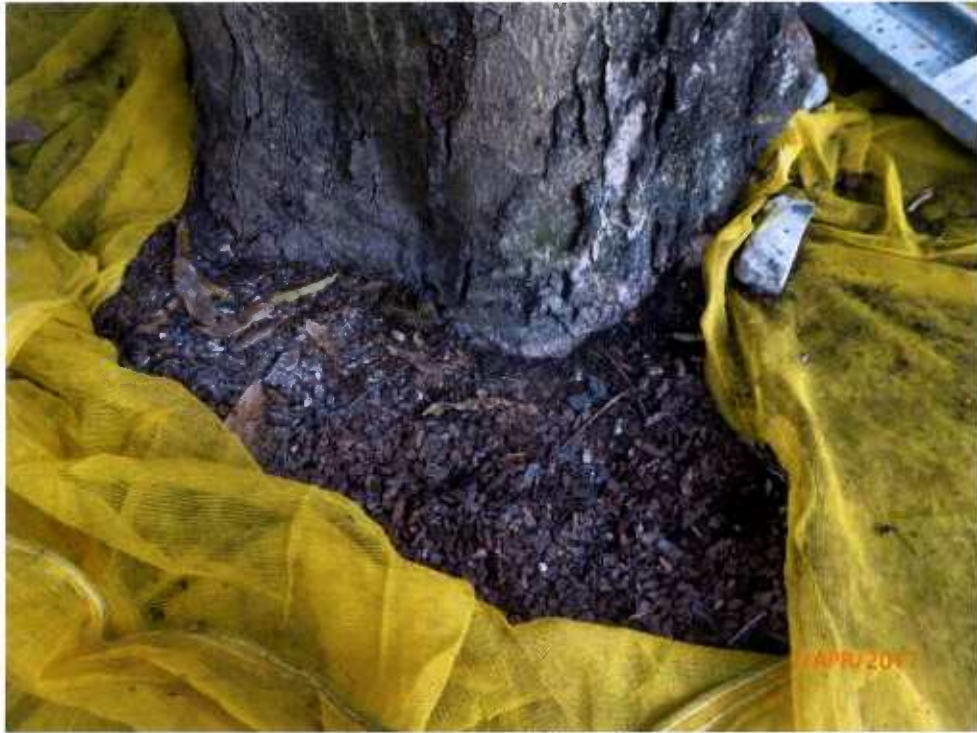
Fig. 3 Health condition of the lower trunk is fair.

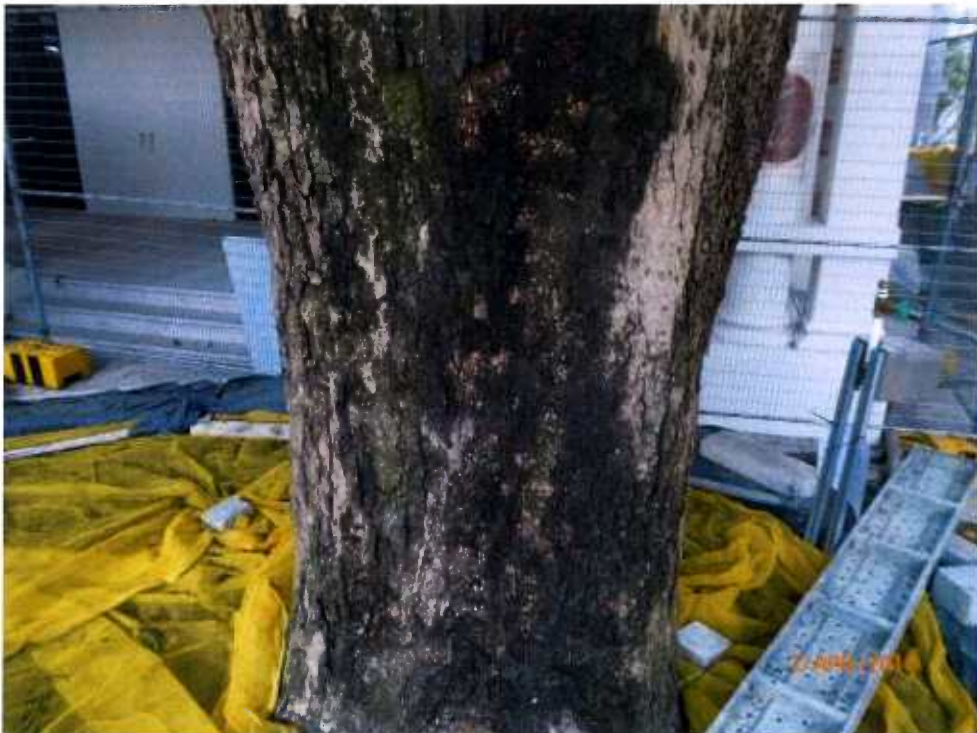
Fig. 4 Health condition of the mid trunk is fair.

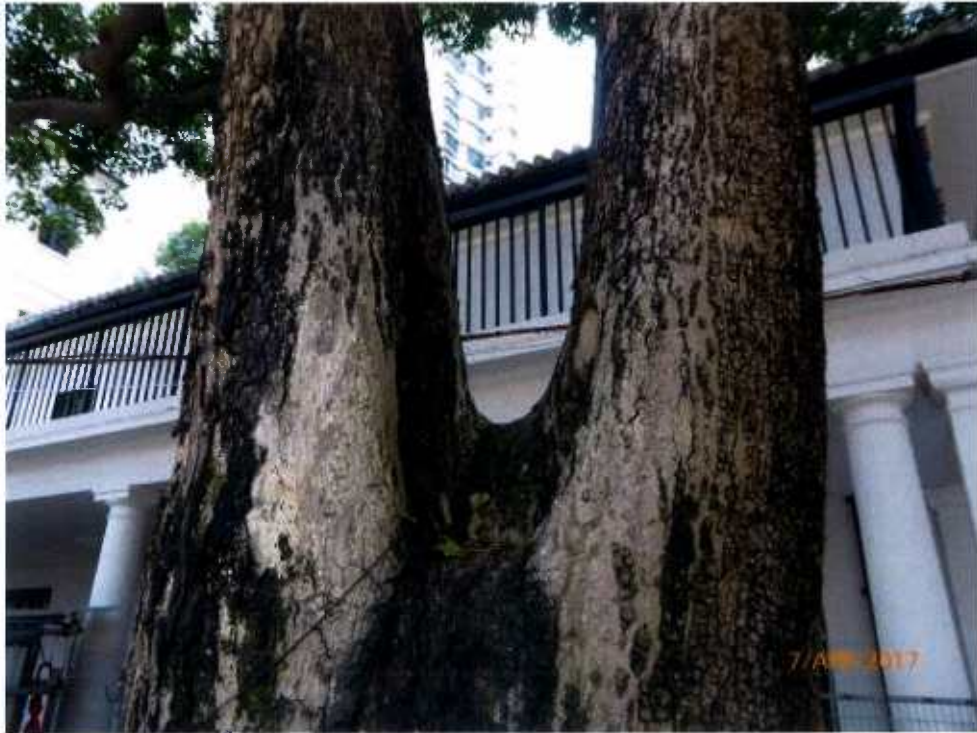
Fig. 5 Health condition of the upper trunk also is fair.

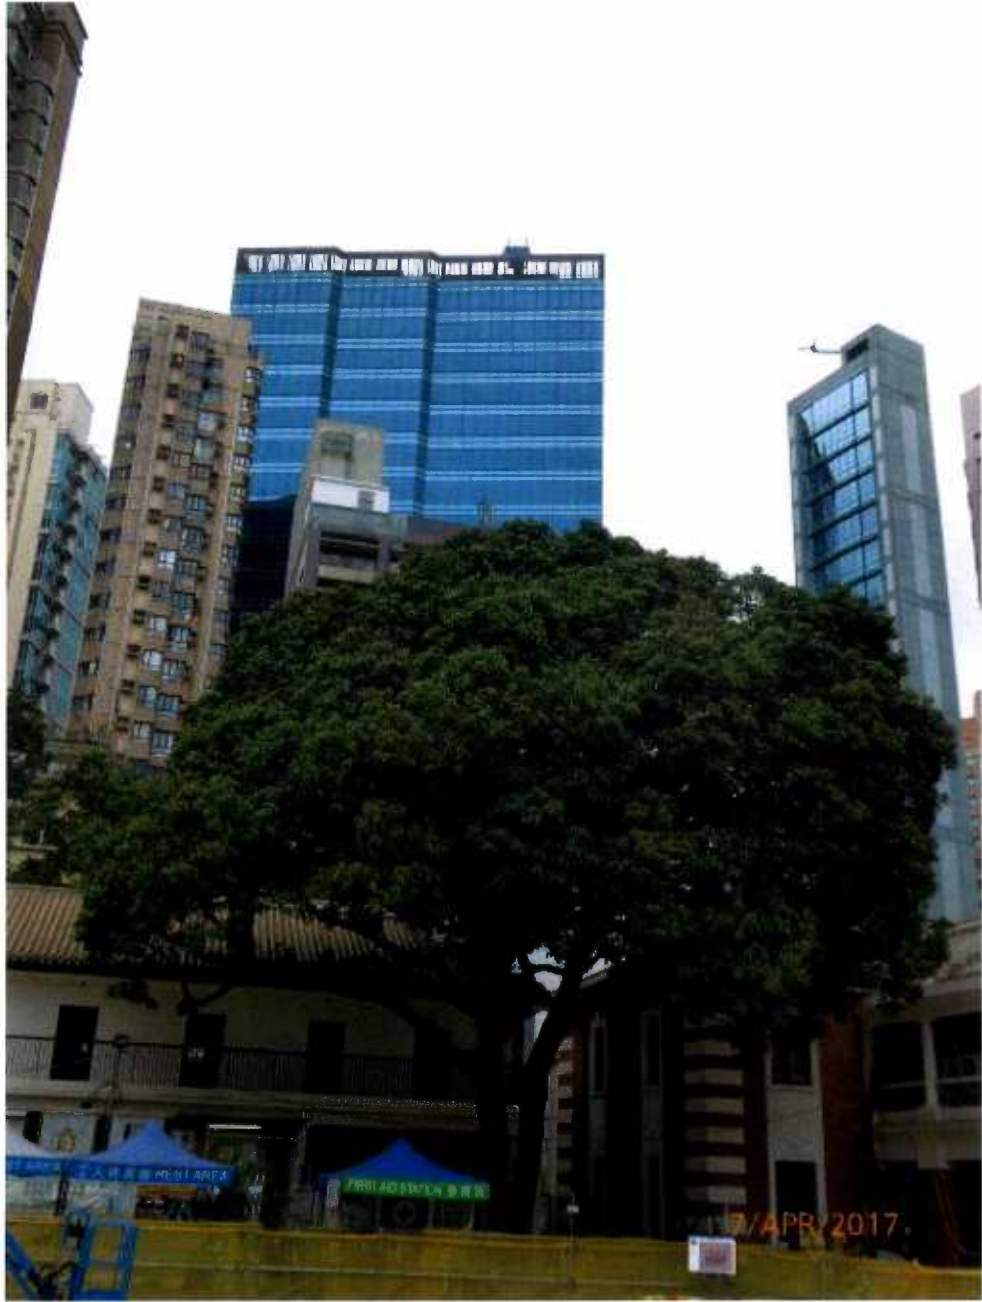
Fig. 12 Overall view of Tree-5 during inspection on 7th April 2017.

As the top soil has been backfilled at the planter by December 2016, we recommend to keep monitoring on the growth of the tree in the coming months.

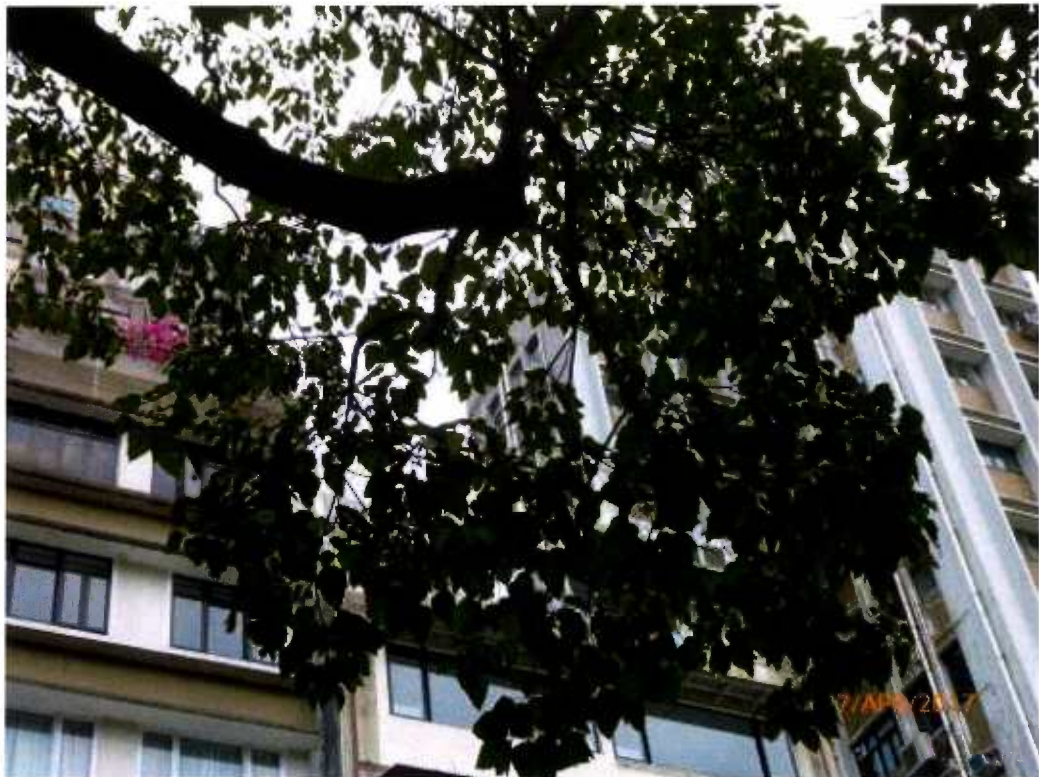
Fig. 8 Faded leaves still appear on the tree due to continuous dry weather.

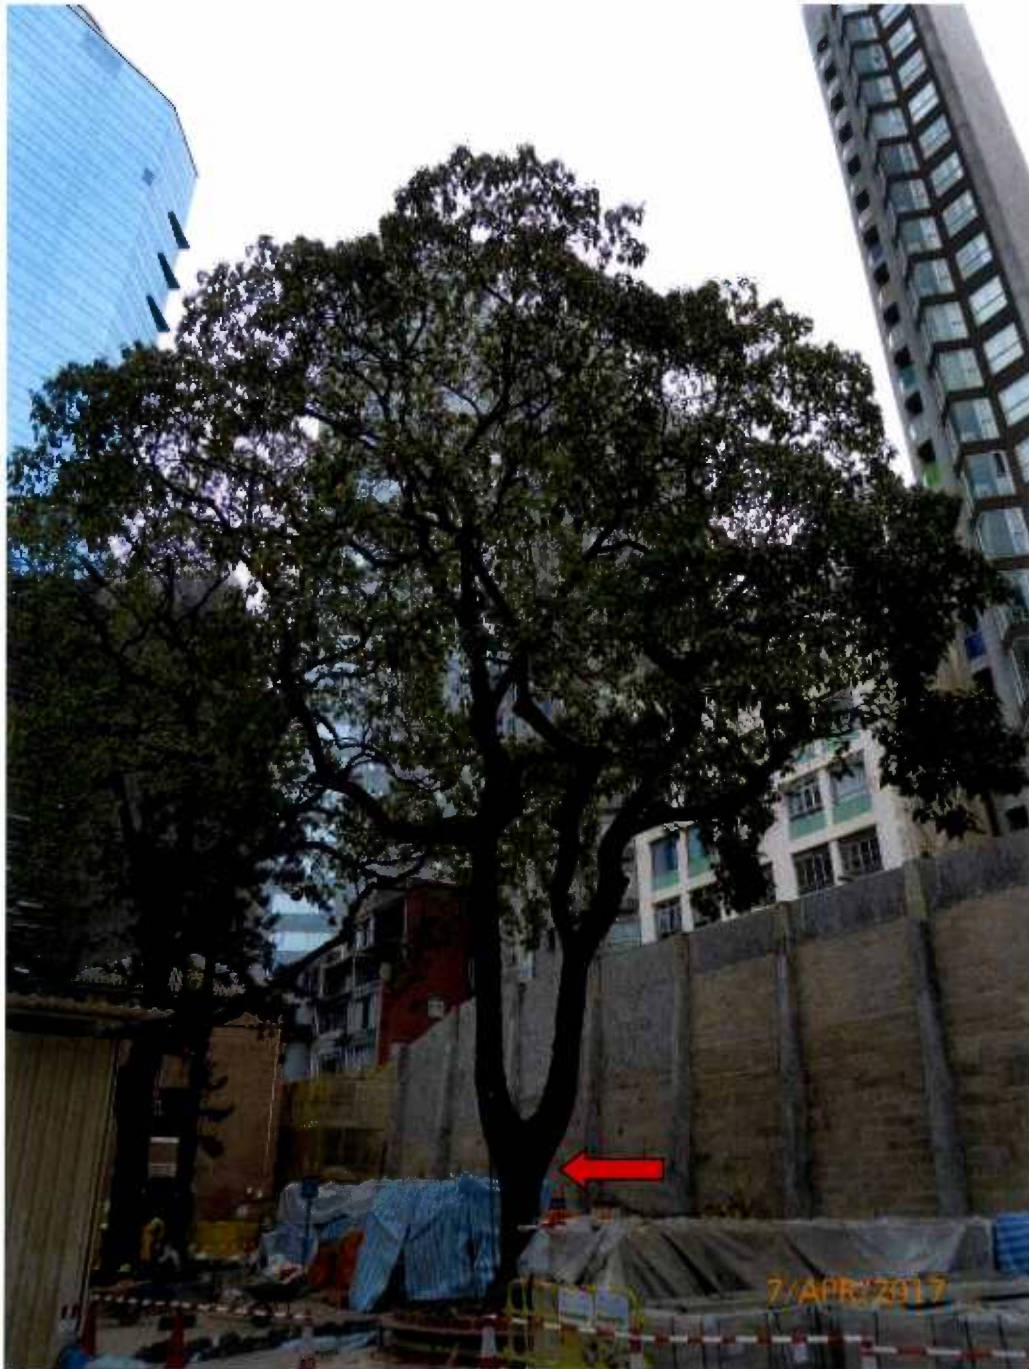
Fig. 12 Overall view of Tree-6 during inspection on 7th April 2017.

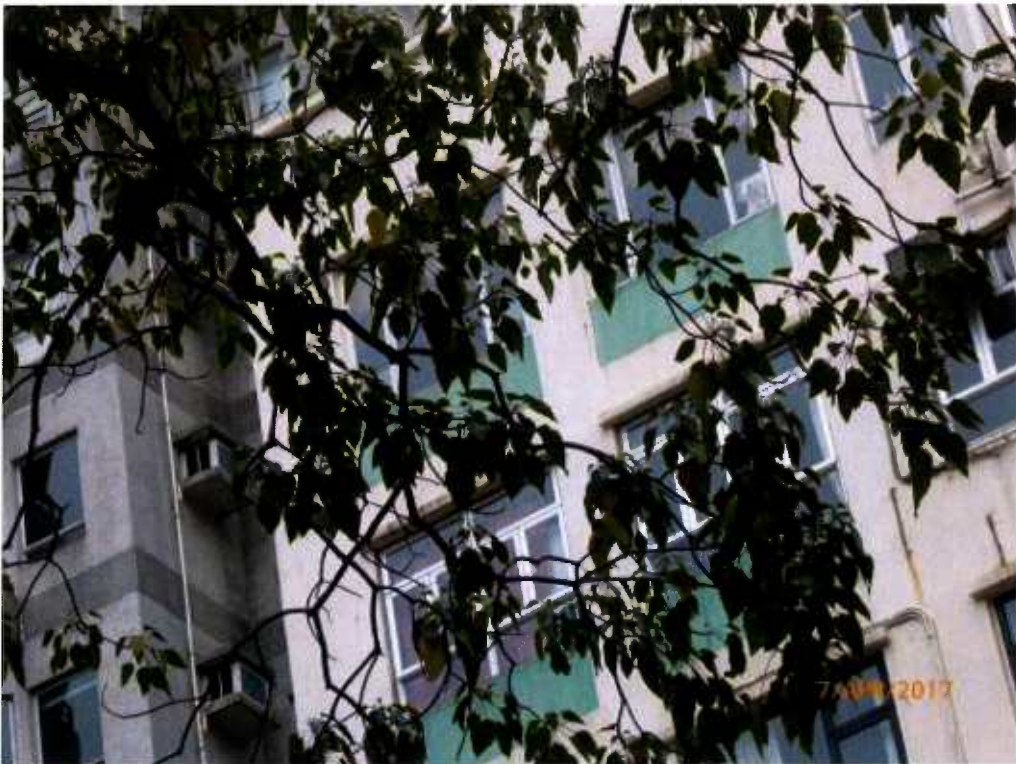
Fig. 8 Faded leaves still appear on the tree due to continuous dry weather.

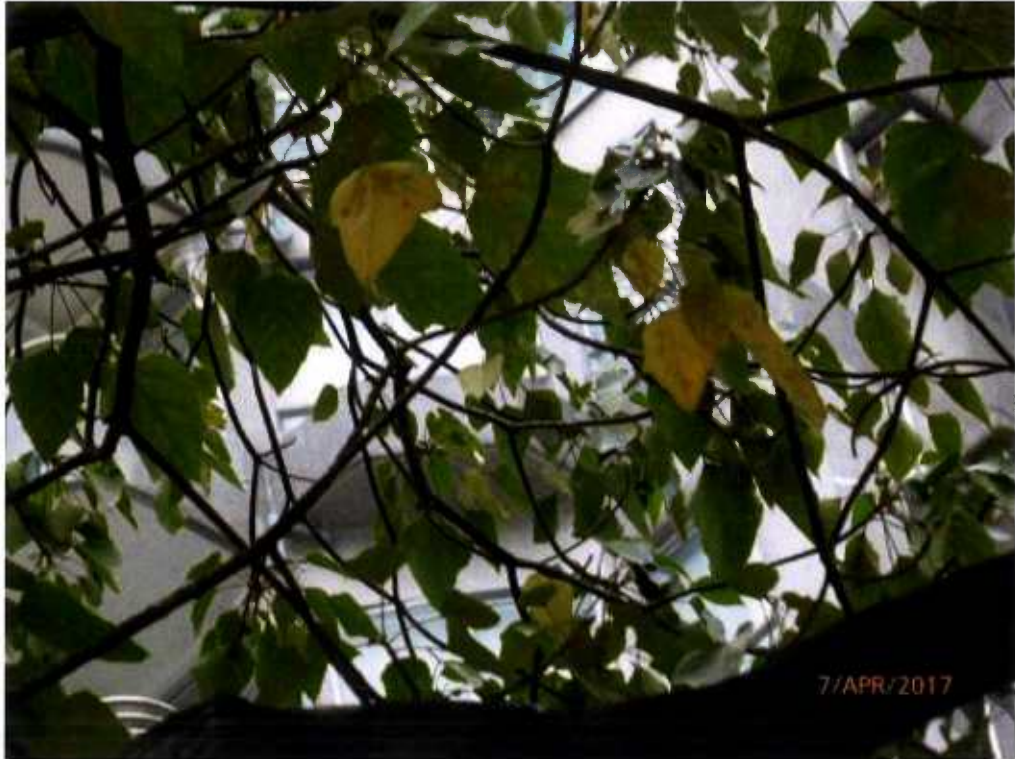
Fig. 9 Signs of Pest (Mealy Bugs 粉狀介殼蟲) are rarely found on Tree-7 due to Pest Control Operation on 25th April 2016.

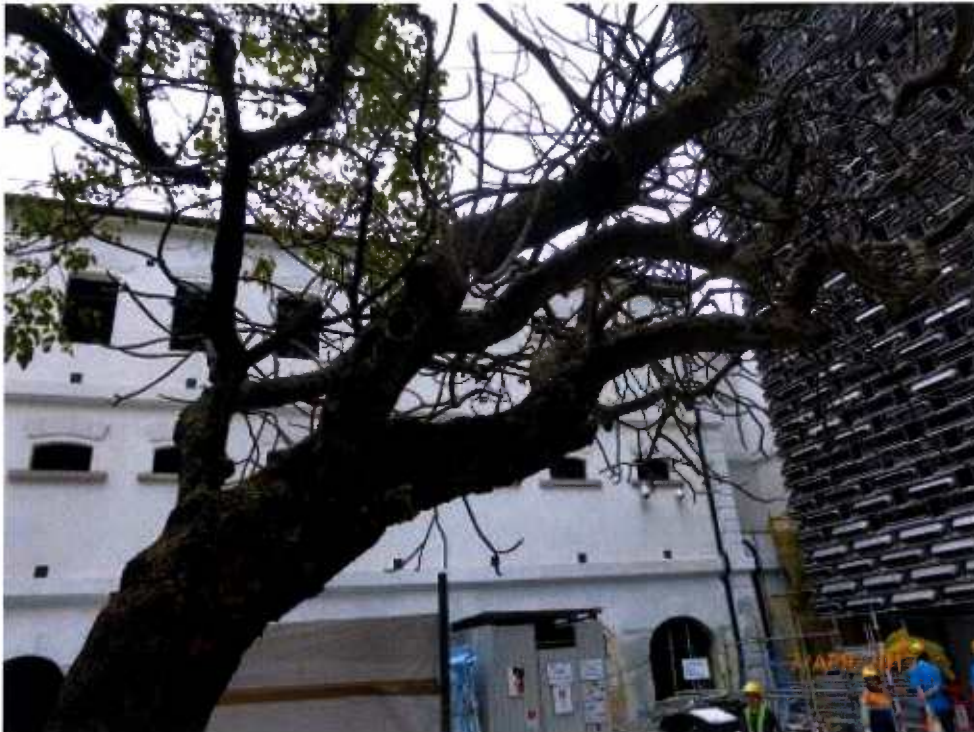
Fig. 6 Leaves on Tree-8 become sparse due to dry seasons.

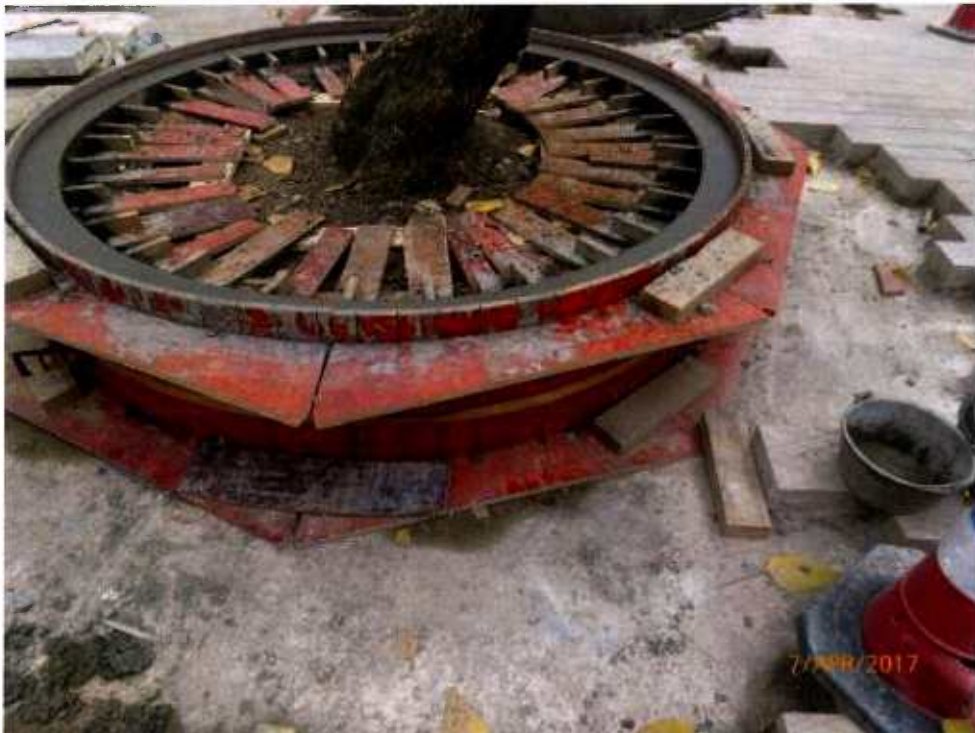
Fig. 8 The planter is under repair.

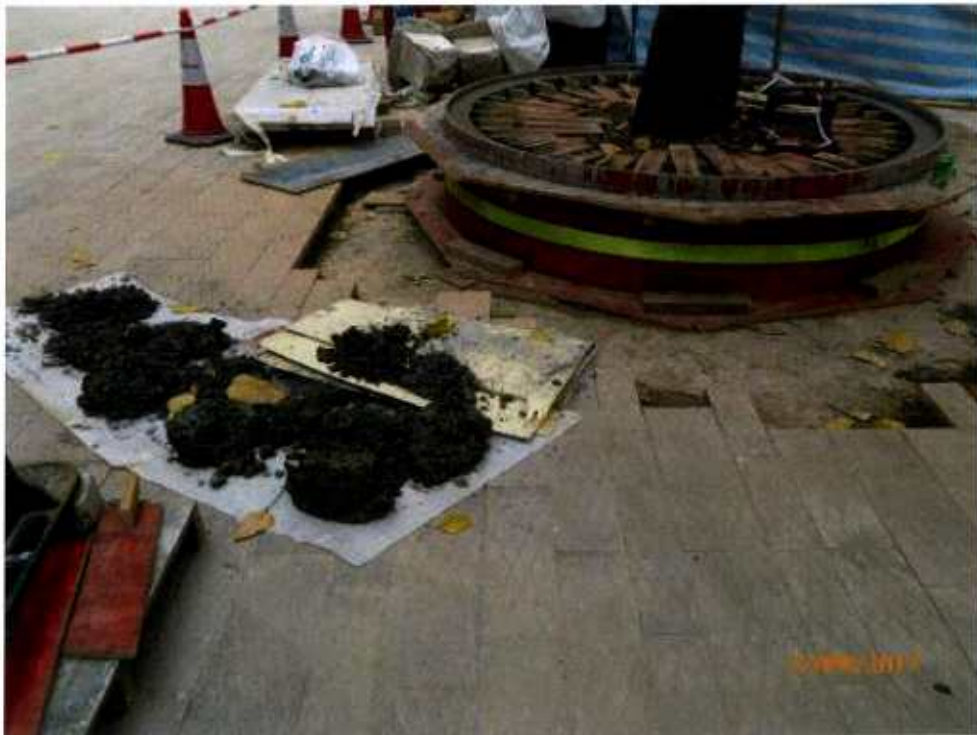
Fig. 10 Many construction materials are placed near the tree.

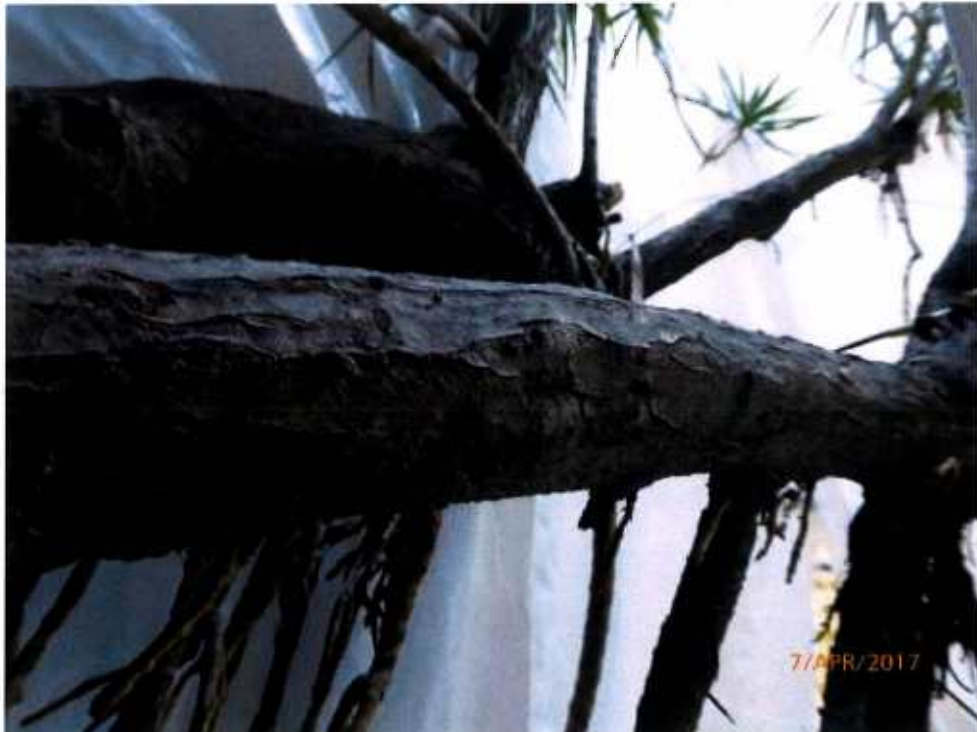
Fig. 6 Withered leaves still remain on the upper branches..

1. To keep monitoring on the growth of the tree especially when the nearby renovation works are in progress.

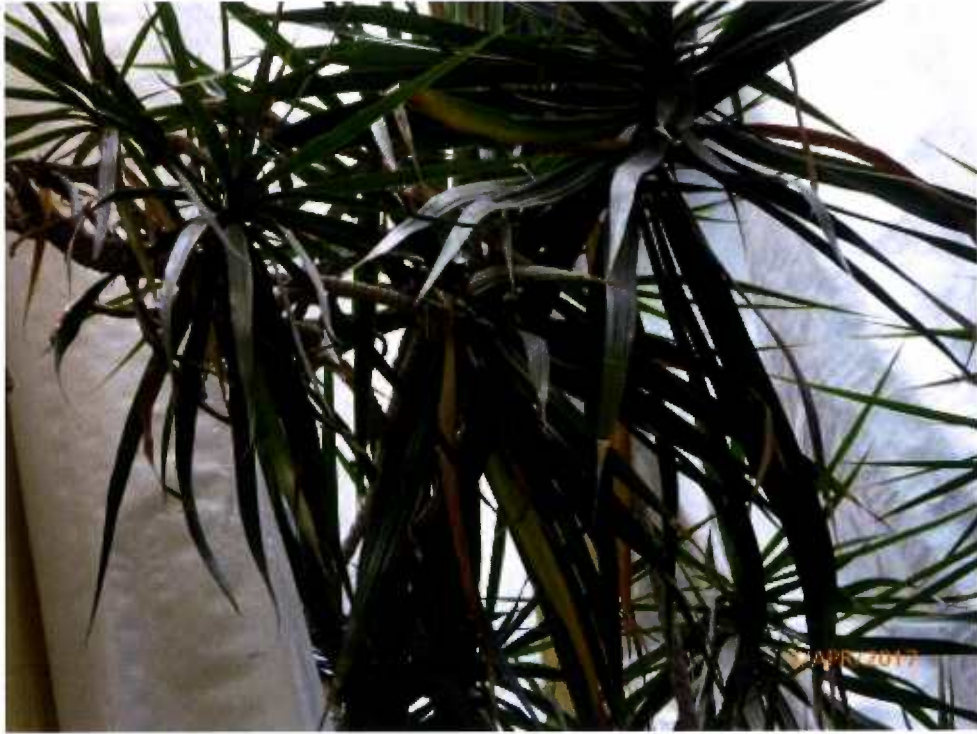
Fig. 7 Withered leaves also appear on the bottom part of Tree-11.

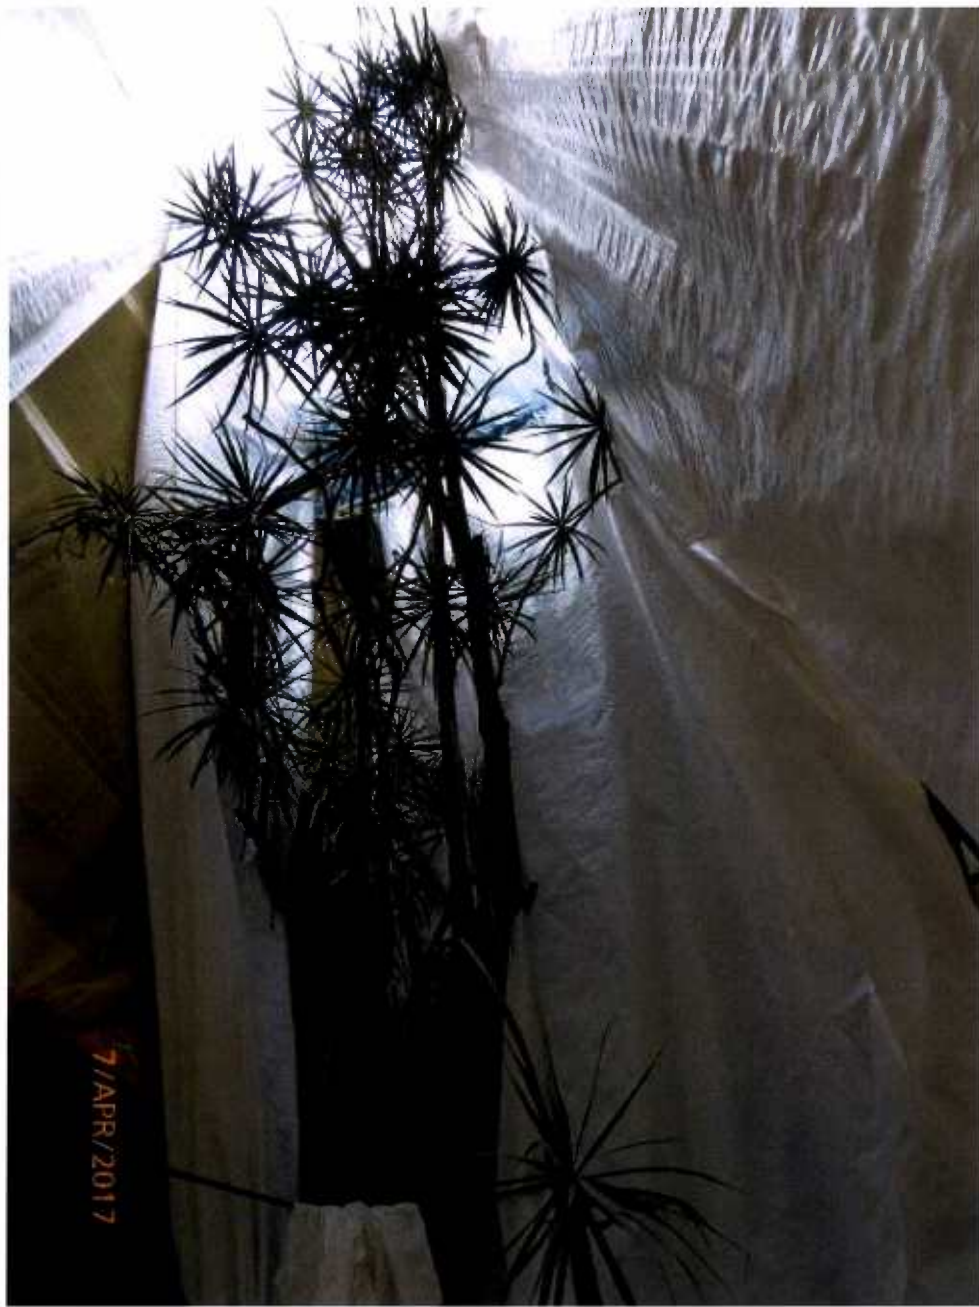
Fig. 12 Overall view of Tree-11 during inspection on 7th April 2017.
