The Jockey Club CPS Limited

Central Police Station Conservation
and Revitalisation Project:
Second Annual EM&A Review Report
(1 November 2012 to 31 October
2013)

Environmental Resources Management

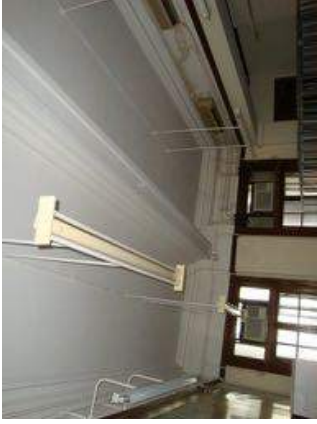
Element no.	Description	Photo ref	Significance	Proposal	Mitigation	Impact
01.009	Plaster ceilings on GF and LG1

Moderate	Install cloud ceilings to accommodate new services	Install fixed grid to minimise damage to ceiling	High
01.010	Timber door frames and architraves	 	Moderate	Conceal in exceptional cases eg. where adjacent new lift shaft	Retain architrave and door frame in situ. Avoid damage to joinery.	High

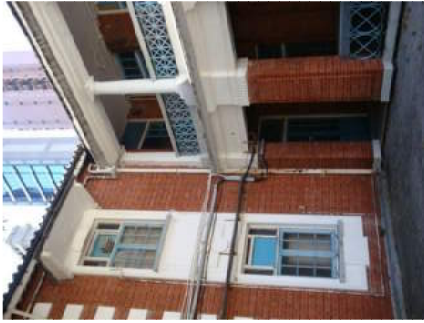
Element no.	Description	Photo ref	Significance	Proposal	Mitigation	Impact
01.012	Rainwater goods

Adverse	Replace with cast iron in pattern to match original and in correct locations	Not applicable	High

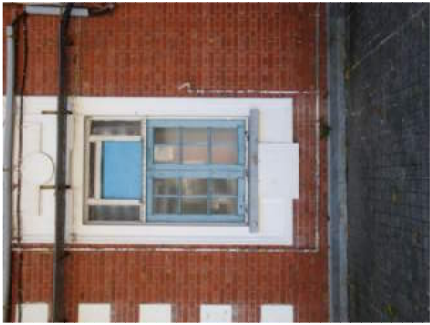
Element no.	Description	Photo ref	Significance	Proposal	Mitigation	Impact
01.016	Altered doors and windows

Adverse	Repair or renew as necessary existing frames to match original patterns	Not applicable	High
01.017	Mezzanine floor in room 01/LG1/13

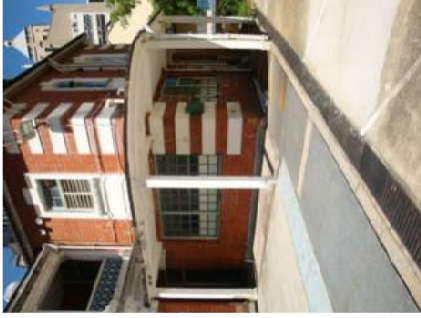
Element no.	Description	Photo ref	Significance	Proposal	Mitigation	Impact
01.031	Reinforced concrete canopy and sash windows

Moderate	Remove canopy and replace sash windows with new windows to match original	Make good brickwork where canopy removed, Reinstate rendered architraves around new window to match similar window facing on West wing	Moderate

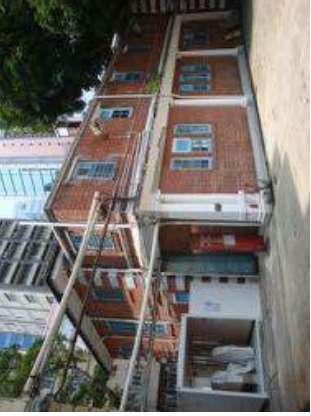
Element no.	Description	Photo ref.	Significance	Proposal	Mitigation	Impact
02.007	Rainwater goods

Adverse	Replace with cast iron in pattern to match original and in correct locations	No applicable	High

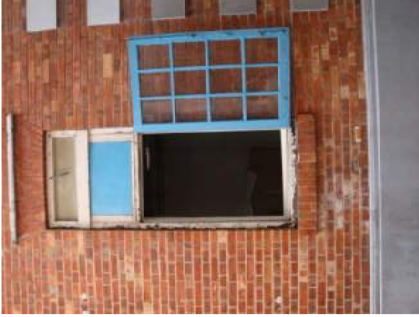
Element no.	Description	Photo ref.	Significance	Proposal	Mitigation	Impact
02.008	Altered doors and windows

Adverse	Repair or renew as necessary existing frames to match original patterns	Not applicable	High

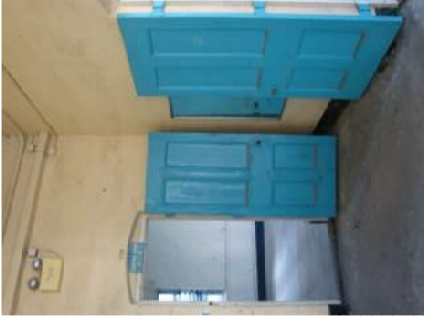
Element no.	Description	Photo ref.	Significance	Proposal	Mitigation	Impact
3.002	Panelled doors

Moderate	Replace where necessary to achieve fire resistance to comply with Code	Re-use where possible. Record design on survey drawings where item cannot be re-used.	Moderate

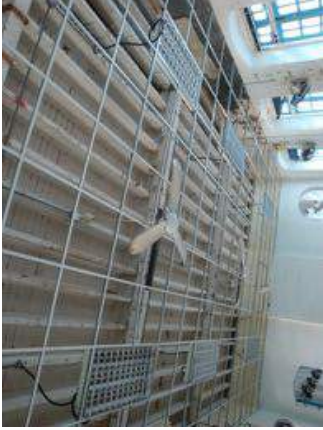
Moderate	Sub-divide two rooms on each floor to provide service core, comprising: lifts, toilets, plant rooms, stores	Form new sub-visions using lightweight partitions to achieve reversibility. Form straight joints at abutments with existing retained walls. Notch new partitions around existing brick corbels at high level as a reminder of current condition.	Moderate
03.021	Exposed soffits of timber floors

Moderate	Underline existing floors to achieve specified fire resistance stated in Code	Avoid unnecessary damage to existing structure. New lining will reduce extent of intervention into existing structure. Keep level of new linings well clear of window heads.	Moderate

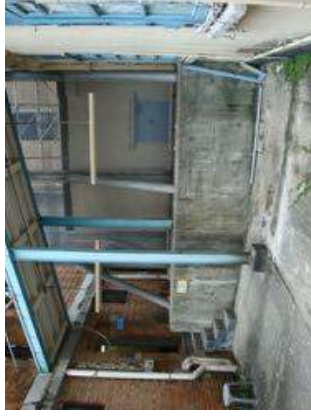
High	Open up selected openings to form new fire escape doors	Retain any salvageable material for possible re-use elsewhere. Retain existing window jambs intact. Cut away masonry to form door openings along same line as window jamb; do not re-bind cut brickwork. Record existing condition on measured survey drawings.	Low
03.023	Single storey outbuildings on south side

Adverse	Demolish	Check for evidence of early route from Magistracy to Prison.	Low

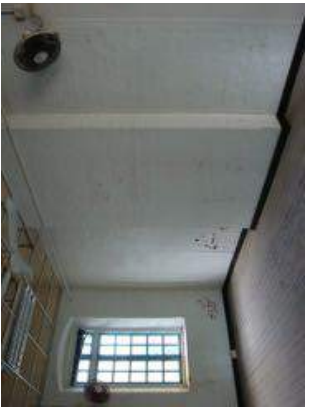
Low	Repair and retain in current location	Not applicable	Neutral
03.026	Window in south wall; original dormitory space

Moderate	Remove window and take down brickwork spandrel; subdivide space to form new fire-protected escape route.	Record existing condition on measured survey drawings. New partition wall to be reversible.	Low

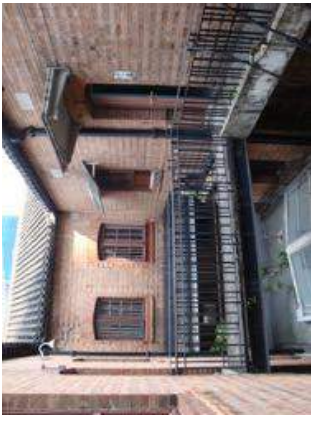
Moderate	Replace with larger sizes/closer spacing to improve performance	Use cast iron to match original pattern Make good all redundant fixing holes	High
09.013	Metal walkways across lightwell

Adverse	Remove walkways and make good brickwork at abutments	Not applicable	High

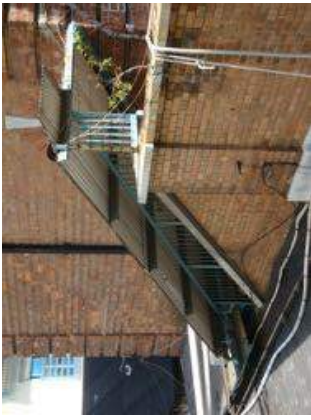
Adverse	Repair or renew as necessary existing frames to match original patterns	Not applicable	High
09.015	Sloping canopy over external stair on west side

Adverse	Remove canopy and supporting structure	Not applicable	Moderate

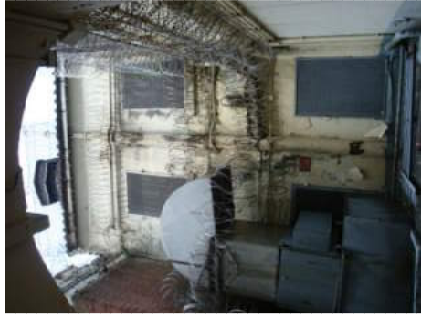
Adverse	Repair or renew as necessary existing frames to match original patterns	Not applicable	High
10.009	External airconditioning units and other external services

Adverse	Remove and make good brickwork	Not applicable	High

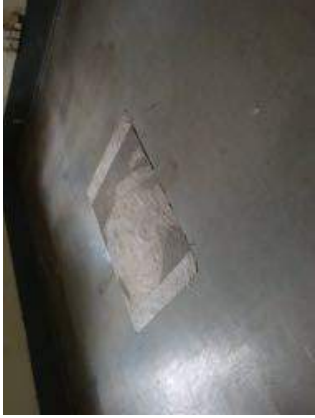
Low	Repair as necessary and retain	Not applicable	Neutral
13.015	Vinyl tile floor

Adverse	Replace	Not applicable	Low

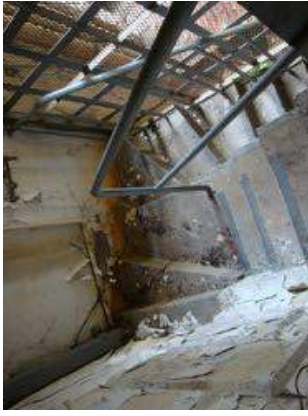
Moderate	Open up window opening to full extent.	Record existing condition on measured survey drawings. Add further detail during demolition works.	Low
14.008	External granite stair from Lower Ground to Ground Floor level

Moderate	Remove stair to make way for new stair in similar position	Review design proposals to see whether existing stair can be retained.	Low
