The Jockey Club CPS Limited

Central Police Station Conservation  
and Revitalisation Project:  
*Seventh Quarterly EM&A Report*  
*(1 May 2013 to 31 July 2013)*

Issue Date: August 2013

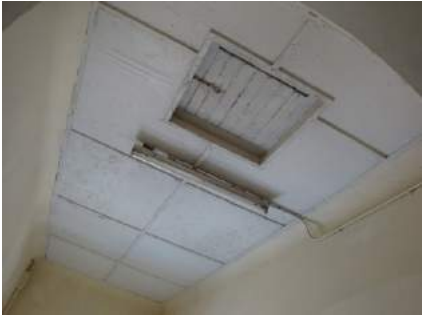
Element no.	Description	Photo ref	Significance	Proposal	Mitigation	Impact
01.001	Flat plywood ceiling lining with plain rectangular cover battens

Adverse	Replace with T&G boarding to match existing	Not applicable	High
01.002	Plaster coving at abutments of walls and ceilings

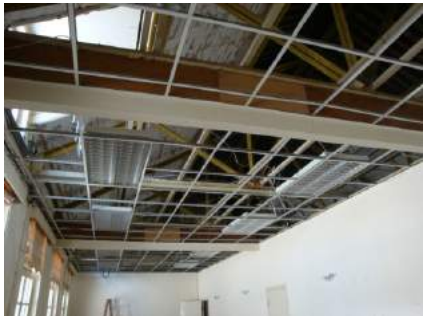
Element no.	Description	Photo ref	Significance	Proposal	Mitigation	Impact
01.003	Lay-in grid suspended ceiling

Adverse	Remove	Not applicable	High
01.004	Timber thresholds at external doors and internal doors between main corridor and individual rooms

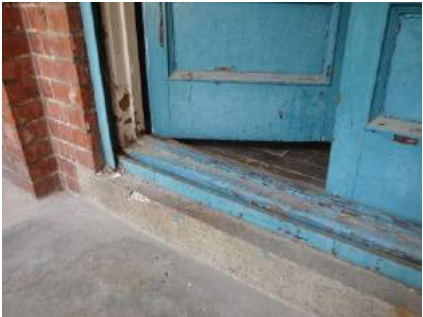
Low	Remove to enable level access	Splice extensions to door jambs, extend width of bottom rail of doors to match existing	Low

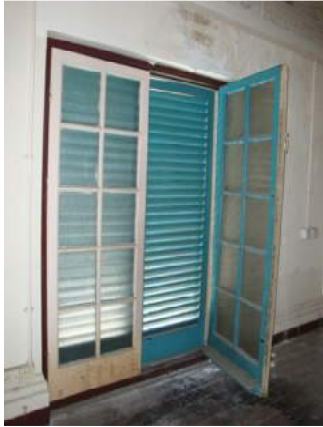
Element no.	Description	Photo ref	Significance	Proposal	Mitigation	Impact
01.007	External shutters

High	Reinstate to match existing pattern	Not applicable	High
01.008	External terraces at 1/F

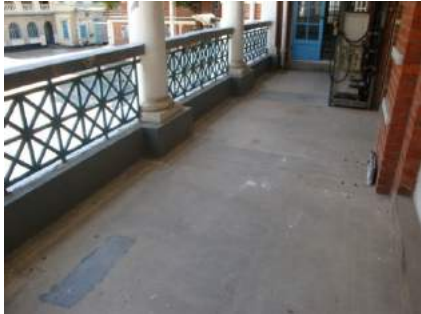
High	Overlay existing concrete paving with timber deck to provide level access	New deck to be reversible	Low

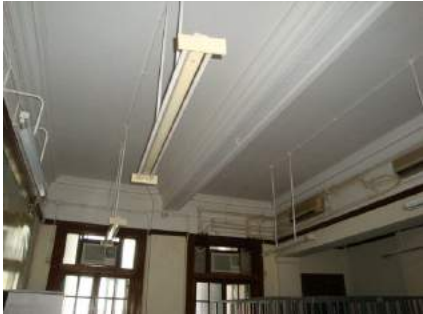
Element no.	Description	Photo ref	Significance	Proposal	Mitigation	Impact
01.009	Plaster ceilings on GF and LG1

Moderate	Install cloud ceilings to accommodate new services	Install fixed grid to minimise damage to ceiling	High
01.010	Timber door frames and architraves

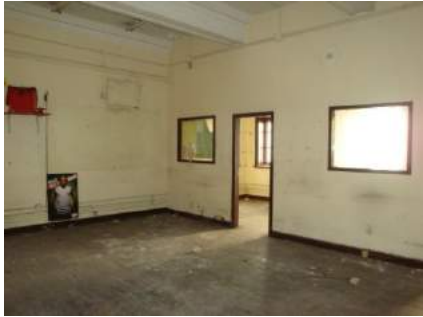
Element no.	Description	Photo ref	Significance	Proposal	Mitigation	Impact
01.011	Concrete floor

Low	Replace where new kitchens and plant rooms to be installed	Carefully remove and retain existing floorboards for re-use. Ensure controlled demolition of concrete structure and removal of debris from building to avoid damage to adjacent surfaces. Protect or carefully remove and set aside adjacent elements such as skirting boards	Low

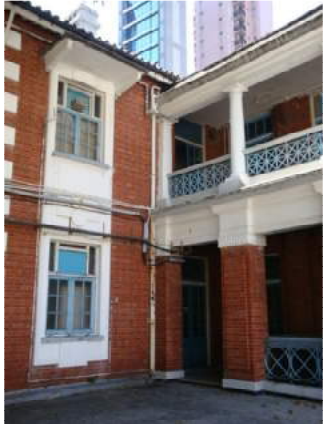
Element no.	Description	Photo ref	Significance	Proposal	Mitigation	Impact
01.012	Rainwater goods

Adverse	Replace with cast iron in pattern to match original and in correct locations	Not applicable	High

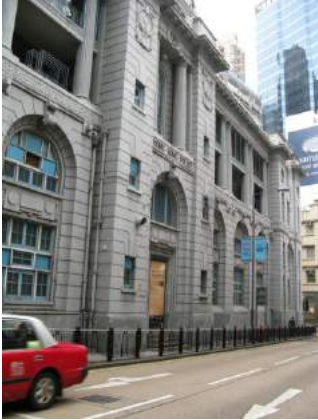
Element no.	Description	Photo ref	Significance	Proposal	Mitigation	Impact
01.013	Exterior decorations

Adverse	Strip off and redecorate	Sample and analyse existing paint media; select new media to suit substrate and significance	High

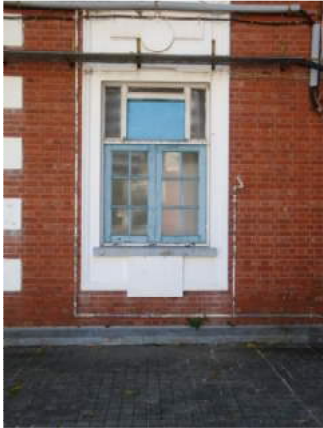
Element no.	Description	Photo ref	Significance	Proposal	Mitigation	Impact
01.016	Altered doors and windows

Adverse	Repair or renew as necessary existing frames to match original patterns	Not applicable	High
01.017	Mezzanine floor in room 01/LG1/13

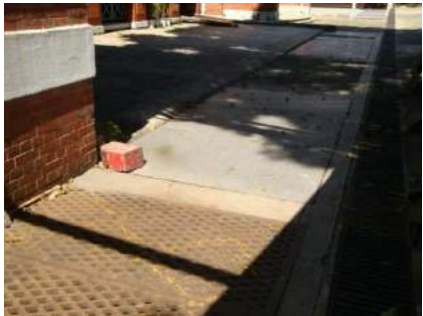
Element no.	Description	Photo ref	Significance	Proposal	Mitigation	Impact
01.018	Cast iron grilles above Service Corridor 01/LG1/35

High	Remove existing steel sheet covering [alterations to grilles awaiting confirmation from HdM]		
01.019	Perforated concrete deck above lightwell

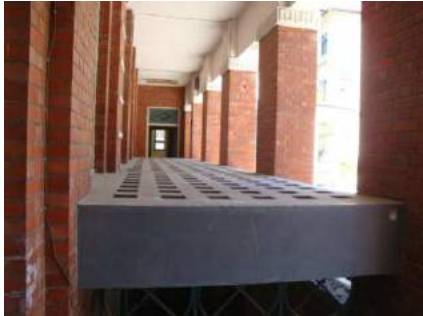
Adverse	Remove deck and make good brickwork at abutments	Not applicable	High

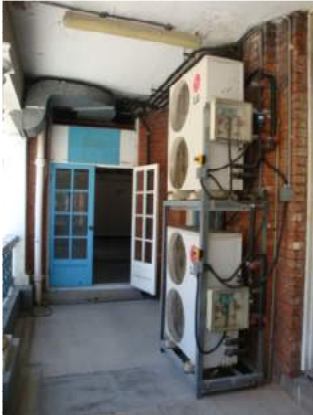
Element no.	Description	Photo ref	Significance	Proposal	Mitigation	Impact
01.020	External airconditioning units and other external services

Adverse	Remove and make good brickwork	Not applicable	High
01.021	Stair balustrades

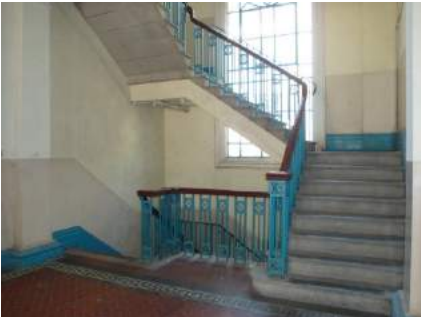
High	Balustrades to be supplemented with additional handrails and supports to mitigate non-compliance with code	New fittings to be of their time and made reversible. Physical intervention to existing stairs and balustrades to be kept to the minimum.	Moderate

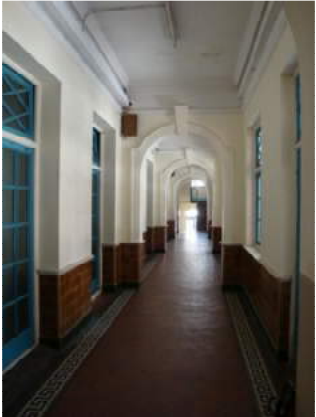
Element no.	Description	Photo ref	Significance	Proposal	Mitigation	Impact
01.022	Main corridors

High	Install new lighting, fire sprinklers, fire doors to comply with Fire Services Code	New fittings to be mounted in a manner that is of its time and reversible. Avoid physical intervention with existing plaster box cornices, architraves, dado rails	High
01.023	Painted signs

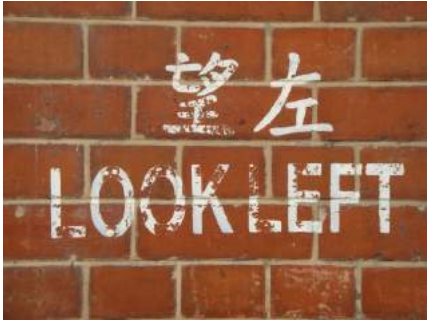
High	Protect in situ	Not applicable	N/A

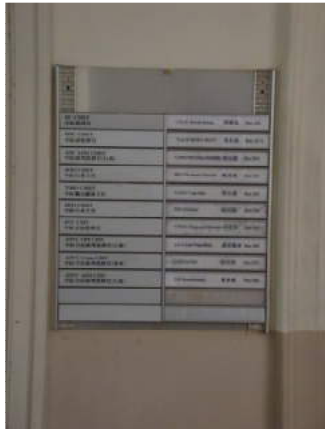
Element no.	Description	Photo ref	Significance	Proposal	Mitigation	Impact
01.024	Fixed signs

Low-High	Remove and refix/display in visitors' centre/discard	Record each sign and assess significance individually and treat accordingly	N/A

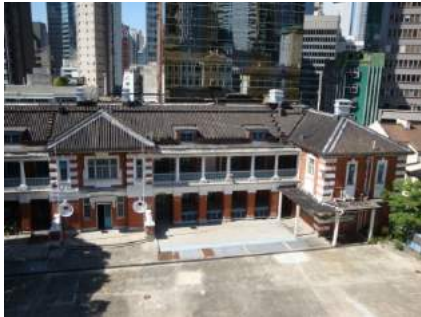
Element no.	Description	Photo ref	Significance	Proposal	Mitigation	Impact
01.025	Pitched roofs

High	New penetrations through roofs for ventilation ducts and other services	<p>Arrange new penetrations so that they conform with the geometry of the existing roof.</p> <p>Model the size and shape of the new ducts so that the impact on the roofscape is minimised.</p> <p>Finish the new ducts in a non-reflective material in a neutral mid-tone.</p>	High

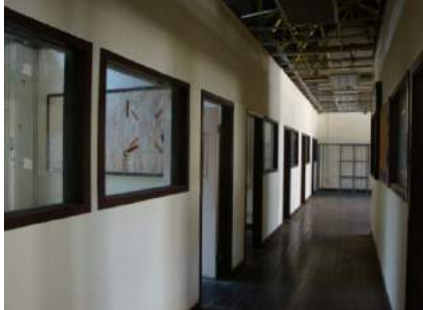
Element no.	Description	Photo ref	Significance	Proposal	Mitigation	Impact
01.029	Modern partitions

Adverse	Remove	Not applicable	High
01.030	Tiled dado

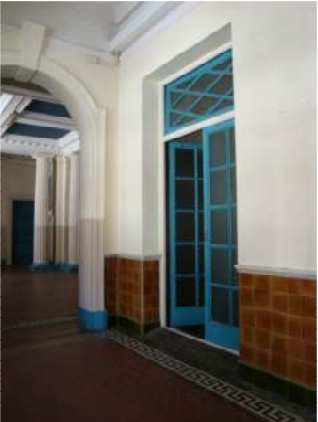
High	Cut away for enlargement of existing windows to form new doorways	Cut back to joint line and adjust tiling pattern to suit new opening. New tiles to match existing sizes and colours.	Moderate

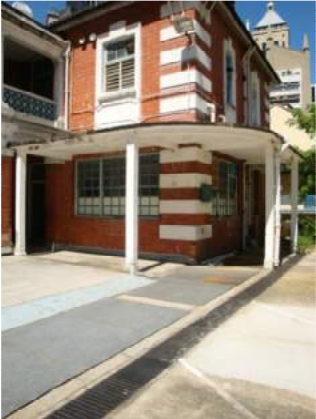
Element no.	Description	Photo ref	Significance	Proposal	Mitigation	Impact
01.031	Reinforced concrete canopy and sash windows

Moderate	Remove canopy and replace sash windows with new windows to match original	Make good brickwork where canopy removed, Reinstate rendered architraves around new window to match similar window facing on West wing	Moderate

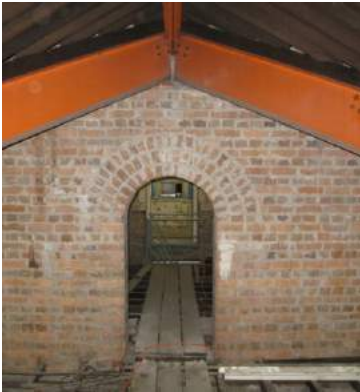
Element no.	Description	Photo ref	Significance	Proposal	Mitigation	Impact
01.032	Arched opening in brick wall above ceiling line

Low	Retain insitu and use to pass through future services. Infill only where opening is within a fire compartment	Use non-combustible material to block opening.	Low

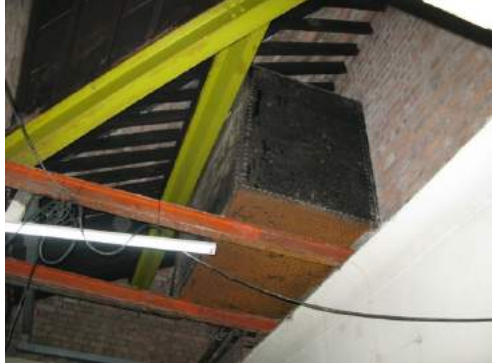
Element no.	Description	Photo ref	Significance	Proposal	Mitigation	Impact
01.033	Ceiling void service installation (Cast Iron Water Tank and pipework)

Low	Remove and make good adjacent surfaces	N/A	Low

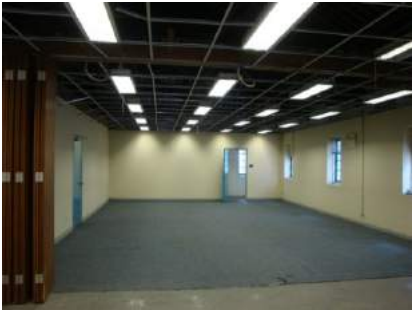
Element no.	Description	Photo ref.	Significance	Proposal	Mitigation	Impact
02.001	Lay-in grid suspended ceiling

Adverse	Remove	Not applicable	High
02.002	Modern internal doors	 	Adverse	Remove	Not applicable	High

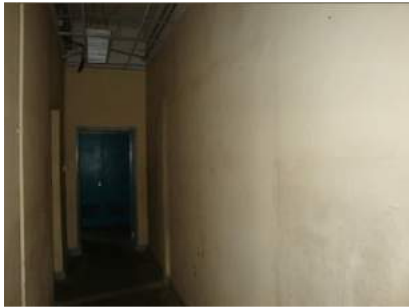
Element no.	Description	Photo ref.	Significance	Proposal	Mitigation	Impact
02.003	Modern partitions

Adverse	Remove	Not applicable	High
02.004	External airconditioning units and other external services

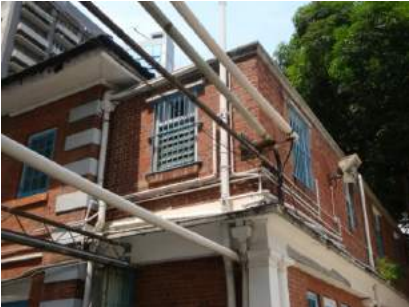
Adverse	Remove and make good brickwork	Not applicable	High

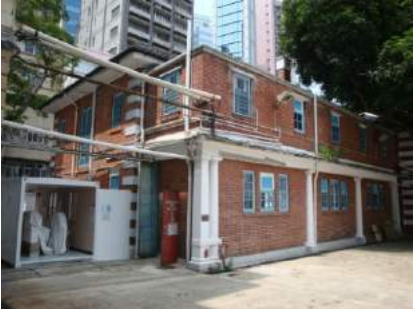
Element no.	Description	Photo ref.	Significance	Proposal	Mitigation	Impact
02.005	Brickwork walls enclosing rooms at GF and FF East side

Low	Remove and reinstate verandah	Not applicable	High
02.006	Concrete floors

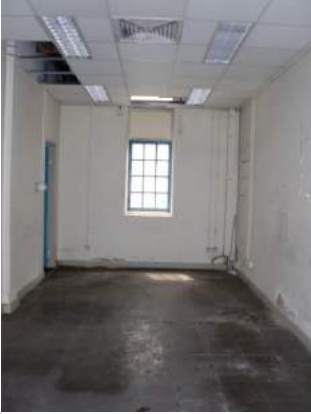
Low	Selected removal to accommodate new stairs and lift shaft	Carefully form openings to ensure structural stability	Low

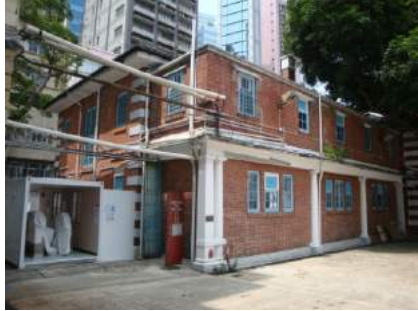
Element no.	Description	Photo ref.	Significance	Proposal	Mitigation	Impact
02.007	Rainwater goods

Adverse	Replace with cast iron in pattern to match original and in correct locations	No applicable	High

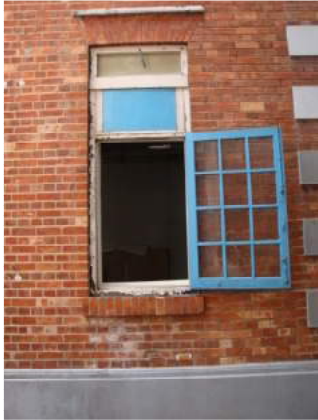
Element no.	Description	Photo ref.	Significance	Proposal	Mitigation	Impact
02.008	Altered doors and windows

Adverse	Repair or renew as necessary existing frames to match original patterns	Not applicable	High

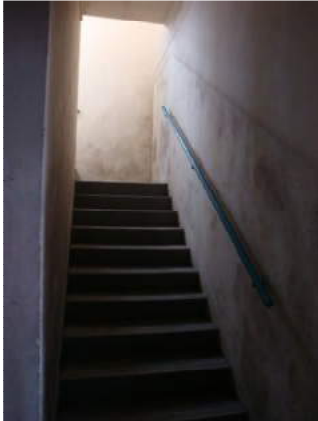
Element no.	Description	Photo ref.	Significance	Proposal	Mitigation	Impact
02.009	Concrete stairs

Adverse	Remove stairs	Not applicable	Moderate

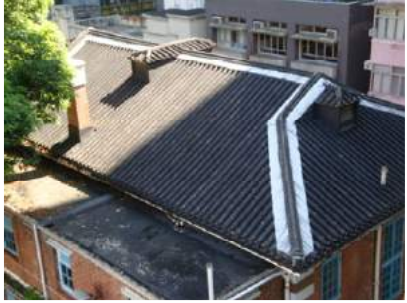
Element no.	Description	Photo ref.	Significance	Proposal	Mitigation	Impact
02.010	Pitched roofs

High	New penetrations through roofs for ventilation ducts and other services	Arrange new penetrations so that they conform with the geometry of the existing roof. Model the size and shape of the new ducts to reduce impact. Finish ducts in a non-reflective material that is neutral in colour and mid-tone.	High
02.011	Roof structure and tiled soffit

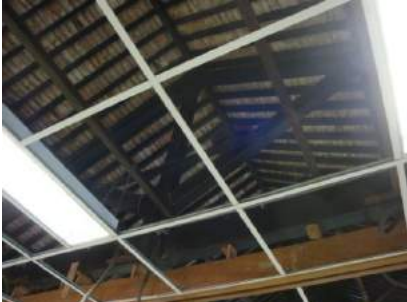
High	Repair and retain.	N/A	Neutral

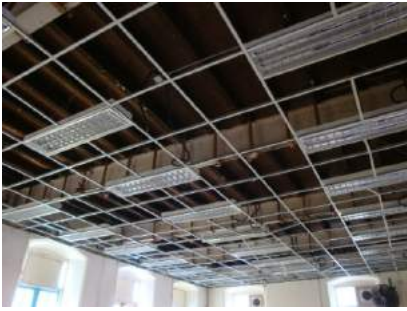
Element no.	Description	Photo ref.	Significance	Proposal	Mitigation	Impact
03.001	Lay-in grid suspended ceiling

Adverse	Remove	Not applicable	High

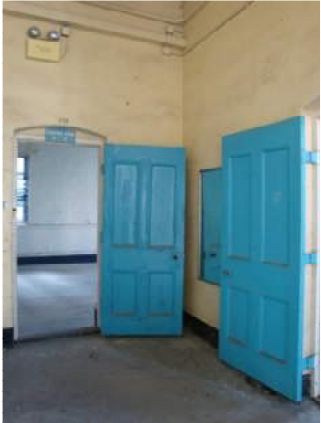
Element no.	Description	Photo ref.	Significance	Proposal	Mitigation	Impact
3.002	Panelled doors

Moderate	Replace where necessary to achieve fire resistance to comply with Code	Re-use where possible. Record design on survey drawings where item cannot be re-used.	Moderate

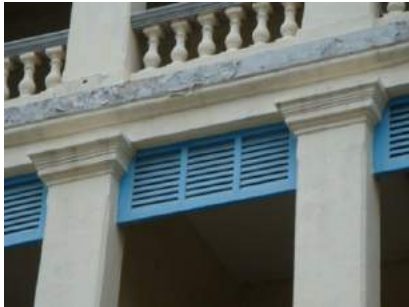
Element no.	Description	Photo ref.	Significance	Proposal	Mitigation	Impact
03.003	External shutters

High	Reinstate to match existing pattern	Not applicable	High
03.004	Timber thresholds at external doors and internal doors between main corridor and individual rooms

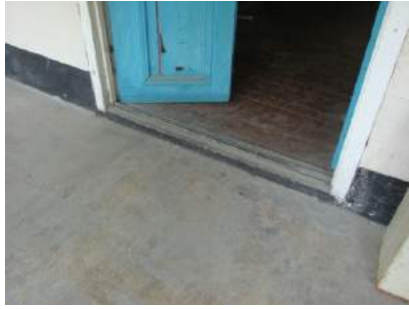
Low	Remove to enable level access	Splice extensions to door jambs, extend width of bottom rail of doors to match existing	Low

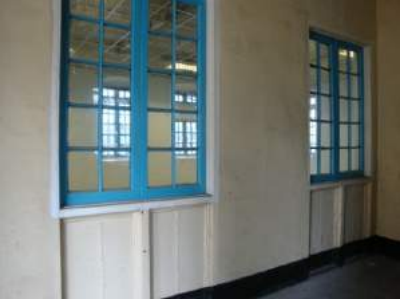
Element no.	Description	Photo ref.	Significance	Proposal	Mitigation	Impact
03.005	Timber spandrel panels below windows

Low	Conceal in exceptional cases eg. where adjacent new lift shaft	Retain frame and spandrel panel where possible. Remove only where necessary in connection with re-planning of interiors. Record on measured survey drawings.	Low
03.006	Timber floors

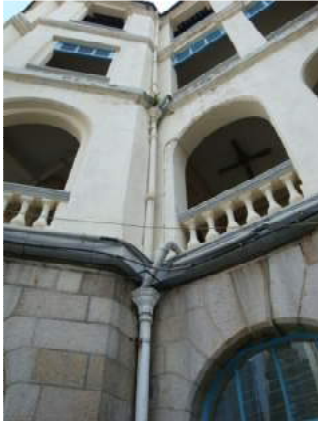
Element no.	Description	Photo ref.	Significance	Proposal	Mitigation	Impact
03.007	Rainwater goods

Adverse	Replace with cast iron in pattern to match original and in correct locations	No applicable	High

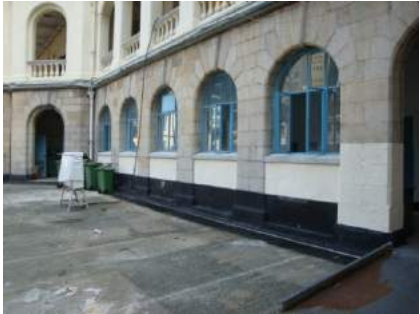
Element no.	Description	Photo ref.	Significance	Proposal	Mitigation	Impact
03.008	Exterior decorations

Adverse	Strip off and redecorate	Sample and analyse existing paint media; select new media to suit substrate and significance	High
03.009	Block existing door openings

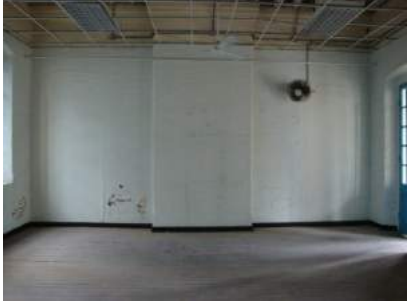
Element no.	Description	Photo ref.	Significance	Proposal	Mitigation	Impact
03.010	Form new door openings

Low	Form new opening as part of re-planning of interiors	New doors and frames to be of their time to avoid confusion about provenance. Re-open original openings where possible. Retain original reveals and arches.	Low

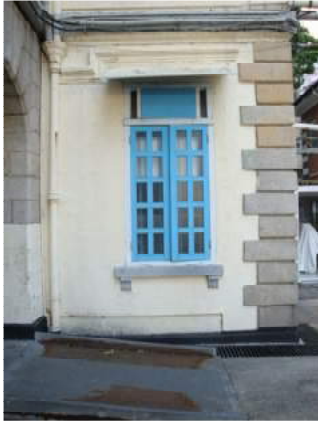
Element no.	Description	Photo ref.	Significance	Proposal	Mitigation	Impact
03.011	Altered doors and windows

Adverse	Repair or renew as necessary existing frames to match original patterns	Not applicable	High

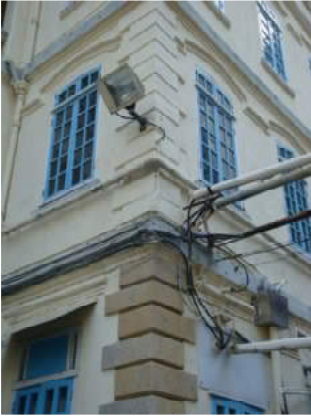
Element no.	Description	Photo ref.	Significance	Proposal	Mitigation	Impact
03.012	External airconditioning units and other external services

Adverse	Remove and make good brickwork	Not applicable	High
03.013	Stair balustrades

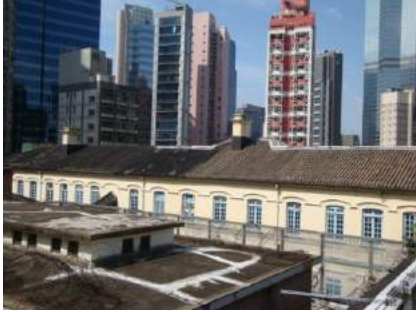
Element no.	Description	Photo ref.	Significance	Proposal	Mitigation	Impact
03.016	Pitched roofs

High	New penetrations through roofs for ventilation ducts and other services	Arrange new penetrations so that they conform with the geometry of the existing roof. Model the size and shape of the new ducts so that the impact on the roofscape is minimised. Finish the new ducts in a non-reflective material that is neutral in colour and mid-tone.	High
03.017	Lean-to structure adjacent North wall

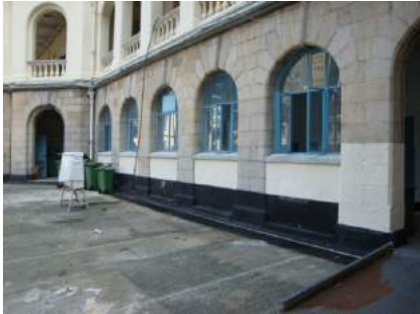
Element no.	Description	Photo ref.	Significance	Proposal	Mitigation	Impact
03.018	Metal-frames windows at GF North elevation

Adverse	Remove window frames, masonry spandrel panels below and reinstate verandah	Not applicable	High
03.019	Internal walls at Ground Floor level

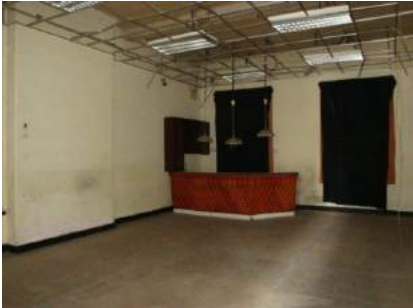
Element no.	Description	Photo ref.	Significance	Proposal	Mitigation	Impact
03.020	Assembly rooms at centre of building (all floors)

Moderate	Sub-divide two rooms on each floor to provide service core, comprising: lifts, toilets, plant rooms, stores	Form new sub-visions using lightweight partitions to achieve reversibility. Form straight joints at abutments with existing retained walls. Notch new partitions around existing brick corbels at high level as a reminder of current condition.	Moderate
03.021	Exposed soffits of timber floors

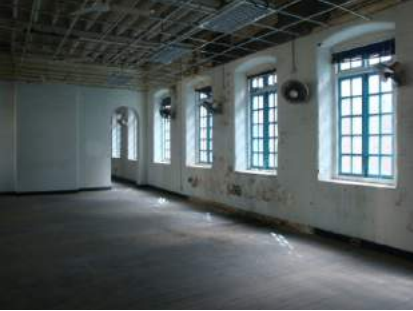
Element no.	Description	Photo ref.	Significance	Proposal	Mitigation	Impact
03.022	Existing window frames/openings

High	Open up selected openings to form new fire escape doors	Retain any salvageable material for possible re-use elsewhere. Retain existing window jambs intact. Cut away masonry to form door openings along same line as window jamb; do not re-bind cut brickwork. Record existing condition on measured survey drawings.	Low
03.023	Single storey outbuildings on south side

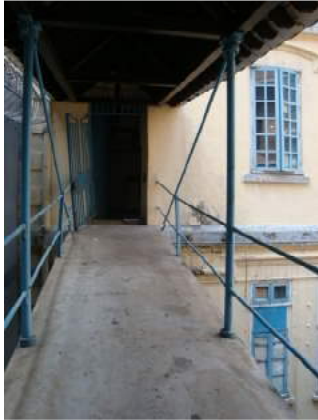
Element no.	Description	Photo ref.	Significance	Proposal	Mitigation	Impact
03.024	Bridge at east end

Moderate	Retain	Not applicable	Neutral

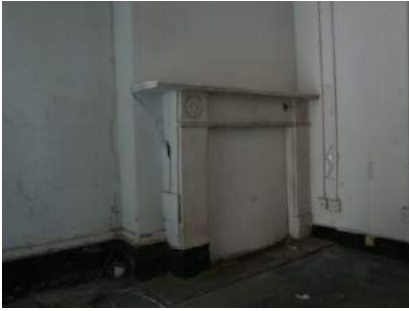
Element no.	Description	Photo ref.	Significance	Proposal	Mitigation	Impact
03.025	Chimneypiece on Ground Floor

Low	Repair and retain in current location	Not applicable	Neutral
03.026	Window in south wall; original dormitory space	 	Moderate	Remove window and take down brickwork spandrel; subdivide space to form new fire-protected escape route.	Record existing condition on measured survey drawings. New partition wall to be reversible.	Low

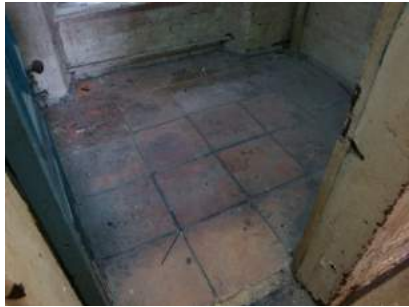
Element no.	Description	Photo ref.	Significance	Proposal	Mitigation	Impact
03.027	Clay-tiled floor in store room adjacent stairs

Low	Remove as part of re-planning of interiors	Record on measured survey drawings	Low

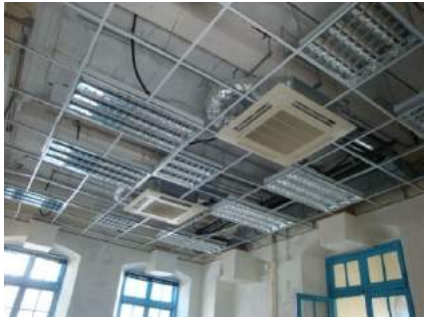
Element no.	Description	Photo ref.	Significance	Proposal	Mitigation	Impact
04.001	Lay-in grid suspended ceiling

Adverse	Remove	Not applicable	High
04.002	Timber thresholds at external doors and internal doors between main corridor and individual rooms

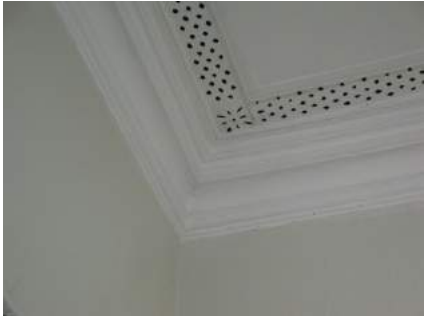
Element no.	Description	Photo ref.	Significance	Proposal	Mitigation	Impact
04.003	Plaster box cornice

Moderate	Remove in exceptional cases where eg. where adjacent new lift shafts	Cut back neatly to a square edge and ensure remaining section is secure.	Moderate

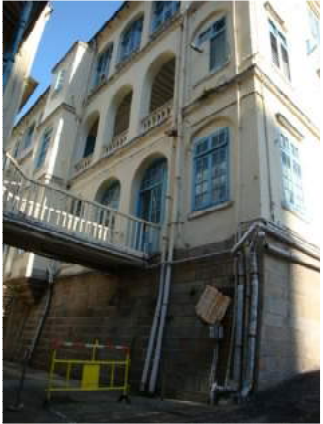
Element no.	Description	Photo ref.	Significance	Proposal	Mitigation	Impact
04.004	Rainwater goods

Adverse	Replace with cast iron in pattern to match original and in correct locations	No applicable	High

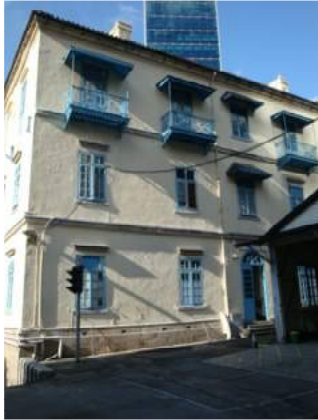
Element no.	Description	Photo ref.	Significance	Proposal	Mitigation	Impact
04.005	Exterior decorations

Adverse	Strip off and redecorate	Sample and analyse existing paint media; select new media to suit substrate and significance	High

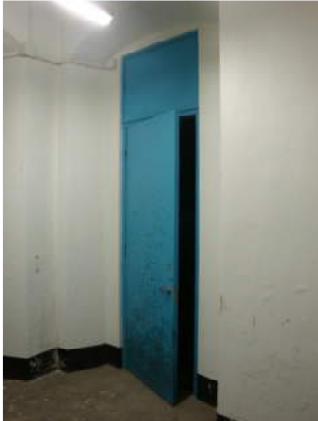
Element no.	Description	Photo ref.	Significance	Proposal	Mitigation	Impact
04.006	Block existing door openings

Moderate	Block opening as part of re-planning of interior	Retain existing door frame and architraves. Use framing and non-combustible sheet linings to block opening.	Moderate

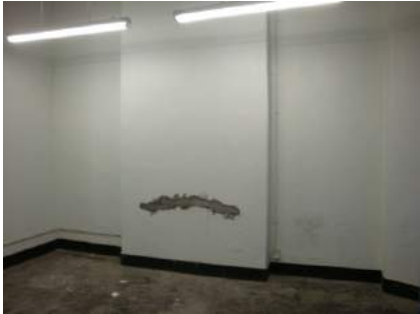
Element no.	Description	Photo ref.	Significance	Proposal	Mitigation	Impact
04.007	Form new door openings

Moderate	Form new opening as part of re-planning of interiors	New doors and frames to be of their time to avoid confusion about provenance	Moderate

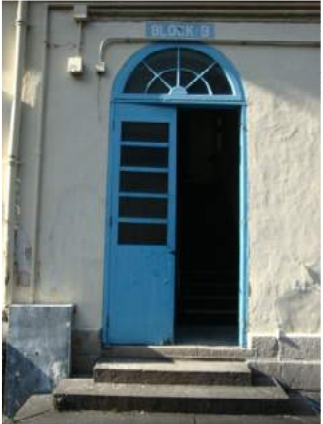
Element no.	Description	Photo ref.	Significance	Proposal	Mitigation	Impact
04.008	Altered doors and windows

Adverse	Repair or renew as necessary existing frames to match original patterns	Not applicable	High

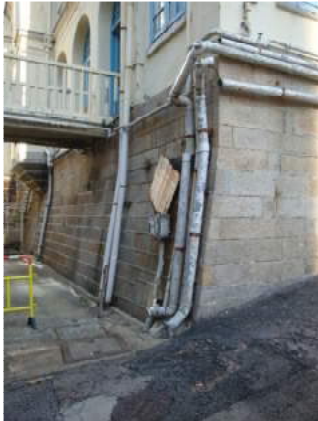
Element no.	Description	Photo ref.	Significance	Proposal	Mitigation	Impact
04.010	External airconditioning units and other external services

Adverse	Remove and make good brickwork	Not applicable	High

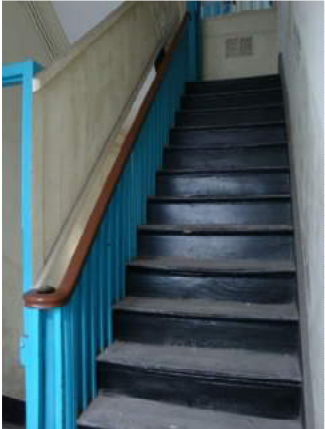
Element no.	Description	Photo ref.	Significance	Proposal	Mitigation	Impact
04.012	Stair from First to Second Floor

High	Replace stair to improve safety	New stair to be built of steel to comply with Code and to distinguish it as being "of its time".	Moderate

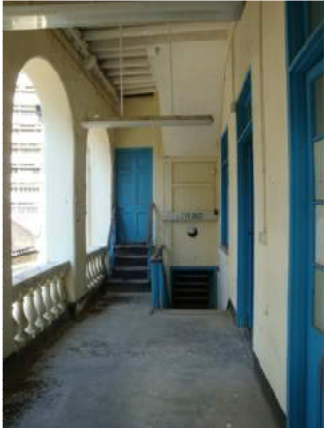
Element no.	Description	Photo ref.	Significance	Proposal	Mitigation	Impact
04.013	External verandahs

High	Install new lighting, fire sprinklers, fire doors to comply with Fire Services Code, extract ducting to external walls	New fittings to be mounted in a manner that is of its time and reversible. Avoid physical intervention with existing plaster box cornices in rooms, architraves, dado rails. Position outlet grilles in external walls on centre-line of arcade arches and above structural arch	High

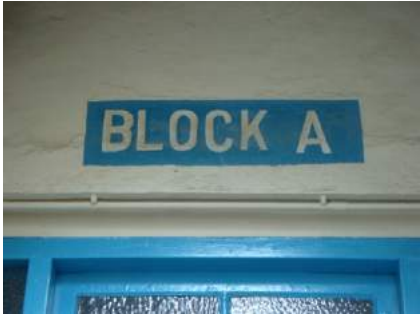
Element no.	Description	Photo ref.	Significance	Proposal	Mitigation	Impact
04.014	Painted signs

High	Protect in situ	Not applicable	N/A
04.015	Fixed signs

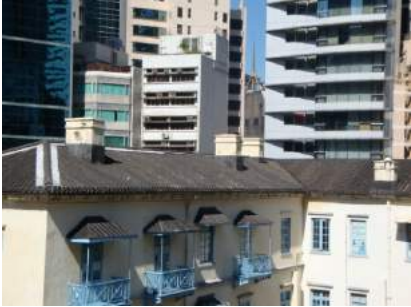
Element no.	Description	Photo ref.	Significance	Proposal	Mitigation	Impact
04.016	Pitched roofs

High	New penetrations through roofs for ventilation ducts and other services	<p>Arrange new penetrations so that they conform with the geometry of the existing roof.</p> <p>Model the size and shape of the new ducts so that the impact on the roofscape is minimised.</p> <p>Finish the new ducts in a non-reflective material that is neutral in colour.</p>	High

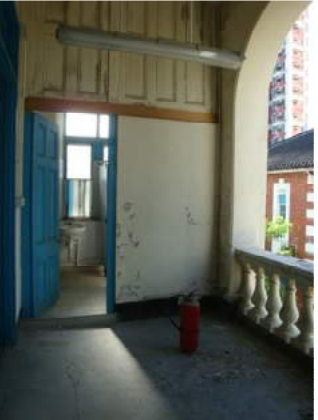
Element no.	Description	Photo ref.	Significance	Proposal	Mitigation	Impact
04.017	Toilets at ends of verandahs

Adverse	Remove and make good finishes	Not applicable	High

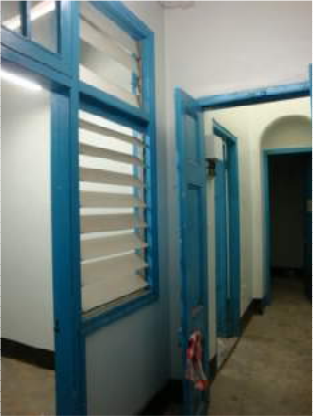
Element no.	Description	Photo ref.	Significance	Proposal	Mitigation	Impact
04.018	Partitions at GF Dormitory A

High	Remove to make way for Interpretation	Prepare measured drawings and photographs before removal.	Moderate

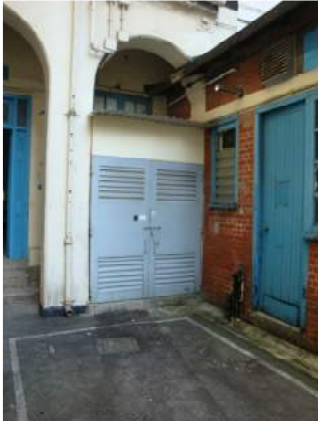
Element no.	Description	Photo ref.	Significance	Proposal	Mitigation	Impact
04.019	Switchgear in old porch 04/G/13

Adverse	Open up porch, remove electrical switchgear and make good	Not applicable	High

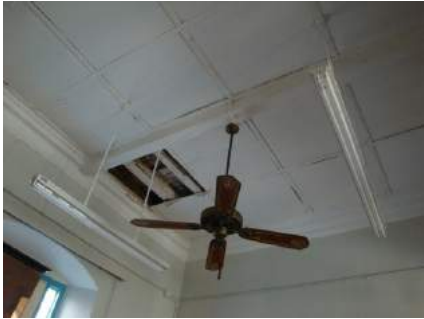
Element no.	Description	Photo ref.	Significance	Proposal	Mitigation	Impact
04.020	Flat plywood ceiling lining with plain rectangular cover battens

Adverse	Replace with T&G boarding to match existing	Not applicable	High

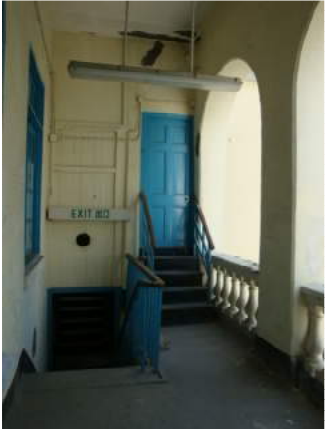
Element no.	Description	Photo ref.	Significance	Proposal	Mitigation	Impact
04.021	Steps up to doorway on FF verandah

Moderate	Remove steps and doorway to form new fore escape route	Record steps and doorway on measured drawings	Moderate

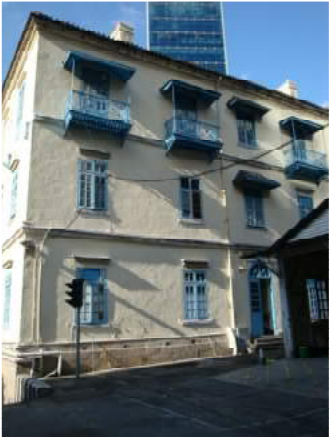
Element no.	Description	Photo ref.	Significance	Proposal	Mitigation	Impact
04.023	Cantilever balconies

High	<p>Retain and repair as necessary.</p> <p>Reinstate balcony on west elevation.</p>	<p>Avoid highly visible intervention to enhance structural integrity and/or compliance with building codes.</p> <p>Restrict access if necessary to achieve this objective.</p>	Low

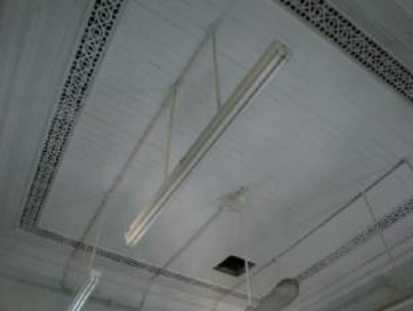
Element no.	Description	Photo ref.	Significance	Proposal	Mitigation	Impact
04.024	Clay tile floor		Low	Retain and repair as necessary	Not applicable	Neutral
04.025	Matched-boarded ceiling with perforated border

Moderate	Repair and retain insitu	Not applicable	Neutral

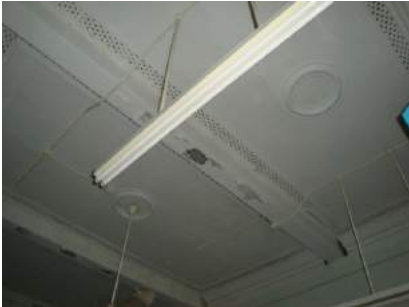
Element no.	Description	Photo ref.	Significance	Proposal	Mitigation	Impact
04.026	Ceiling rose

Low	Repair and retain insitu	Not applicable	Neutral

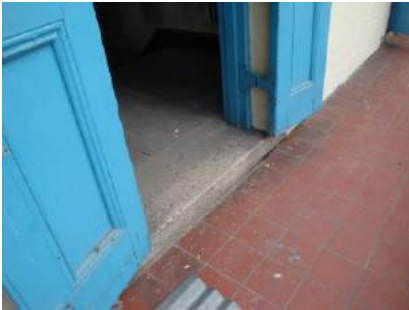
Element no.	Description	Photo ref.	Significance	Proposal	Mitigation	Impact
06.001	Granite thresholds at external doors

Low	Retain; install timber deck flush with level of step where necessary	Avoid alteration to step.	Low
06.002	Pitched roof

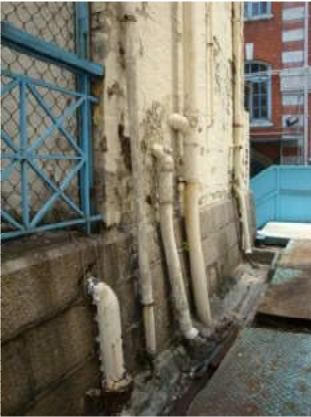
Element no.	Description	Photo ref.	Significance	Proposal	Mitigation	Impact
06.003	Rainwater goods

Adverse	Replace with cast iron in pattern to match original and in correct locations	Not applicable	High
06.004	Exterior decorations

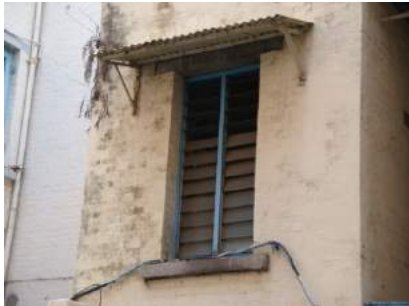
Element no.	Description	Photo ref.	Significance	Proposal	Mitigation	Impact
06.005	Altered doors and windows

Adverse	Adverse	Repair or renew as necessary existing frames to match original patterns	Not applicable
06.006	External airconditioning units and other external services

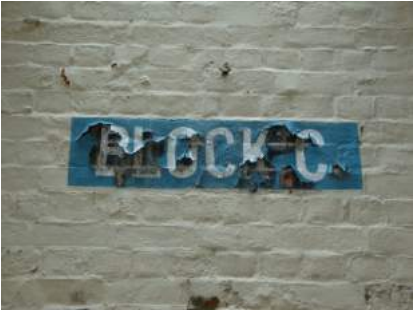
Element no.	Description	Photo ref.	Significance	Proposal	Mitigation	Impact
06.007	Painted signs

High	Protect in situ	Not applicable	N/A
06.008	Fixed signs

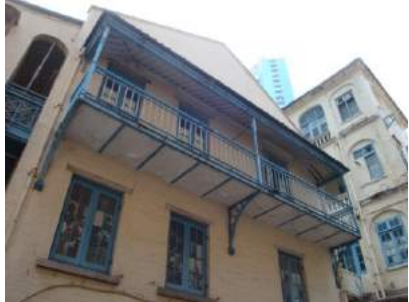
Element no.	Description	Photo ref.	Significance	Proposal	Mitigation	Impact
06.009	Cantilever balconies

High	Retain and repair as necessary.	Avoid highly visible intervention to enhance structural integrity and/or compliance with building codes. Restrict access if necessary to achieve this objective.	Low
06.010	Iron balustrades

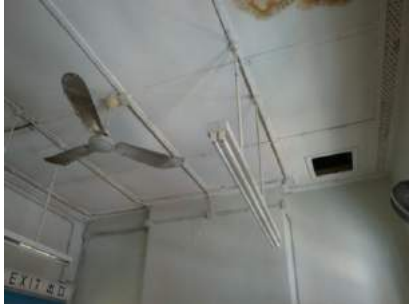
Element no.	Description	Photo ref.	Significance	Proposal	Mitigation	Impact
06.011	Perforated margin at perimeter of ceiling

Low	Repair and retain.	Where fire-proofing of floor is required, use a product that can be installed within the floor void, leaving the ceiling lining intact.	Low
06.012	Block existing door openings

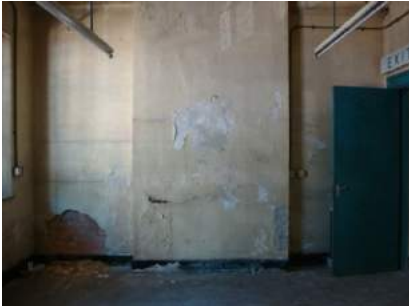
Element no.	Description	Photo ref.	Significance	Proposal	Mitigation	Impact
06.013	Form new door openings

Moderate	Form new opening as part of re-planning of interiors	New doors and frames to be of their time to avoid confusion about provenance	Moderate
06.014	Stair balustrades

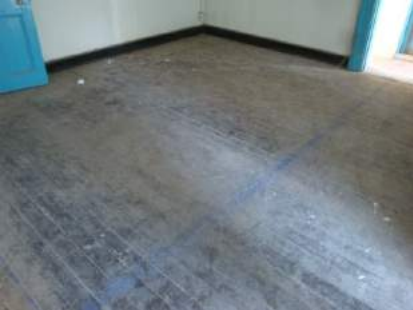
Element no.	Description	Photo ref.	Significance	Proposal	Mitigation	Impact
06.015	Timber floors

High	Retain all boarded floors and skirtings	Reinstate floor boards and skirtings after fire proofing works	Low
06.016	Vinyl tile floor

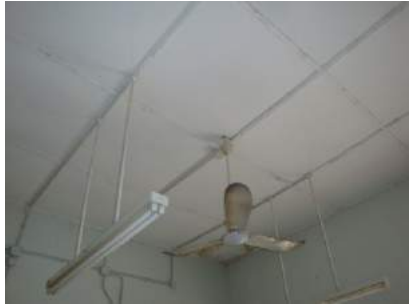
Element no.	Description	Photo ref.	Significance	Proposal	Mitigation	Impact
06.017	Batten and panel ceiling lining

Low	Replace with lath and plaster ceiling	Not applicable	Low
06.018	Exposed roof covering

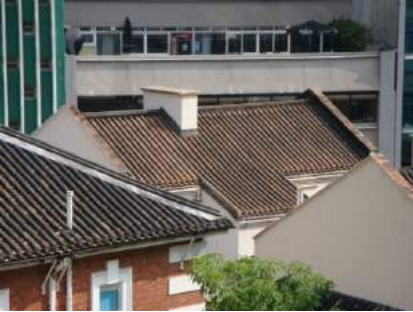
Element no.	Description	Photo ref.	Significance	Proposal	Mitigation	Impact
07.001	Pitched roofs

High	New penetrations through roofs for ventilation ducts and other services	<p>Arrange new penetrations so that they conform with the geometry of the existing roof.</p> <p>Model the size and shape of the new ducts so that the impact on the roofscape is minimised.</p> <p>Finish the new ducts in a non-reflective material that is neutral in colour and mid-tone.</p>	High
07.002	Rainwater goods

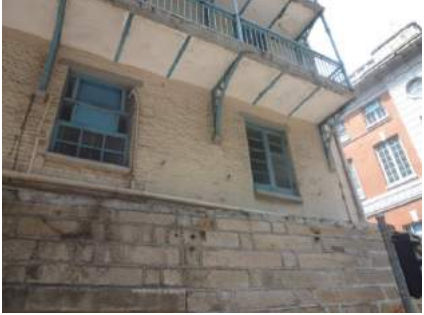
Element no.	Description	Photo ref.	Significance	Proposal	Mitigation	Impact
07.003	Exterior decorations

Adverse	Strip off and redecorate	Sample and analyse existing paint media; select new media to suit substrate and significance	High
07.004	Altered doors and windows

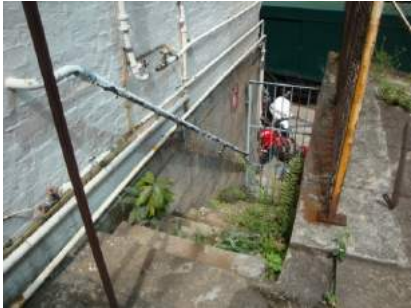
Element no.	Description	Photo ref.	Significance	Proposal	Mitigation	Impact
07.005	External airconditioning units and other external services

Adverse	Remove and make good brickwork	Not applicable	High
07.006	Clothes drying racks

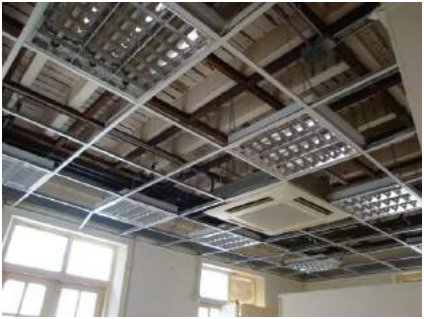
Element no.	Description	Photo ref.	Significance	Proposal	Mitigation	Impact
07.008	Lay-in grid suspended ceiling

Adverse	Remove	Not applicable	High
07.009	Corbelled brickwork at perimeter of room

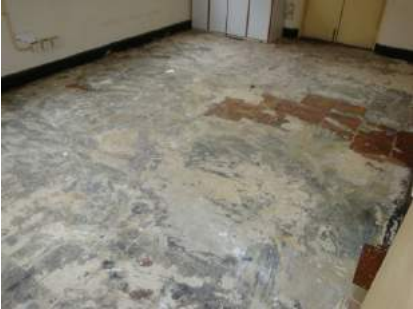
Element no.	Description	Photo ref.	Significance	Proposal	Mitigation	Impact
07.010	Plywood floor

Adverse	Replace with hardwood floor boards	Not applicable	High
07.011	Timber thresholds at external doors and internal doors between main corridor and individual rooms

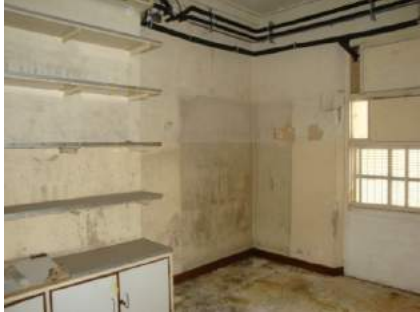
Element no.	Description	Photo ref.	Significance	Proposal	Mitigation	Impact
07.012	Form new door openings

Moderate	Form new opening as part of re-planning of interiors	New doors and frames to be of their time to avoid confusion about provenance	Moderate
07.013	Stair balustrades

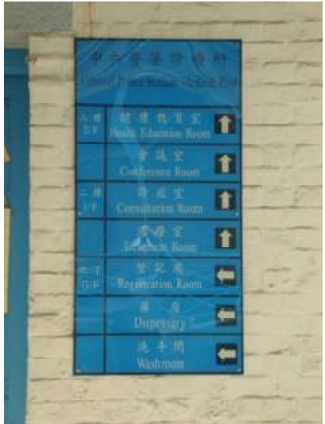
Element no.	Description	Photo ref.	Significance	Proposal	Mitigation	Impact
07.014	Fixed signs

Low-High	Remove and refix/display in visitors' centre/discard	Record each sign and assess significance individually and treat accordingly	N/A

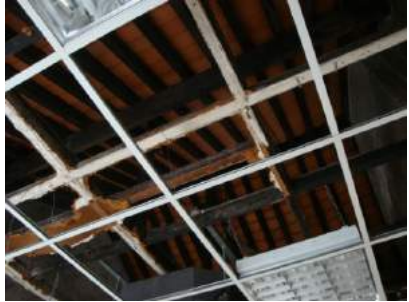
Element no.	Description	Photo ref.	Significance	Proposal	Mitigation	Impact
07.015	Exposed roof tiling

Moderate	Retain as existing	Consider insulating between upper and lower layers of roof tiles to provide thermal insulation and vapour barrier	Low
07.016	Concrete floor

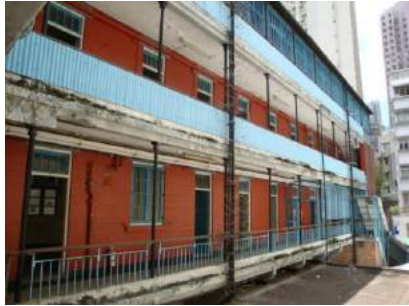
Element no.	Description	Photo ref.	Significance	Proposal	Mitigation	Impact
08.001	Panelled doors

Low	Replace where necessary to achieve compliance with Building Code	Re-use where possible. Record design on survey drawings where element cannot be re-used.	Moderate
08.002	Rainwater goods

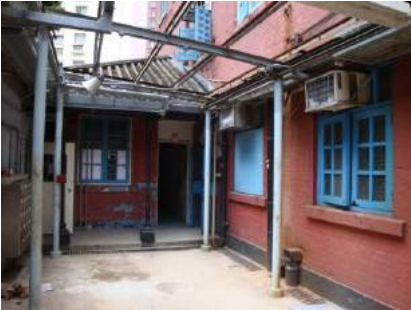
Element no.	Description	Photo ref.	Significance	Proposal	Mitigation	Impact
08.003	Exterior decorations

Adverse	Strip off and redecorate	Sample and analyse existing paint media; select new media to suit substrate and significance	High
08.004	Block existing door openings

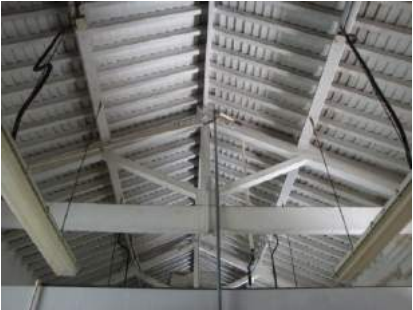
Element no.	Description	Photo ref.	Significance	Proposal	Mitigation	Impact
08.005	Timber roof structure

High	Retain	Not applicable	Neutral
08.006	External stair at west end

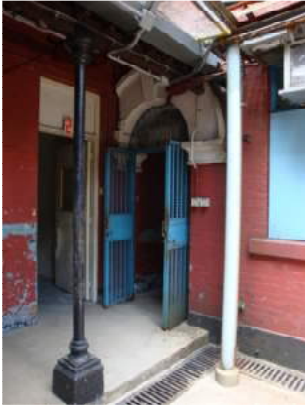
Element no.	Description	Photo ref.	Significance	Proposal	Mitigation	Impact
08.007	External airconditioning units and other external services

Adverse	Remove and make good brickwork	Not applicable	High
08.008	Painted signs

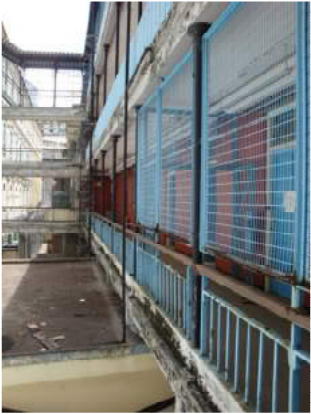
Element no.	Description	Photo ref.	Significance	Proposal	Mitigation	Impact
08.009	Wire mesh screens

Adverse	Remove	Not applicable	Low
08.010	Internal walls and concrete floors

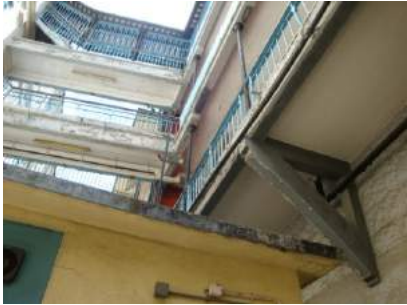
Element no.	Description	Photo ref.	Significance	Proposal	Mitigation	Impact
					clashes.	
08.011	Cantilever balconies on north side

Moderate	Repair and retain insitu	Not applicable

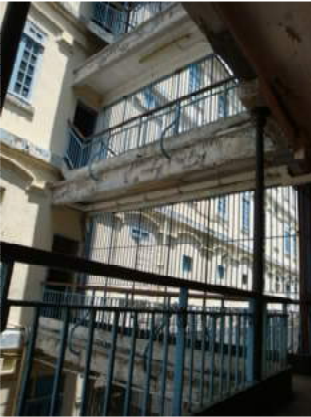
Element no.	Description	Photo ref.	Significance	Proposal	Mitigation	Impact
08.012	Bridge access to Barrack Block

Moderate	Retain	Repair as necessary.  Alter balustrade to achieve reasonable level of operational safety.  Restrict access to repairs and maintenance and means of escape.	Low
08.013	Balcony balustrades

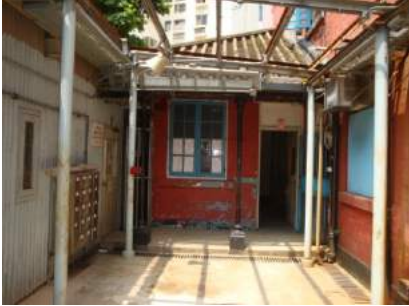
Element no.	Description	Photo ref.	Significance	Proposal	Mitigation	Impact
08.014	Single-storey outbuilding with pitched roof over

Low	Demolish to make way for new loading bay.	<p>Record on measured survey drawings.</p> <p>Infill existing internal opening leaving reveals exposed.</p> <p>Tooth-in new brickwork at abutments after existing walls removed.</p> <p>Salvage cast iron columns for possible re-use.</p>	Low
08.015	Corrugated steel sheet on balcony balustrades

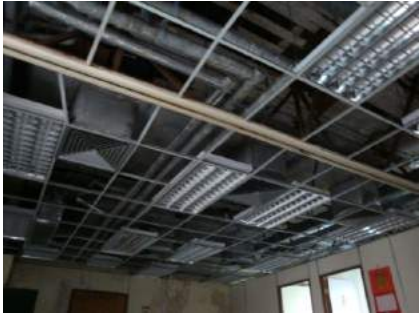
Element no.	Description	Photo ref.	Significance	Proposal	Mitigation	Impact
09.001	Lay-in grid suspended ceiling

Adverse	Remove	Not applicable	High
09.002	Modern partitions

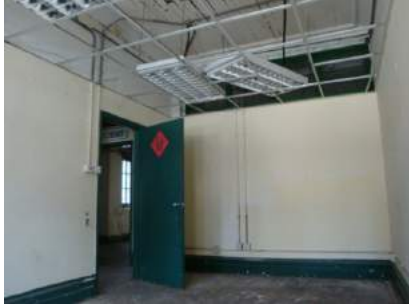
Element no.	Description	Photo ref.	Significance	Proposal	Mitigation	Impact
09.003	Internal walls

Moderate	Remove selected internal walls where strictly necessary as part of re-planning of interiors	Walls or early or original date to be retained in part eg. By leaving a “nib” where the wall is bonded to another wall. At the point where the wall is cut away, form the cut-line on the line of a vertical joint in alternate courses. Bricks in the remaining courses to be left “as cut”, and not re-bonded, as evidence of the current condition.	Moderate
09.004	Plaster box cornice

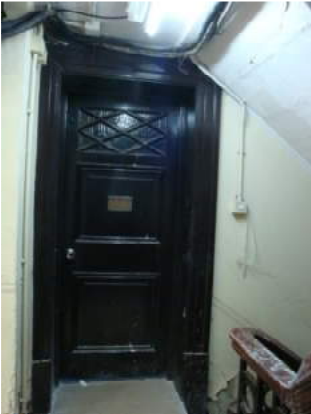
Element no.	Description	Photo ref.	Significance	Proposal	Mitigation	Impact
09.006	Block existing door openings

Moderate	Block opening as part of re-planning of interior	Retain existing door frame and architraves. Use framing and non-combustible sheet linings to block opening.	Moderate
09.007	Form new door openings		Moderate	Form new opening as part of re-planning of interiors	New doors and frames to be of their time to avoid confusion about provenance	Moderate

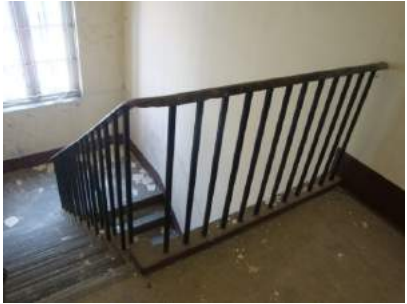
Element no.	Description	Photo ref.	Significance	Proposal	Mitigation	Impact
09.008	Stair balustrades

High	Balustrades to be supplemented with additional handrails and supports to mitigate non-compliance with code	New fittings to be of their time and made reversible. Physical intervention to existing stairs and balustrades to be kept to the minimum.	Moderate
09.009	Fixed signs	 	Low-High	Remove and refix/display in visitors' centre/discard	Record each sign and assess significance individually and treat accordingly	N/A

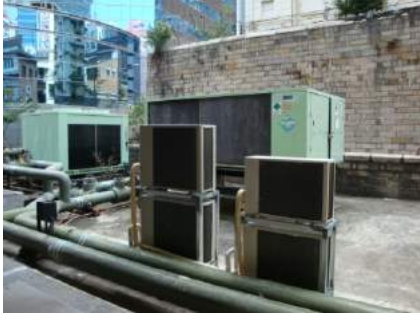
Element no.	Description	Photo ref.	Significance	Proposal	Mitigation	Impact
09.010	External airconditioning units and other external services

Adverse	Remove and make good brickwork	Not applicable	High
09.011	Pitched roofs

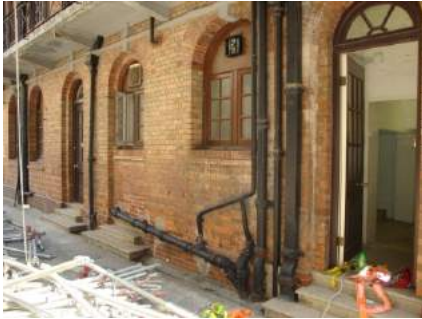
Element no.	Description	Photo ref.	Significance	Proposal	Mitigation	Impact
09.012	Rainwater goods

Moderate	Replace with larger sizes/closer spacing to improve performance	Use cast iron to match original pattern Make good all redundant fixing holes	High
09.013	Metal walkways across lightwell

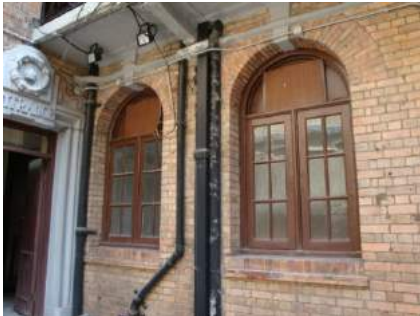
Element no.	Description	Photo ref.	Significance	Proposal	Mitigation	Impact
09.014	Altered doors and windows

Adverse	Repair or renew as necessary existing frames to match original patterns	Not applicable	High
09.015	Sloping canopy over external stair on west side

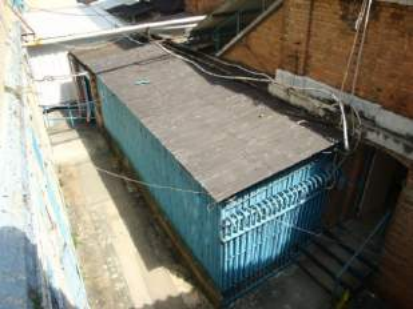
Element no.	Description	Photo ref.	Significance	Proposal	Mitigation	Impact
09.016	Single storey secure shelter at North West corner

Low	Demolish	Make good brickwork at abutments.	Low
09.017	Iron railing adjacent south side of item 09.016 above

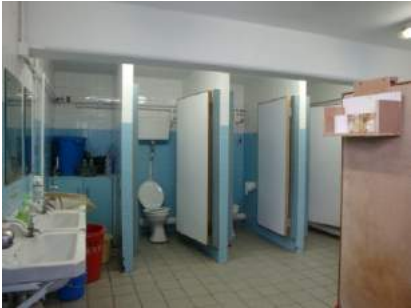
Element no.	Description	Photo ref.	Significance	Proposal	Mitigation	Impact
09.018	Public toilets in 09/LG1/17, 24

Adverse	Strip out sanitaryware, and fit-out for pottery display/service access. Form new door openings in east walls.	Retain existing door openings and metal-barred gates. Retain external granite steps and existing ground level.	Low
09.019	Cell doors

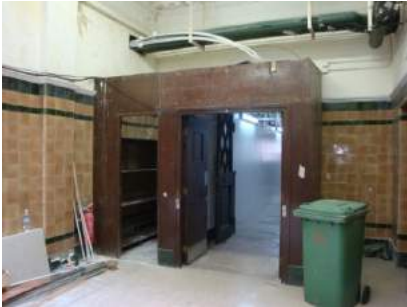
Element no.	Description	Photo ref.	Significance	Proposal	Mitigation	Impact
09.020	Meeting room at G/02-05	 	Moderate	Remove timber panelling from walls and sub divide to form new toilets and lift shaft	Record existing wall linings, and any earlier lining behind, on measured survey drawings.	Moderate
09.021	Lobbies within entrance hall G/12

Adverse	Remove	Not applicable	N/A

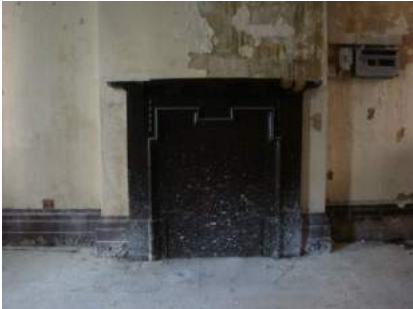
Adverse	Strip out plant, remove partition walls and restore galleries	Not applicable	High
09.023	Chimney piece

Moderate	Retain	Not applicable	Neutral

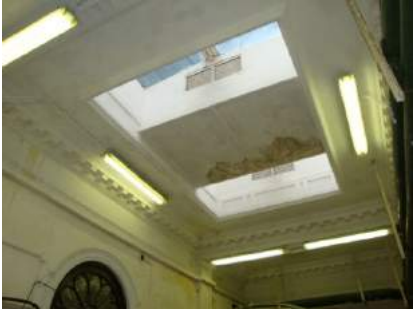
Element no.	Description	Photo ref.	Significance	Proposal	Mitigation	Impact
09.024	Lanterns above entrance hall

Adverse	Remove existing lanterns and install single lantern	Not applicable	Moderate
09.025	Boarded ceilings on Second Floor

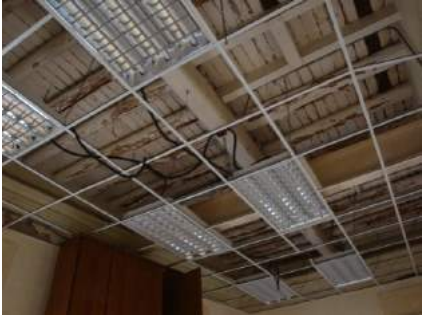
Element no.	Description	Photo ref.	Significance	Proposal	Mitigation	Impact
10.001	Lay-in grid suspended ceiling

Adverse	Remove	Not applicable	High
10.002	Plaster box cornice

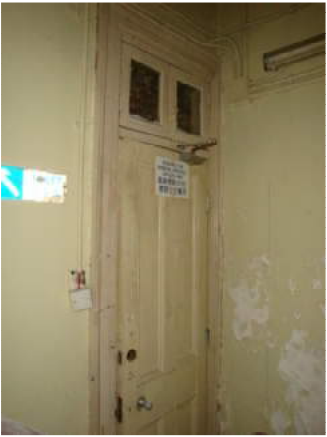
Element no.	Description	Photo ref.	Significance	Proposal	Mitigation	Impact
10.003	Panelled doors and linings

Moderate	Replace where necessary to achieve fire resistance to comply with Code	Re-use where possible. Record design on survey drawings where element cannot be re-used.	Moderate

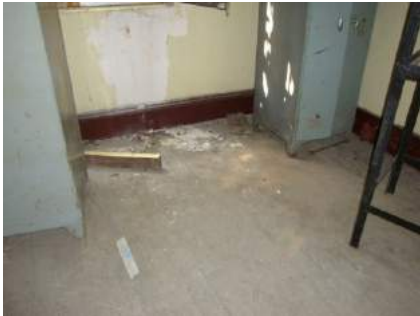
Element no.	Description	Photo ref.	Significance	Proposal	Mitigation	Impact
10.004	Timber boarded floor with moulded skirtings

High	Repair as necessary and retain	Lift carefully and refix upon completion of fire-proofing and services installation	Low
10.005	Exterior decorations
