The Jockey Club CPS Limited

Central Police Station Conservation  
and Revitalisation Project:  
*Seventh Quarterly EM&A Report*  
*(1 May 2013 to 31 July 2013)*

Issue Date: August 2013

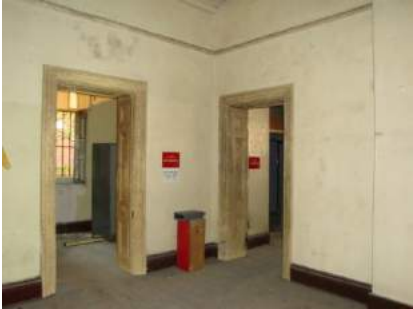
Element no.	Description	Photo ref.	Significance	Proposal	Mitigation	Impact
10.006	Block existing door openings

Moderate	Block opening as part of re-planning of interior	Retain existing door frame and architraves. Use framing and non-combustible sheet linings to block opening.	Moderate
10.007	Form new door openings

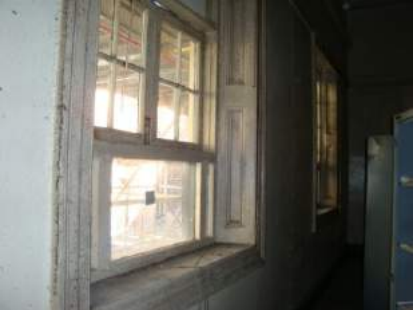
Element no.	Description	Photo ref.	Significance	Proposal	Mitigation	Impact
10.008	Altered doors and windows

Adverse	Repair or renew as necessary existing frames to match original patterns	Not applicable	High
10.009	External airconditioning units and other external services

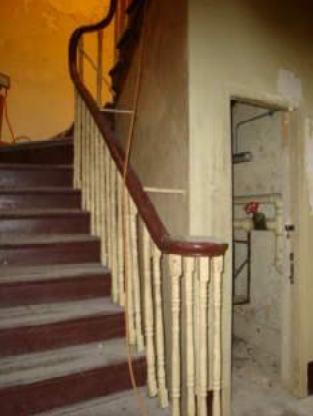
Element no.	Description	Photo ref.	Significance	Proposal	Mitigation	Impact
10.010	Stair balustrades

High	Balustrades to be supplemented with additional handrails and supports to mitigate non-compliance with code	New fittings to be of their time and made reversible. Physical intervention to existing stairs and balustrades to be kept to the minimum.	Moderate

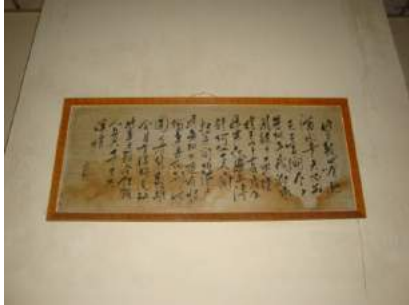
Element no.	Description	Photo ref.	Significance	Proposal	Mitigation	Impact
10.011	Fixed signs

Low-High	Remove and refix/display in visitors' centre/discard	Record each sign and assess significance individually and treat accordingly	N/A
10.012	Pitched roofs

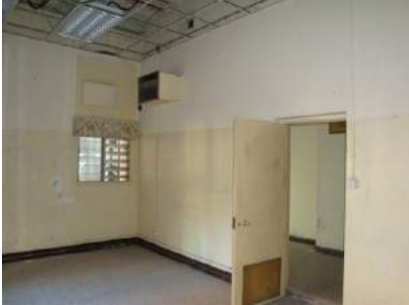
Element no.	Description	Photo ref.	Significance	Proposal	Mitigation	Impact
10.013	Internal walls

Moderate	Remove selected internal walls where strictly necessary as part of re-planning of interiors	Walls or early or original date to be retained in part eg. By leaving a “nib” where the wall is bonded to another wall. At the point where the wall is cut away, form the cut-line on the line of a vertical joint in alternate courses. Bricks in the remaining courses to be left “as cut”, and not re-bonded, as evidence of the current condition.	Moderate

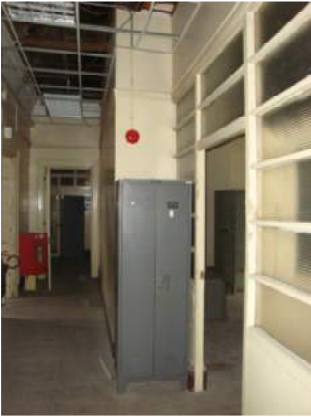
Element no.	Description	Photo ref.	Significance	Proposal	Mitigation	Impact
10.014	Partitions on SF

Moderate	Remove partitions	Record partitions on measured drawings	Moderate
10.015	Blocked windows on south elevation of south-east wing

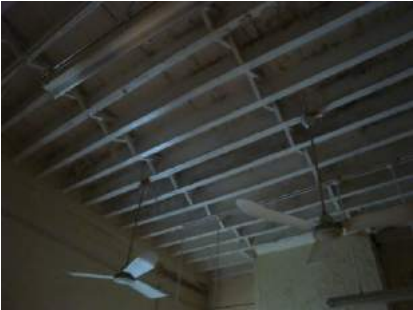
Element no.	Description	Photo ref.	Significance	Proposal	Mitigation	Impact
10.016	Open-joisted ceiling on Ground Floor of south-east wing

Moderate	Underline floor to provide fire protection.	Avoid intrusive alteration. Use fire-proofing products and methods that enable existing structure and boarding to be retained.	Low
10.017	Moulded timber picture rail

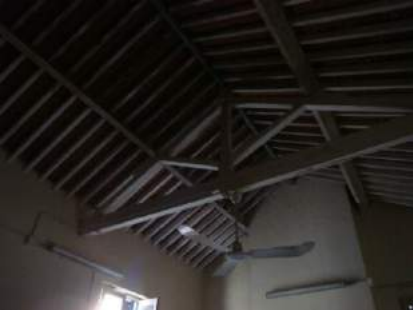
Element no.	Description	Photo ref.	Significance	Proposal	Mitigation	Impact
10.018	Timber roof structure above south-east wing

Moderate	Repair as necessary and retain	Avoid intrusive alteration. Retain open appearance/	Low
10.019	Timber stair

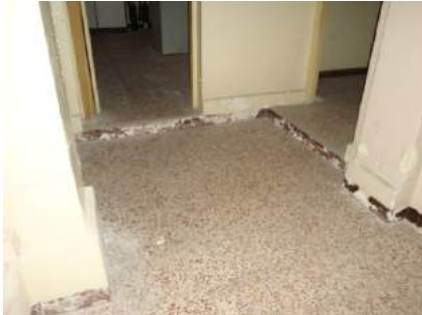
Element no.	Description	Photo ref.	Significance	Proposal	Mitigation	Impact
10.020	Clay/terrazzo tile floor on Ground Floor and steps

Adverse	Adjust levels to enable level access and replace floor finish	Not applicable	Low
10.024	Granite wall on North elevation

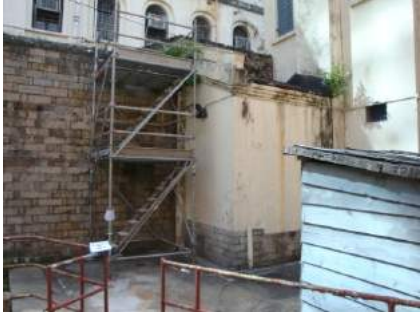
Element no.	Description	Photo ref.	Significance	Proposal	Mitigation	Impact
10.025	Single storey outbuilding at South East corner

Moderate	Demolish outbuilding and make good at abutments	Record outbuilding on measured drawings	Low
10.026	Blocked archway on East elevation

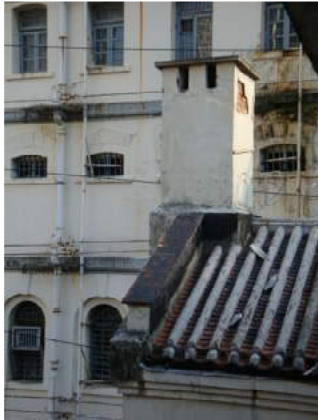
Element no.	Description	Photo ref.	Significance	Proposal	Mitigation	Impact
10.027	Chimney on east elevation

Low	Retain	Not applicable	Neutral
10.028	Cantilever balconies

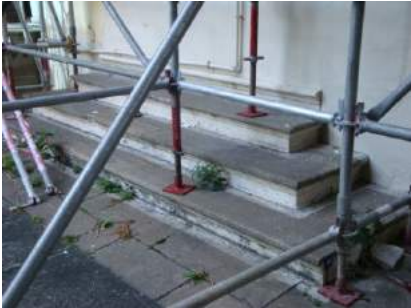
Element no.	Description	Photo ref.	Significance	Proposal	Mitigation	Impact
10.029	Steps on east elevation

Moderate	Repair as necessary and retain	Not applicable	Neutral
10.030	Decorative metal screen (See also item 10.026)

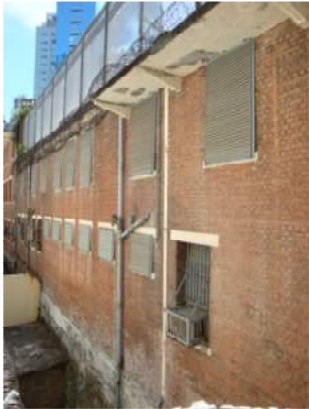
Element no.	Description	Photo ref.	Significance	Proposal	Mitigation	Impact
11.002	External airconditioning units and other external services

Adverse	Remove and make good brickwork	Not applicable	High
11.003	Painted signs

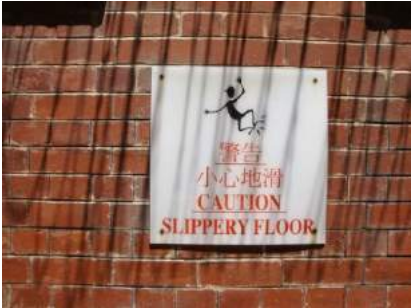
Element no.	Description	Photo ref.	Significance	Proposal	Mitigation	Impact
11.004	Fixed signs

Low-High	Remove and refix/display in visitors' centre/discard	Record each sign and assess significance individually and treat accordingly	N/A
11.005	Concrete stairs

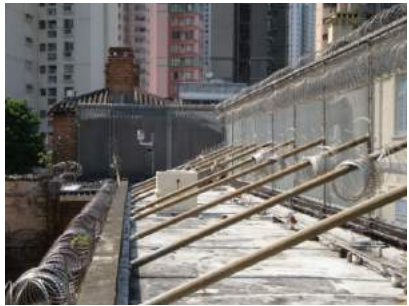
Element no.	Description	Photo ref.	Significance	Proposal	Mitigation	Impact
11.006	Flat roof

Low	Form new rooftop extension at West end to accommodate fire escape stair	Form straight joint at abutment with building 08 Ablutions Block	Low
11.007	Security screen at roof level

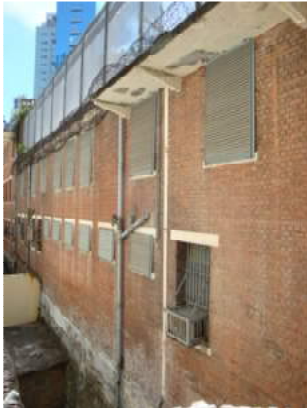
Element no.	Description	Photo ref.	Significance	Proposal	Mitigation	Impact
11.008	Rainwater goods

Adverse	Replace with cast iron in pattern to match original and in correct locations	Not applicable	High

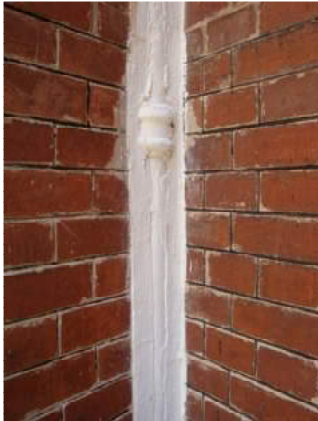
Element no.	Description	Photo ref.	Significance	Proposal	Mitigation	Impact
11.009	Rainwater goods

Low	Remove embedded cast iron pipework set into wall to reduce long term maintenance burden	Record on measured survey drawings. Make good cavity.	Low

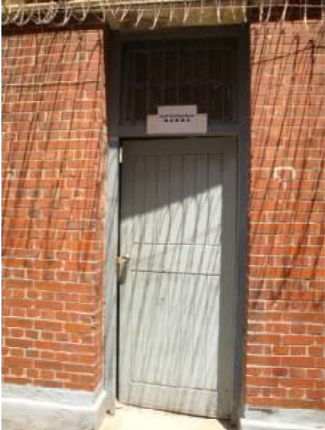
Element no.	Description	Photo ref.	Significance	Proposal	Mitigation	Impact
11.010	Timber doors

Low	Repair and retain	Not applicable	Neutral

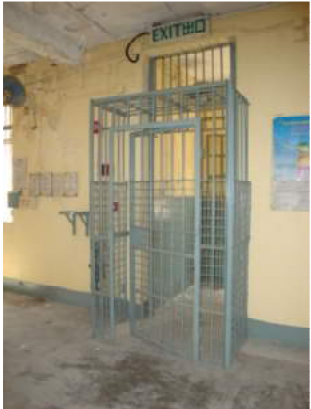
Element no.	Description	Photo ref.	Significance	Proposal	Mitigation	Impact
11.011	Security screen and door at First Floor

Low	Remove	Record on measured survey drawings	Low
11.012	Door thresholds and plinth

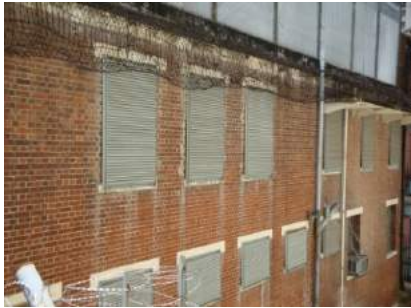
Element no.	Description	Photo ref.	Significance	Proposal	Mitigation	Impact
11.013	Metal louvres on window openings

Adverse	Remove	Not applicable	Low

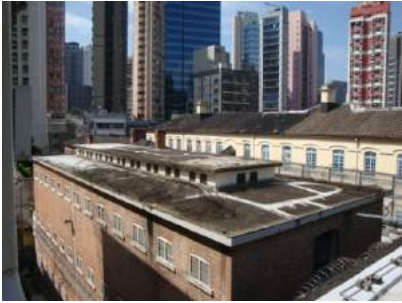
Element no.	Description	Photo ref.	Significance	Proposal	Mitigation	Impact
12.001	Flat roof

Moderate	Repair and retain	Avoid roof penetrations as far as possible	Low
12.002	Cells at GF level

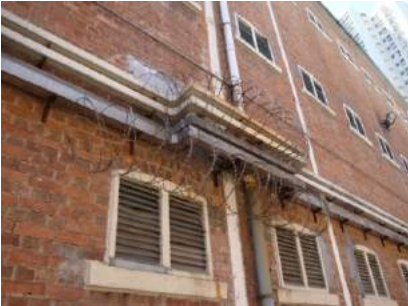
Element no.	Description	Photo ref.	Significance	Proposal	Mitigation	Impact
12.003	External airconditioning units and other external services

Adverse	Remove and make good brickwork	Not applicable	High
12.004	Painted signs

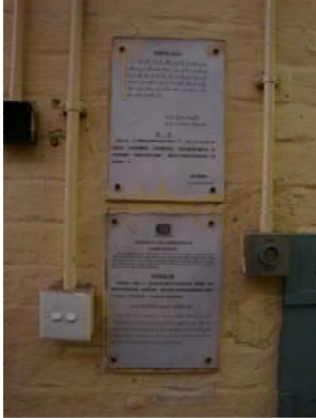
Element no.	Description	Photo ref.	Significance	Proposal	Mitigation	Impact
12.005	Fixed signs

Low-High	Remove and refix/display in visitors' centre/discard	Record each sign and assess significance individually and treat accordingly	N/A
12.006	Rainwater goods

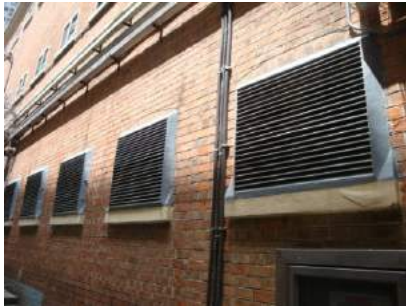
Element no.	Description	Photo ref.	Significance	Proposal	Mitigation	Impact
12.009	External walls

Moderate	Form openings in North and South walls in conjunction with new North-South route across site	Cut brickwork to form openings in North and South walls; do not re-bond brickwork.	Moderate

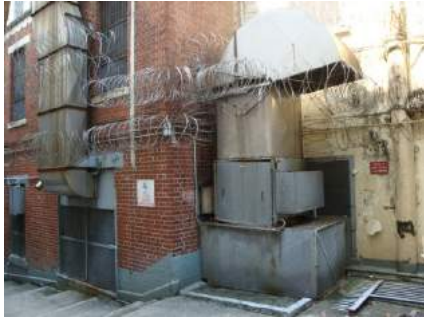
Element no.	Description	Photo ref.	Significance	Proposal	Mitigation	Impact
13.001	External airconditioning units and other external services

Adverse	Remove	Not applicable	Moderate

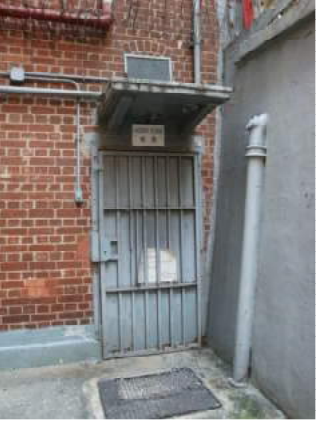
Element no.	Description	Photo ref.	Significance	Proposal	Mitigation	Impact
13.002	Door to Ladder Store

Low	Retain	Not applicable	Neutral
13.003	Security bars at window openings

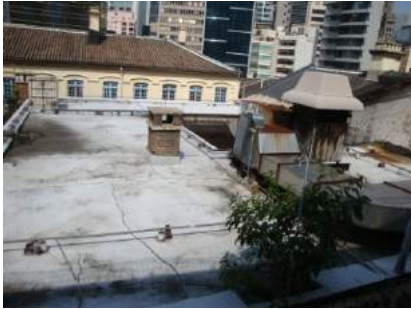
Element no.	Description	Photo ref.	Significance	Proposal	Mitigation	Impact
13.004	Flat roof

Low	Retain	Avoid roof penetrations as far as possible.	Low
13.005	Eaves detail

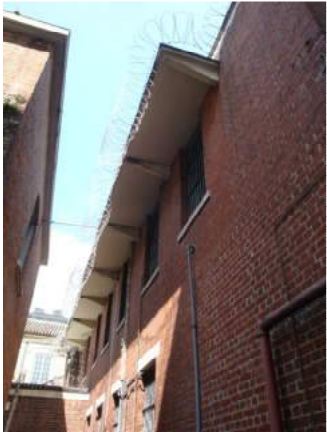
Element no.	Description	Photo ref.	Significance	Proposal	Mitigation	Impact
13.006	Cantilever reinforced concrete canopy

Low	Retain	Not applicable	Neutral

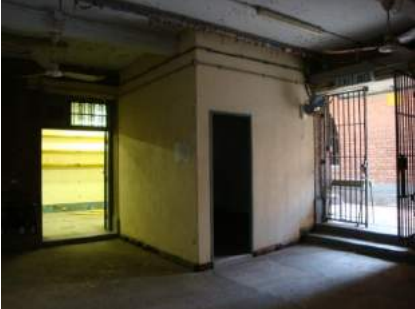
Element no.	Description	Photo ref.	Significance	Proposal	Mitigation	Impact
13.007	Internal partition walls

Low	Remove as part of re-planning of interiors	Record on measured survey drawings	Low
13.008	Fixed signs

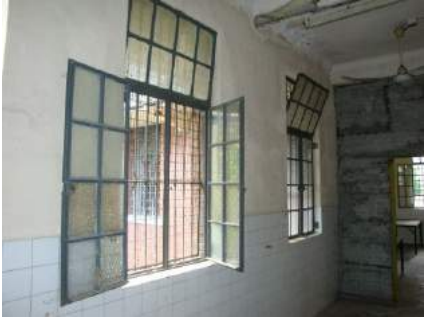
Element no.	Description	Photo ref.	Significance	Proposal	Mitigation	Impact
13.009	Metal window frames

Moderate	Repair and retain	Not applicable	Neutral
13.010	Internal security screens

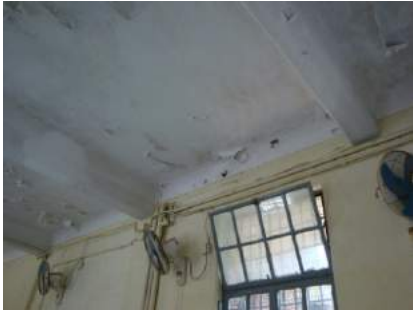
Element no.	Description	Photo ref.	Significance	Proposal	Mitigation	Impact
13.011	Coving at abutments between RC beams and walls

Low	Avoid penetrations for services installations as far as possible.	Cut away neatly for services penetrations and make good at abutments.	Low
13.012	Communal cells at Ground Floor

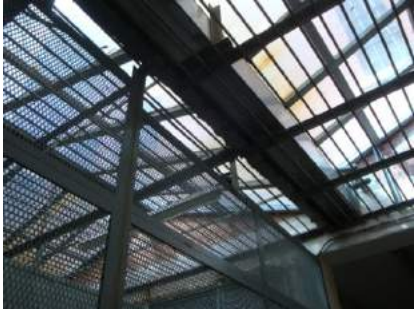
Element no.	Description	Photo ref.	Significance	Proposal	Mitigation	Impact
13.013	Rooflight and security bars over communal cells

Moderate	Remove as part of re-planning of interiors	Record on measured survey drawings	Low
13.014	Granite threshold at external door openings

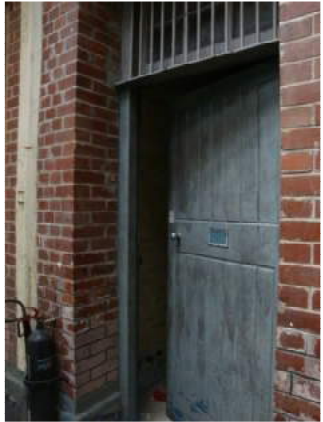
Element no.	Description	Photo ref.	Significance	Proposal	Mitigation	Impact
13.015	Timber boarded doors with fanlight over

Low	Repair as necessary and retain	Not applicable	Neutral
13.015	Vinyl tile floor

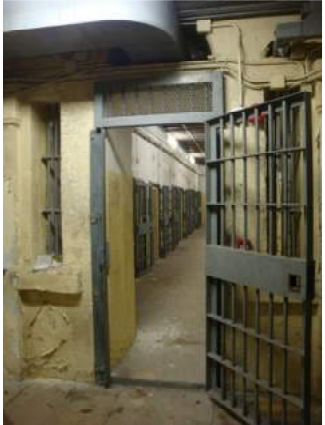
Element no.	Description	Photo ref.	Significance	Proposal	Mitigation	Impact
14.001	West entrance at Lower Ground Floor

Moderate	Retain as public entrance at this level.	<p>Retain security gate and granite threshold.</p> <p>Adjust adjacent ground level as necessary to achieve barrier-free access.</p> <p>Pin gate back against adjacent wall in the open position if necessary.</p>	Low

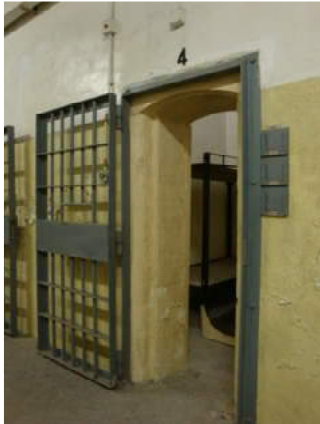
Element no.	Description	Photo ref.	Significance	Proposal	Mitigation	Impact
14.004	Brick reveals with bull-nosed arrisses and segmental arch over (generally north side, alternating with granite surrounds – see previous item)

High	Retain door surround and gate wherever possible	Pin back gate against wall	Low

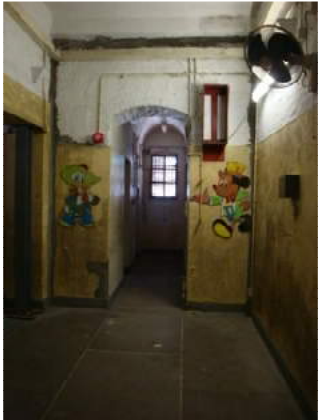
Element no.	Description	Photo ref.	Significance	Proposal	Mitigation	Impact
14.005	Arched opening at East end First Floor

Low	Retain as existing	Not applicable	Low
14.006	Concrete floor generally at Lower Ground Floor

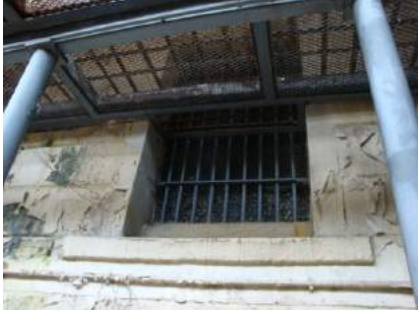
Element no.	Description	Photo ref.	Significance	Proposal	Mitigation	Impact
14.007	Part-blocked windows at Lower Ground Floor - extent of blocking varies.

Moderate	Open up window opening to full extent.	Record existing condition on measured survey drawings. Add further detail during demolition works.	Low
14.008	External granite stair from Lower Ground to Ground Floor level

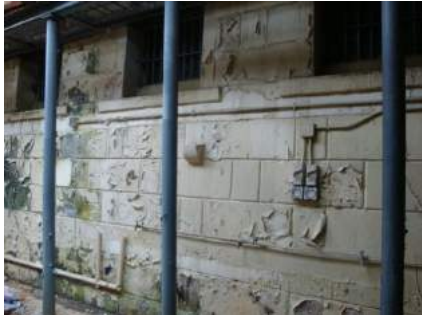
Element no.	Description	Photo ref.	Significance	Proposal	Mitigation	Impact
14.009	Ashlar pattern on external walls

Moderate	Form new openings for entrance/exit to building	<p>Set out new openings to cause minimum disruption to ashlar pattern.</p> <p>Record existing pattern on measured survey drawings.</p>	Low

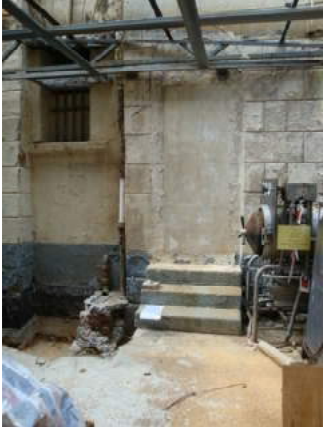
Element no.	Description	Photo ref.	Significance	Proposal	Mitigation	Impact
14.010	Blocked doorway at south-east corner

Low	Preserve blocked opening intact.	Not applicable	Neutral

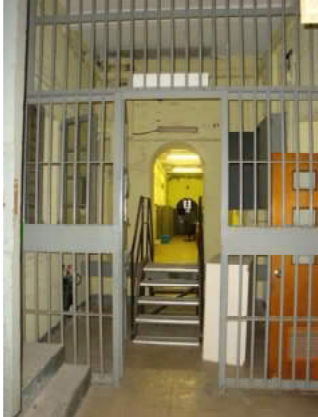
Element no.	Description	Photo ref.	Significance	Proposal	Mitigation	Impact
14.011	Metal security gate and screen

Low	Retain insitu	Pin gate in open position if necessary	Neutral

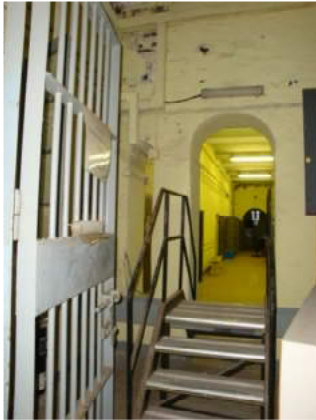
Element no.	Description	Photo ref.	Significance	Proposal	Mitigation	Impact
14.012	Half-round headed doorway and side lights at Ground Floor west end

Moderate	Retain insitu	Not applicable	Neutral
14.013	Structural steelwork bracing and temporary access stair

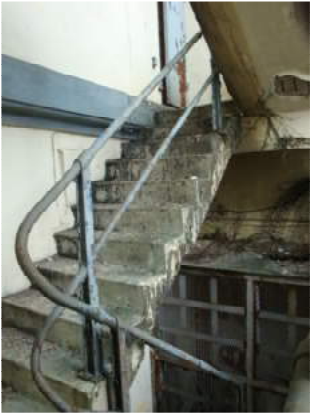
Element no.	Description	Photo ref.	Significance	Proposal	Mitigation	Impact
14.014	RC staircase at north-east corner

Low	Remove	Record on measured drawings	Low
14.015	Vinyl tile floor on suspended timber floor

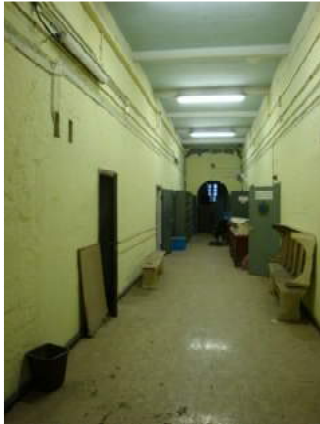
Element no.	Description	Photo ref.	Significance	Proposal	Mitigation	Impact
14.016	Cell walls at Ground Floor

Moderate	Retain insitu	<p>Use existing door openings wherever possible.</p> <p>Avoid further alteration to existing altered openings where feasible.</p>	Low

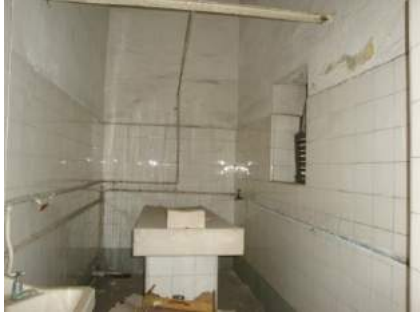
Element no.	Description	Photo ref.	Significance	Proposal	Mitigation	Impact
14.017	Mortuary

High	Preserve insitu	Avoid any service penetrations from adjacent spaces	Neutral
14.018	Brickwork surrounds to doorways with segmental arches over

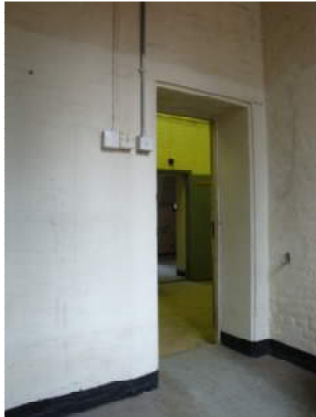
Element no.	Description	Photo ref.	Significance	Proposal	Mitigation	Impact
14.019	Granite surrounds to doorways with lintels over

Moderate	Increase width in selected locations to allow wheelchairs to pass	Record on measured survey drawings.  Limit interventions as far as possible.	Low
14.020	Flat ceilings at Ground Floor

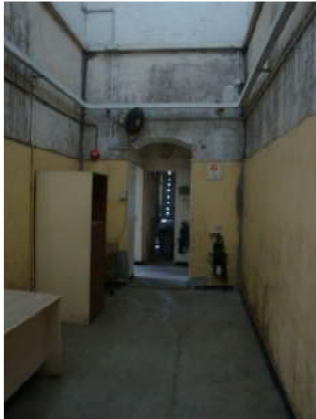
Element no.	Description	Photo ref.	Significance	Proposal	Mitigation	Impact
14.021	Arched opening at east end

Low	Retain insitu	Not applicable	Neutral

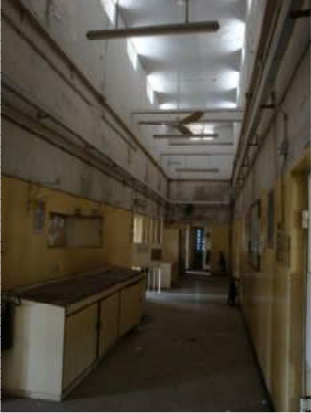
Element no.	Description	Photo ref.	Significance	Proposal	Mitigation	Impact
14.022	Top-lit central hall

High	Retain insitu	Not applicable	Neutral

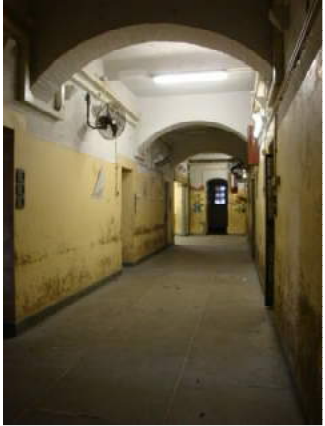
Element no.	Description	Photo ref.	Significance	Proposal	Mitigation	Impact
14.023	Arches across central hall at First Floor

Moderate	Retain insitu	Not applicable	Neutral

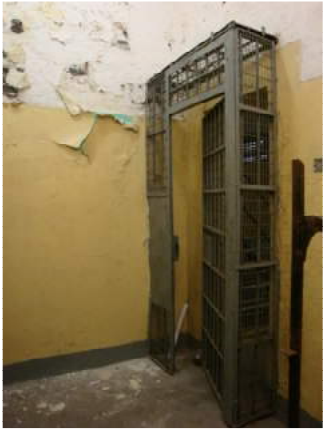
Element no.	Description	Photo ref.	Significance	Proposal	Mitigation	Impact
14.024	Inset security gate and screen in First Floor cells

Low	Remove to suit new use	Remove where necessary.  Record on measured drawings.	Low

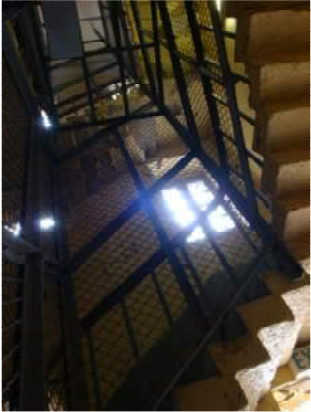
Element no.	Description	Photo ref.	Significance	Proposal	Mitigation	Impact
14.030	Main stair

High	Remove wire mesh and framing	Record on measured drawings	Low

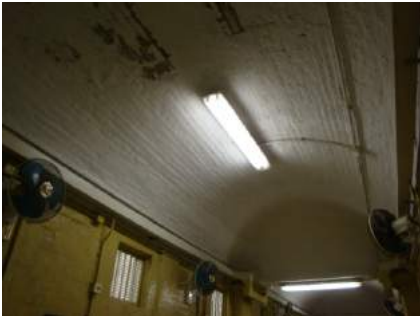
Element no.	Description	Photo ref.	Significance	Proposal	Mitigation	Impact
14.031	Brick vault over central hall at Ground Floor

High	Retain insitu	Not applicable	Neutral
14.032	Terrazzo floor in central hall at Ground floor

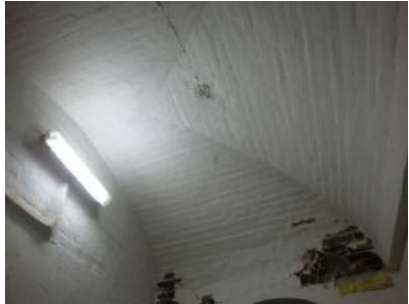
Element no.	Description	Photo ref.	Significance	Proposal	Mitigation	Impact
14.033	Brick vaults above cells

High	Retain insitu	Avoid penetrations for services	Neutral
14.034	Cell walls (later additions)

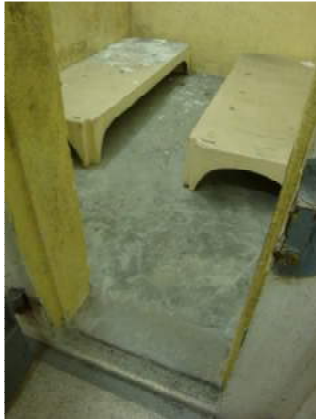
Element no.	Description	Photo ref.	Significance	Proposal	Mitigation	Impact
14.037	Cell floors

Low	Remove to enable piled underpinning	Record on measured survey drawings	Low

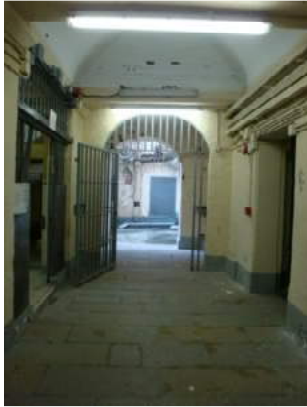
Element no.	Description	Photo ref.	Significance	Proposal	Mitigation	Impact
14.039	Granite pavement in cross-passage between East and West Wings

Moderate	Repair as necessary and retain insitu	Not applicable	Neutral
14.040	Granite threshold at doorway between cross-passage and East Wing

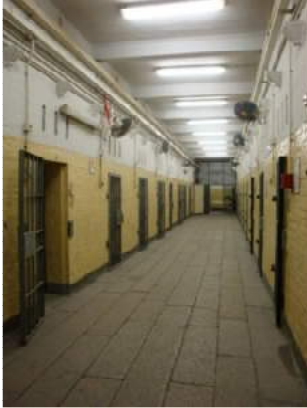
Element no.	Description	Photo ref.	Significance	Proposal	Mitigation	Impact
14.041	Brick vault over cross-passage	 	High	Retain insitu	Avoid any services penetrations	Neutral
14.042	Granite floor in central hall at First Floor

Moderate	Retain insitu	Repair where necessary	Neutral

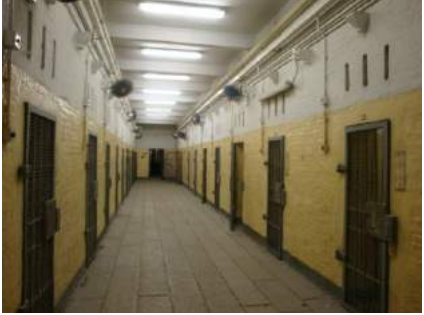
Element no.	Description	Photo ref.	Significance	Proposal	Mitigation	Impact
14.043	Cell walls flanking central hall at First Floor

High	Retain insitu	Not applicable	Neutral
14.044	Brickwork spandrels below cell windows at Second Floor

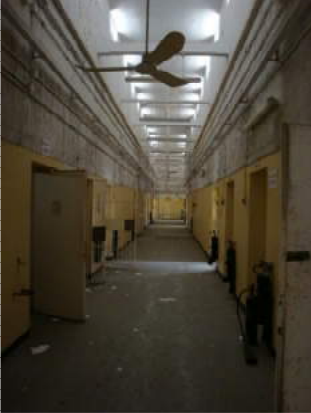
Element no.	Description	Photo ref.	Significance	Proposal	Mitigation	Impact
14.046	Double-height central hall at Second Floor

High	Retain insitu	Not applicable	Neutral

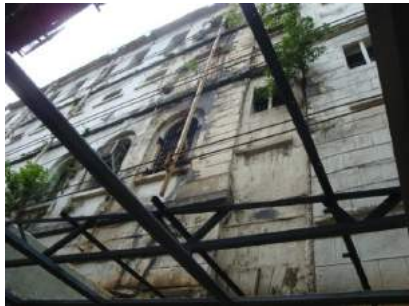
Element no.	Description	Photo ref.	Significance	Proposal	Mitigation	Impact
14.049	Metalwork and structural steel framing on exterior (typical)

Adverse	Remove	Not applicable	High
14.050	Blind arcade, south elevation

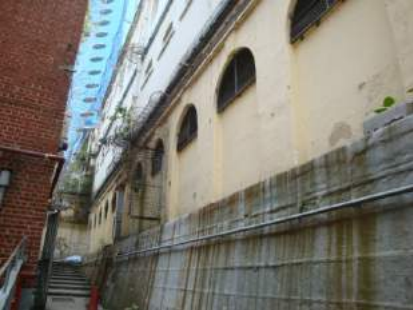
Element no.	Description	Photo ref.	Significance	Proposal	Mitigation	Impact
14.051	Blind arcade, north elevation

Low	Retain insitu	Not applicable	Neutral
14.052	Fence wall, east end of D Hall Yard

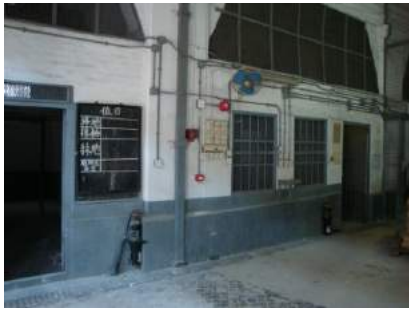
Element no.	Description	Photo ref.	Significance	Proposal	Mitigation	Impact
15.001	Dividing walls at Lower Ground Floor

Moderate	Remove to enable multi-purpose use	Record on measured survey drawings	Low
15.002	Dividing walls at Lower Ground Floor

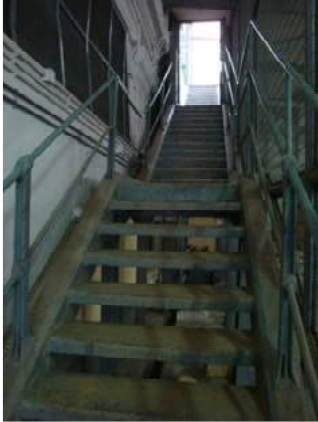
Element no.	Description	Photo ref.	Significance	Proposal	Mitigation	Impact
15.003	Staircase within Laundry Yard

Moderate	Remove to enable construction of Arbuthnot Wing	Record on measured survey drawings	Low

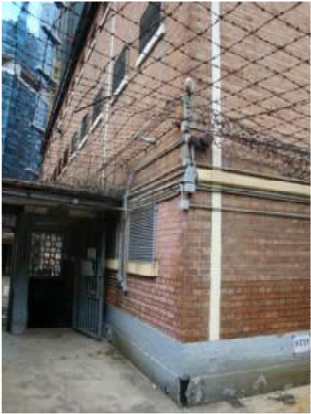
Element no.	Description	Photo ref.	Significance	Proposal	Mitigation	Impact
15.004	Services installations

Adverse	Remove	Not applicable	Moderate
15.005	Metal louvres over cell window openings

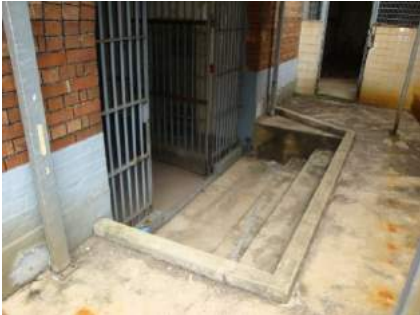
Element no.	Description	Photo ref.	Significance	Proposal	Mitigation	Impact
15.006	Raised ground level adjacent entrance

Low	Remove to enable level access	Record on measured survey drawings	Low
15.007	Access balconies and apertures

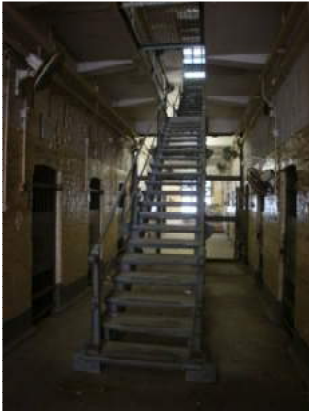
Element no.	Description	Photo ref.	Significance	Proposal	Mitigation	Impact
15.008	Central staircase

High	Retain	Provide secondary staircase within cell blocks to achieve code compliance	Low

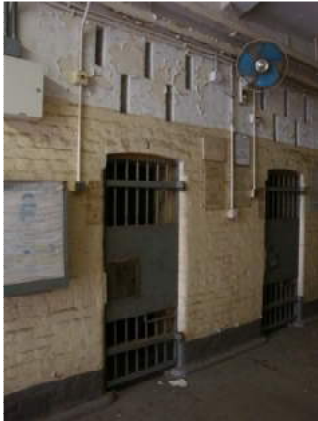
Element no.	Description	Photo ref.	Significance	Proposal	Mitigation	Impact
15.009	Cell walls flanking central hall

High	Retain	Pin back cell doors against walls.	Neutral

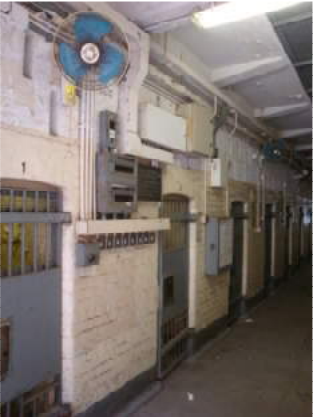
Element no.	Description	Photo ref.	Significance	Proposal	Mitigation	Impact
15.010	Services installations

Adverse	Remove	Not applicable	Moderate
15.011	Balcony balustrades

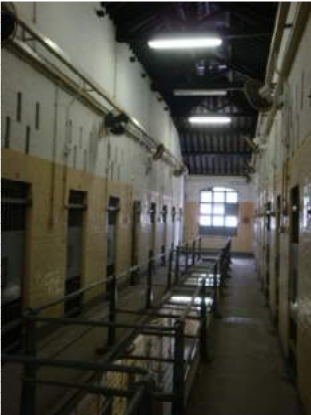
Element no.	Description	Photo ref.	Significance	Proposal	Mitigation	Impact
15.012	Second Floor central hall

High	Retain	Not applicable	Neutral

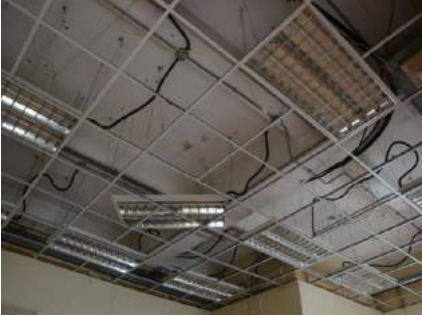
Element no.	Description	Photo ref.	Significance	Proposal	Mitigation	Impact
17.001	Lay-in grid suspended ceiling

Adverse	Remove	Not applicable	High

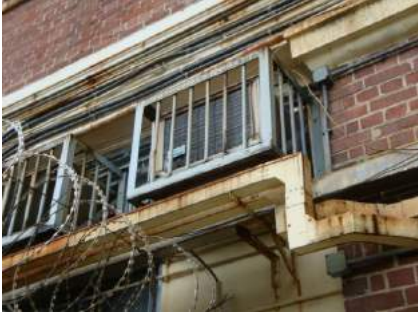
Element no.	Description	Photo ref.	Significance	Proposal	Mitigation	Impact
17.004	External airconditioning units and other external services

Adverse	Remove and make good brickwork	Not applicable	High
17.005	Fixed signs

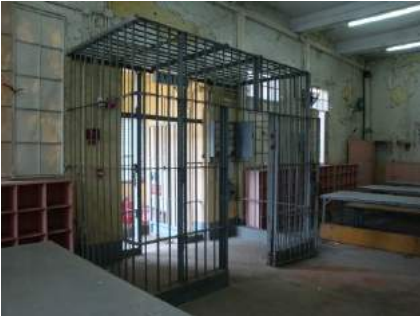
Element no.	Description	Photo ref.	Significance	Proposal	Mitigation	Impact
17.006	Security screen at First Floor entrance

Low	Remove	Record on measured drawings	Low
17.007	Metal windows

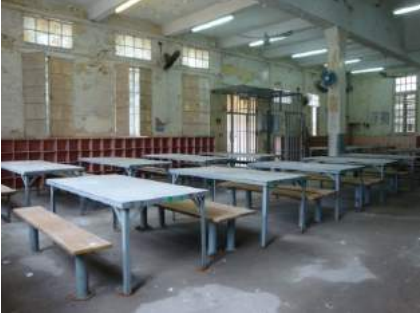
Element no.	Description	Photo ref.	Significance	Proposal	Mitigation	Impact
17.008	Fixed furniture

Moderate	Remove to accommodate gallery space	None	Low
17.009	Security screens

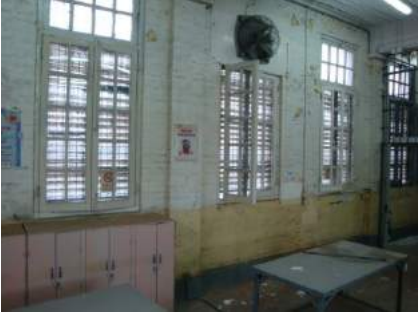
Element no.	Description	Photo ref.	Significance	Proposal	Mitigation	Impact
17.010	Timber windows

Moderate	Remove at First Floor to accommodate gallery space and block structural openings with blockwork	Record on measured drawings	Moderate
17.011	Communal washing/lavatory facilities

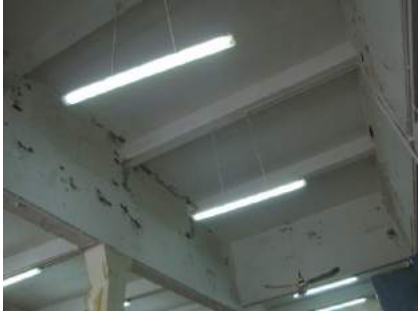
Element no.	Description	Photo ref.	Significance	Proposal	Mitigation	Impact
17.012	Blocked up lantern light

Low	Unblock lantern and fit glazing	Record on measured drawings	Low
17.013	Security gates at Ground openings

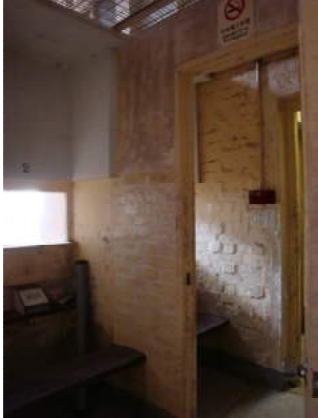
Element no.	Description	Photo ref.	Significance	Proposal	Mitigation	Impact
17.014	Interview booths

High	Remove to accommodate new gallery	Rebuild in new location	Moderate
17.015	External stair to First Floor

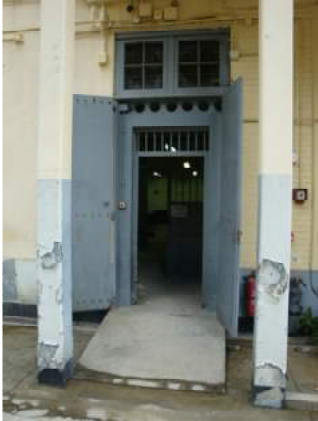
Element no.	Description	Photo ref.	Significance	Proposal	Mitigation	Impact
17.016	Ground Floor main entrance

Low	Retain as existing.	Keep fixed shut if not required for operational use.	Low

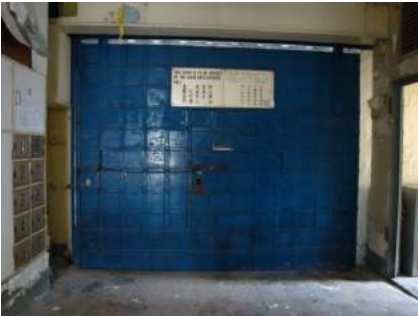
Element no.	Description	Photo ref.	Significance	Proposal	Mitigation	Impact
17.018	Blue Entrance Gate (facing Old Bailey Street)

High	Retain in situ	Maintain in working order	Neutral
17.019	Blue Entrance Gate (inner) and enclosed yard

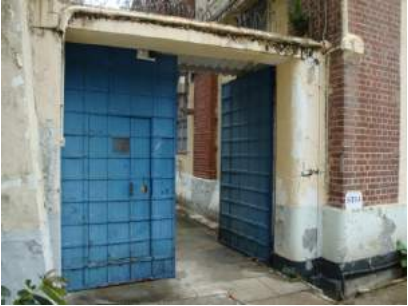
Element no.	Description	Photo ref.	Significance	Proposal	Mitigation	Impact
17.020	Blue Entrance Gate (inner) facing Prison Yard

Moderate	Retain gate and enclosing frame	Repair and maintain in working order	Low

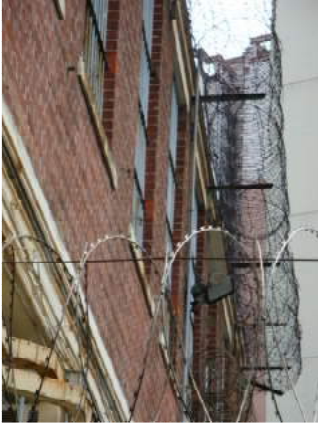
Element no.	Description	Photo ref.	Significance	Proposal	Mitigation	Impact
17.021	Barbed wire

Moderate	Remove	Record on measured drawings. Make good fixing points where attached to brickwork.	Low

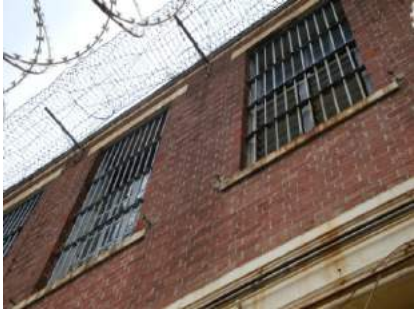
Element no.	Description	Photo ref.	Significance	Proposal	Mitigation	Impact
17.022	Metal security bars at windows

Moderate	Remove as part of blocking up window openings to accommodate gallery space at First Floor	Record on measured drawings	Low
17.023	External toilets at Ground Floor adjacent East elevation

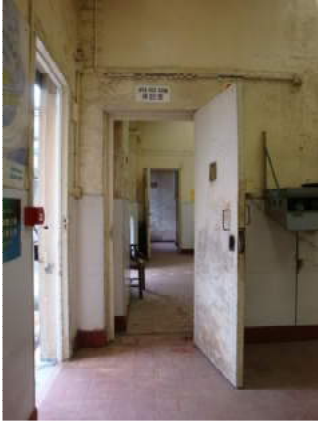
Element no.	Description	Photo ref.	Significance	Proposal	Mitigation	Impact
17.024	Open Visit Room

Low	Space reallocated to other uses	Record on measured drawings. Salvage entrance sign and re-use in new layout of interview booths.	Low

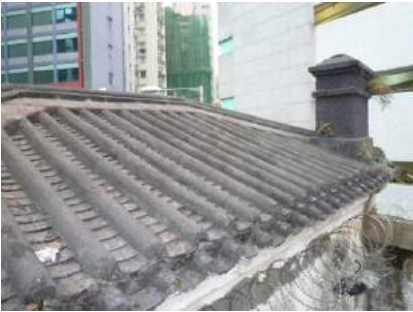
Element no.	Description	Photo ref.	Significance	Proposal	Mitigation	Impact
19.001	Pitched roofs

High	New penetrations through roofs for ventilation ducts and other services	Arrange new penetrations so that they conform with the geometry of the existing roof. Model the size and shape of the new ducts so that the impact on the roofscape is minimised. Finish the new ducts in a non-reflective material that is neutral in colour and mid-tone.	High
19.002	Chimney

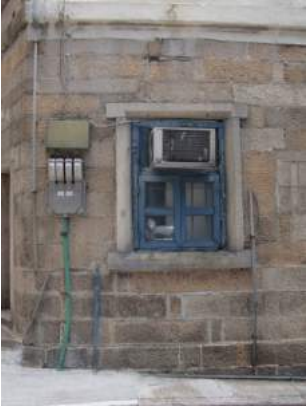
Element no.	Description	Photo ref.	Significance	Proposal	Mitigation	Impact
19.003	Rainwater goods and other external services

Adverse	Remove and make good wall surface. Replace defective and non-matching rainwater goods with cast iron fittings to match original.	Not applicable	Moderate

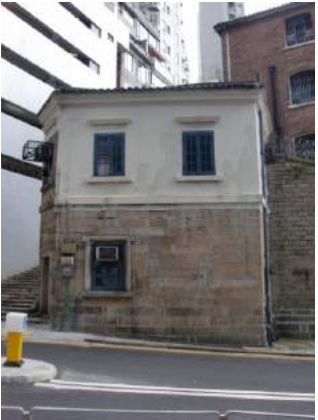
Element no.	Description	Photo ref.	Significance	Proposal	Mitigation	Impact
19.004	External stone wall facing

High	Carry out close inspection of painted areas to determine extent of original granite facing and remove paint media where applicable.	Not applicable	Moderate

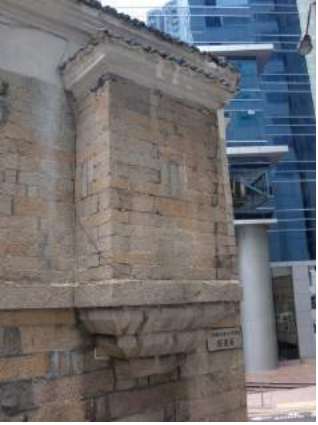
Element no.	Description	Photo ref.	Significance	Proposal	Mitigation	Impact
19.005	Gun loops

High	Remove concrete infilling and make good stonework where necessary.	Not applicable	Moderate

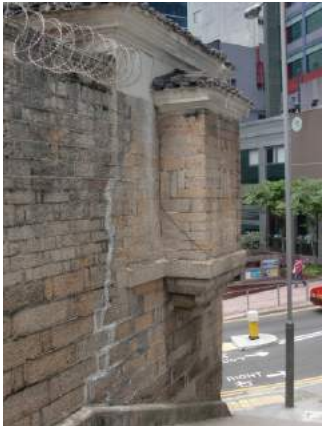
Element no.	Description	Photo ref.	Significance	Proposal	Mitigation	Impact
19.006	Look-out turret

High	Repair and retain insitu	Not applicable	Neutral

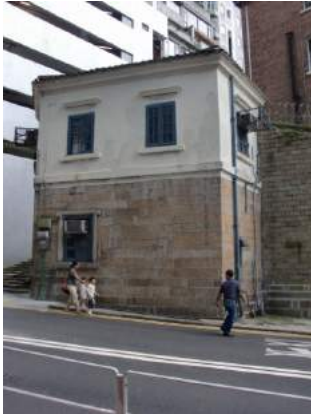
Element no.	Description	Photo ref.	Significance	Proposal	Mitigation	Impact
19.007	Windows

Moderate	Remove and make good stonework as necessary	Record existing windows on measured survey drawings	Moderate

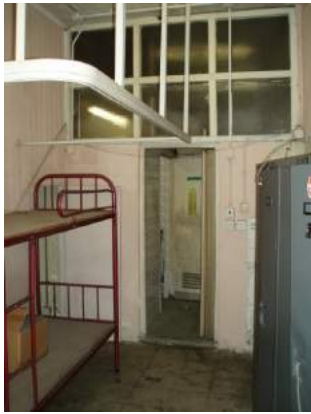
Element no.	Description	Photo ref.	Significance	Proposal	Mitigation	Impact
19.008	Modern partitions

Adverse	Remove	Not applicable	Moderate

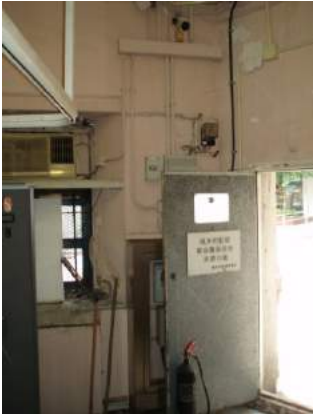
Element no.	Description	Photo ref.	Significance	Proposal	Mitigation	Impact
19.009	Electrical services

Adverse	Remove	Not applicable	Moderate
19.010	Lay-in grid suspended ceiling

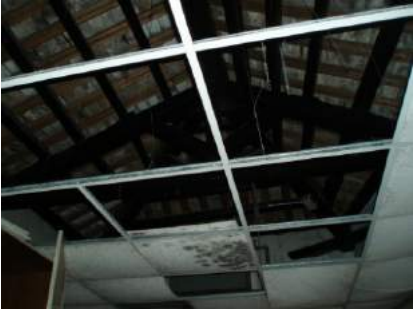
Element no.	Description	Photo ref.	Significance	Proposal	Mitigation	Impact
19.011	Exposed timber roof structure

High	Repair and retain insitu	Not applicable	Neutral
19.012	Timber stair
