Central Police Station Conservation
and Revitalisation Project:
Thirteenth Quarterly EM&A Report
(1 November 2014 to 31 January
2015)

Issue Date: March 2015

Annex N	<i>A Summary of Current Condition of Character Defining Elements</i>

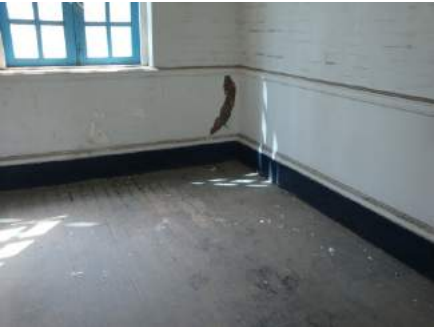
Low	Conceal in exceptional cases eg. where adjacent new lift shaft	Retain frame and spandrel panel where possible. Remove only where necessary in connection with re-planning of interiors. Record on measured survey drawings.	Low
03.006	Timber floors

High	Replace where new kitchens and plant rooms to be installed	Limit extent of removal as much as possible. Carefully remove and retain existing floorboards for re-use. Ensure controlled dismantling of timber structure and set aside for possible re-use. Protect or carefully remove and set aside adjacent elements such as skirting boards	Medium
