Central Police Station Conservation
and Revitalisation Project:
16th Quarterly EM&A Report
(1 August 2015 to 31 October 2015)

Issue Date: November 2015

Annex N	<i>A Summary of Condition of Character Defining Elements, Historic Buildings and Structures</i>

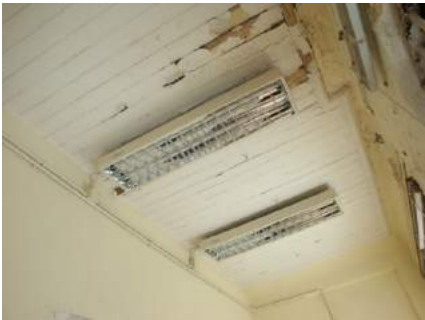
Low	Remove	Record on measured drawings and photographs	Low
01.028	Tongued and grooved flat and sloped timber boarded ceilings

Moderate	Repair where necessary and reinstate where missing	Not applicable	Moderate

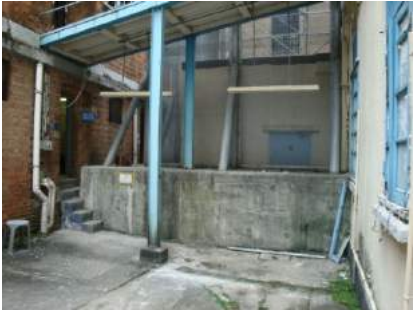
High	Open up selected openings to form new fire escape doors	Retain any salvageable material for possible re-use elsewhere. Retain existing window jambs intact. Cut away masonry to form door openings along same line as window jamb; do not re-bind cut brickwork. Record existing condition on measured survey drawings.	Low
03.023	Single storey outbuildings on south side

Adverse	Demolish	Check for evidence of early route from Magistracy to Prison.	Low

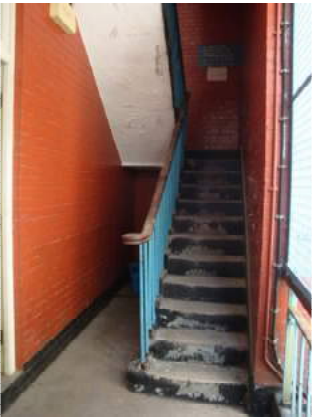
High	Retain	Not applicable	Neutral
08.006	External stair at west end

Moderate	Retain	Repair as necessary. Alter balustrade to achieve reasonable level of operational safety. Restrict access to repairs and maintenance and means of escape.	Low

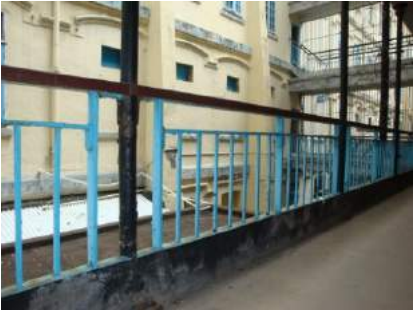
Moderate	Retain	Repair as necessary. Alter balustrade to achieve reasonable level of operational safety. Restrict access to repairs and maintenance and means of escape.	Low
08.013	Balcony balustrades

Low	Repair as necessary and retain. Remove selected sections to enable installation of new bridge connections to Barrack Block.	Avoid removal of associated iron columns. Form interventions at selected positions so as to maintain the rhythm of the balustrades and ensure proper support at ends.	Low

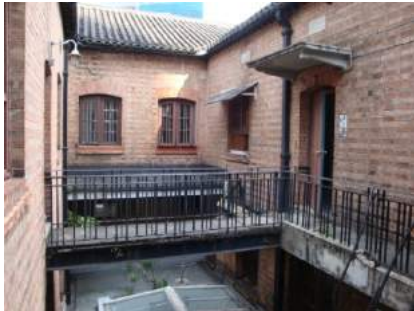
Moderate	Replace with larger sizes/closer spacing to improve performance	Use cast iron to match original pattern Make good all redundant fixing holes	High
09.013	Metal walkways across lightwell

Adverse	Remove walkways and make good brickwork at abutments	Not applicable	High

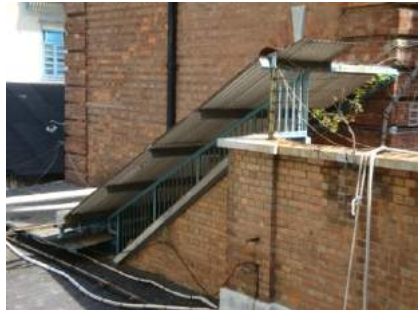
Adverse	Repair or renew as necessary existing frames to match original patterns	Not applicable	High
09.015	Sloping canopy over external stair on west side

Adverse	Remove canopy and supporting structure	Not applicable	Moderate

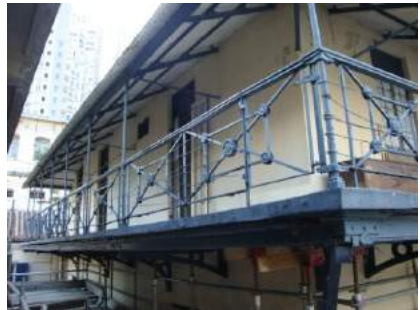
High	Repair as necessary and retain	Lift carefully and refix upon completion of fire-proofing and services installation	Low
10.005	Exterior decorations

Adverse	Strip off and redecorate	Sample and analyse existing paint media; select new media to suit substrate and significance	High

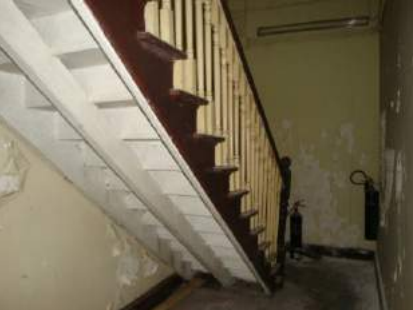
Moderate	Repair as necessary and retain	Avoid intrusive alteration. Retain open appearance/	Low
10.019	Timber stair

Moderate	Underline with fire-resisting lining	Repair as necessary and retain.	Low

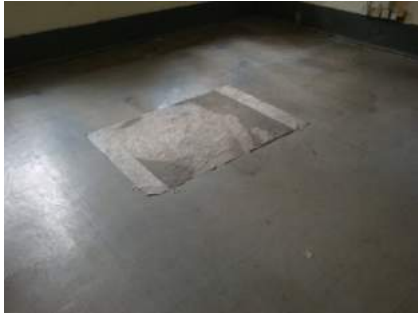
Low	Repair as necessary and retain	Not applicable	Neutral
13.015	Vinyl tile floor

Adverse	Replace	Not applicable	Low

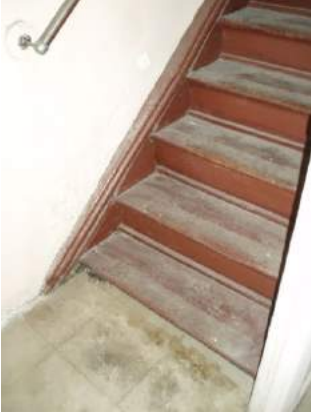
High	Repair and retain insitu	Not applicable	Neutral
19.012	Timber stair

Moderate	Remove	Record on measured surveys drawings	Low
