Central Police Station Conservation
and Revitalisation Project:
20th Quarterly EM&A Report
(1 August 2016 to 31 October 2016)

Issue Date: January 2017

Environmental Resources Management

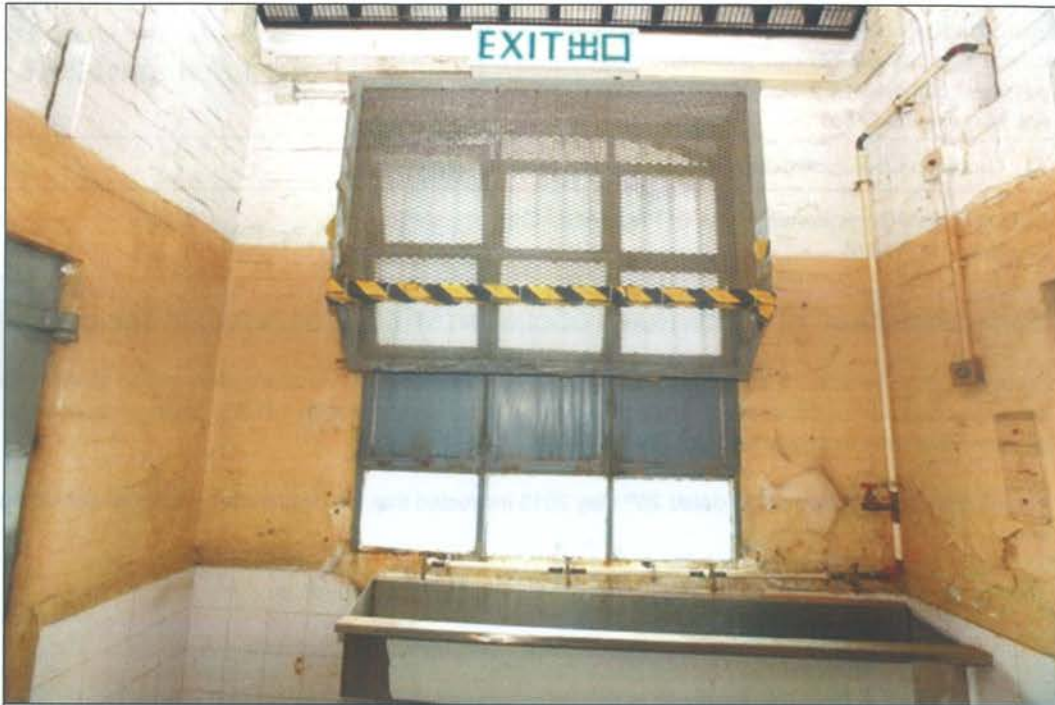
Above, photograph taken by the Management Contractor on 17th August, 2011, showing the overall look of the window.

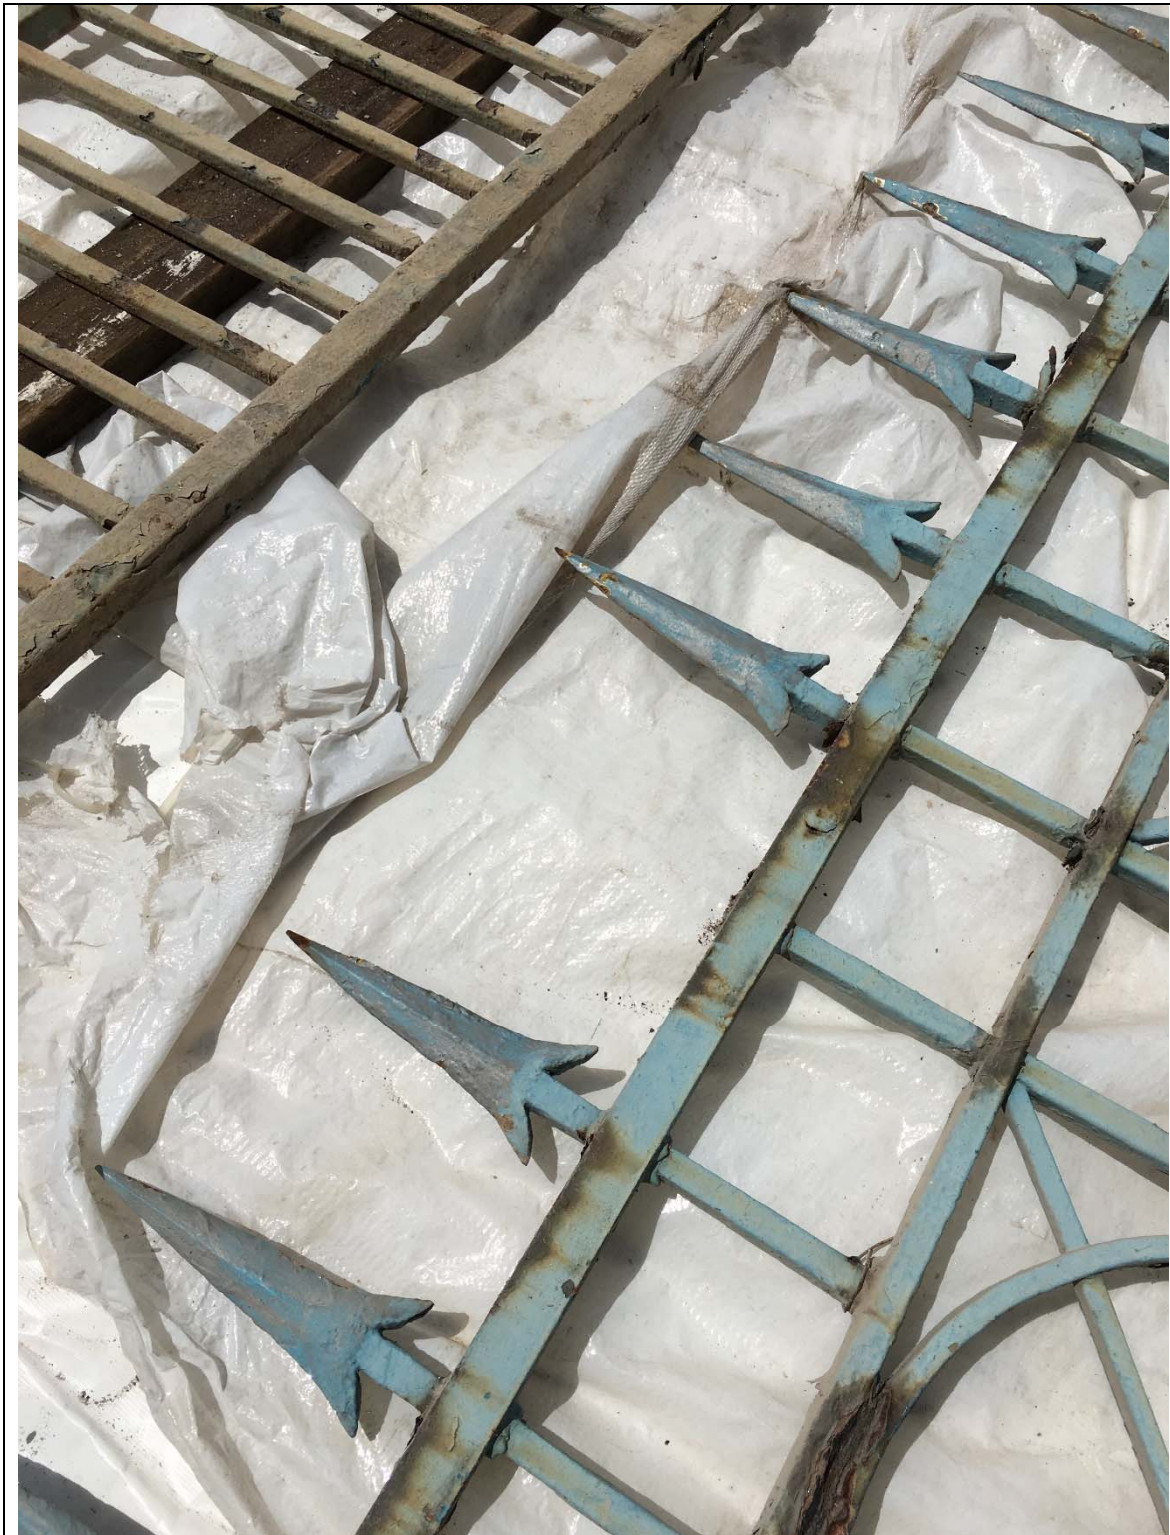
Above, photo taken on 21st July 2016, showing the drop bolt on the right hand side leaf was bent.

Above, photo taken on 21st July 2016, showing one arrow on left hand side leaf was missing.

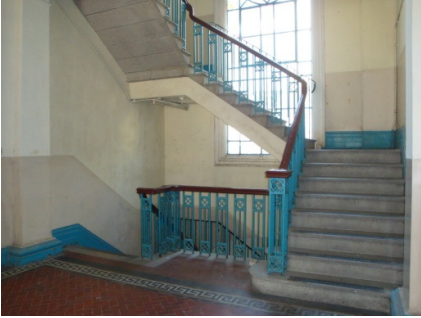
Adverse	Remove and make good brickwork	Not applicable	High
01.021	Stair balustrades

High	Balustrades to be supplemented with additional handrails and supports to mitigate non-compliance with code	New fittings to be of their time and made reversible. Physical intervention to existing stairs and balustrades to be kept to the minimum.	Moderate

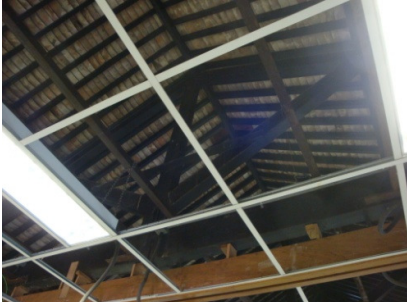
High	Repair and retain.	N/A	Neutral

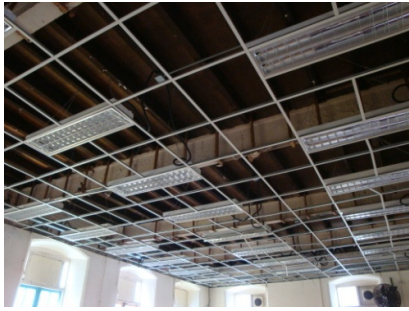
Element no.	Description	Photo ref.	Significance	Proposal	Mitigation	Impact
03.001	Lay-in grid suspended ceiling

Adverse	Remove	Not applicable	High

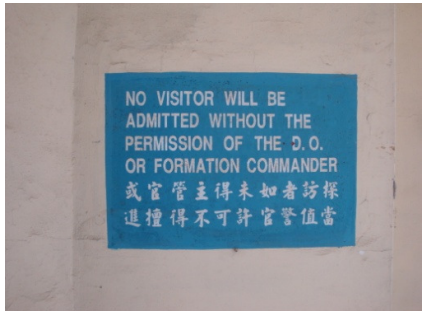
Element no.	Description	Photo ref.	Significance	Proposal	Mitigation	Impact
03.014	Painted signs

High	Protect in situ	Not applicable	N/A
03.015	Fixed signs	 	Low-High	Remove and refix/display in visitors' centre/discard	Record each sign and assess significance individually and treat accordingly	N/A

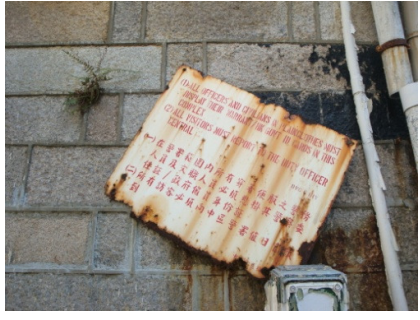
Low-High	Remove and refix/display in visitors' centre/discard	Record each sign and assess significance individually and treat accordingly	N/A

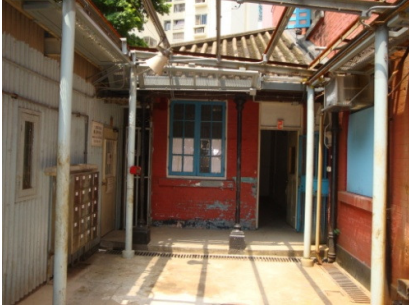
Element no.	Description	Photo ref.	Significance	Proposal	Mitigation	Impact
08.014	Single-storey outbuilding with pitched roof over

Low	Demolish to make way for new loading bay.	<p>Record on measured survey drawings.</p> <p>Infill existing internal opening leaving reveals exposed.</p> <p>Tooth-in new brickwork at abutments after existing walls removed.</p> <p>Salvage cast iron columns for possible re-use.</p>	Low
08.015	Corrugated steel sheet on balcony balustrades

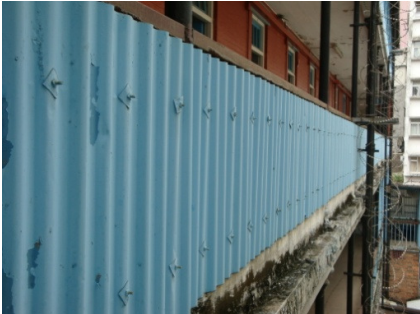
Adverse	Remove	Not applicable	Low

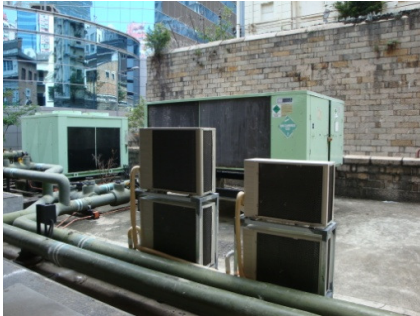
Element no.	Description	Photo ref.	Significance	Proposal	Mitigation	Impact
09.010	External airconditioning units and other external services

Adverse	Remove and make good brickwork	Not applicable	High
09.011	Pitched roofs

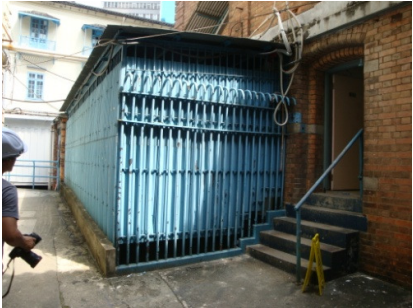
Moderate	Retain; including remains of bars (now removed) between existing railings and east side of Barracks Block.	Not applicable	Neutral

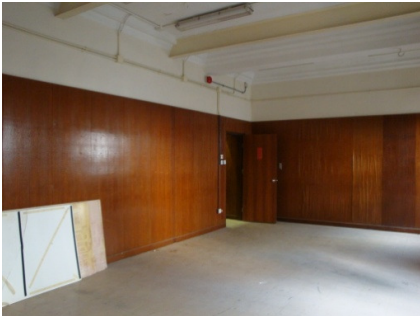
Element no.	Description	Photo ref.	Significance	Proposal	Mitigation	Impact
09.020	Meeting room at G/02-05

Moderate	Remove timber panelling from walls and sub divide to form new toilets and lift shaft	Record existing wall linings, and any earlier lining behind, on measured survey drawings.	Moderate
09.021	Lobbies within entrance hall G/12	 	Adverse	Remove	Not applicable	N/A

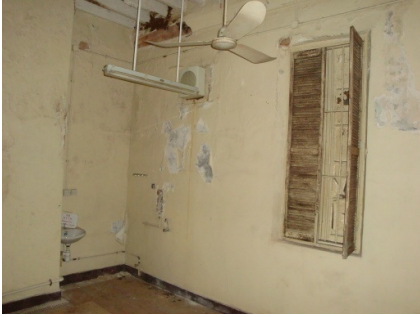
Moderate	Remove partitions	Record partitions on measured drawings	Moderate
10.015	Blocked windows on south elevation of south-east wing

Adverse	Re-open window openings and reinstate window frames and glazing	Not applicable	Moderate

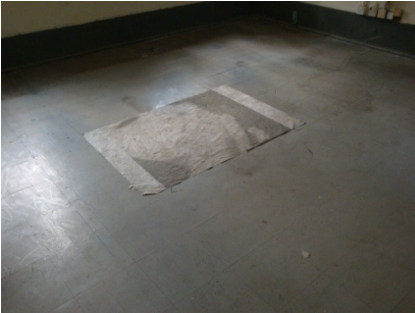
Low	Repair as necessary and retain	Not applicable	Neutral
13.015	Vinyl tile floor

Adverse	Replace	Not applicable	Low

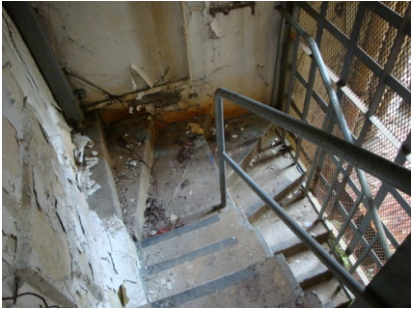
Moderate	Open up window opening to full extent.	Record existing condition on measured survey drawings. Add further detail during demolition works.	Low
14.008	External granite stair from Lower Ground to Ground Floor level

Moderate	Remove stair to make way for new stair in similar position	Review design proposals to see whether existing stair can be retained.	Low

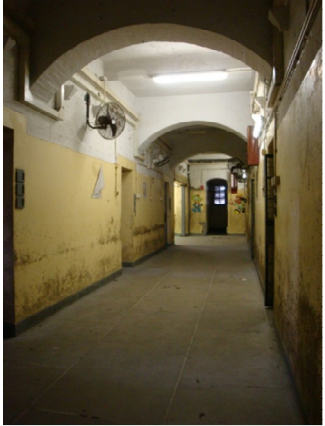
Element no.	Description	Photo ref.	Significance	Proposal	Mitigation	Impact
14.023	Arches across central hall at First Floor

Moderate	Retain insitu	Not applicable	Neutral

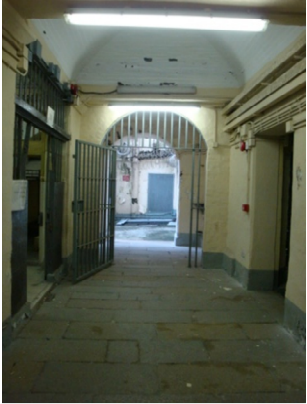
Element no.	Description	Photo ref.	Significance	Proposal	Mitigation	Impact
14.039	Granite pavement in cross-passage between East and West Wings

Moderate	Repair as necessary and retain insitu	Not applicable	Neutral
14.040	Granite threshold at doorway between cross-passage and East Wing

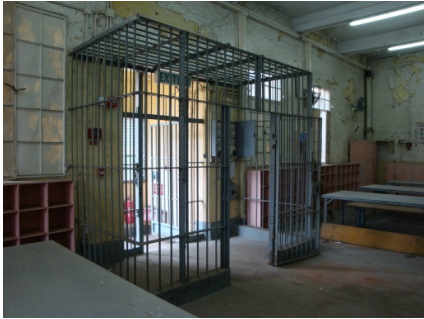
Element no.	Description	Photo ref.	Significance	Proposal	Mitigation	Impact
17.006	Security screen at First Floor entrance

Low	Remove	Record on measured drawings	Low
17.007	Metal windows
