The Jockey Club CPS Limited

Central Police Station Conservation
and Revitalisation Project:
Ninth Quarterly EM&A Report
(1 November 2013 to 31 January
2014)

Issue Date: February 2014

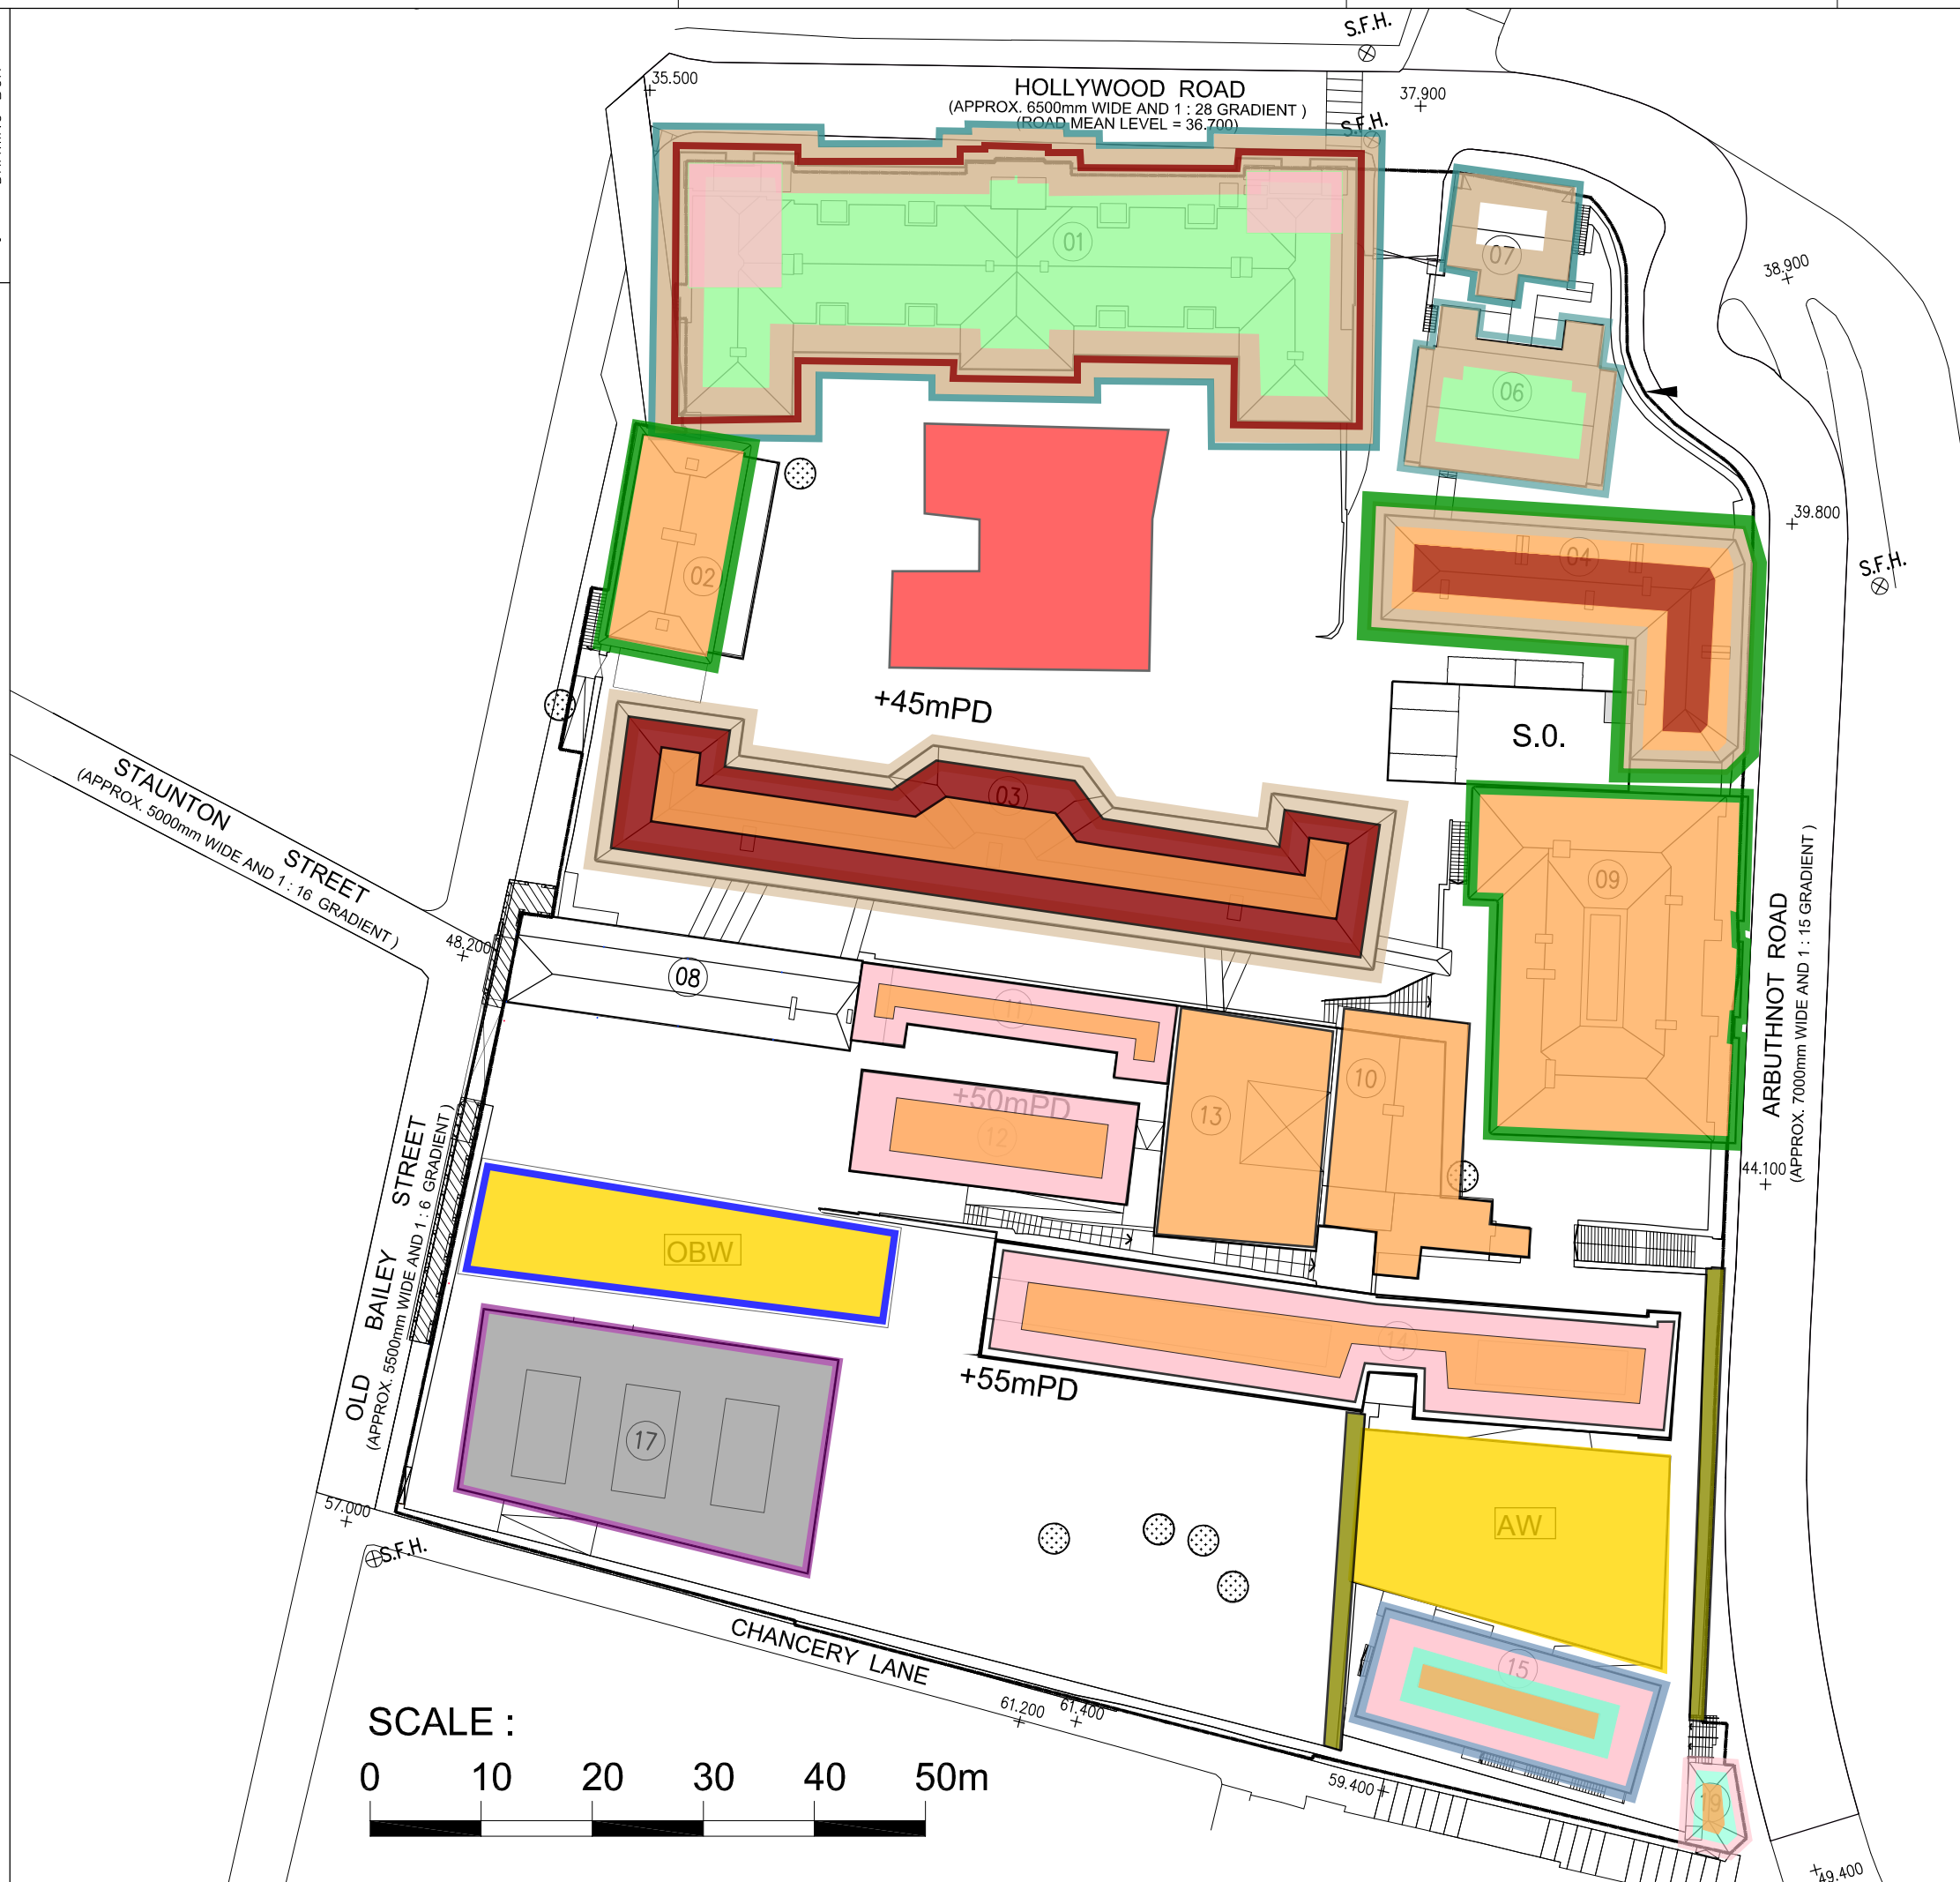
Site Layout Plan marked with Works

- 1. General Strip Out
- 2. Channel Planking Work
- 3. Basement Construction
- 4. Underpinning Works
- 5. E&M Installation / opening
- 6. Roof Tiles Replacement Works
- 7. Pilling Works & pre-Loading Test
- 8. Structure A&A Works
- 9. Repair Works to Timber Window, Door
- 10. Demolition Works / Slab Demolition
- 11. External Scaffolding Erection
- 12. Excavation & Construction of Ground Beam
- 13. ELS Works and Pump Well Test
- 14. Revetment Wall Strengthening

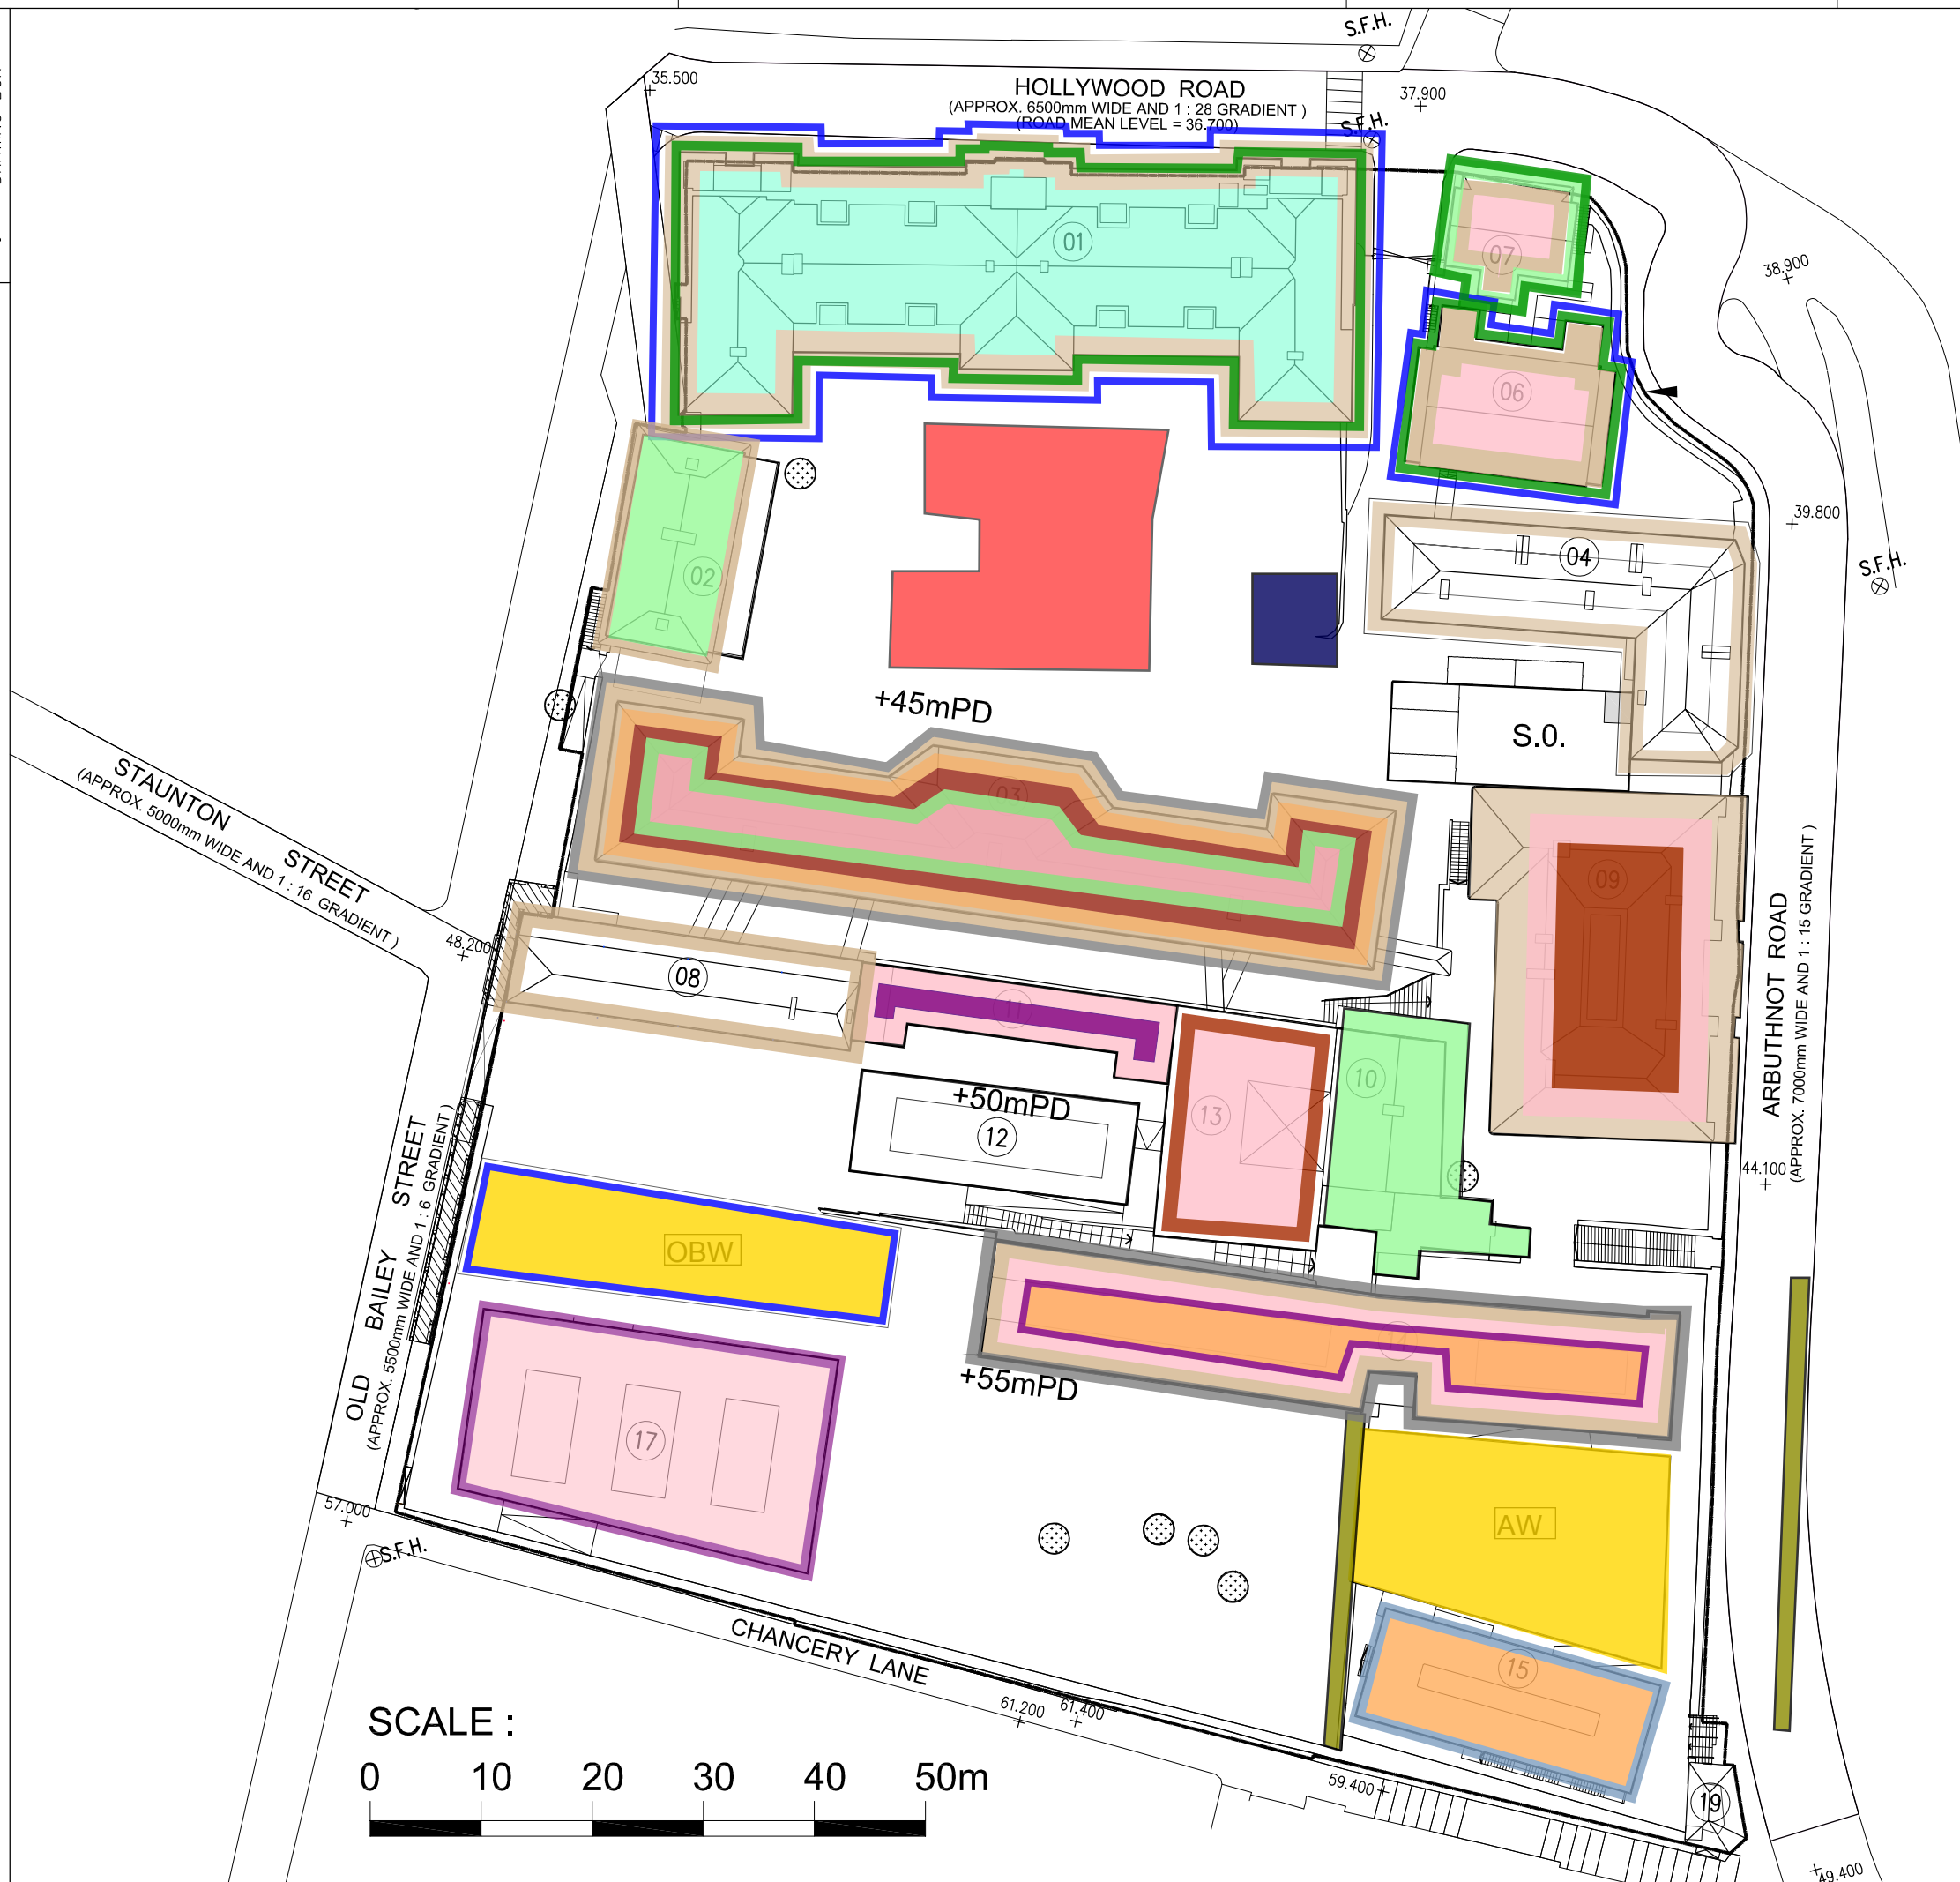
Annex A3 Site Layout Plan marked with Works (November- 2013)

- 1. E&M Installation / Opening
- 2. Removal of Non-structural Infill Wall
- 3. Basement Construction
- 4. Underpinning Works
- 5. Tower Crane Erection
- 6. Roof Tiles Replacement Works
- 7. ELS Works
- 8. Structure A&A Works
- 9. Repair Works to Timber Window, Door and Structure Floor
- 10. Demolition Works / Slab Demolition
- 11. Facade Cleaning and Repair
- 12. New Structure Construction
- 13. Balcony Repair
- 14. Revetment Wall Strengthening

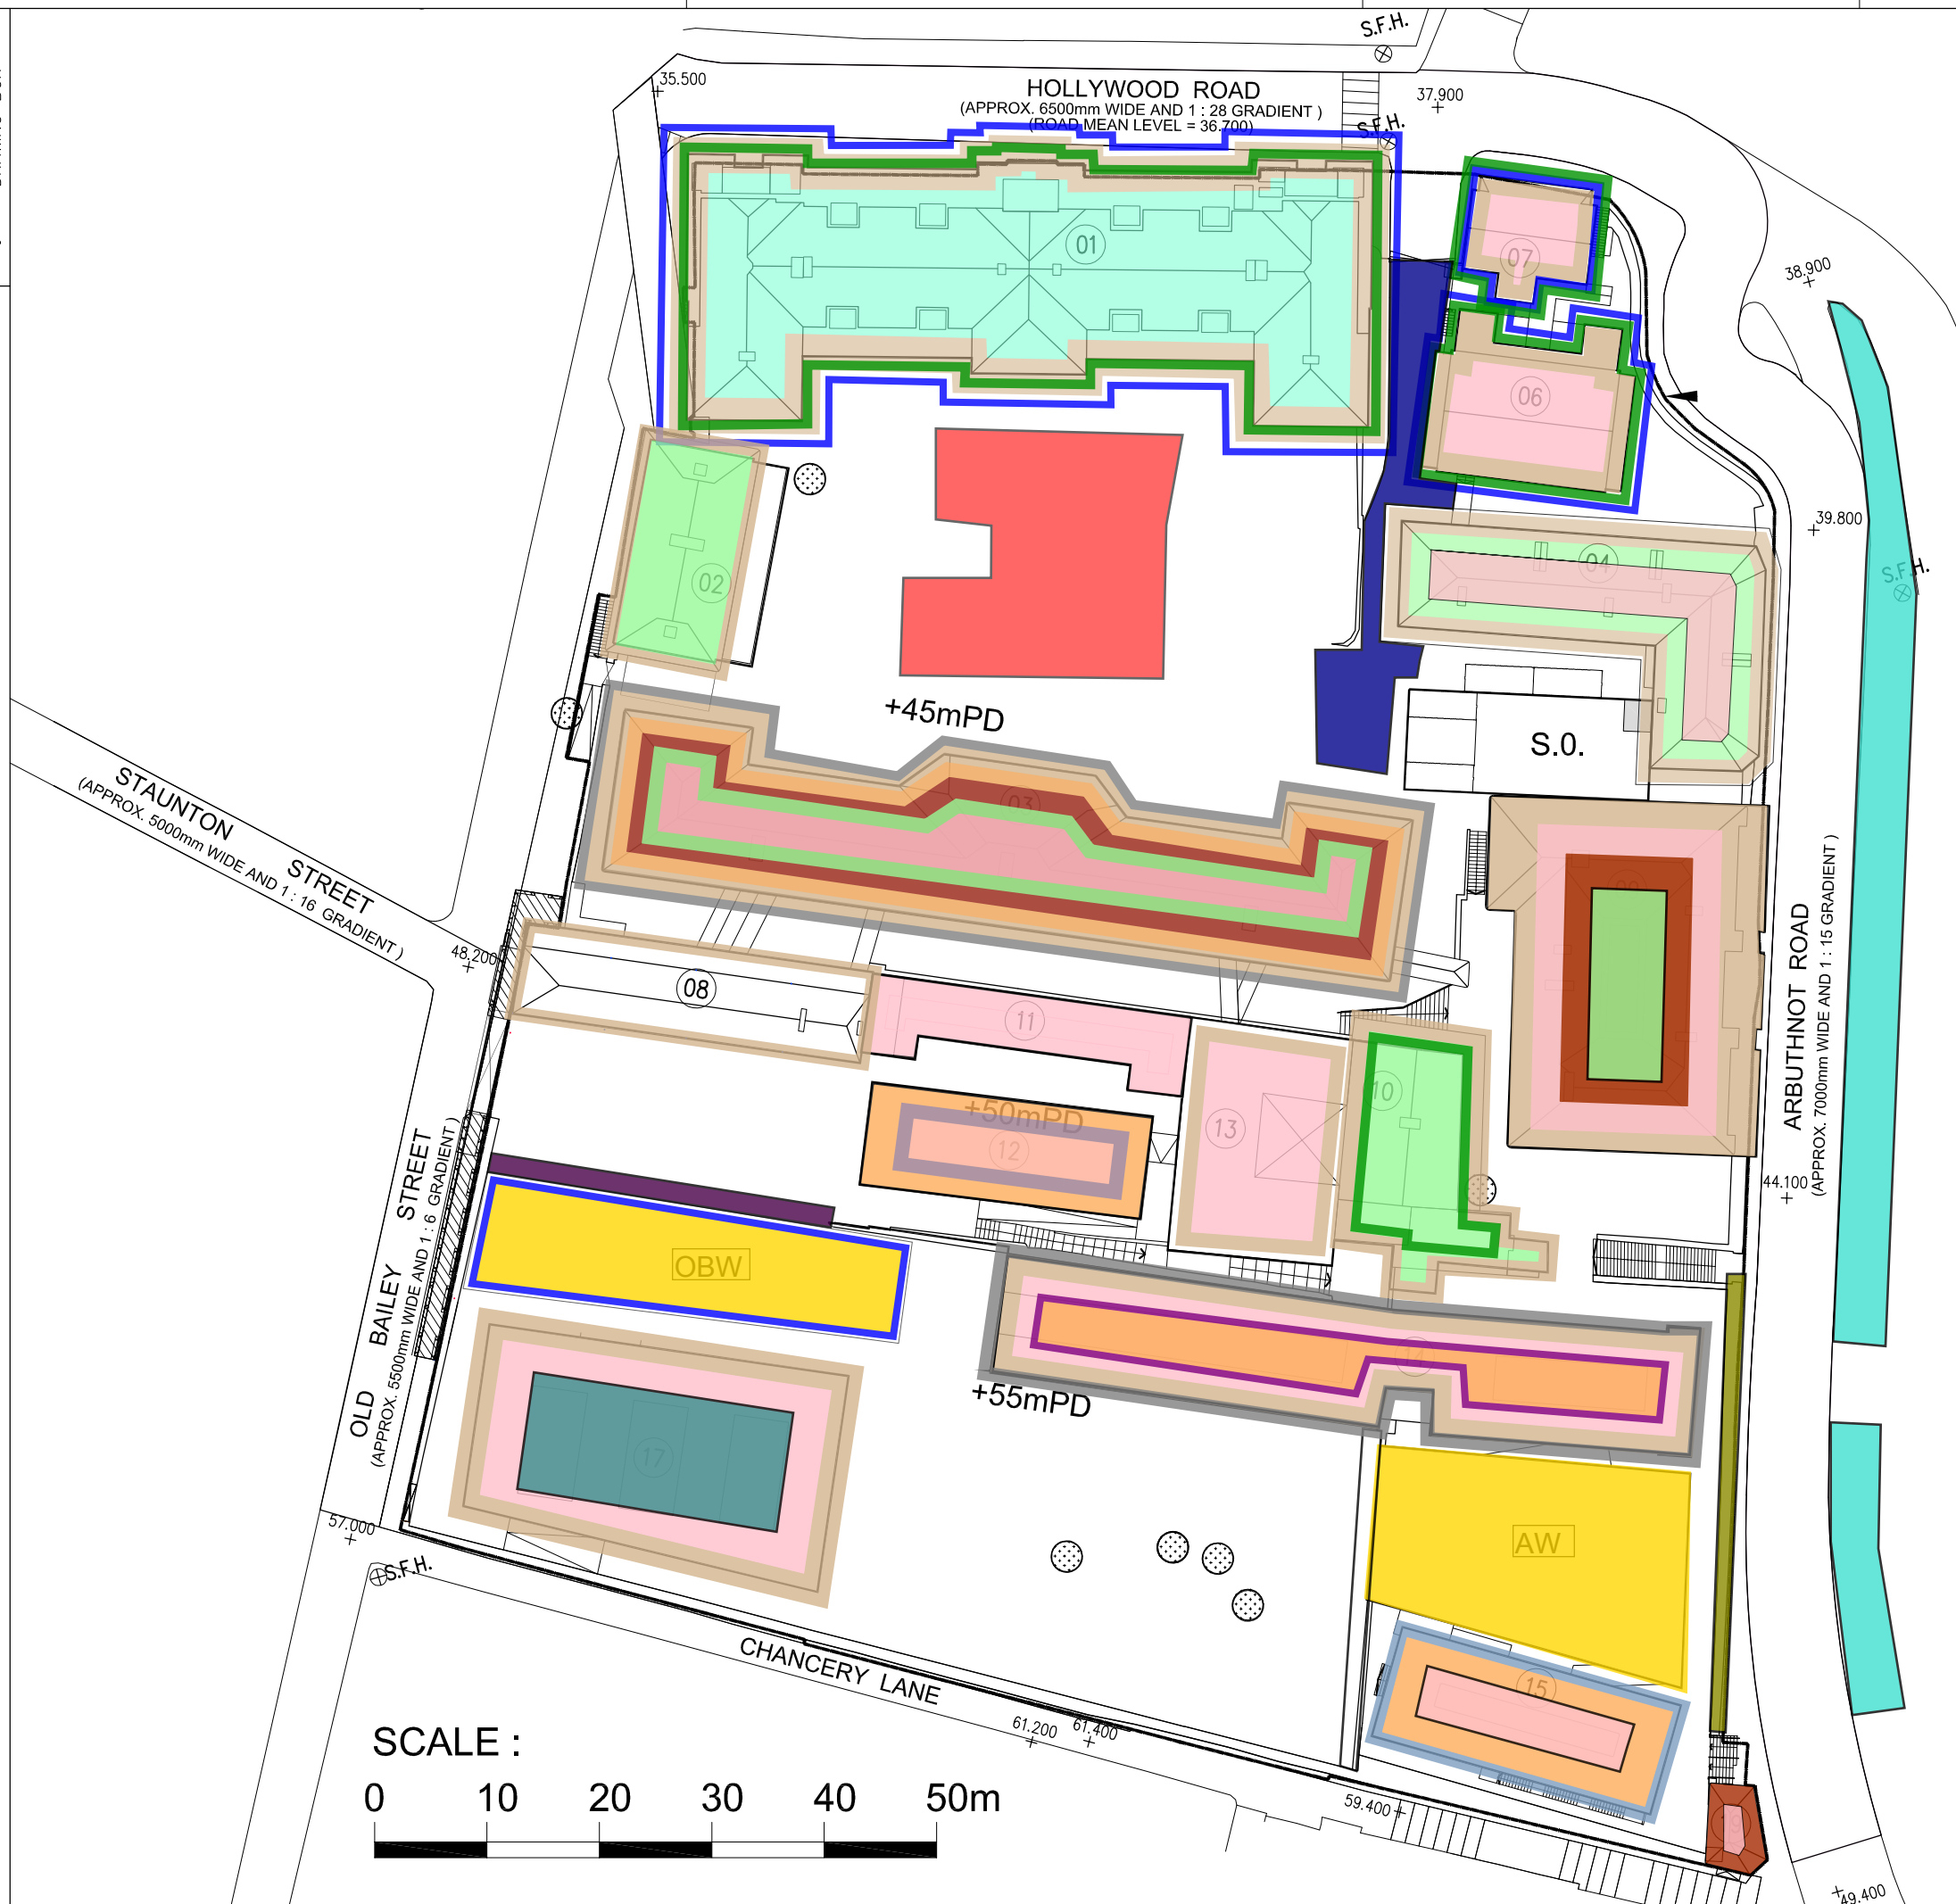
Annex A3 Site Layout Plan marked with Works (December- 2013)

- 1. E&M Installation / Opening
- 2. Removal of Non-structural Infill Wall
- 3. Basement Construction
- 4. Underpinning Works
- 5. Excavation of Pottinger Ramp
- 6. Roof Tiles Replacement Works
- 7. ELS Works
- 8. Structure A&A Works
- 9. Repair Works to Timber Window, Door and Structure Floor
- 10. Demolition Works
- 11. Facade Cleaning and Repair
- 12. New Structure Construction
- 13. Balcony Repair
- 14. Revetment Wall Strengthening
- 15. Revetment Wall Salvage
- 16. Utilities Diversion Work
- 17. Drainage works
- 18. Channel Planking Work

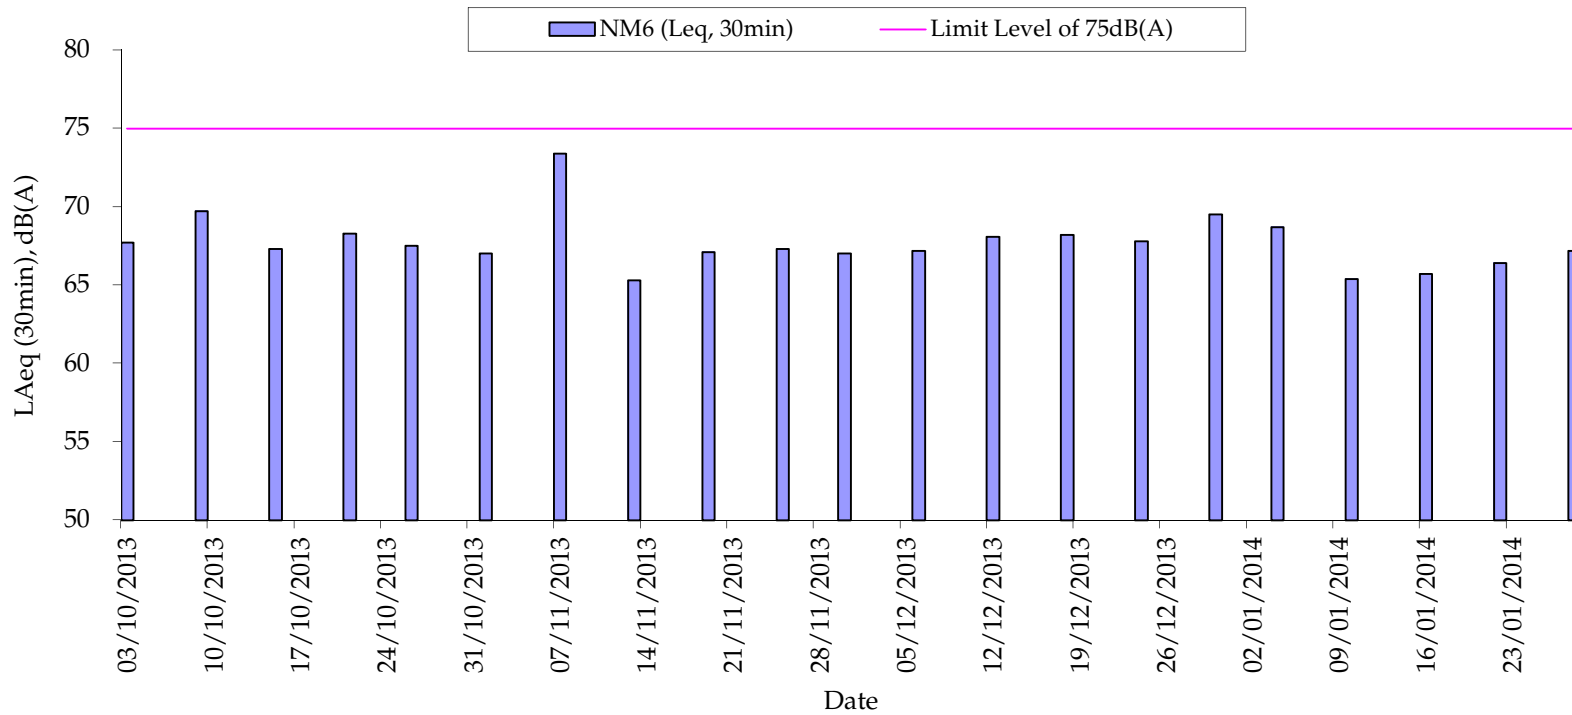
Normal Weekdays Noise Monitoring Results at NM6 - Chancery Mansion (Leq, 30min)

Remark:
- 75dB(A) was adopted as the Limit Level during normal weekdays in the reporting period

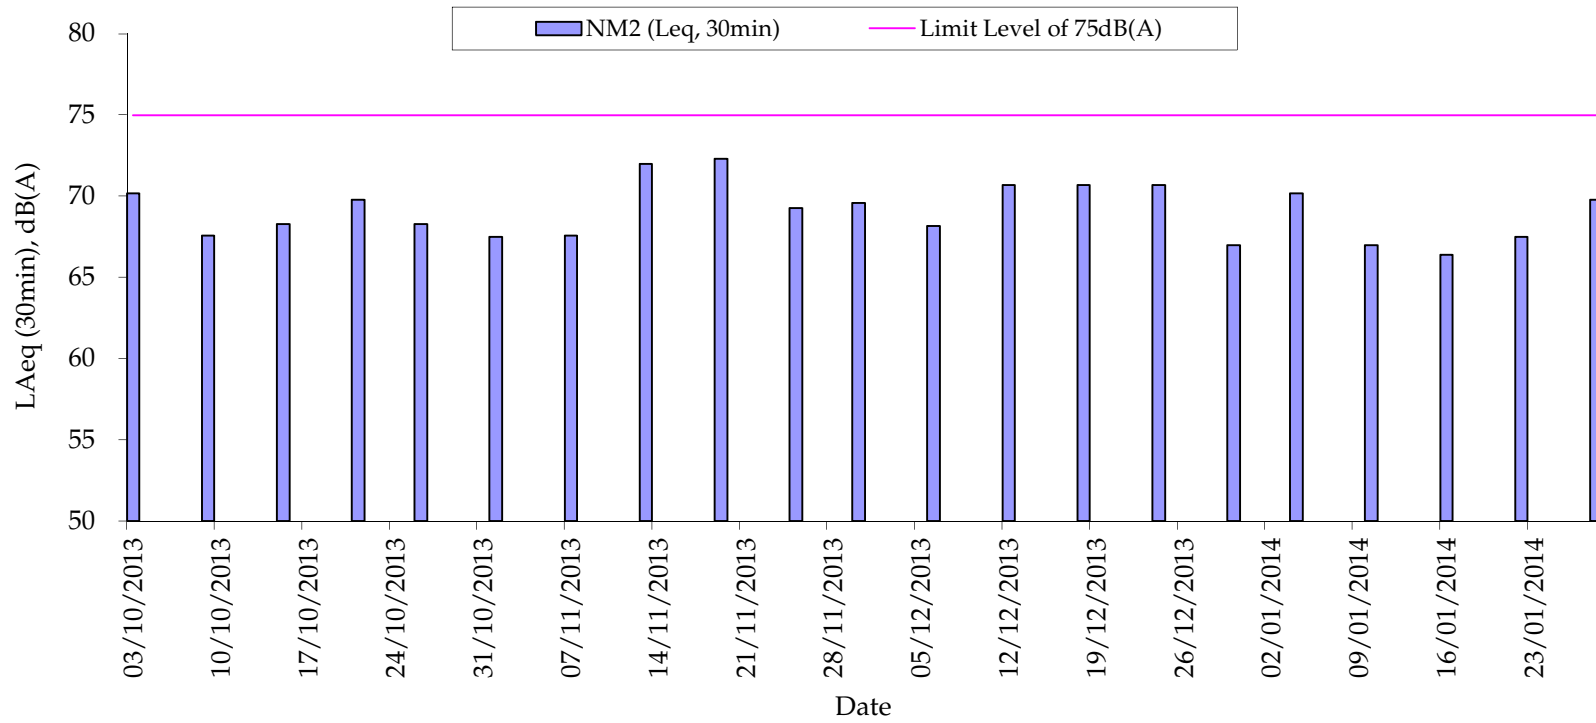
Normal Weekdays Noise Monitoring Results at NM2 - Ho Fook Building (Leq, 30min)

Remark:
- 75dB(A) was adopted as the Limit Level during normal weekdays in the reporting period

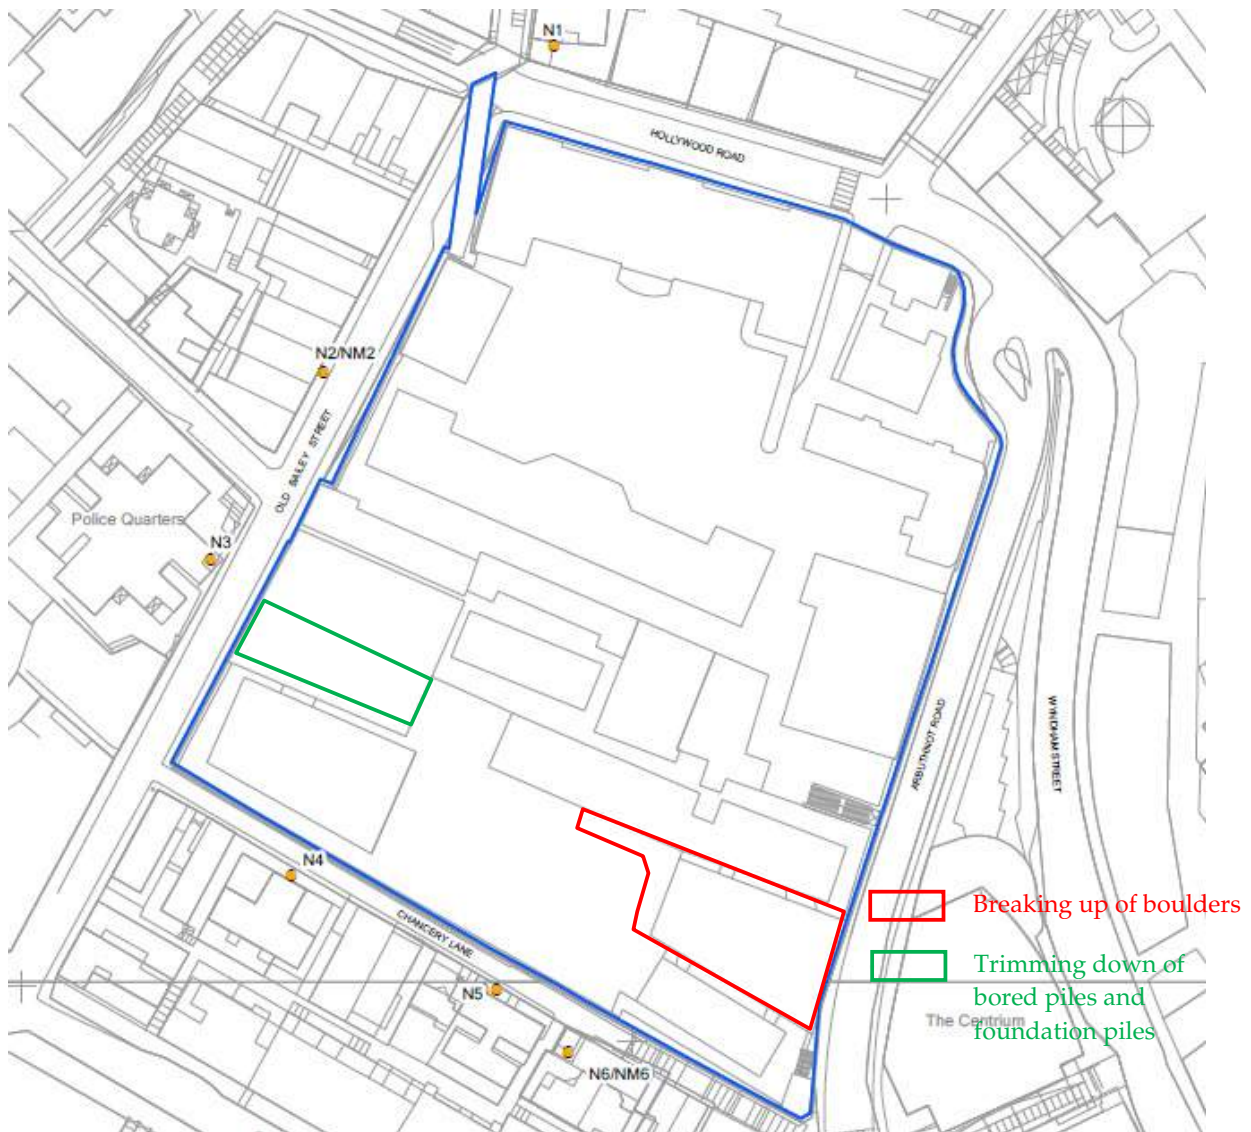
3. According to the requirement of the Environmental Permit (EP) of the Project, regular daytime noise monitoring at designated noise monitoring stations (NM2 and NM6) should be conducted and the monitoring results showed compliance with the construction noise standard. The designated noise monitoring stations are shown in the figure below.

Further to the findings of investigation, the noise generated from the construction activities complies with the noise criteria and the works are carried out strictly following the necessary requirements specified in EIA, EM&A Manual, EMP, Method Statements, General and Particular Specifications of this Project. The Contractor will continue to follow these requirements. On 17 January 2014, the Contractor has notified all workers and operation supervisor of the complaint and reminded them to minimise the potential noise generated as much as possible during any work activities. In particular, the Contractor has been reminded to provide acoustic curtain, where applicable, to the handheld mechanical equipment and properly install noise barriers during major construction activities in the future.

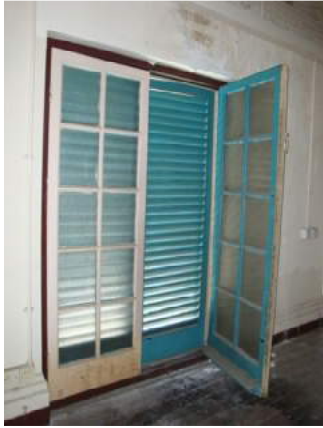
Element no.	Description	Photo ref	Significance	Proposal	Mitigation	Impact
01.007	External shutters

High	Reinstate to match existing pattern	Not applicable	High
01.008	External terraces at 1/F

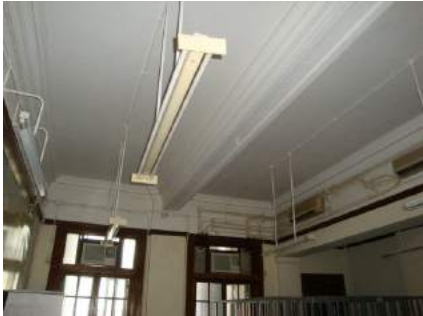
Element no.	Description	Photo ref	Significance	Proposal	Mitigation	Impact
01.009	Plaster ceilings on GF and LG1

Moderate	Install cloud ceilings to accommodate new services	Install fixed grid to minimise damage to ceiling	High
01.010	Timber door frames and architraves

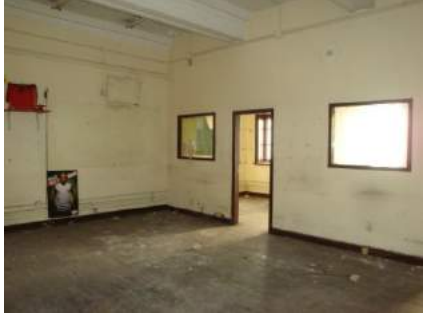
Element no.	Description	Photo ref	Significance	Proposal	Mitigation	Impact
01.011	Concrete floor

Low	Replace where new kitchens and plant rooms to be installed	Carefully remove and retain existing floorboards for re-use. Ensure controlled demolition of concrete structure and removal of debris from building to avoid damage to adjacent surfaces. Protect or carefully remove and set aside adjacent elements such as skirting boards	Low

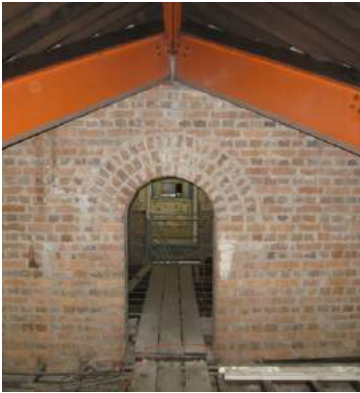
Element no.	Description	Photo ref	Significance	Proposal	Mitigation	Impact
01.032	Arched opening in brick wall above ceiling line

Low	Retain insitu and use to pass through future services. Infill only where opening is within a fire compartment	Use non-combustible material to block opening.	Low

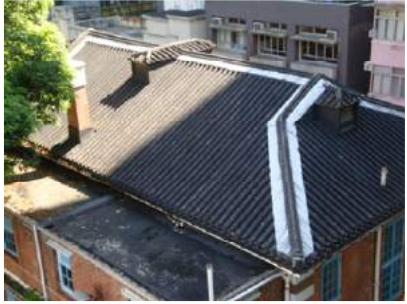
Element no.	Description	Photo ref.	Significance	Proposal	Mitigation	Impact
02.010	Pitched roofs

High	New penetrations through roofs for ventilation ducts and other services	Arrange new penetrations so that they conform with the geometry of the existing roof. Model the size and shape of the new ducts to reduce impact. Finish ducts in a non-reflective material that is neutral in colour and mid-tone.	High
02.011	Roof structure and tiled soffit

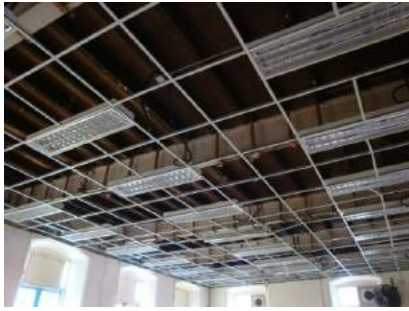
Element no.	Description	Photo ref.	Significance	Proposal	Mitigation	Impact
03.001	Lay-in grid suspended ceiling

Adverse	Remove	Not applicable	High

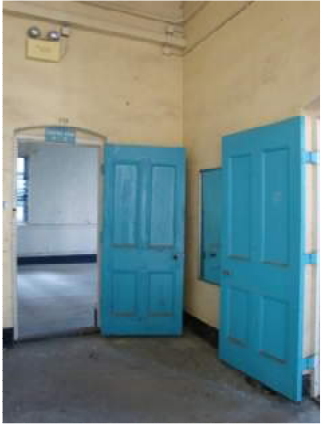
Element no.	Description	Photo ref.	Significance	Proposal	Mitigation	Impact
3.002	Panelled doors

Moderate	Replace where necessary to achieve fire resistance to comply with Code	Re-use where possible. Record design on survey drawings where item cannot be re-used.	Moderate

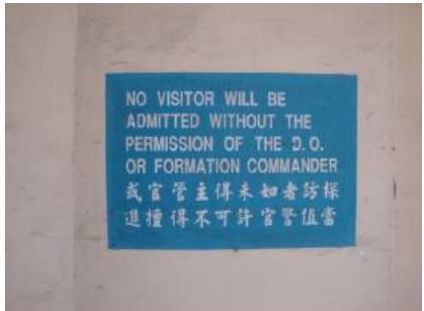
Element no.	Description	Photo ref.	Significance	Proposal	Mitigation	Impact
03.014	Painted signs

High	Protect in situ	Not applicable	N/A
03.015	Fixed signs

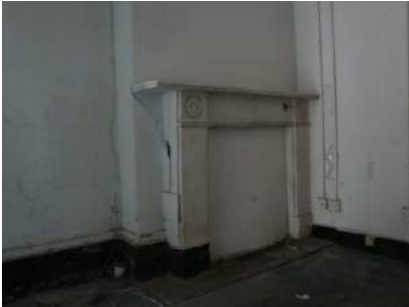
Element no.	Description	Photo ref.	Significance	Proposal	Mitigation	Impact
03.025	Chimneypiece on Ground Floor

Low	Repair and retain in current location	Not applicable	Neutral
03.026	Window in south wall; original dormitory space

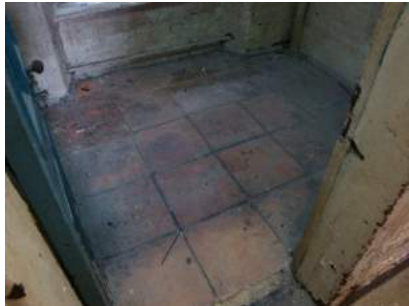
Element no.	Description	Photo ref.	Significance	Proposal	Mitigation	Impact
03.027	Clay-tiled floor in store room adjacent stairs

Low	Remove as part of re-planning of interiors	Record on measured survey drawings	Low

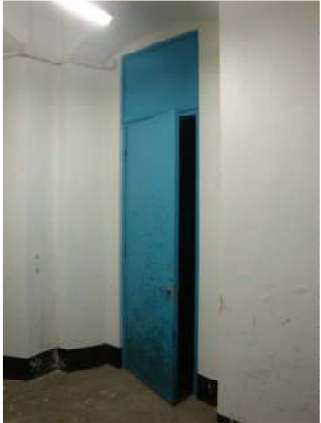
Element no.	Description	Photo ref.	Significance	Proposal	Mitigation	Impact
04.006	Block existing door openings

Moderate	Block opening as part of re-planning of interior	Retain existing door frame and architraves. Use framing and non-combustible sheet linings to block opening.	Moderate

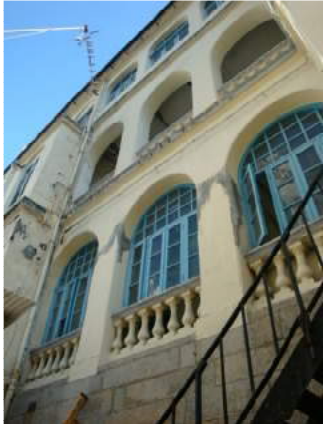
Element no.	Description	Photo ref.	Significance	Proposal	Mitigation	Impact
04.009	Window frames in arcades of North and East elevations

Adverse	Remove window frames and make good masonry reveals and reinstate verandah	Not applicable	High

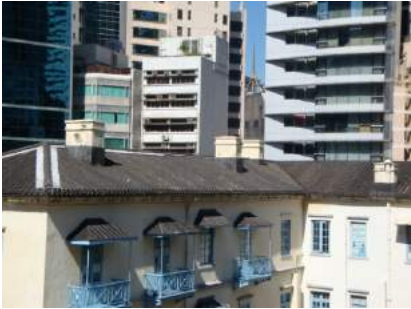
Element no.	Description	Photo ref.	Significance	Proposal	Mitigation	Impact
04.016	Pitched roofs

High	New penetrations through roofs for ventilation ducts and other services	<p>Arrange new penetrations so that they conform with the geometry of the existing roof.</p> <p>Model the size and shape of the new ducts so that the impact on the roofscape is minimised.</p> <p>Finish the new ducts in a non-reflective material that is neutral in colour.</p>	High

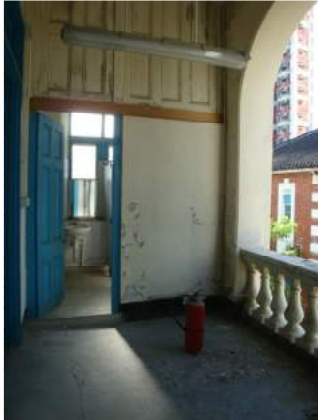
Element no.	Description	Photo ref.	Significance	Proposal	Mitigation	Impact
04.017	Toilets at ends of verandahs

Adverse	Remove and make good finishes	Not applicable	High

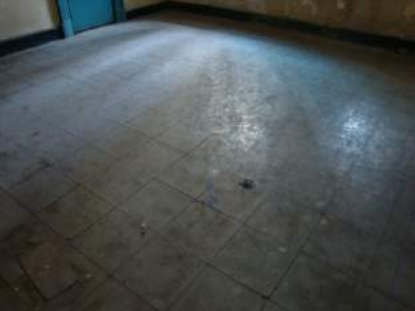
High	Retain all boarded floors and skirtings	Reinstate floor boards and skirtings after fire proofing works	Low
06.016	Vinyl tile floor

Adverse	Remove tiles; renew boarded floor boards if necessary	Not applicable	Moderate

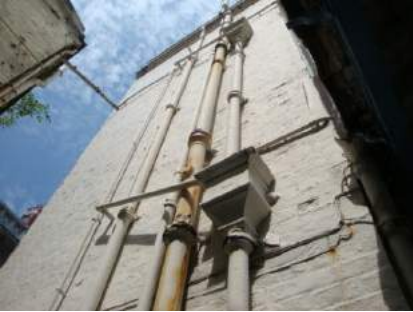
High	New penetrations through roofs for ventilation ducts and other services	<p>Arrange new penetrations so that they conform with the geometry of the existing roof.</p> <p>Model the size and shape of the new ducts so that the impact on the roofscape is minimised.</p> <p>Finish the new ducts in a non-reflective material that is neutral in colour and mid-tone.</p>	High
07.002	Rainwater goods

Adverse	Replace with cast iron in pattern to match original and in correct locations	No applicable	High

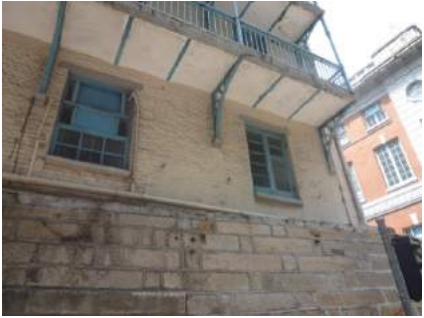
Element no.	Description	Photo ref.	Significance	Proposal	Mitigation	Impact
07.003	Exterior decorations

Adverse	Strip off and redecorate	Sample and analyse existing paint media; select new media to suit substrate and significance	High
07.004	Altered doors and windows

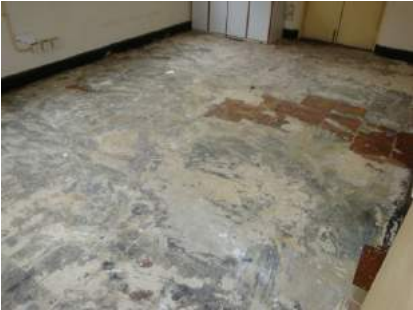
Element no.	Description	Photo ref.	Significance	Proposal	Mitigation	Impact
07.010	Plywood floor

Adverse	Replace with hardwood floor boards	Not applicable	High
07.011	Timber thresholds at external doors and internal doors between main corridor and individual rooms

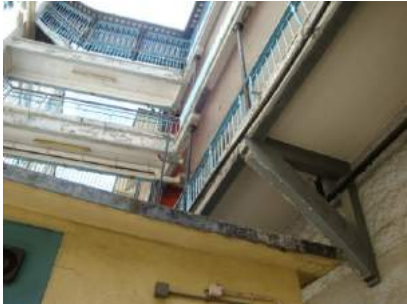
Element no.	Description	Photo ref.	Significance	Proposal	Mitigation	Impact
					clashes.	
08.011	Cantilever balconies on north side

Moderate	Repair and retain insitu	Not applicable

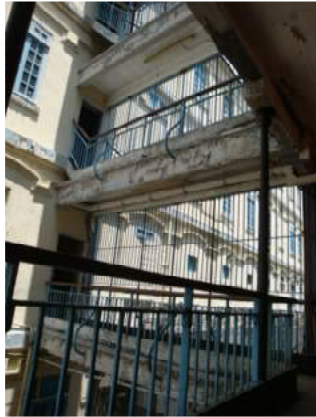
Element no.	Description	Photo ref.	Significance	Proposal	Mitigation	Impact
08.012	Bridge access to Barrack Block

Moderate	Retain	<p>Repair as necessary.</p> <p>Alter balustrade to achieve reasonable level of operational safety.</p> <p>Restrict access to repairs and maintenance and means of escape.</p>	Low
08.013	Balcony balustrades

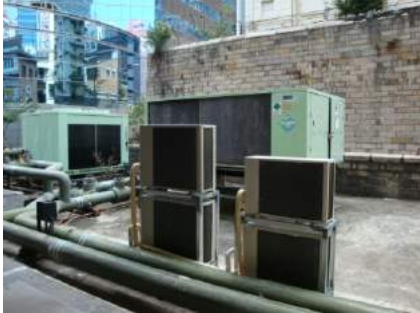
Element no.	Description	Photo ref.	Significance	Proposal	Mitigation	Impact
09.010	External airconditioning units and other external services

Adverse	Remove and make good brickwork	Not applicable	High
09.011	Pitched roofs

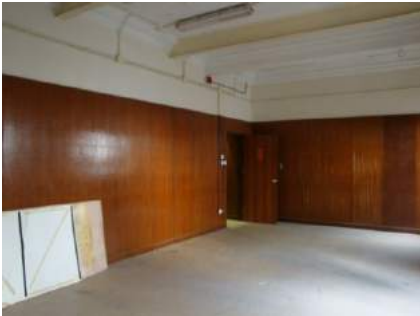
Element no.	Description	Photo ref.	Significance	Proposal	Mitigation	Impact
09.020	Meeting room at G/02-05

Moderate	Remove timber panelling from walls and sub divide to form new toilets and lift shaft	Record existing wall linings, and any earlier lining behind, on measured survey drawings.	Moderate
09.021	Lobbies within entrance hall G/12

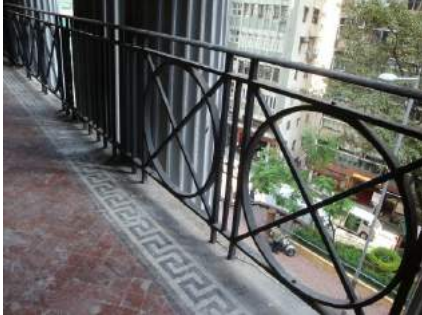
Element no.	Description	Photo ref.	Significance	Proposal	Mitigation	Impact
09.026	Iron gates at top of external stair	 	Moderate	Retain	No applicable	Neutral
09.027	Iron balustrade adjacent terrace at First Floor east side

High	Retain; install structural glass balustrade inboard of ironwork to provide compliance with Building Codes	Avoid penetration of existing tiled pavement when fixing glass balustrade.	Low

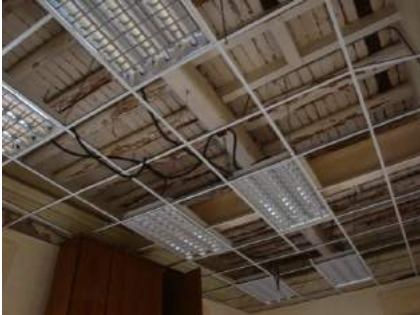
Element no.	Description	Photo ref.	Significance	Proposal	Mitigation	Impact
10.001	Lay-in grid suspended ceiling

Adverse	Remove	Not applicable	High
10.002	Plaster box cornice

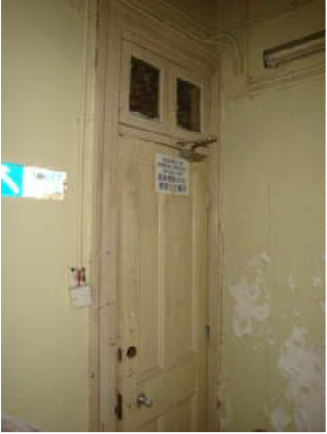
Element no.	Description	Photo ref.	Significance	Proposal	Mitigation	Impact
10.003	Panelled doors and linings

Moderate	Replace where necessary to achieve fire resistance to comply with Code	Re-use where possible. Record design on survey drawings where element cannot be re-used.	Moderate

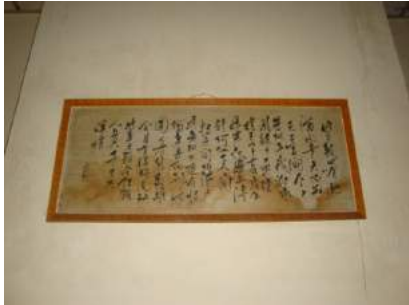
Element no.	Description	Photo ref.	Significance	Proposal	Mitigation	Impact
10.011	Fixed signs

Low-High	Remove and refix/display in visitors' centre/discard	Record each sign and assess significance individually and treat accordingly	N/A
10.012	Pitched roofs

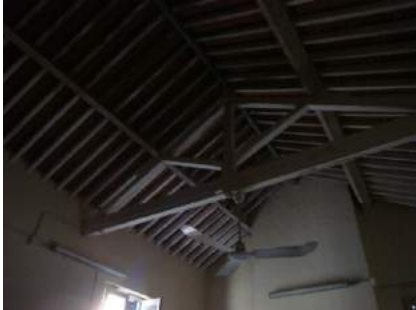
Element no.	Description	Photo ref.	Significance	Proposal	Mitigation	Impact
10.018	Timber roof structure above south-east wing

Moderate	Repair as necessary and retain	Avoid intrusive alteration. Retain open appearance/	Low
10.019	Timber stair

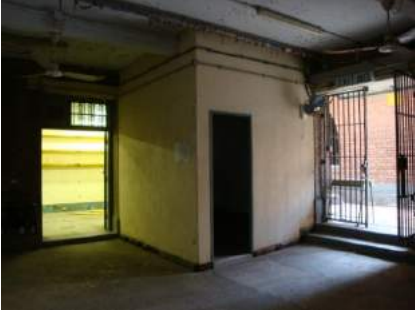
Element no.	Description	Photo ref.	Significance	Proposal	Mitigation	Impact
13.007	Internal partition walls

Low	Remove as part of re-planning of interiors	Record on measured survey drawings	Low
13.008	Fixed signs

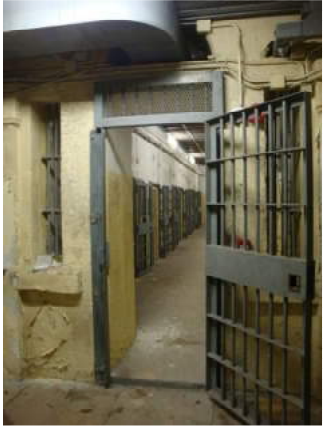
Element no.	Description	Photo ref.	Significance	Proposal	Mitigation	Impact
14.001	West entrance at Lower Ground Floor

Moderate	Retain as public entrance at this level.	<p>Retain security gate and granite threshold.</p> <p>Adjust adjacent ground level as necessary to achieve barrier-free access.</p> <p>Pin gate back against adjacent wall in the open position if necessary.</p>	Low

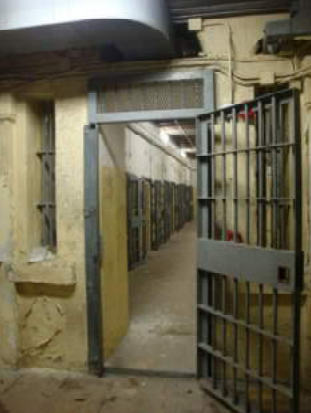
Element no.	Description	Photo ref.	Significance	Proposal	Mitigation	Impact
14.002	Half-round headed doorway and side lights

Moderate	Retain	Remove air duct and make good masonry above arch.	Low

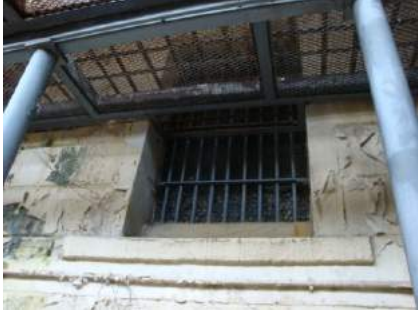
Element no.	Description	Photo ref.	Significance	Proposal	Mitigation	Impact
14.007	Part-blocked windows at Lower Ground Floor - extent of blocking varies.

Moderate	Open up window opening to full extent.	Record existing condition on measured survey drawings. Add further detail during demolition works.	Low
14.008	External granite stair from Lower Ground to Ground Floor level

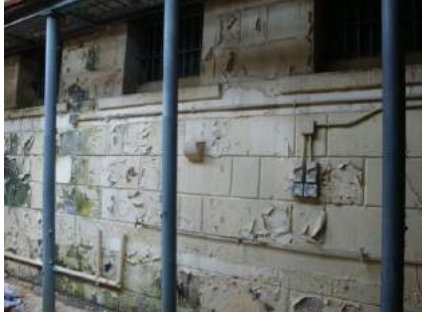
Element no.	Description	Photo ref.	Significance	Proposal	Mitigation	Impact
14.009	Ashlar pattern on external walls

Moderate	Form new openings for entrance/exit to building	<p>Set out new openings to cause minimum disruption to ashlar pattern.</p> <p>Record existing pattern on measured survey drawings.</p>	Low

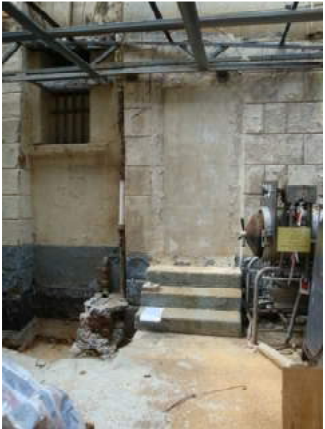
Element no.	Description	Photo ref.	Significance	Proposal	Mitigation	Impact
14.010	Blocked doorway at south-east corner

Low	Preserve blocked opening intact.	Not applicable	Neutral

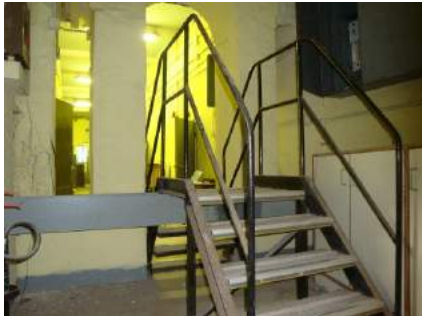
Moderate	Retain insitu	Not applicable	Neutral
14.013	Structural steelwork bracing and temporary access stair

Adverse	Remove upon completion of underpinning	Not applicable	Moderate
