The Jockey Club CPS Limited

Central Police Station Conservation
and Revitalisation Project:
Ninth Quarterly EM&A Report
(1 November 2013 to 31 January
2014)

Issue Date: February 2014

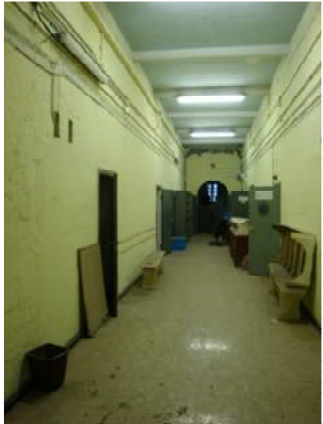
Element no.	Description	Photo ref.	Significance	Proposal	Mitigation	Impact
14.016	Cell walls at Ground Floor

Moderate	Retain insitu	<p>Use existing door openings wherever possible.</p> <p>Avoid further alteration to existing altered openings where feasible.</p>	Low

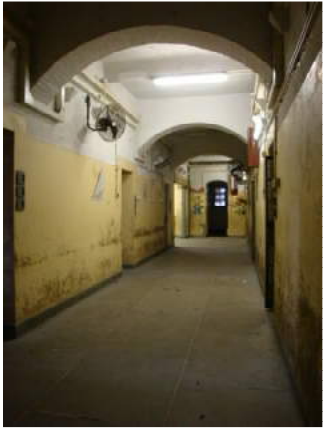
Element no.	Description	Photo ref.	Significance	Proposal	Mitigation	Impact
14.023	Arches across central hall at First Floor

Moderate	Retain insitu	Not applicable	Neutral

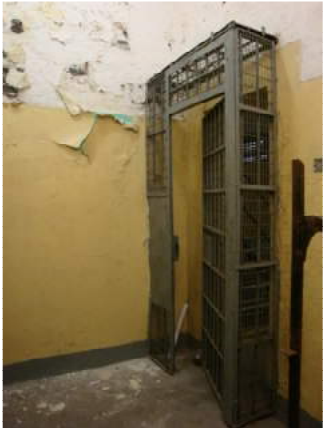
Element no.	Description	Photo ref.	Significance	Proposal	Mitigation	Impact
14.024	Inset security gate and screen in First Floor cells

Low	Remove to suit new use	Remove where necessary. Record on measured drawings.	Low

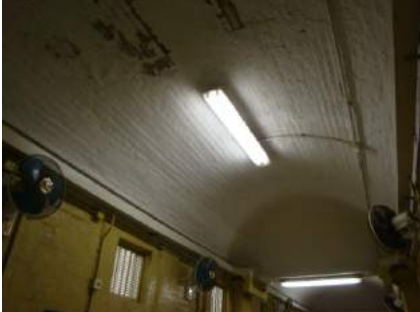
Element no.	Description	Photo ref.	Significance	Proposal	Mitigation	Impact
14.031	Brick vault over central hall at Ground Floor

High	Retain insitu	Not applicable	Neutral
14.032	Terrazzo floor in central hall at Ground floor

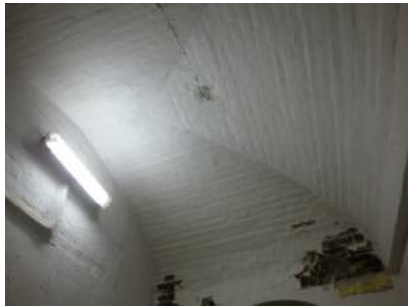
Element no.	Description	Photo ref.	Significance	Proposal	Mitigation	Impact
14.033	Brick vaults above cells

High	Retain insitu	Avoid penetrations for services	Neutral
14.034	Cell walls (later additions)

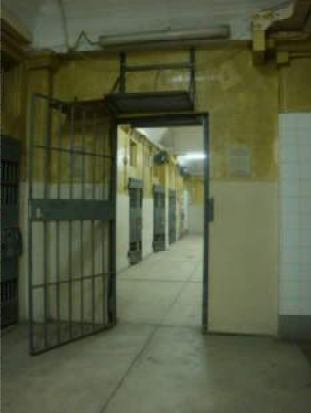
Element no.	Description	Photo ref.	Significance	Proposal	Mitigation	Impact
14.038	Partition wall across central hall at Ground Floor

Low	Remove to accommodate new cafe	Record on measured survey drawings	Low

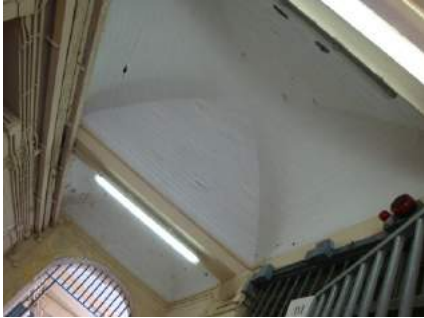
Element no.	Description	Photo ref.	Significance	Proposal	Mitigation	Impact
14.041	Brick vault over cross-passage

High	Retain insitu	Avoid any services penetrations	Neutral
14.042	Granite floor in central hall at First Floor

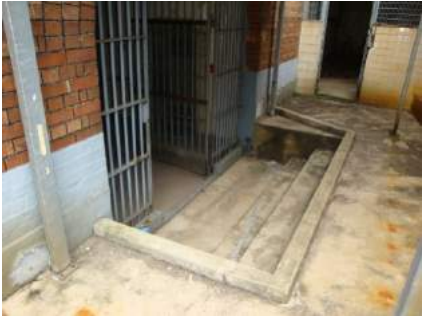
Element no.	Description	Photo ref.	Significance	Proposal	Mitigation	Impact
15.006	Raised ground level adjacent entrance

Low	Remove to enable level access	Record on measured survey drawings	Low
15.007	Access balconies and apertures

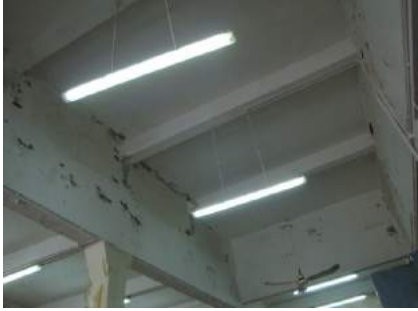
Element no.	Description	Photo ref.	Significance	Proposal	Mitigation	Impact
17.012	Blocked up lantern light

Low	Unblock lantern and fit glazing	Record on measured drawings	Low
17.013	Security gates at Ground openings

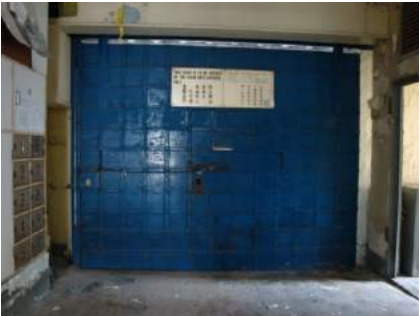
Element no.	Description	Photo ref.	Significance	Proposal	Mitigation	Impact
17.018	Blue Entrance Gate (facing Old Bailey Street)

High	Retain in situ	Maintain in working order	Neutral
17.019	Blue Entrance Gate (inner) and enclosed yard
