The Jockey Club CPS Limited

Central Police Station Conservation
and Revitalisation Project:
55th Monthly EM&A Report
(1 May to 31 May 2016)

Issue Date: June 2016

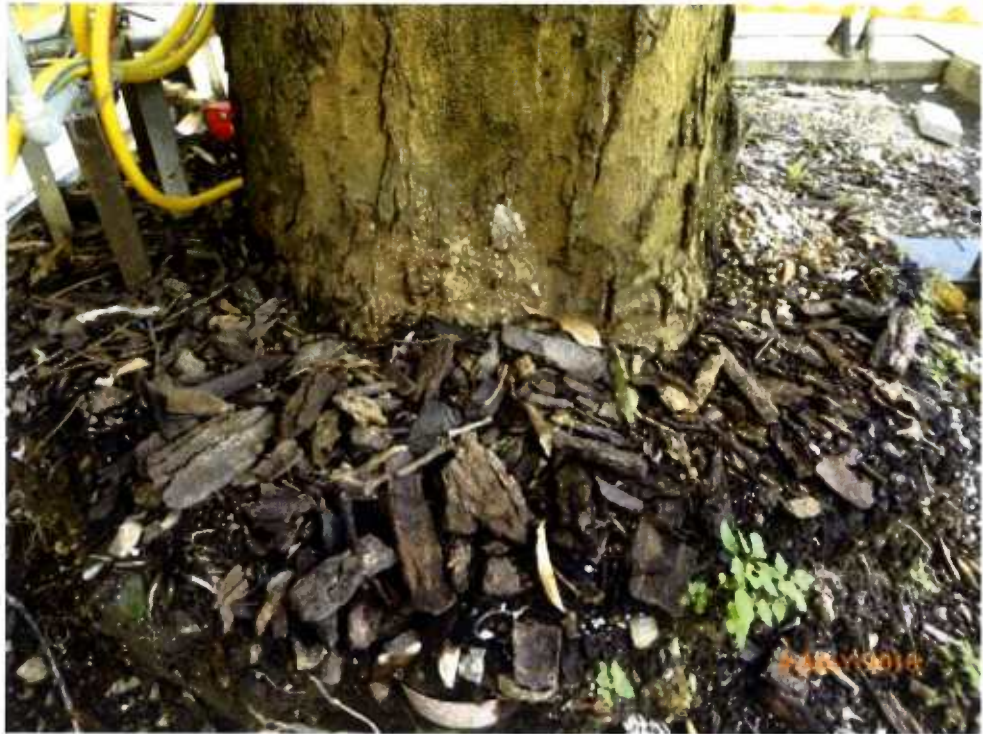
Fig. 3 Some roots have exposed at the edge of the planter. Recommend to cover the roots with Hessian Clothes.

1. **To cover the exposed roots with Hessian Clothes.**

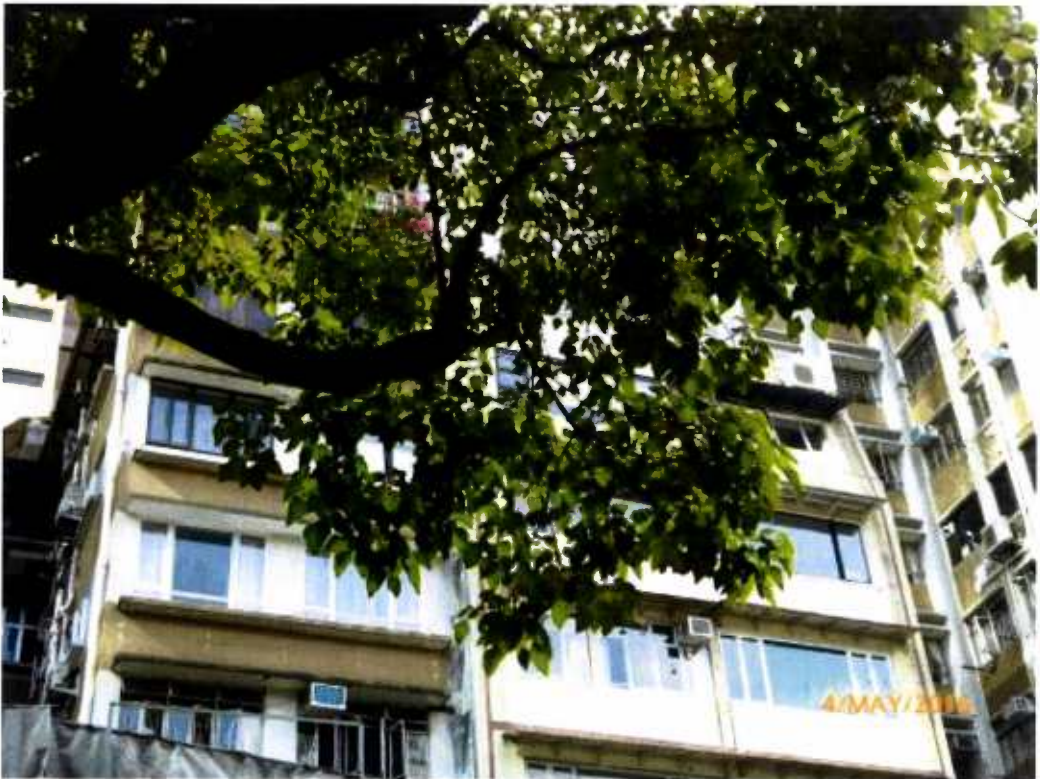
Fig. 8 Signs of Pest (Mealy Bugs 粉狀介殼蟲) have apparently reduced on the tree due to Pest Control Operation on 25th May 2016.

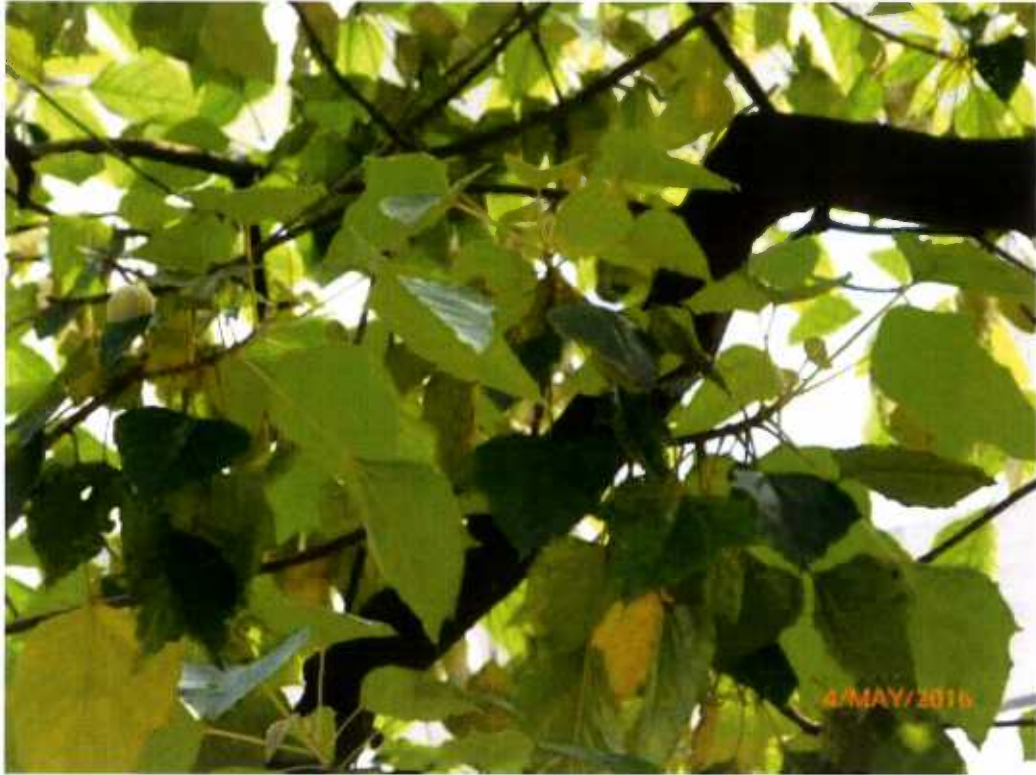
Fig. 9 Signs of Pest (Mealy Bugs 粉狀介殼蟲) are rarely found on Tree-6 due to Pest Control Operation on 25th May 2016..

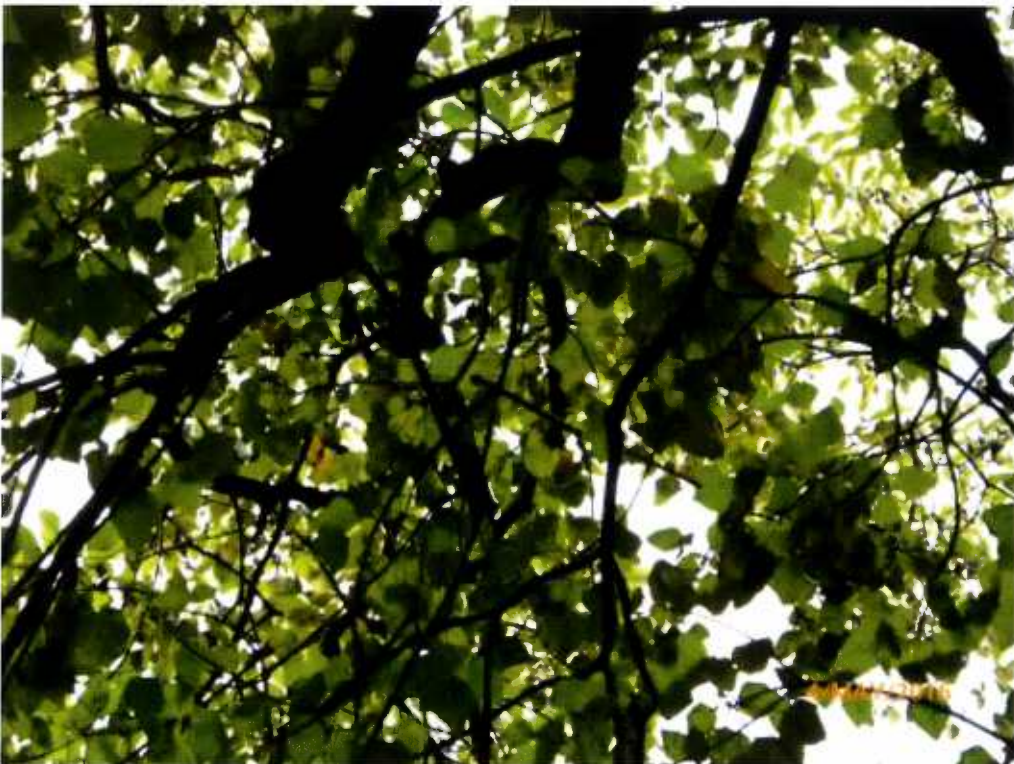
Fig. 8 Signs of Pest (Mealy Bugs 粉狀介殼蟲) have apparently reduced on Tree-7 due to Pest Control Operation on 25th May 2016.

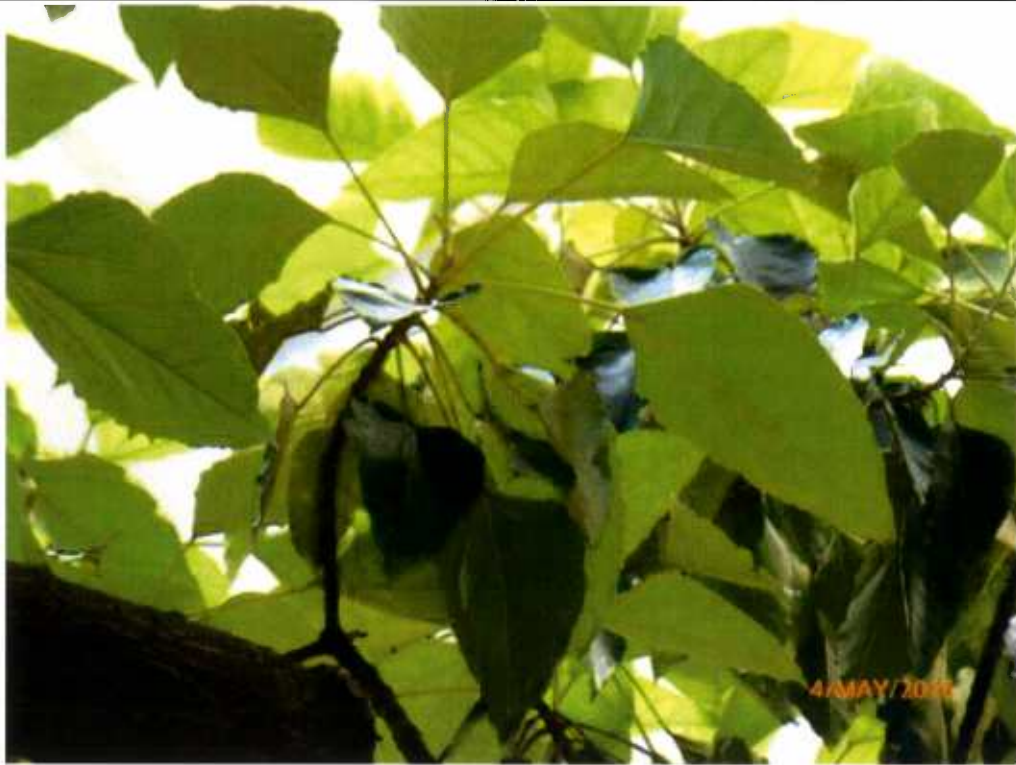
Fig. 9 Signs of Pest (Mealy Bugs 粉狀介殼蟲) are rarely found on the tree due to Pest Control Operation on 25th May 2016.

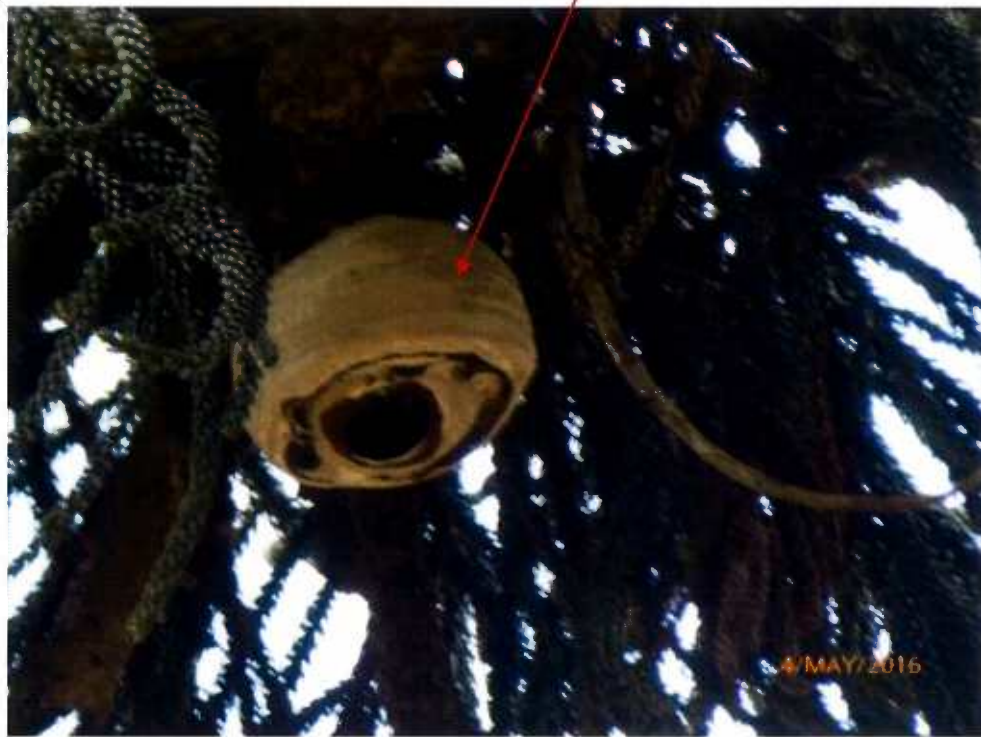
Fig. 8 A wasp-hive is found hanging on the lower branches of Tree-9.
Recommend to remove the wasp-hive as soon as possible.

1. To remove the wasp-hive away from the tree as soon as possible.

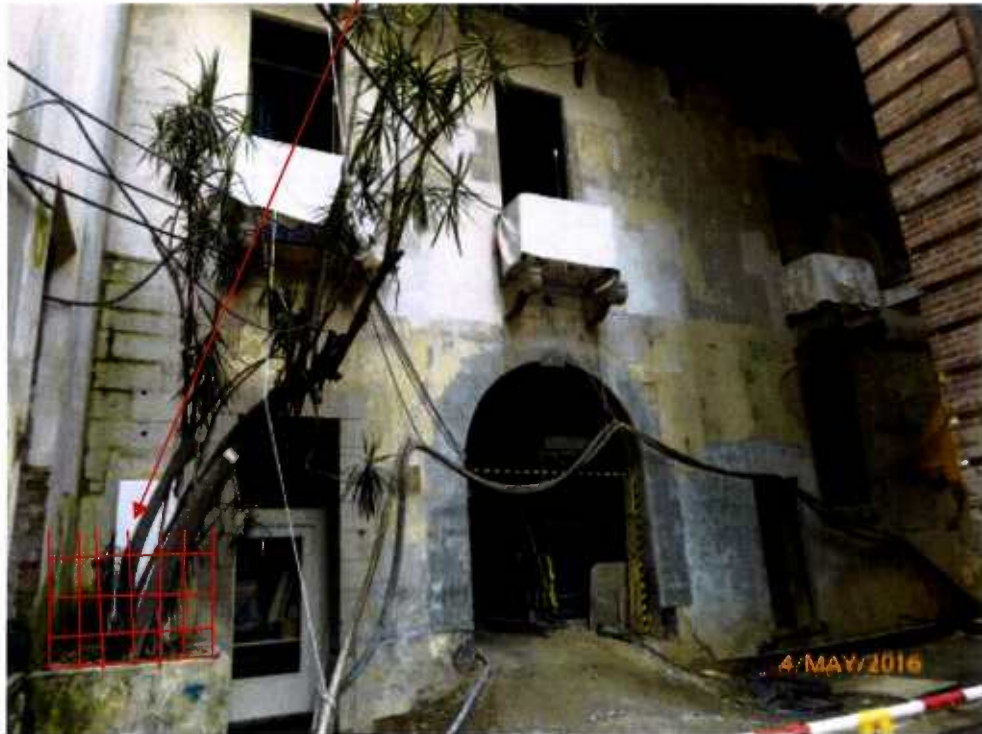
Fig. 9 Renovation works are in progress near Tree-11. Recommend to set up a small cordon zone to protect the tree.
