The Jockey Club CPS Limited

Central Police Station Conservation and Revitalisation Project:
Twenty-first Monthly EM&A Report (1 July to 31 July 2013)

Issue Date: August 2013

Reference 0095646

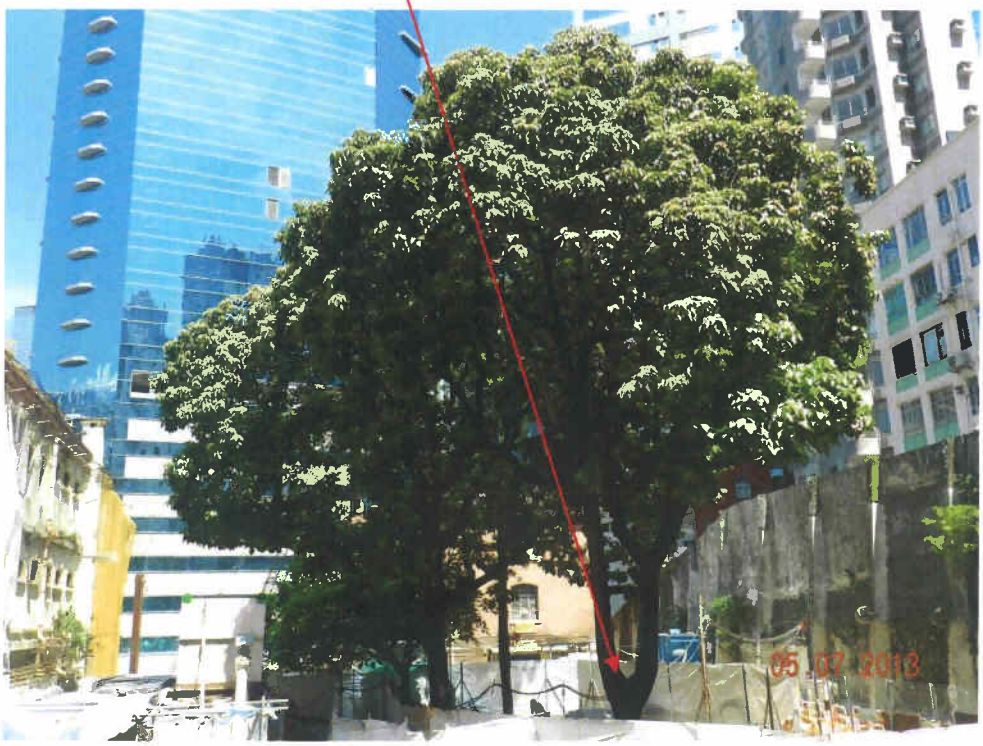
Fig. 8 Overall view of Tree-6 during inspection on 5th July 2013.

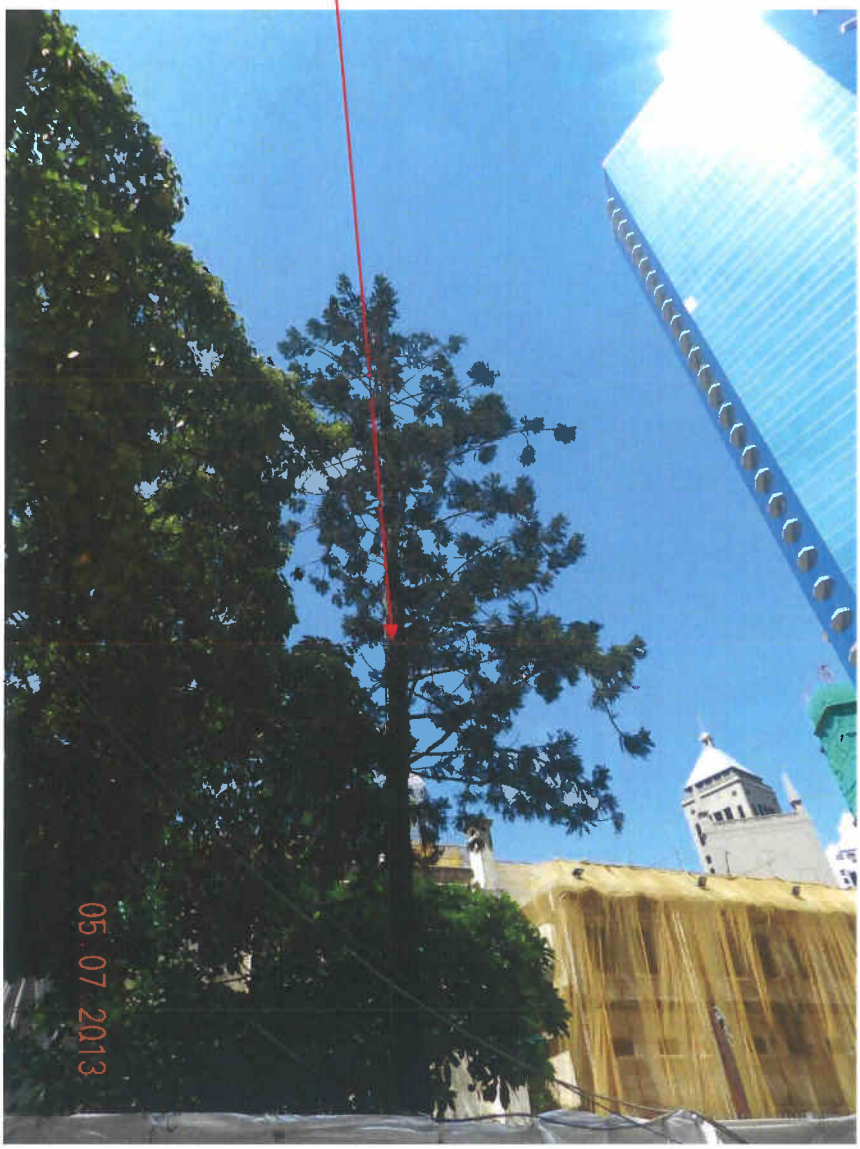
Fig. 8 Overall view of Tree-9 during inspection on 5th July 2013.

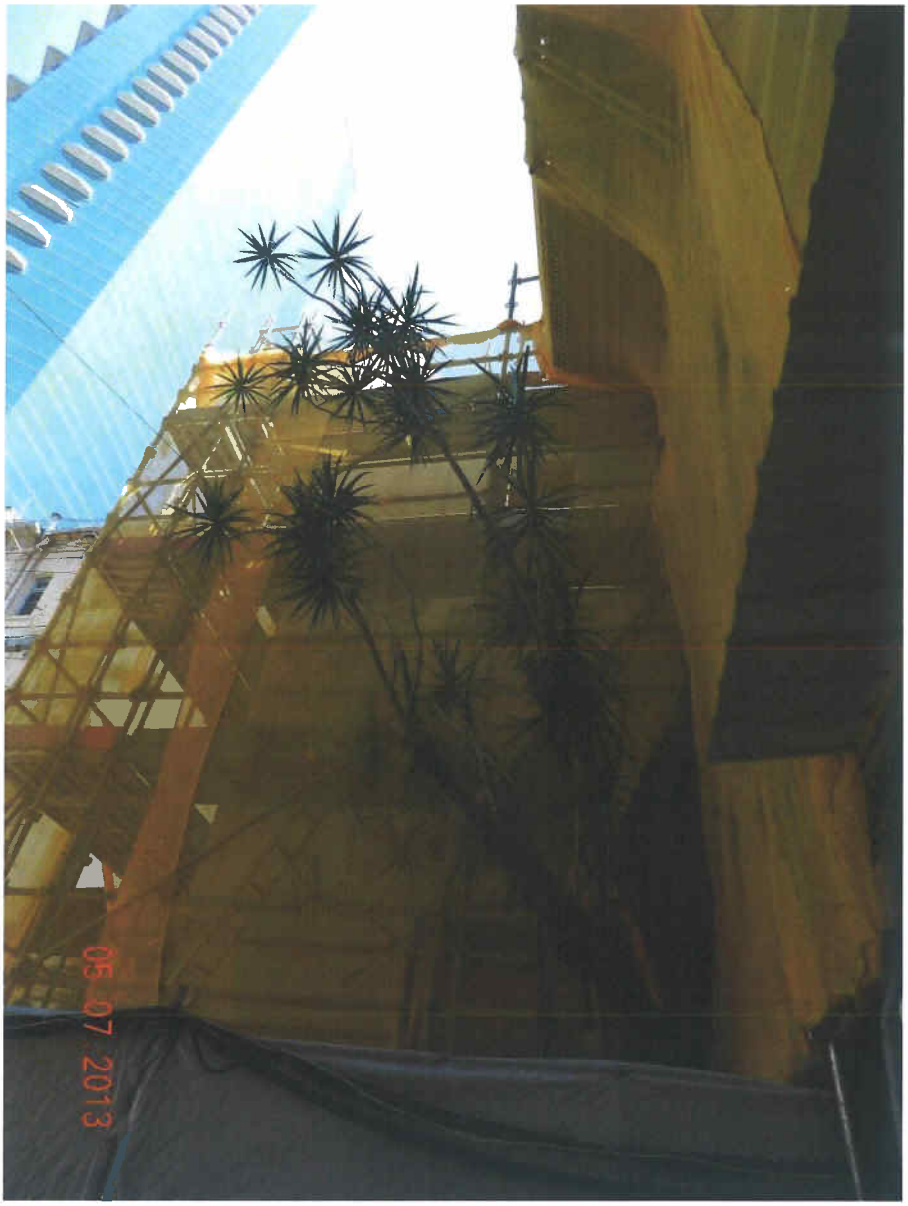
Fig. 8 Overall view of Tree-11 during inspection on 5th July 2013.
