Central Police Station Conservation
and Revitalisation Project:
77th Monthly EM&A Report
(1 March to 31 March 2018)

Issue Date: April 2018

Reference 0095646

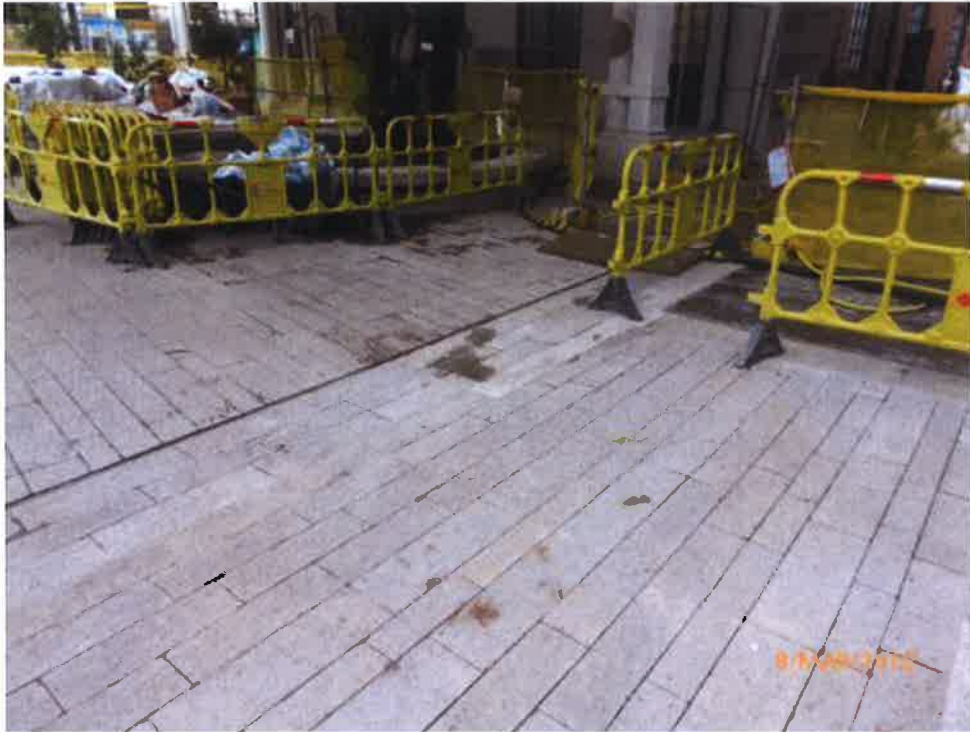
Fig. 10 The access near the planter appears clean and tidy.

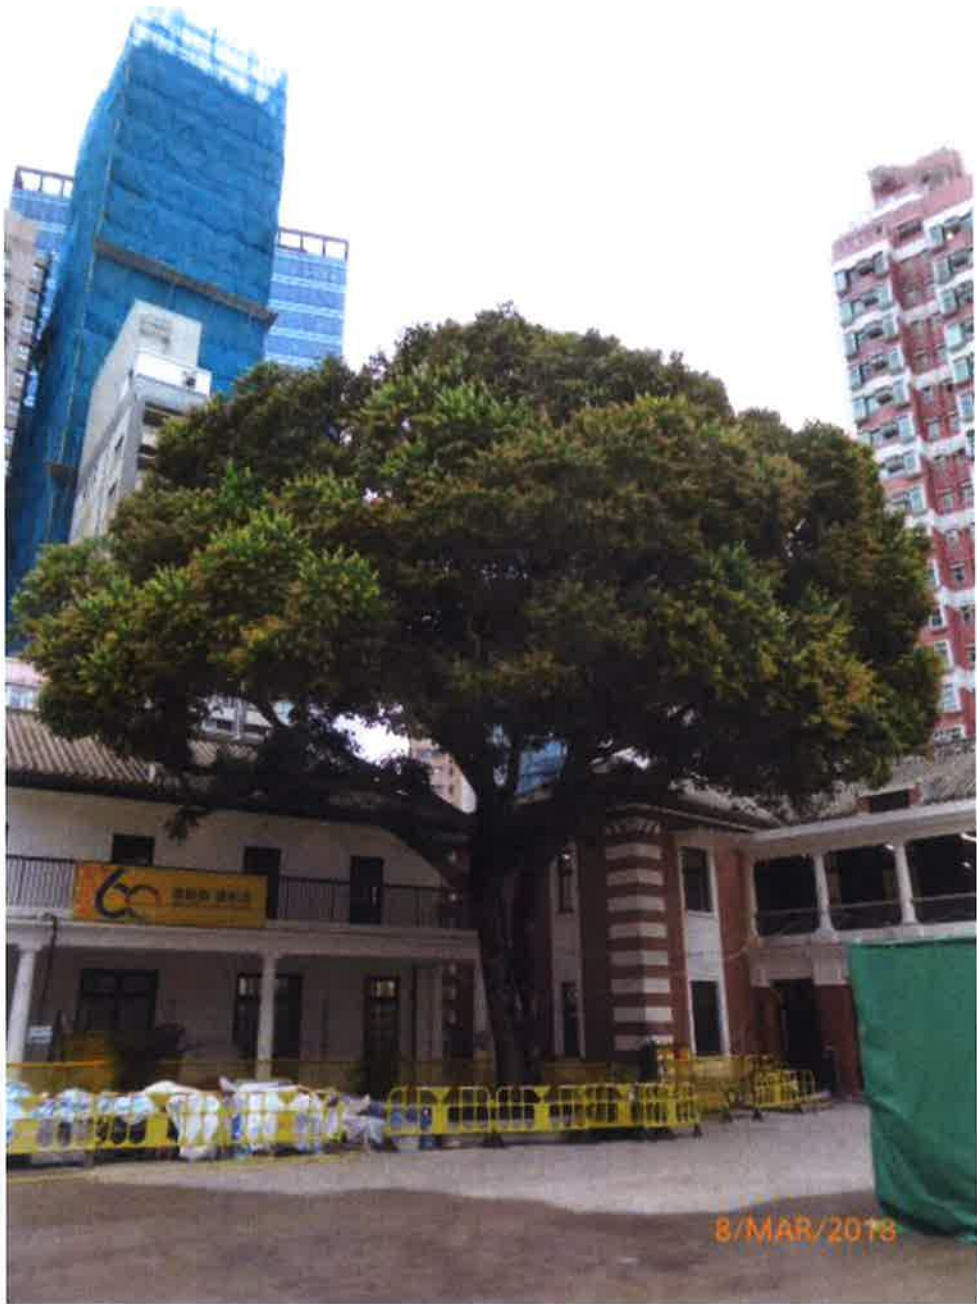
Fig. 12 Overall view of Tree-5 during inspection on 8th March 2018.
