**FINDINGS ON THE
PARTIAL COLLAPSE OF THE MARRIED
INSPECTORS QUARTERS AT
THE CENTRAL POLICE STATION
COMPOUND ON 29 MAY 2016**

Independent Review Panel

31 October 2016

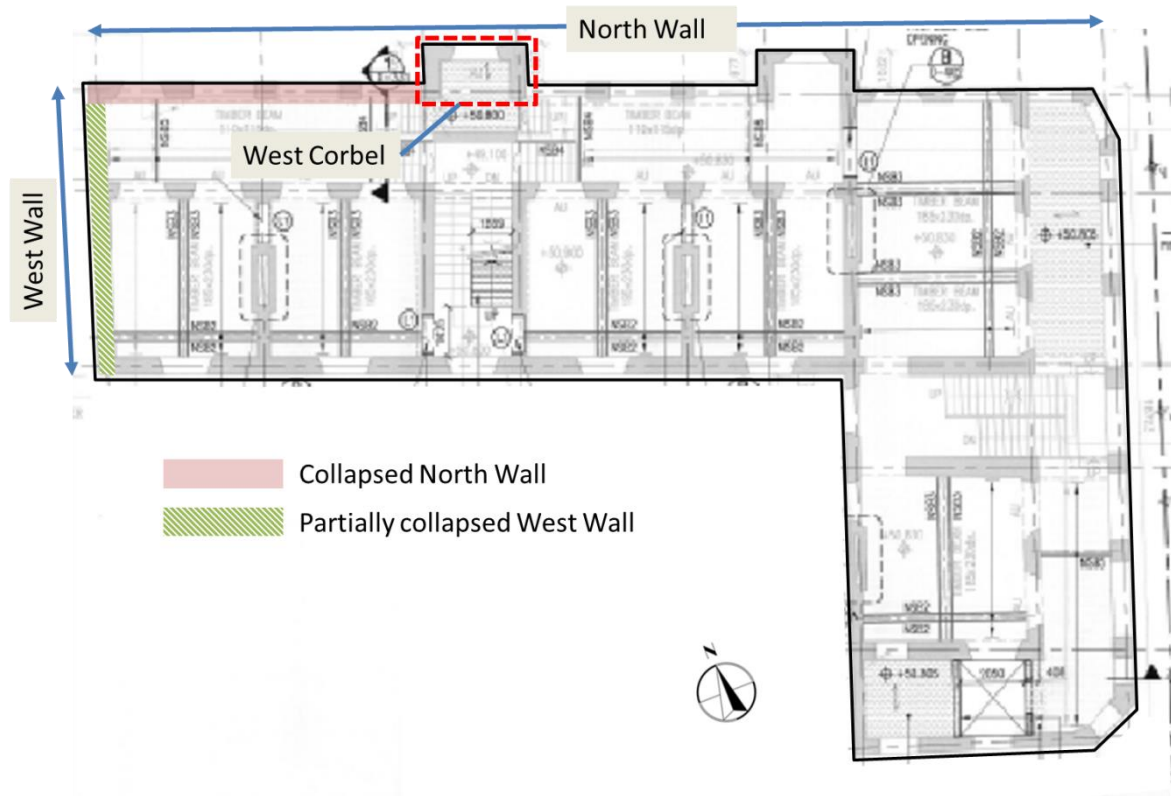
Figure 3: Layout Plan of MIQ Building

5. The Panel's view is that the three likely causes of the partial collapse are:
 - (a) In March 2016, the West Corbel was temporarily supported by steel support while excavation was carried out at its base for the purpose of installing permanent reinforcement as part of the strengthening works on the west bay window on the North Wall. The temporary steel support would have deflected as a result of carrying the weight of the West Corbel, causing settlement of the West Corbel, which in turn would have caused stress to increase in the adjacent brick columns C4 and C3 of the North Wall (see Figure 4a). Whilst the increase in the stresses in those brick
