Central Police Station Conservation
and Revitalisation Project:
63rd Monthly EM&A Report
(1 January to 31 January 2017)

Issue Date: February 2017

Environmental Resources Management

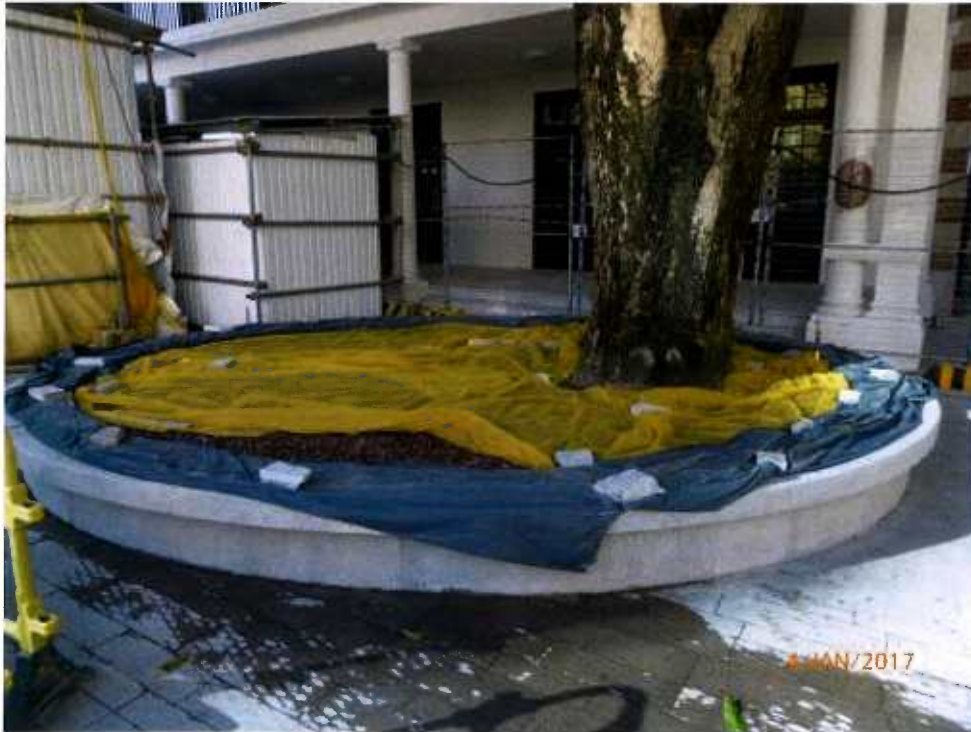
Fig. 11 Size of the mulch is too small, not up to ASD Spec. required standard.

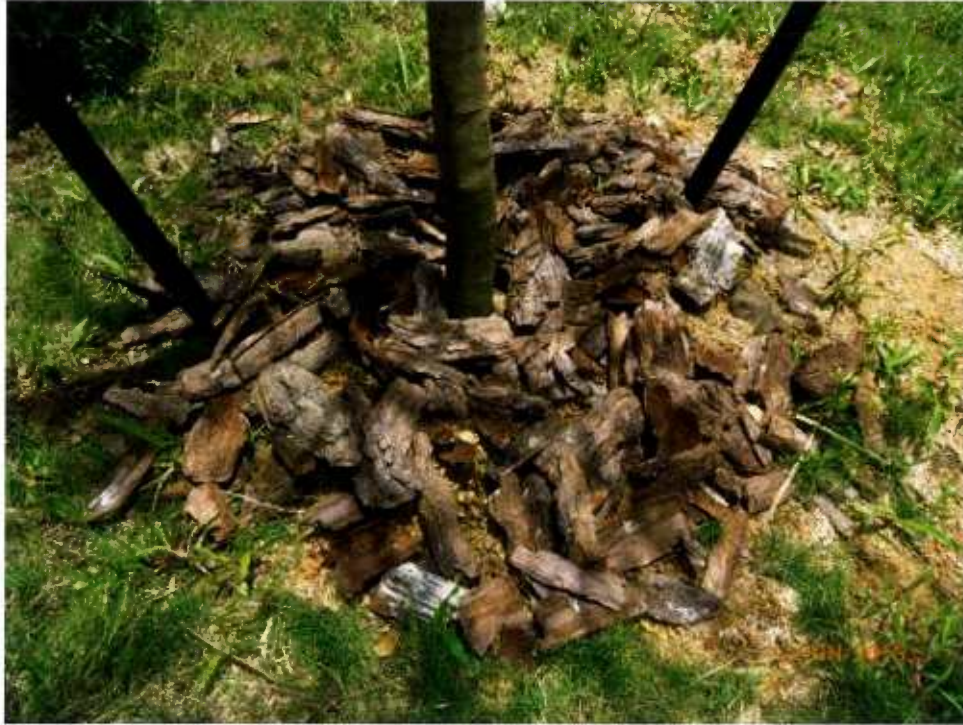
Fig. 13 The site near Tree-5 is clean and tidy.

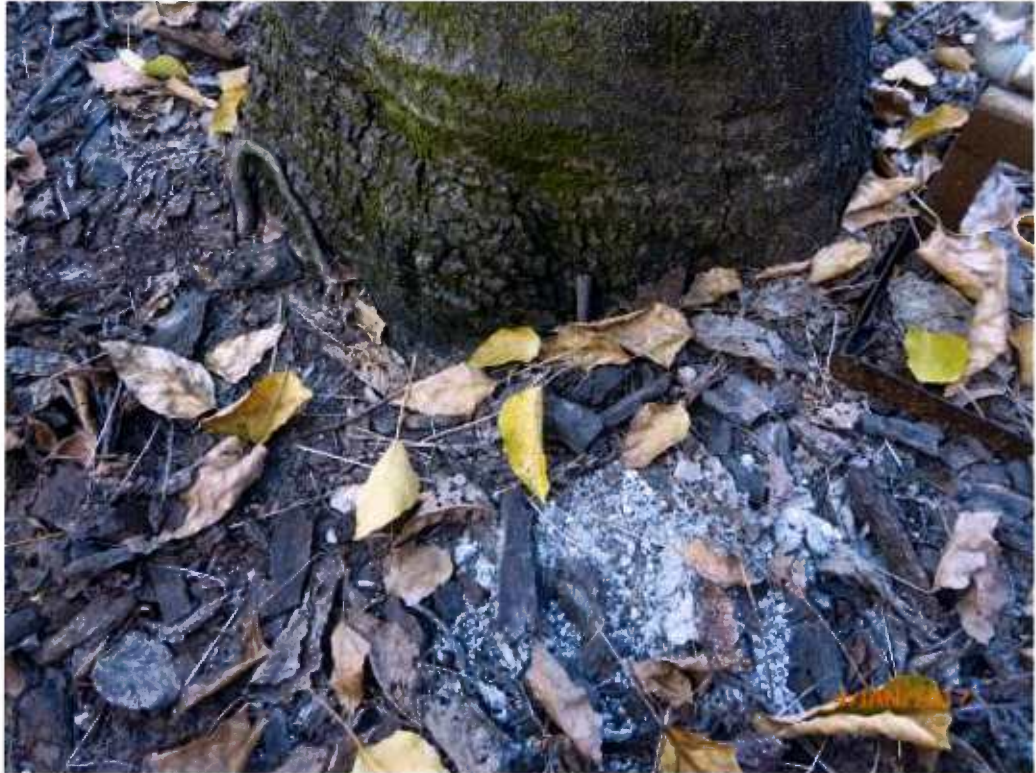
Fig 3. Health condition of the lower trunk is fair.

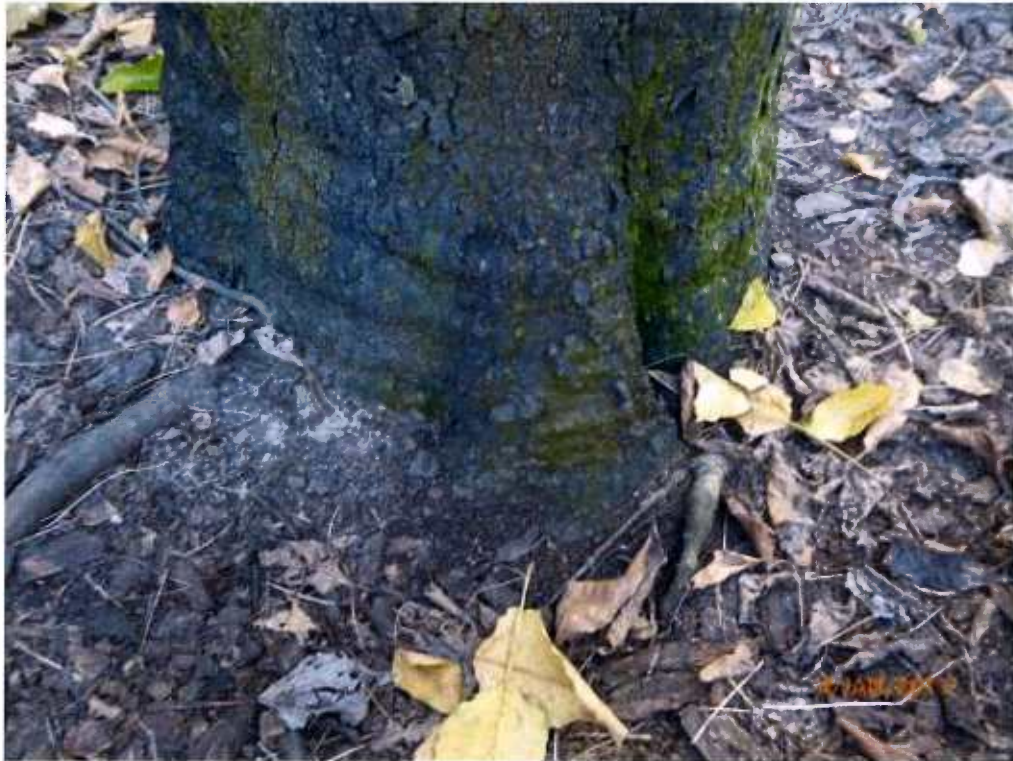
Fig 3. Health condition of the lower trunk is fair.

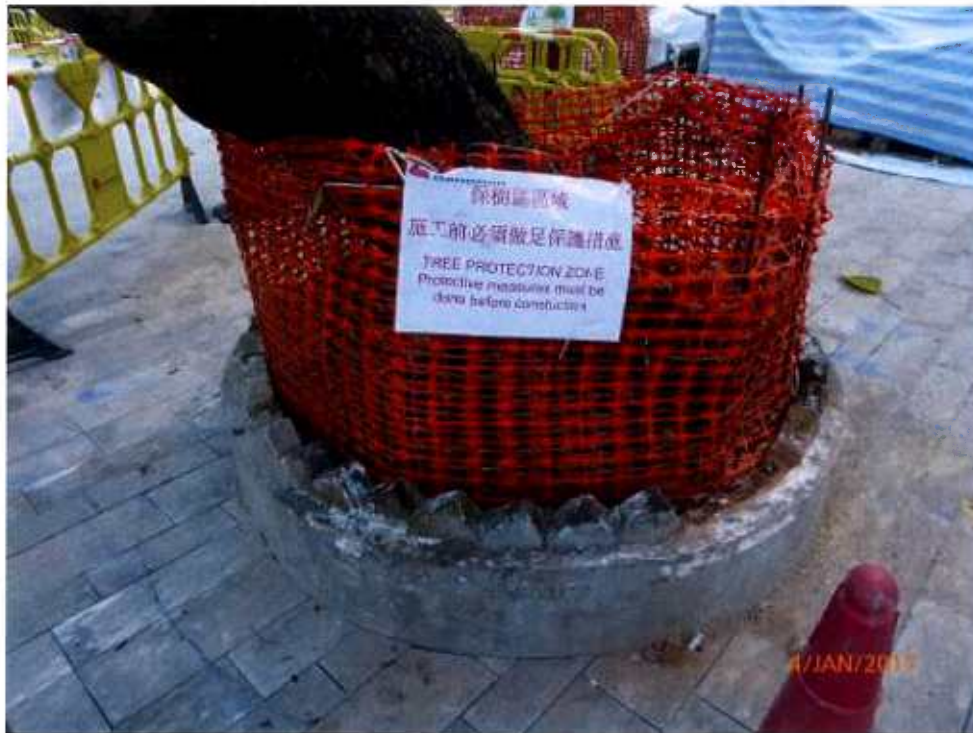
Fig. 9 The site near the planter is clean and tidy.

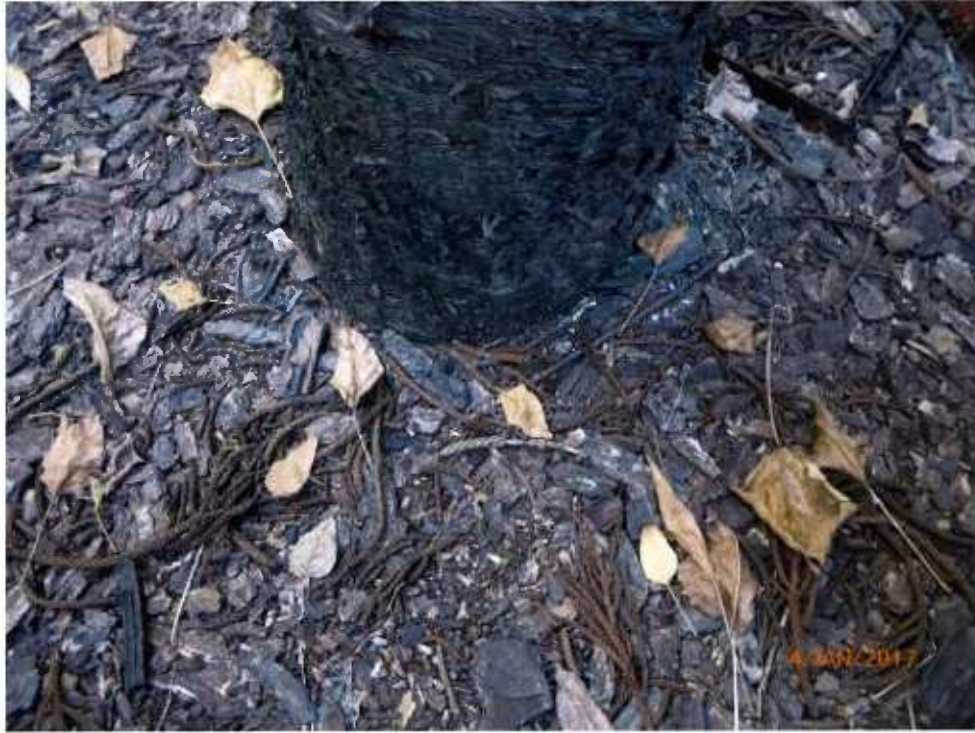
Fig. 3 Health condition of the lower trunk is fair.

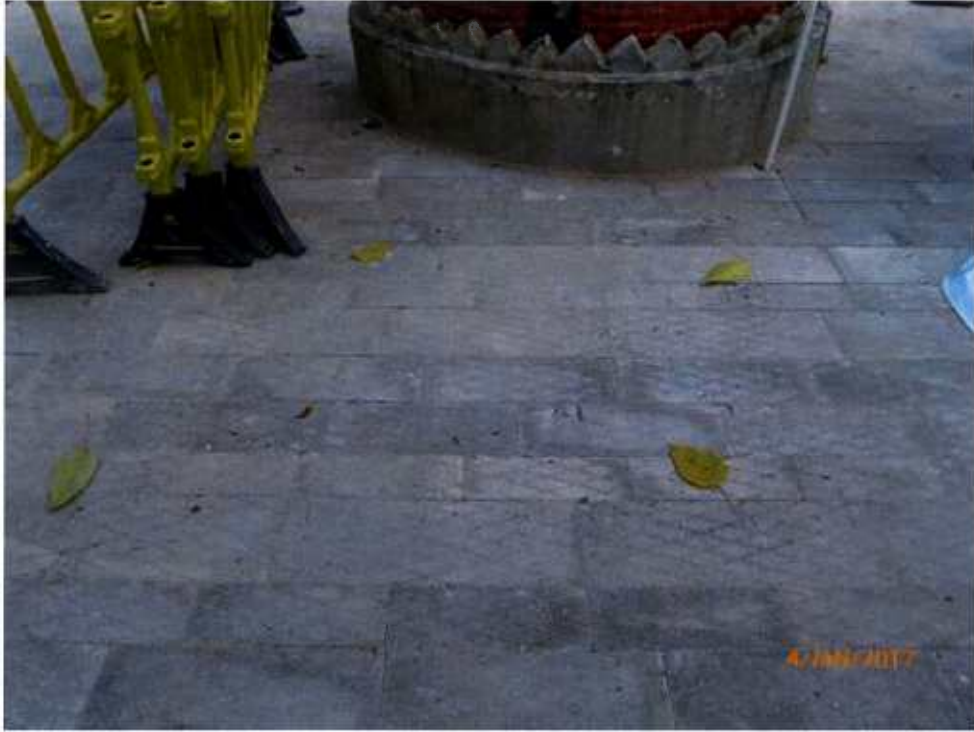
Fig. 11 The access near the tree also appears clean and tidy.

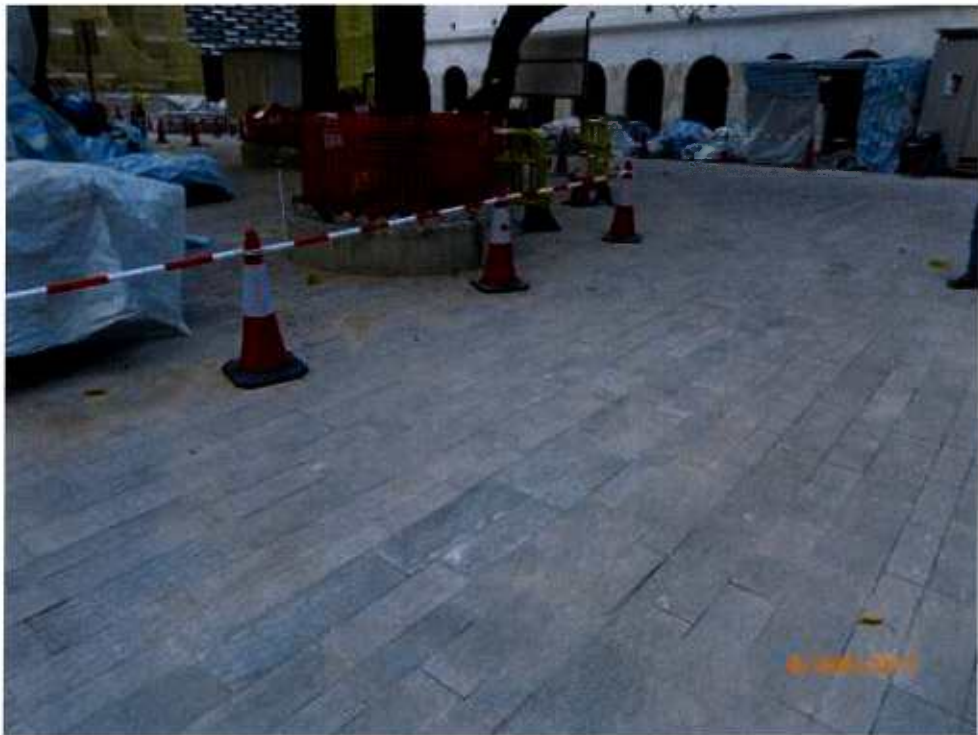
Fig. 12 Overall view of Tree-9 during inspection on 4th January 2017.

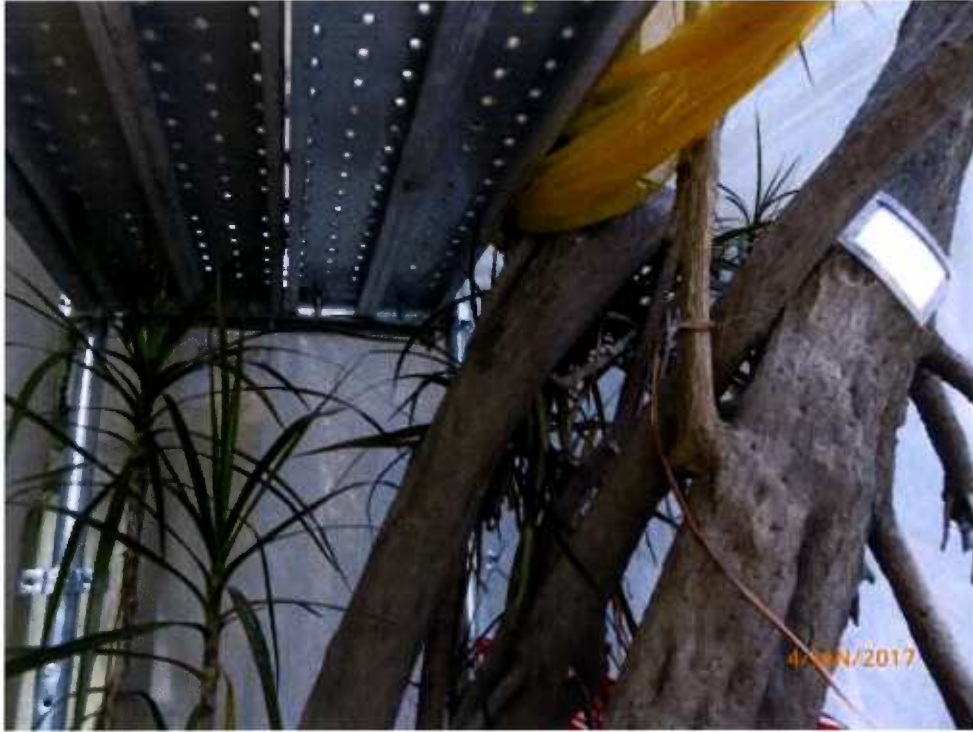
Fig. 9 A temporary shelter is erected to protect the tree.

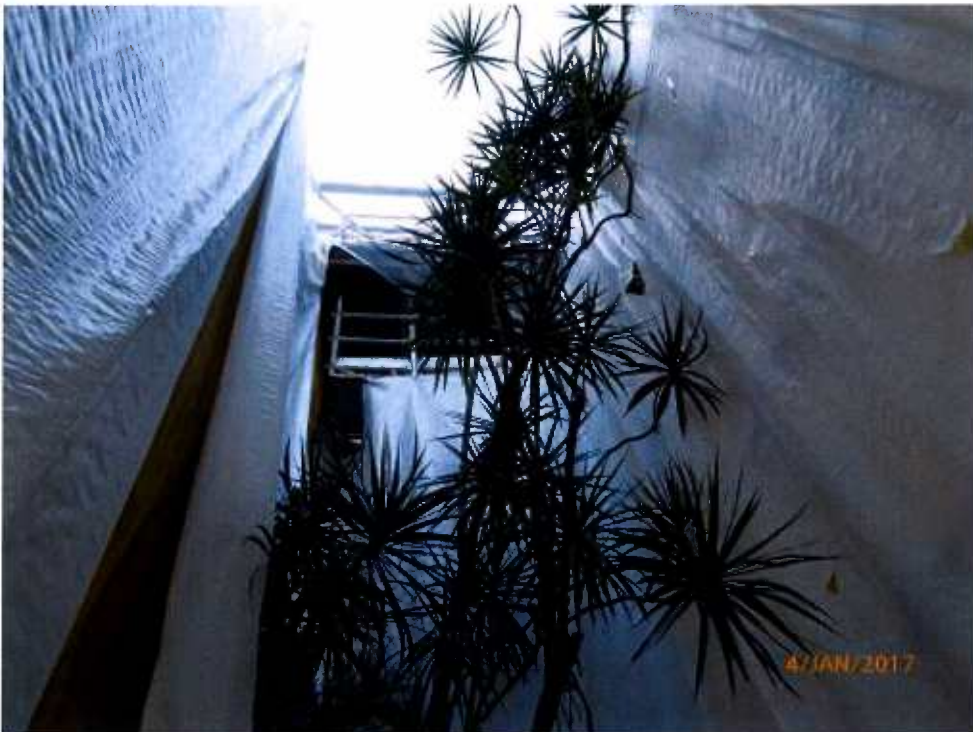
Fig. 10 Renovation works are in progress near Tree-11.
