The Jockey Club CPS Limited

Central Police Station Conservation  
and Revitalisation Project:  
*70<sup>th</sup> Monthly EM&A Report*  
*(1 August to 31 August 2017)*

Issue Date: September 2017

**Environmental Resources Management**

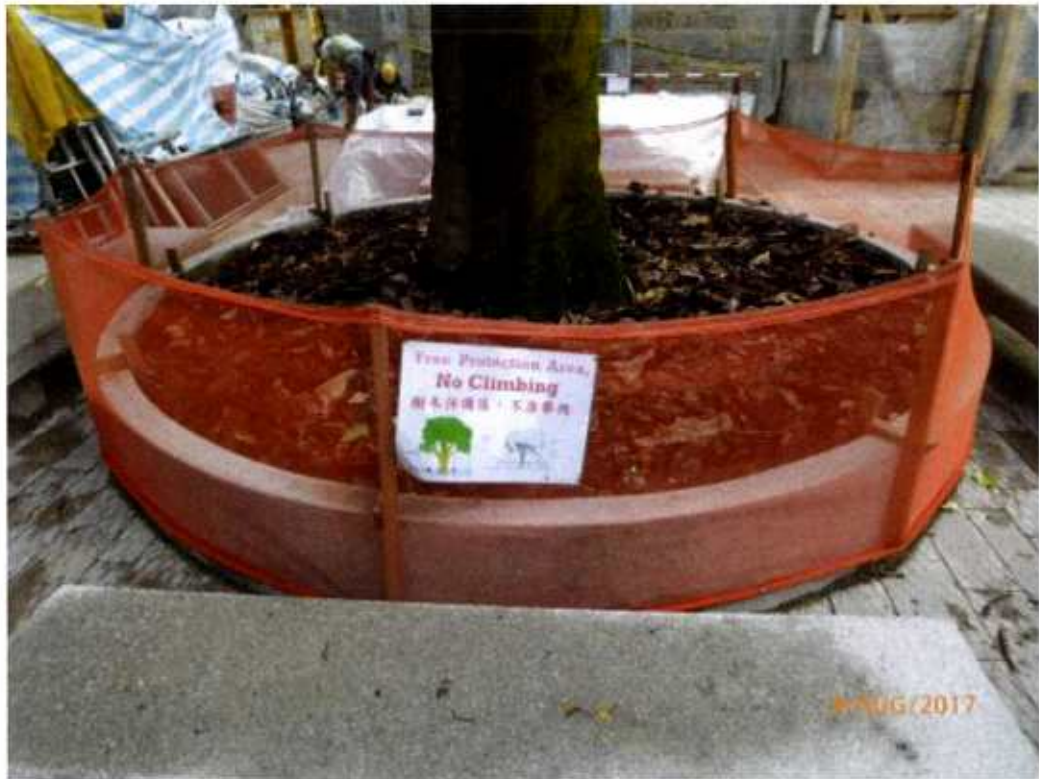
Fig. 10 The Tree Protection Zone is in good order.

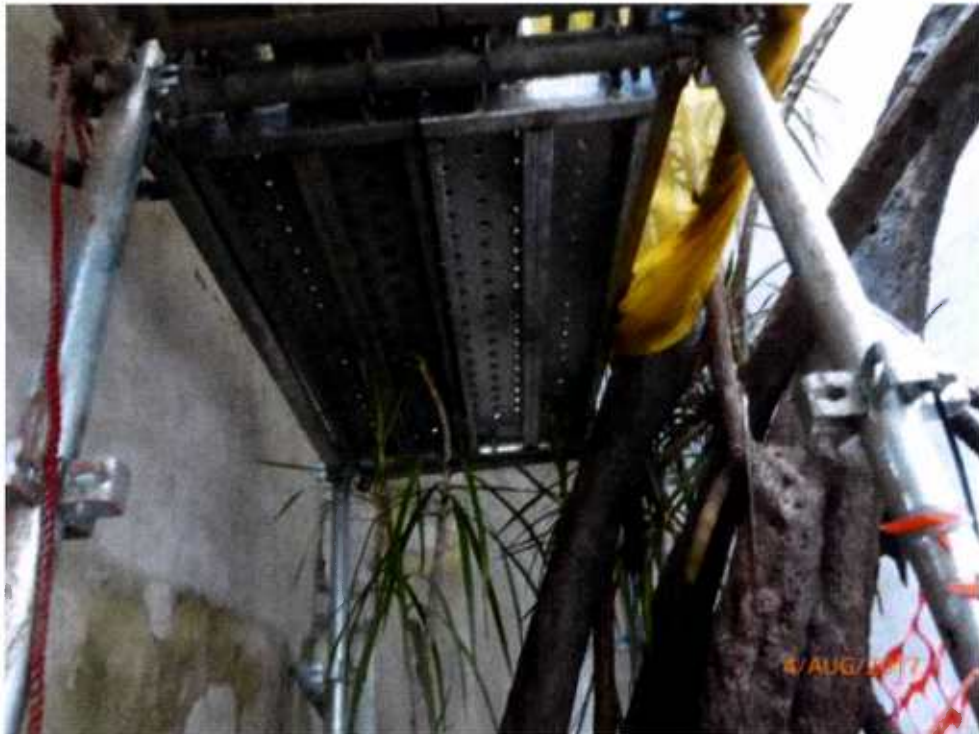
Fig. 10 A large shelter has been erected at site to protect the tree.

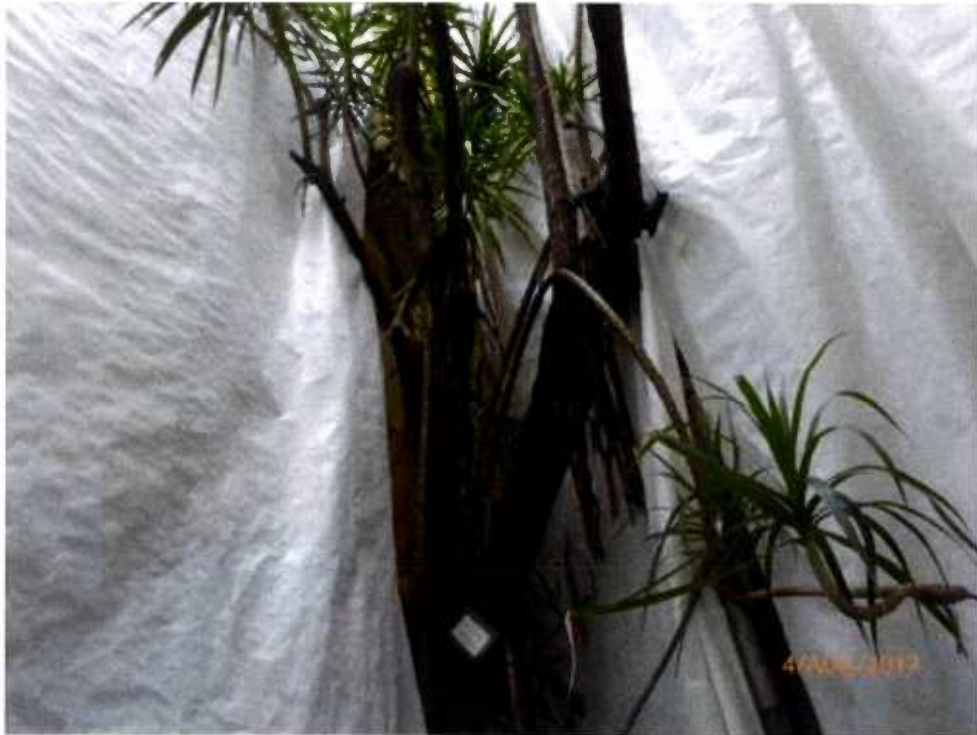
Fig. 11 Renovation works are in progress near Tree-11.

1. **To remove the construction debris away from the planter.**
2. **To keep close monitoring on the growth of Tree-11 especially when the nearby renovation works are in progress.**
