# Central Police Station Conservation and Revitalisation Project

*EIA Report:  
Volume II - Annexes*

**Built Heritage Resources within CPS –  
Detailed Baseline Studies and Impact Assessments**

**Annex A1**  
Built Heritage Resources: Baseline Studies and Impact Assessments

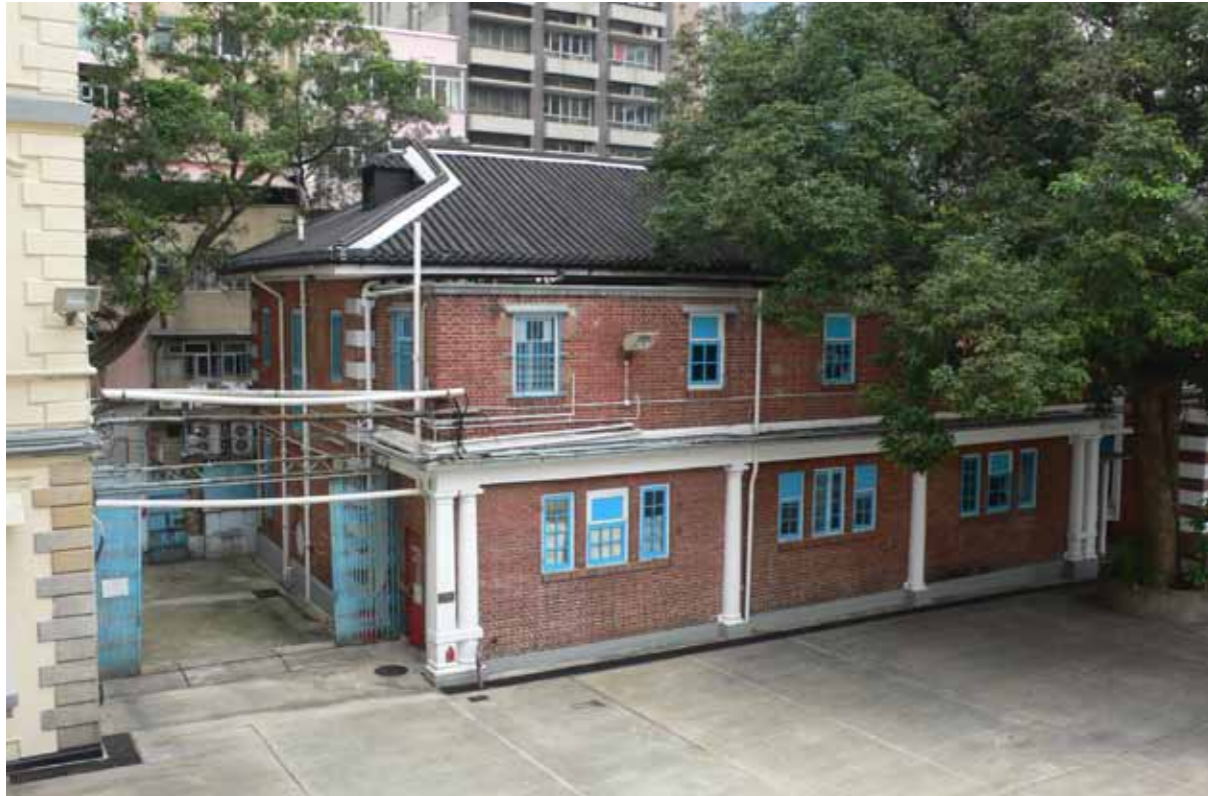
The east elevation originally had a single storey projecting porch with 3 bay colonnade of Tuscan columns having coupled circular and square columns at each end. This has since been blocked in and a first floor added above; the later construction is of a lower quality than the original building (e.g. with irregular fenestration and missing the rubbed brick arches). The columns and quoins are still partially visible. The southeast corner of the first floor extension retains metal security bars on two of its windows – though the current use of this area as a toilet has no connection to these earlier bars.

Figure 1 - East (Parade Ground) elevation showing the infilled ground floor arcade and the poor quality first floor addition

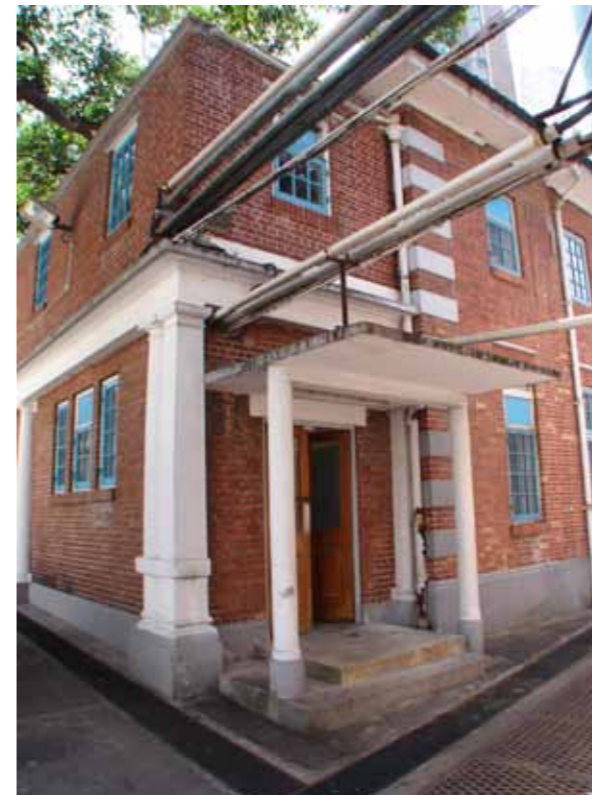
Figure 4 - Canopy on north elevation

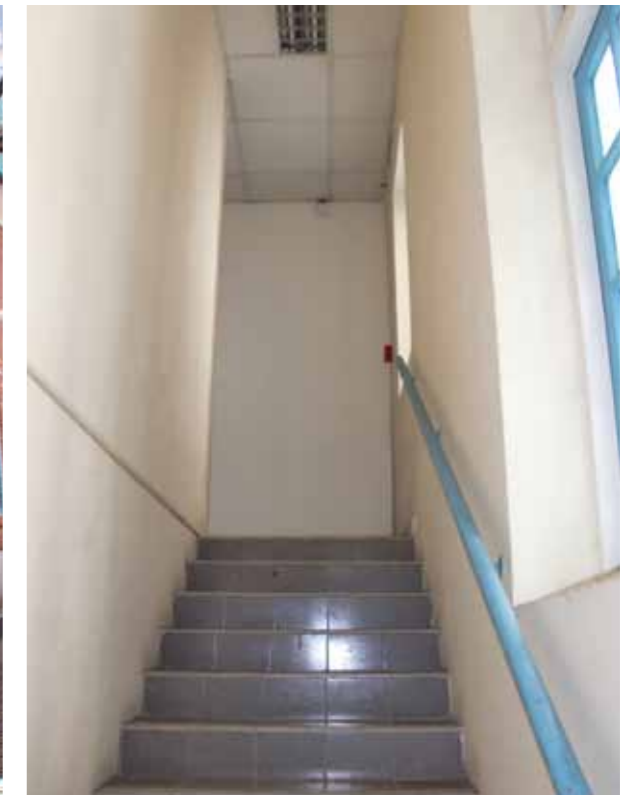
Figure 5 - Existing staircase in the south part of the building

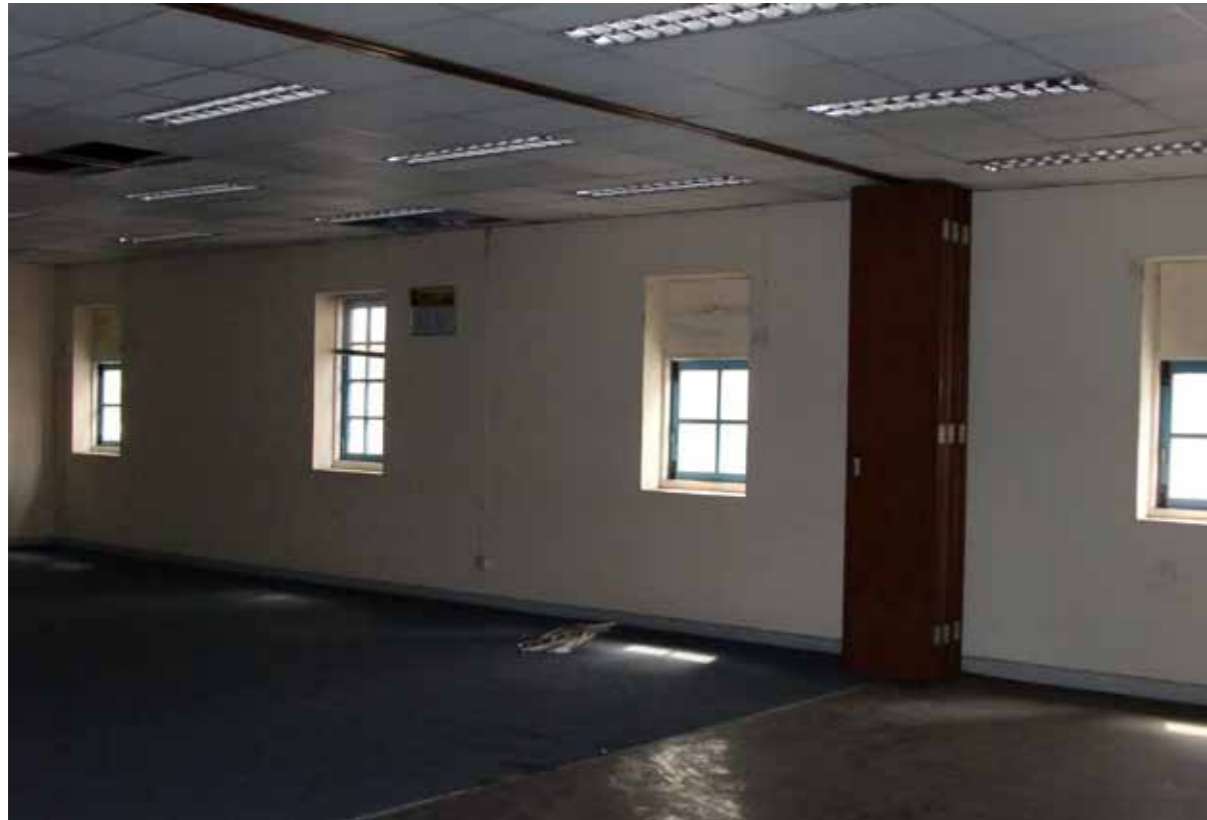
Figure 6 - First floor interior as fitted out for its final use by the Traffic Police

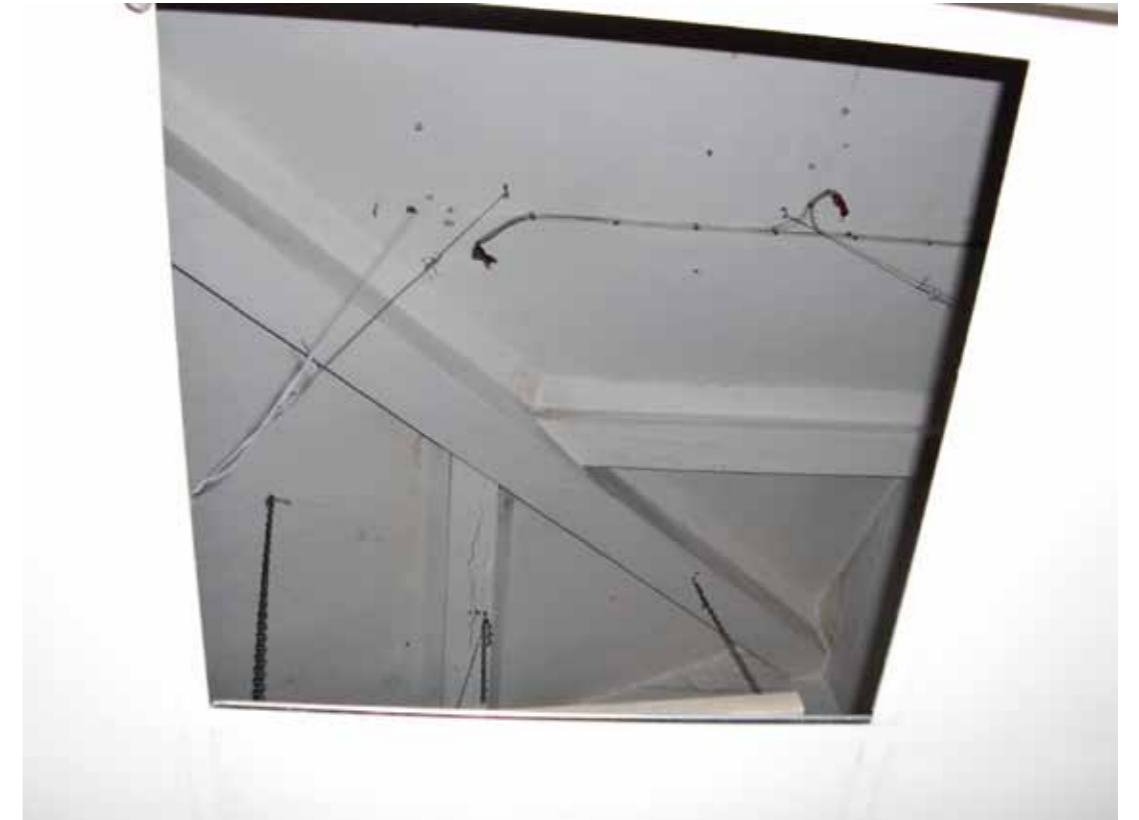
Figure 7 - Ceiling structure in 02/F/09

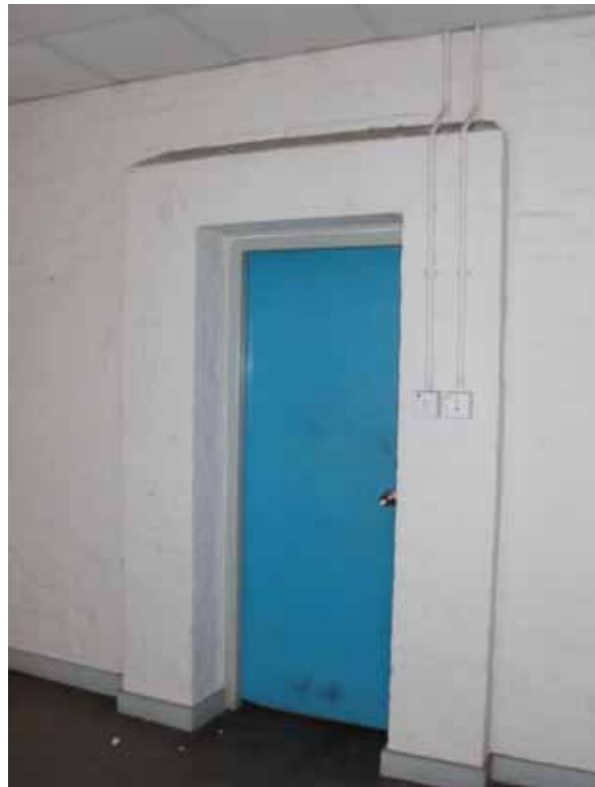
Figure 8 - Door into room 02/F/09

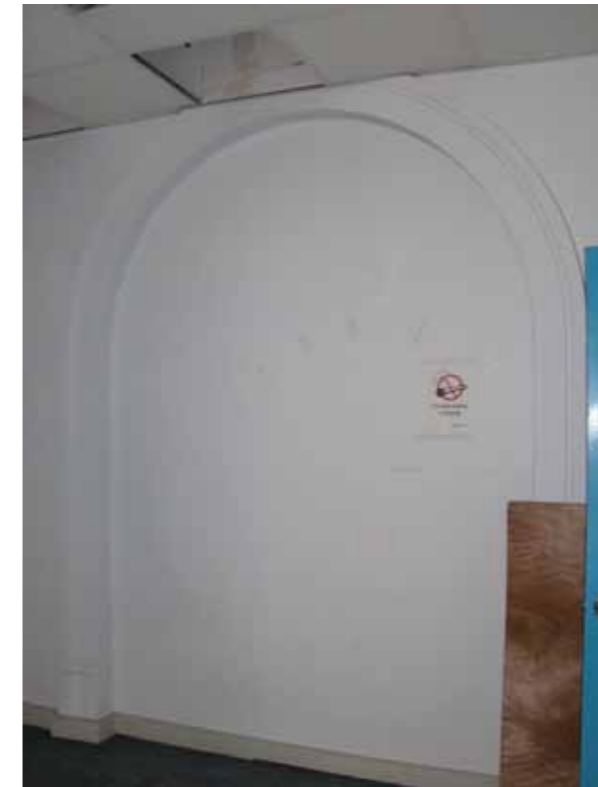
Figure 10 - Blocked archway in 02/G/03

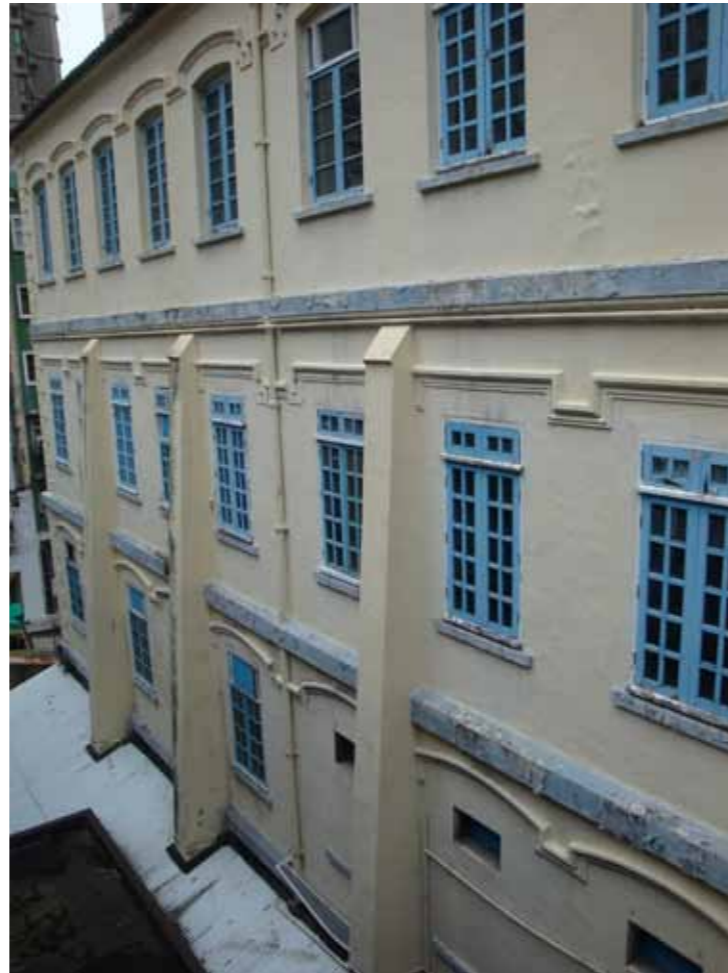
Figure 3 - Partial view of the south elevation showing blocked windows on the ground floor, and buttresses added c.1906

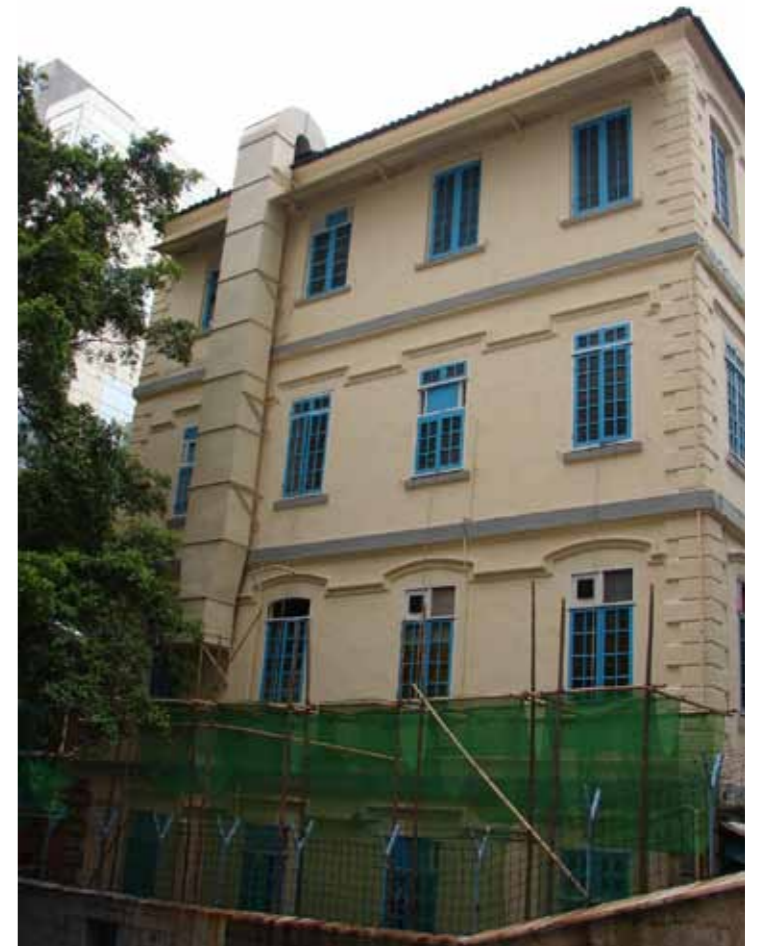
Figure 4 - West elevation showing large ductwork for one of the modern kitchens and third floor corrugated metal sunshade

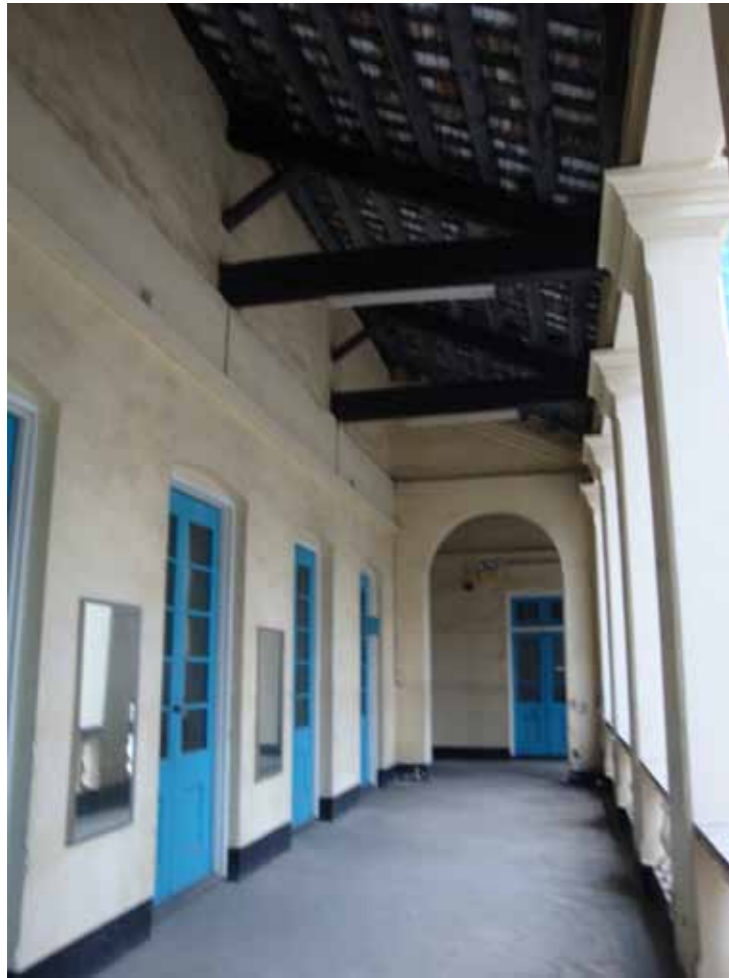
Figure 5 - Third floor verandah with exposed ceiling structure

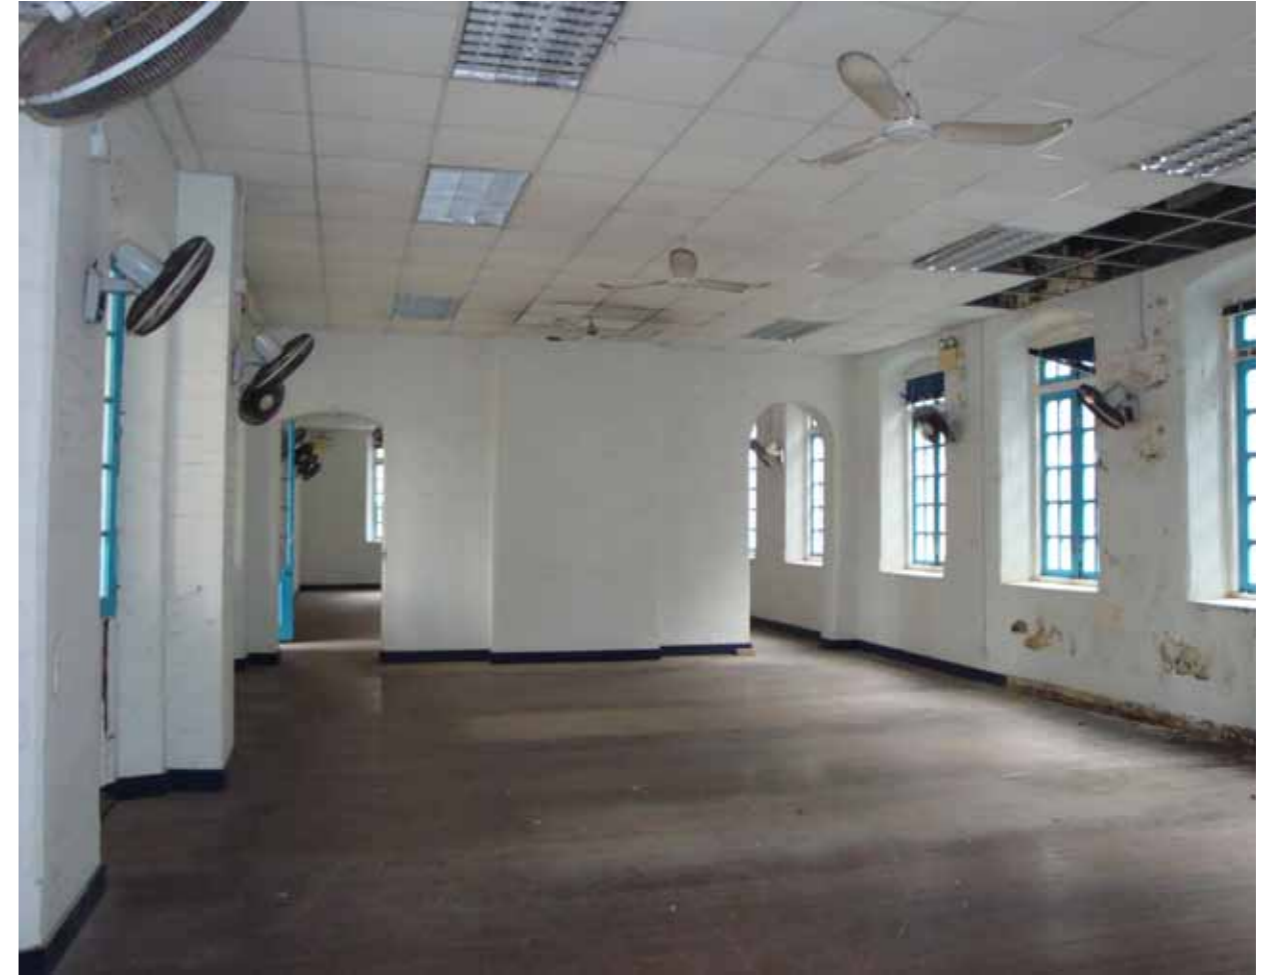
Figure 7 - Second floor dormitory

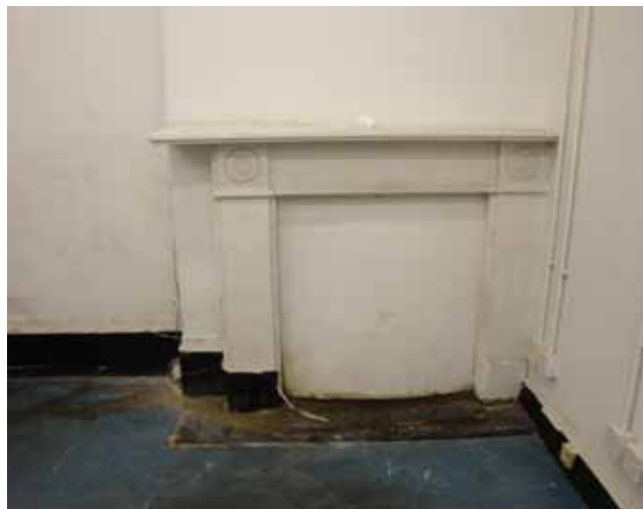
Figure 8 - The last surviving fireplace in the building, in one of the ground floor west rooms

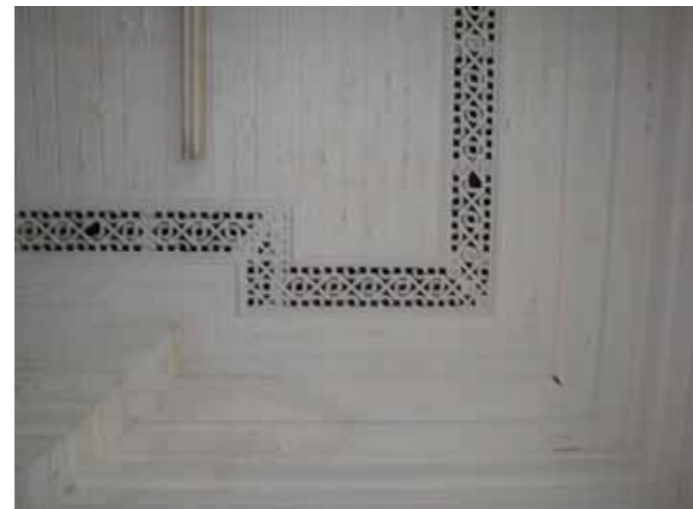
Figure 10 - Third floor ceiling with metal ventilation grille c.1929

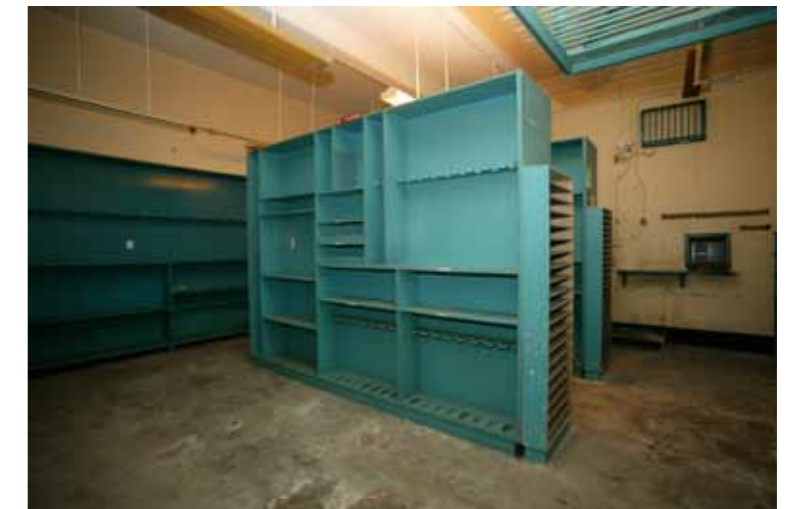
Figure 11 - The Armoury in the west part of the ground floor
