Central Police Station Conservation
and Revitalisation Project:
Thirty-sixth Monthly EM&A Report
(1 October to 31 October 2014)

Issue Date: November 2014

Environmental Resources Management

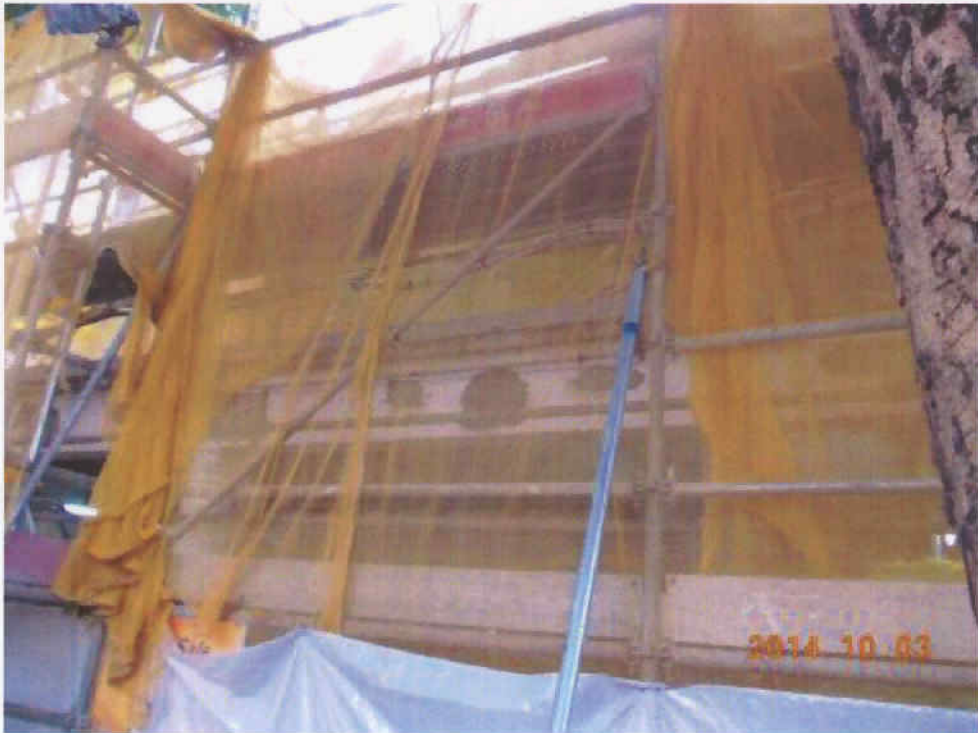
Fig. 8 Cleanliness of the site near the entrance is acceptable.

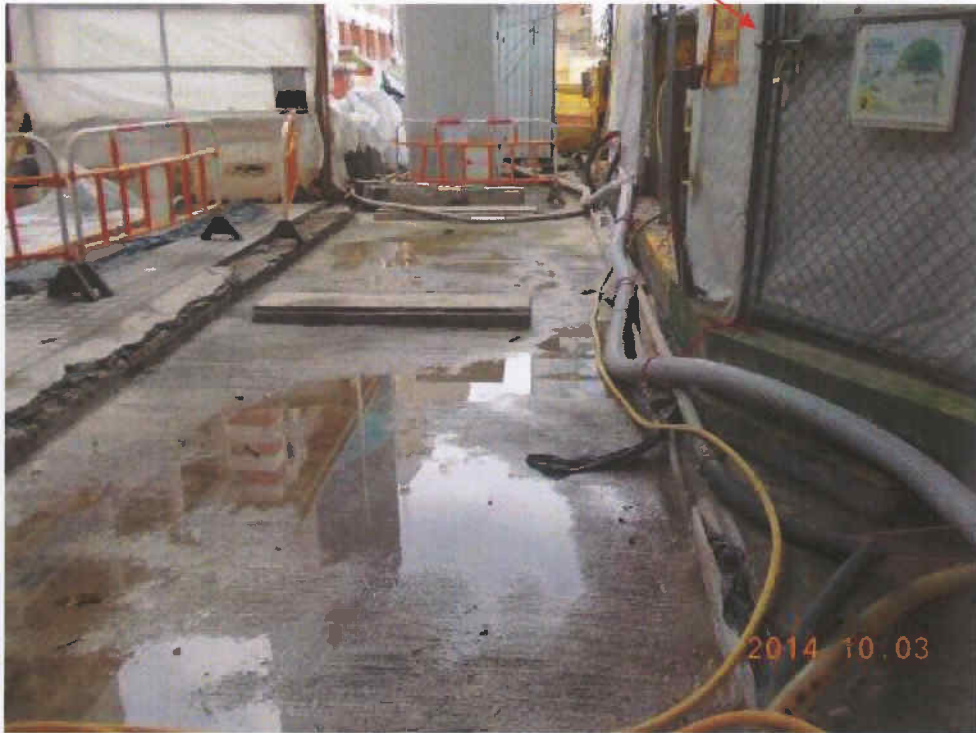
Fig. 9 Construction works are in progress outside the cordon zone.

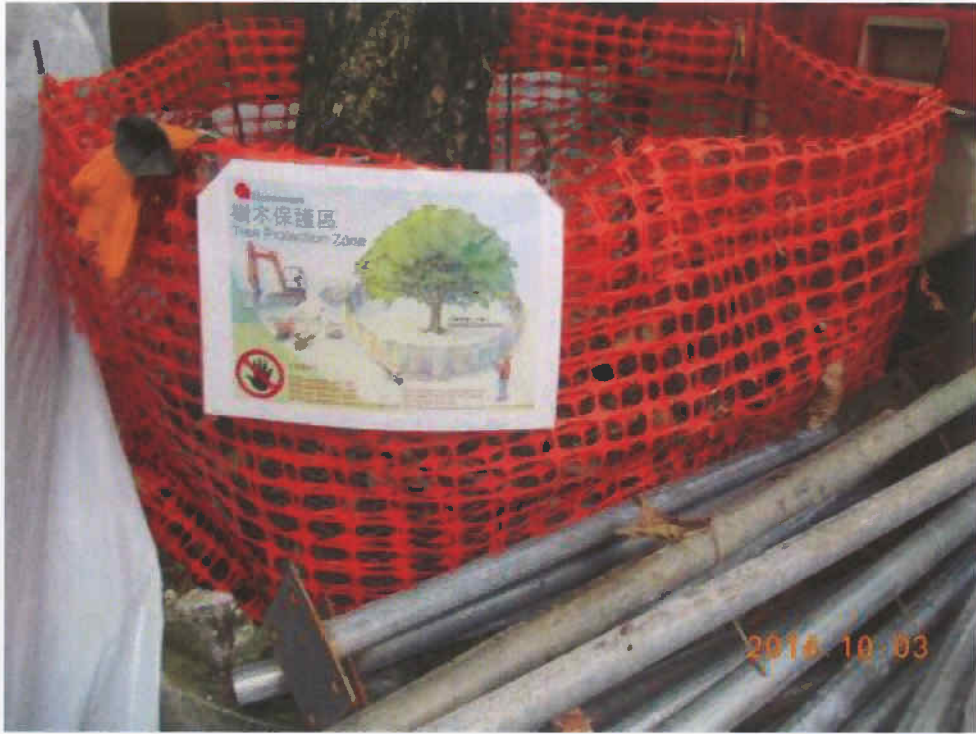
Fig. 7 The site near the planter is clean and tidy.

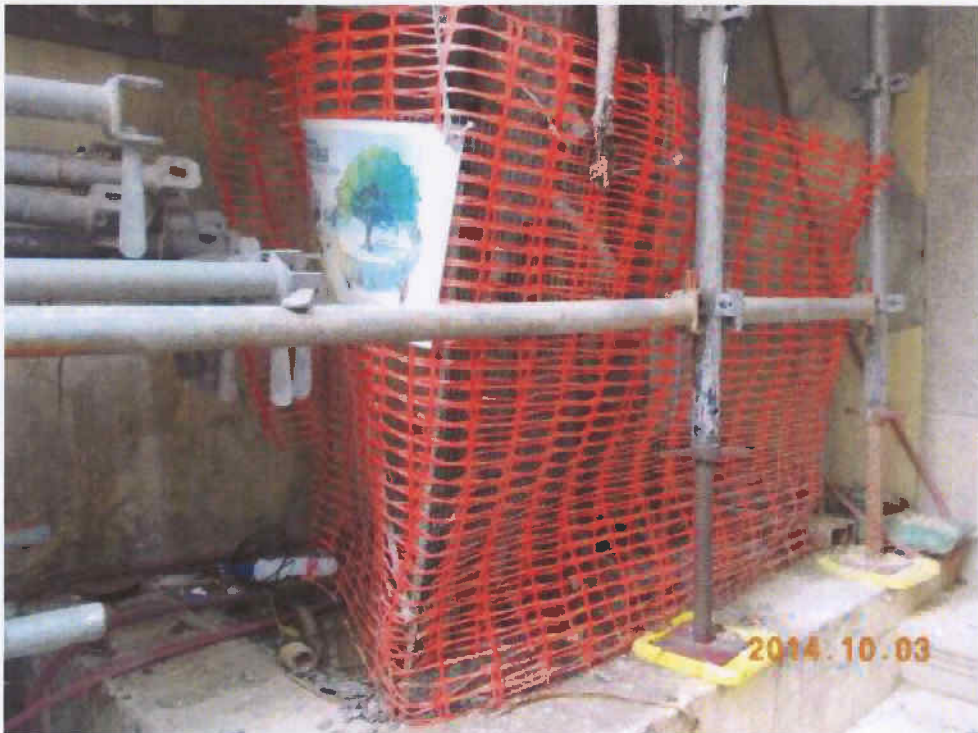
Fig. 10 Cleanliness of the site outside the cordon zone is acceptable.
