The Jockey Club CPS Limited

Central Police Station Conservation
and Revitalisation Project:
66th Monthly EM&A Report
(1 April to 30 April 2017)

Issue Date: May 2017

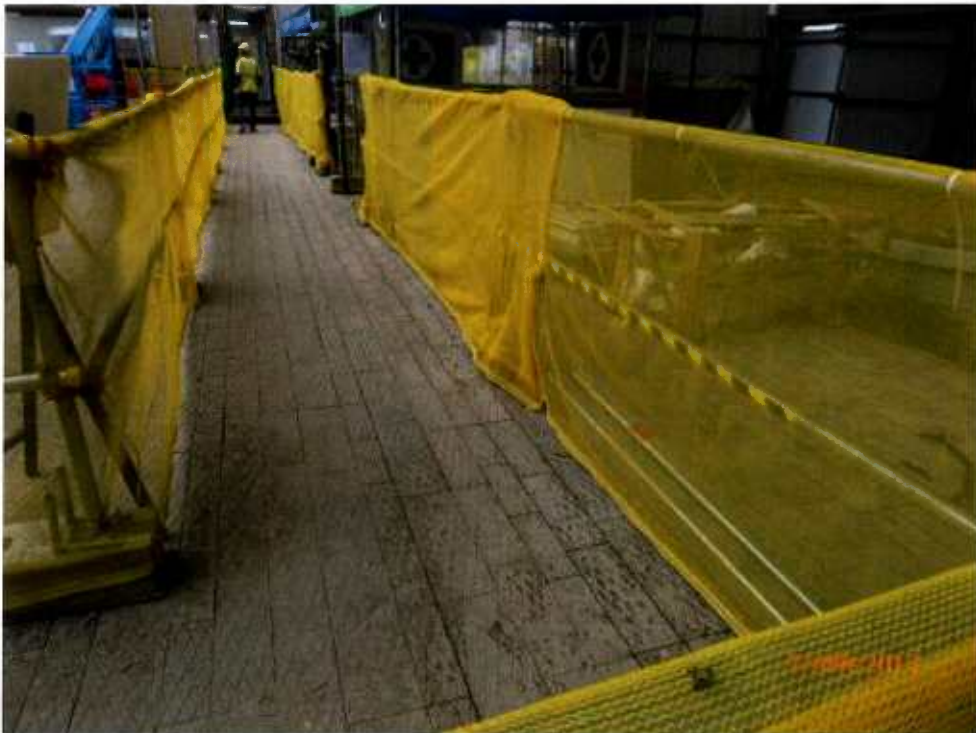
Fig. 12 Overall view of Tree-5 during inspection on 7th April 2017.

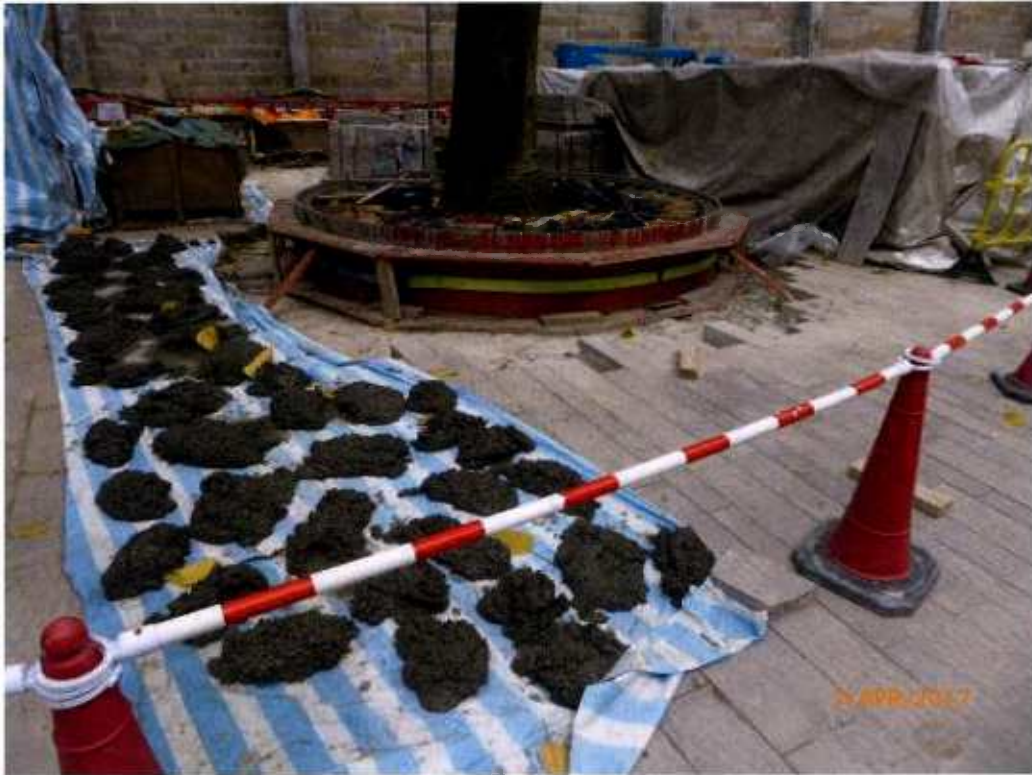
Fig. 11 The access near the planter is clean and tidy.

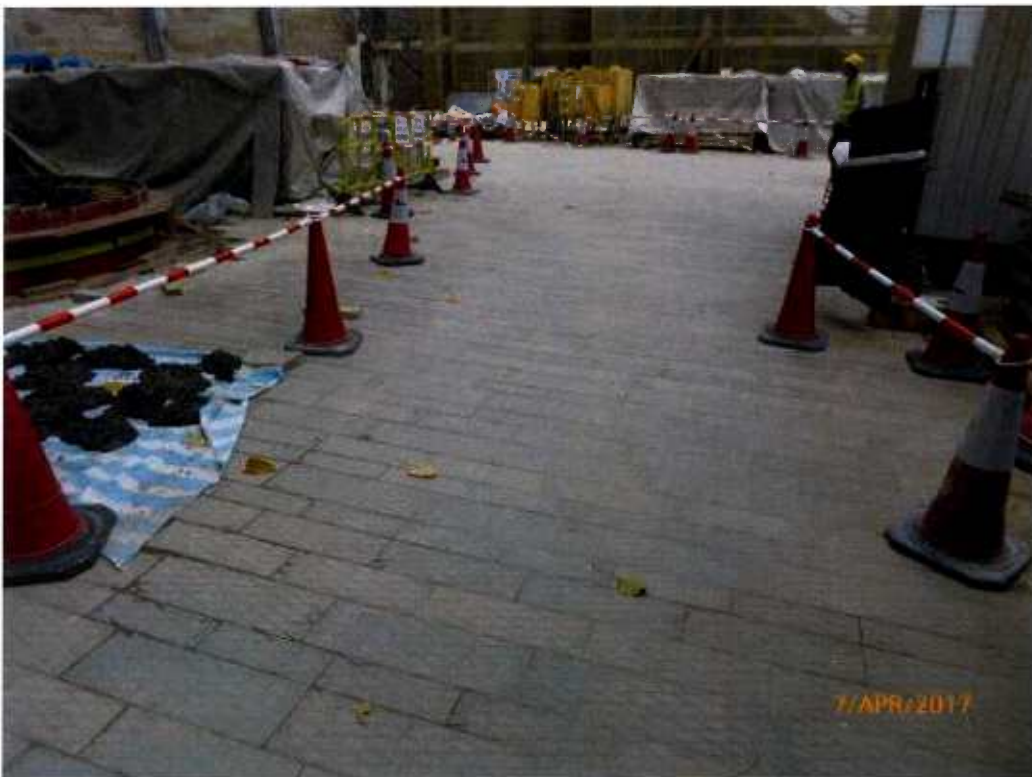
Fig. 12 Overall view of Tree-6 during inspection on 7th April 2017.

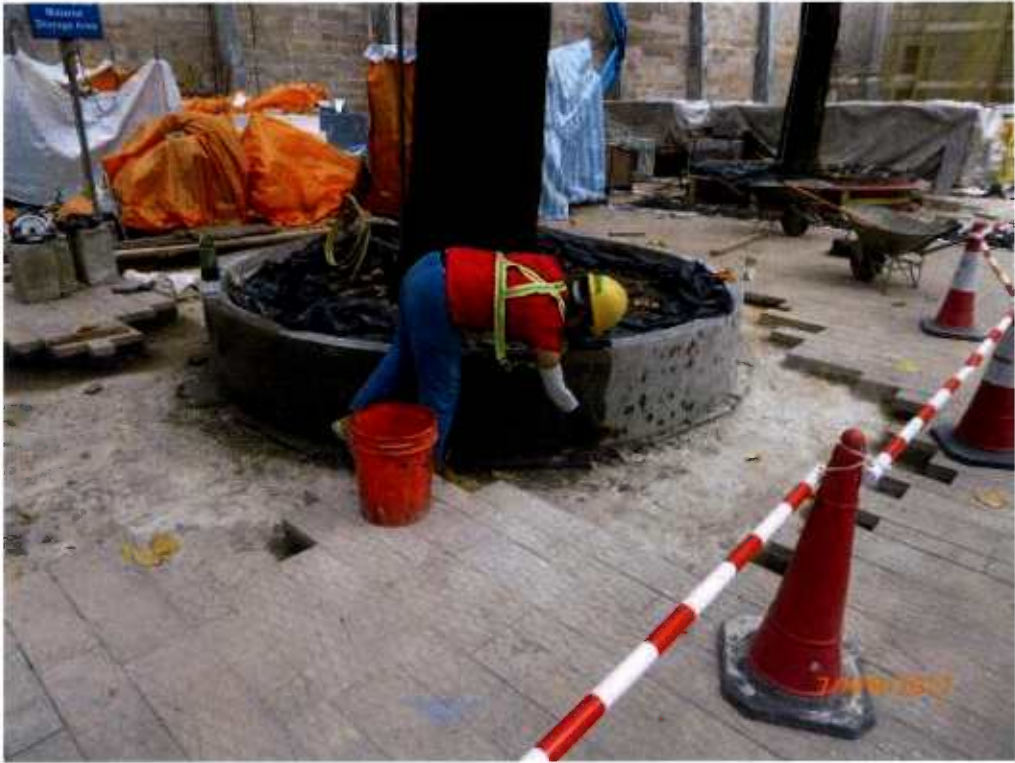
Fig. 11 The site near the tree is clean and tidy.

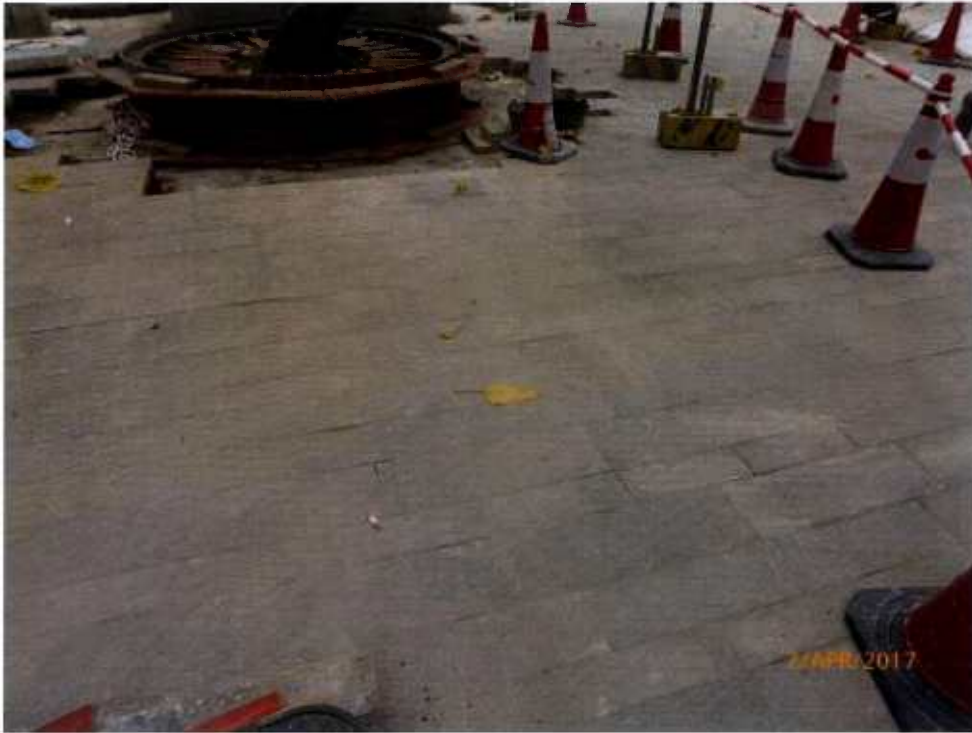
Fig. 9 The access near the tree is clean and tidy.

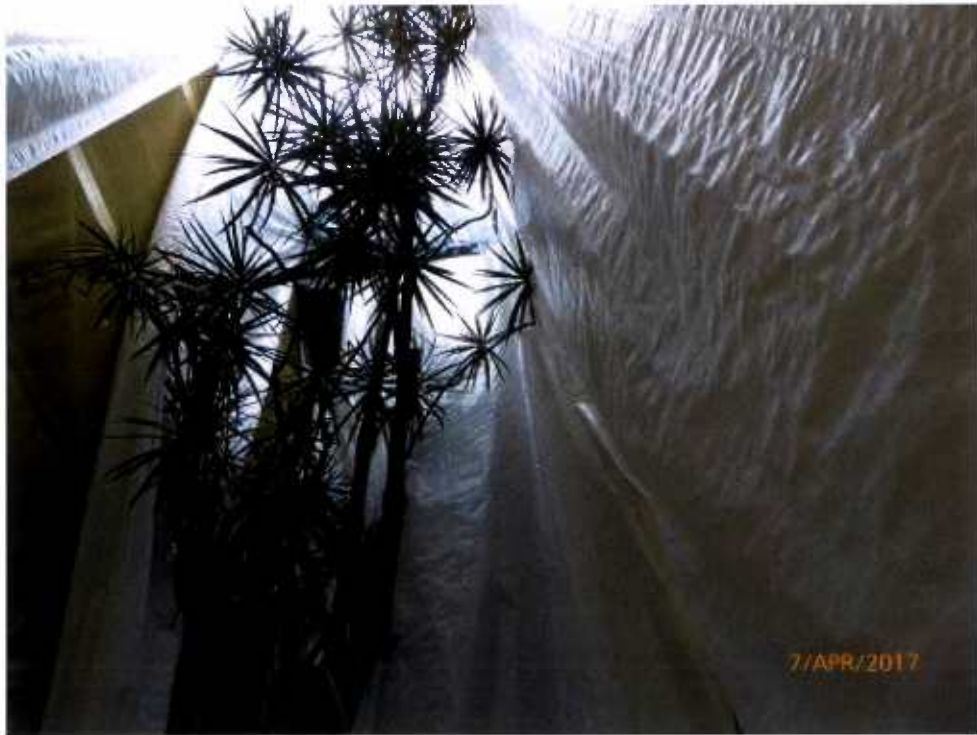
Fig. 9 Tree protection zone is in order at the time of inspection.

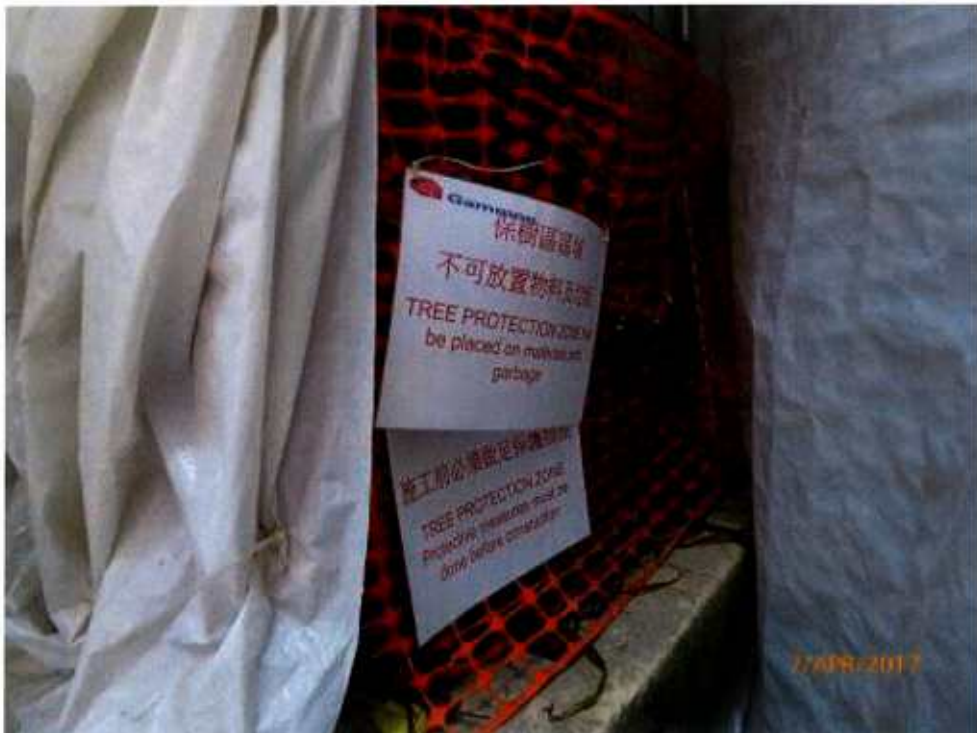
Fig. 10 Renovation works are in progress near Tree-11.

1. To keep monitoring on the growth of the tree especially when the nearby renovation works are in progress.

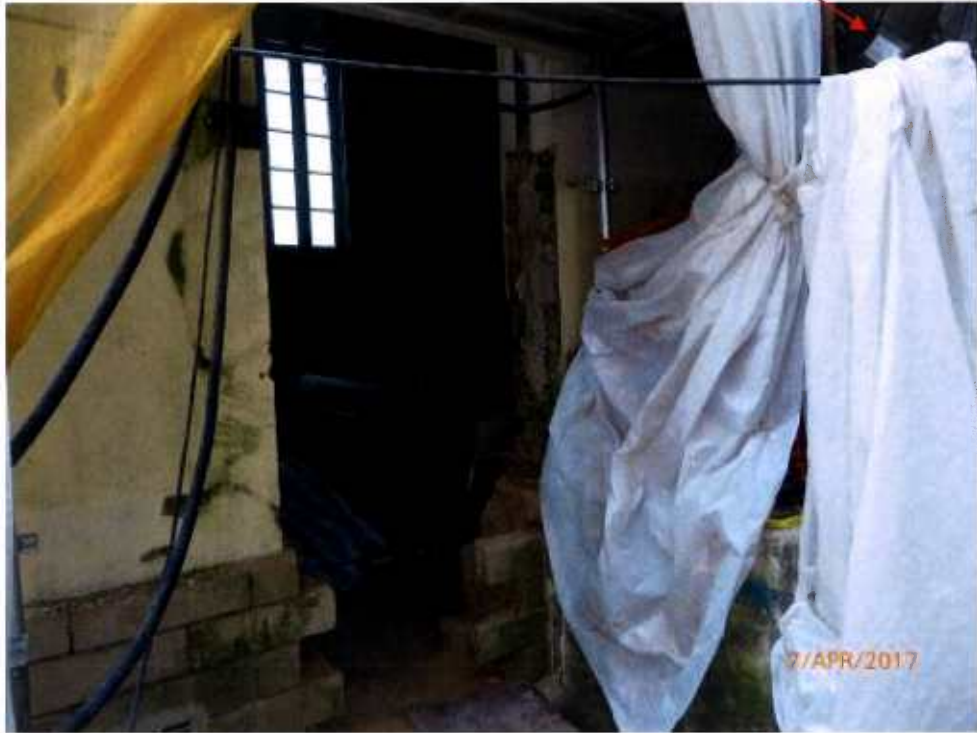
Fig. 11 Renovation works also are in progress on the other side of the tree.
