Central Police Station Conservation
and Revitalisation Project:
77th Monthly EM&A Report
(1 March to 31 March 2018)

Issue Date: April 2018

Reference 0095646

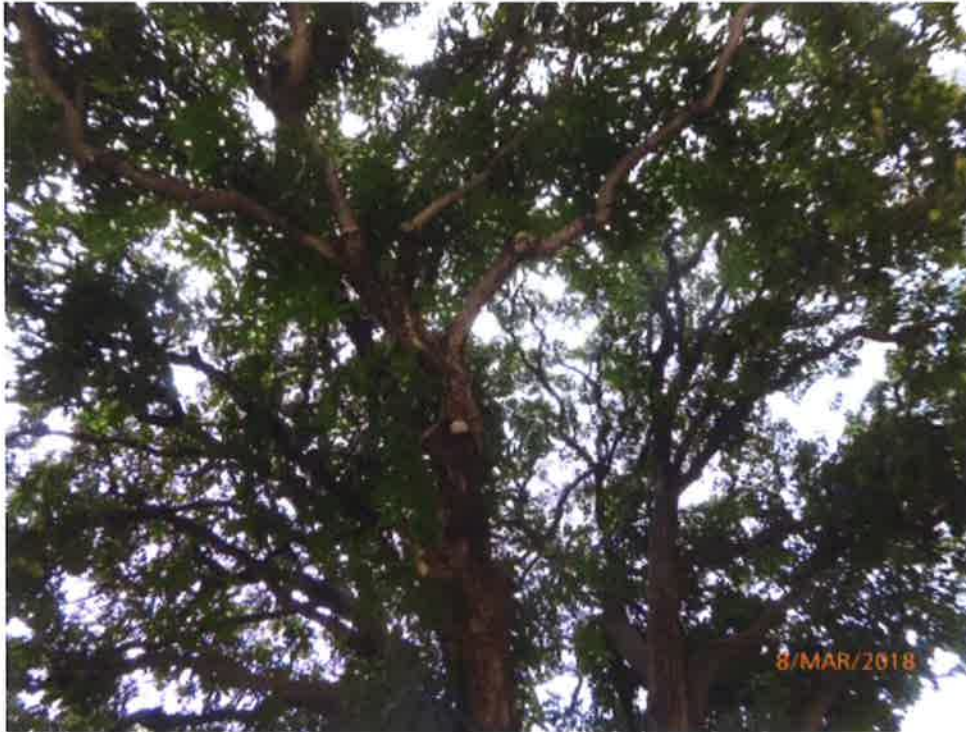
Fig. 6 The crown is full of vigorous and green leaves.

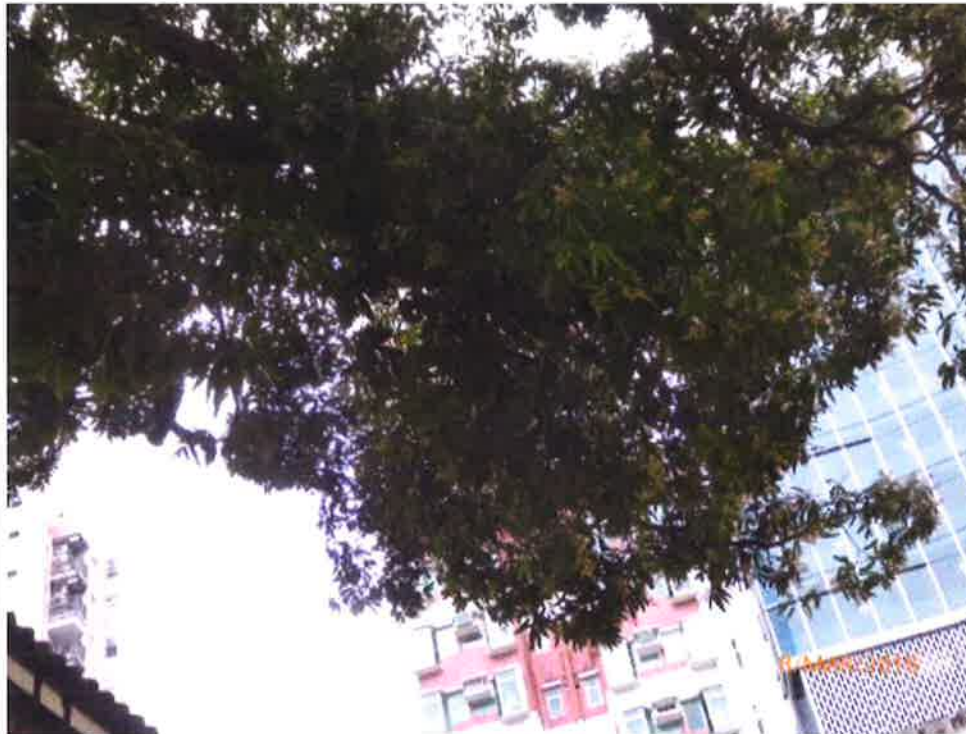
Fig. 7 Vigorous and green leaves also are growing on the lower branches.

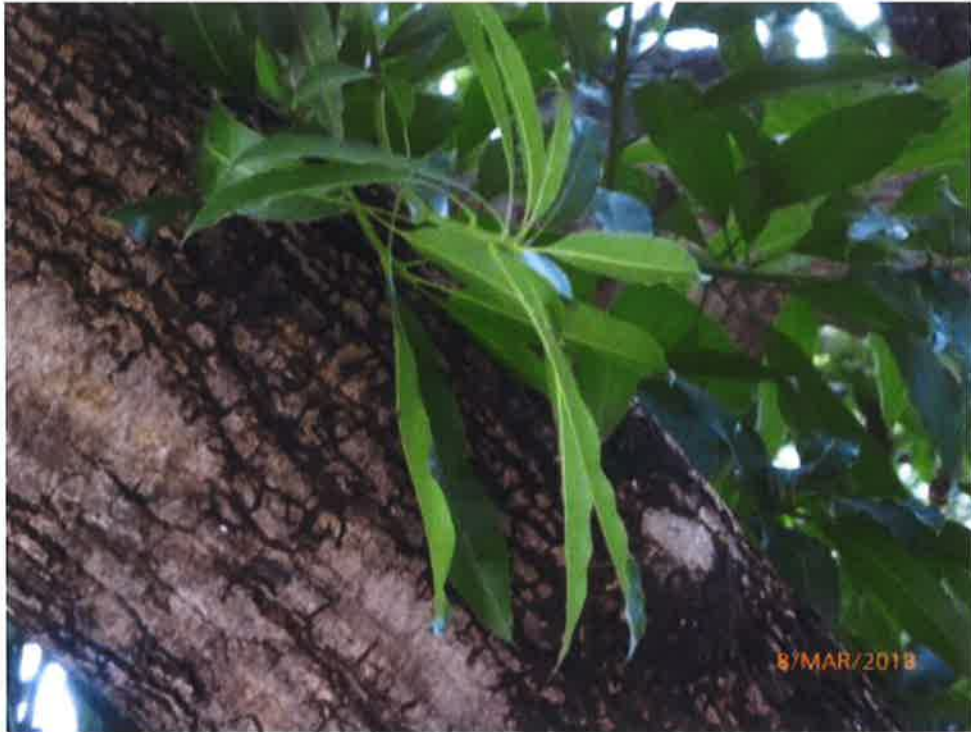
Fig. 8 Some young and green leaves appear on the tree.

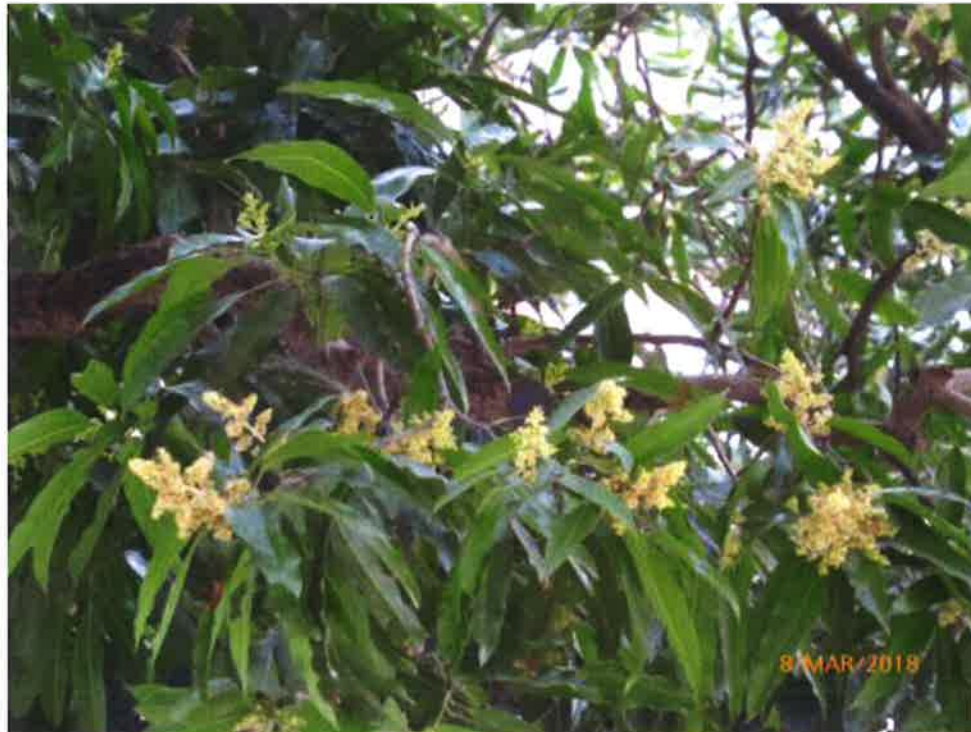
Fig. 9 Many flowers also appear on Tree-5.

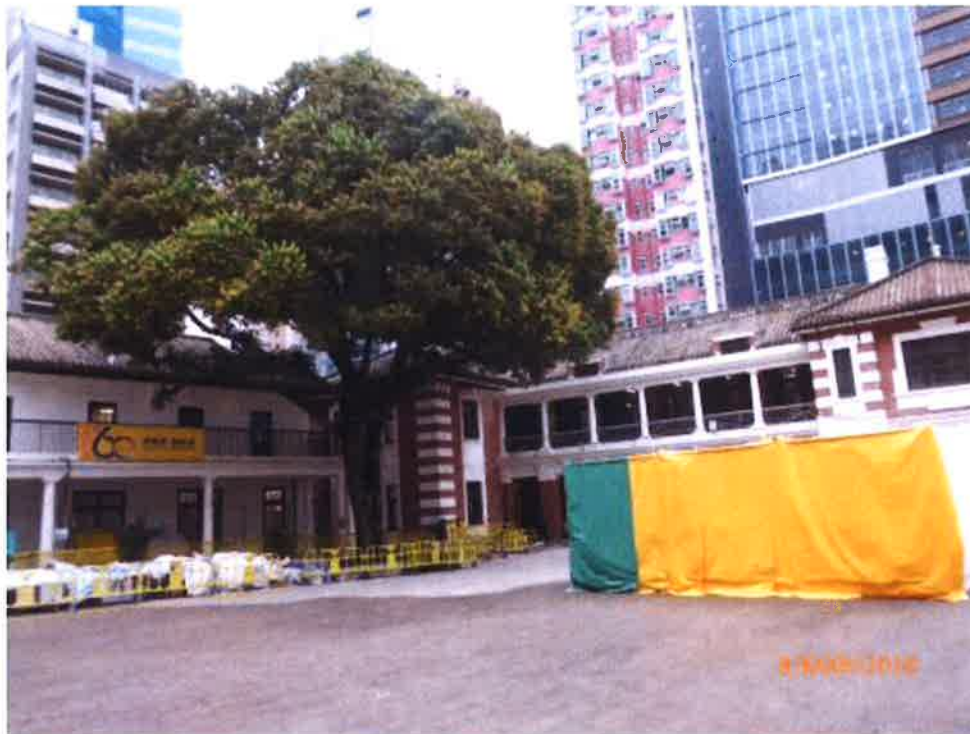
Fig. 11 The site near Tree-5 also is clean and tidy.

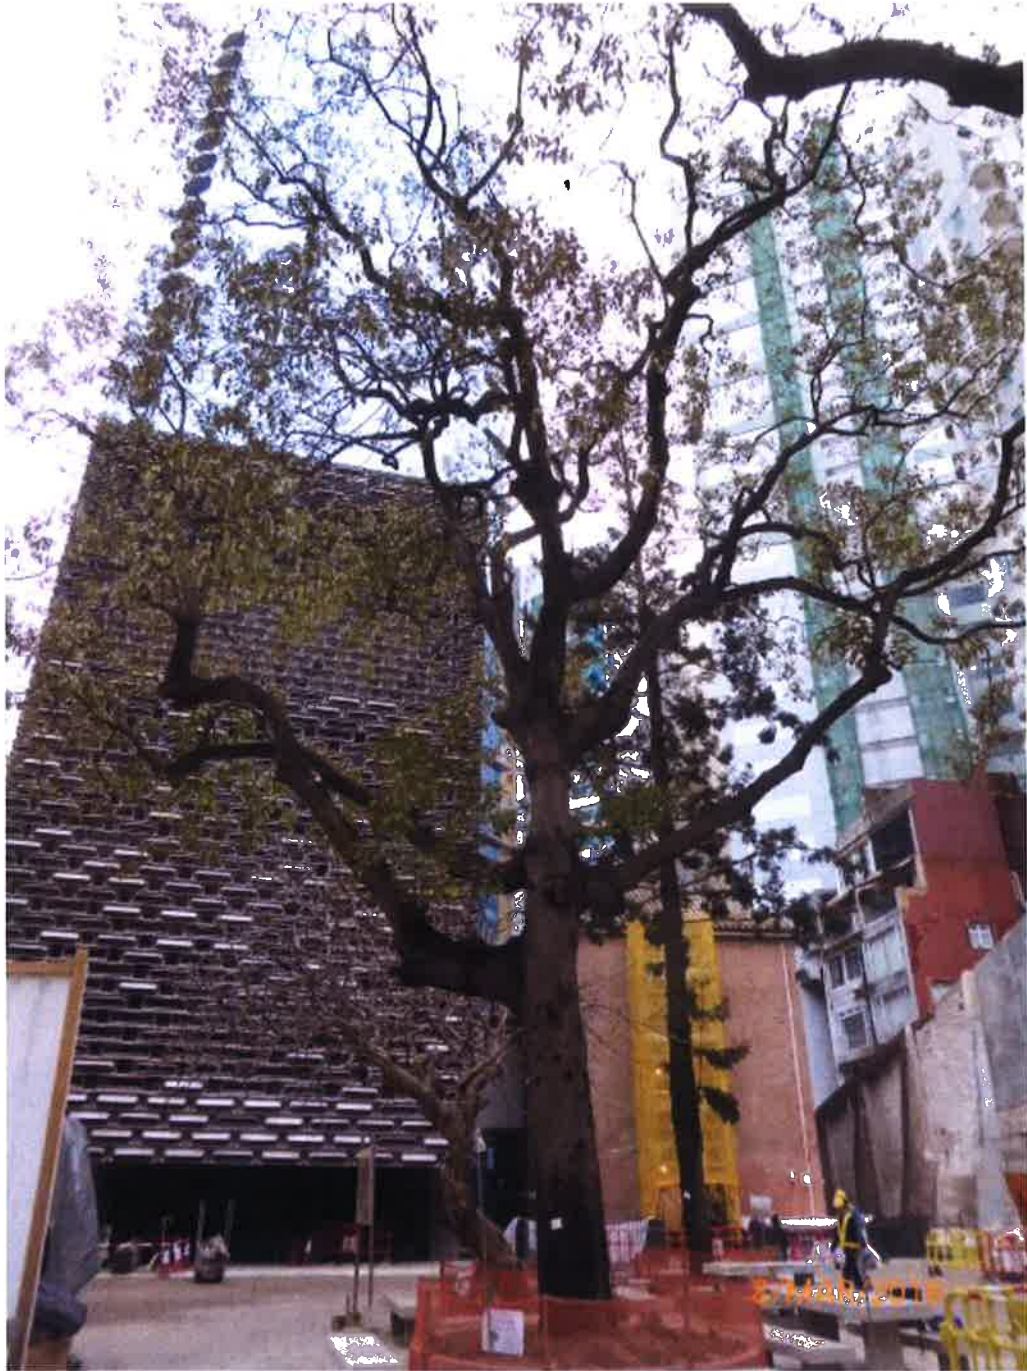
Fig. 12 Overall view of Tree-7 during inspection on 8th March 2018.

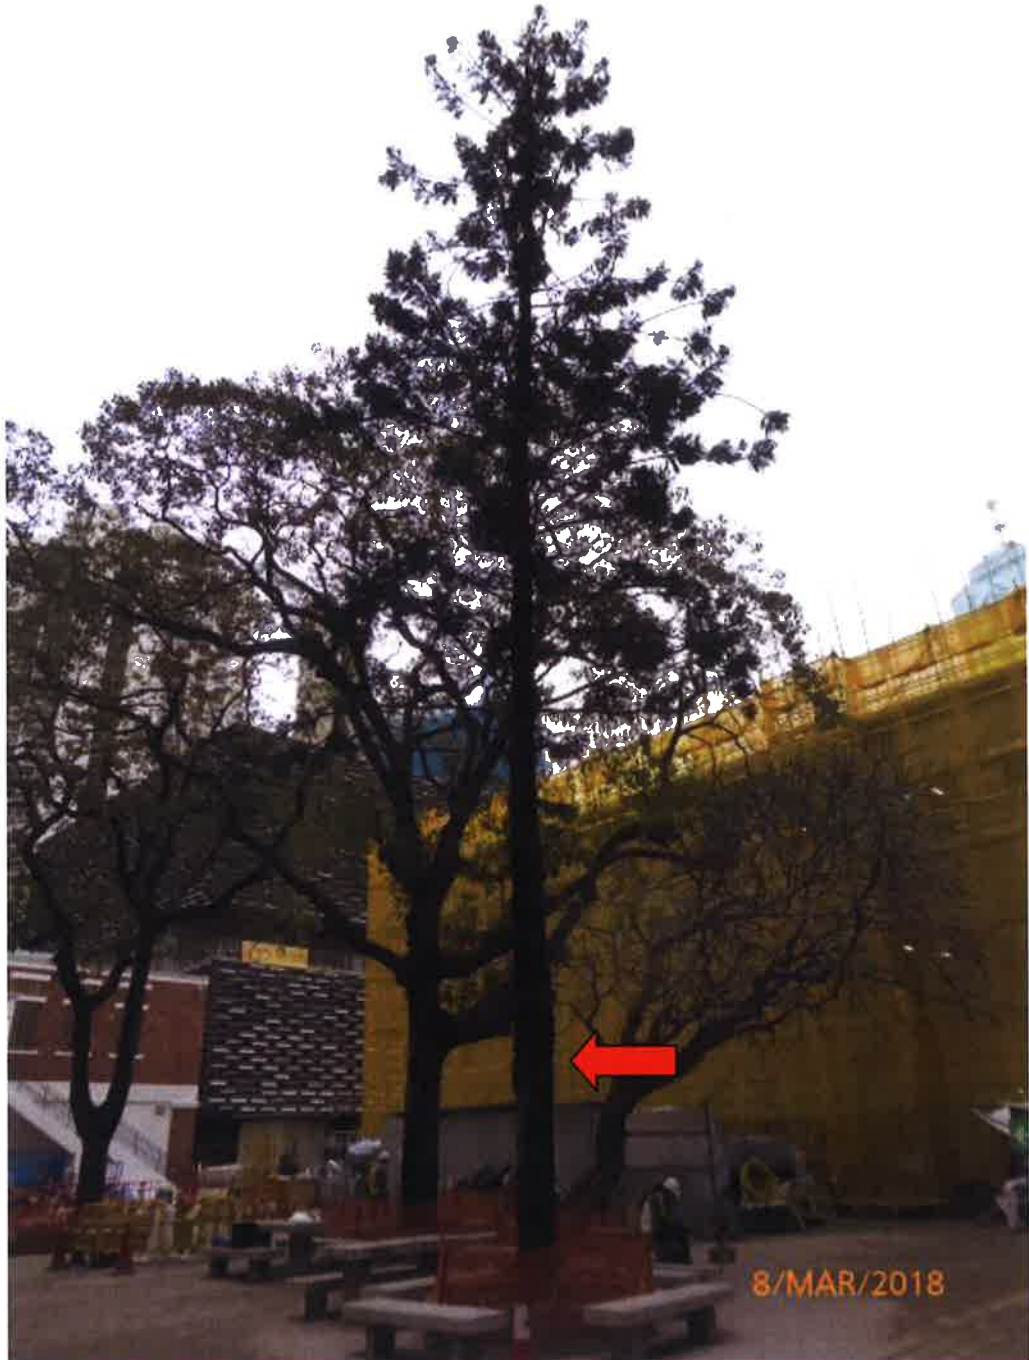
Fig. 12 Overall view of Tree-9 during inspection on 8th March 2018.

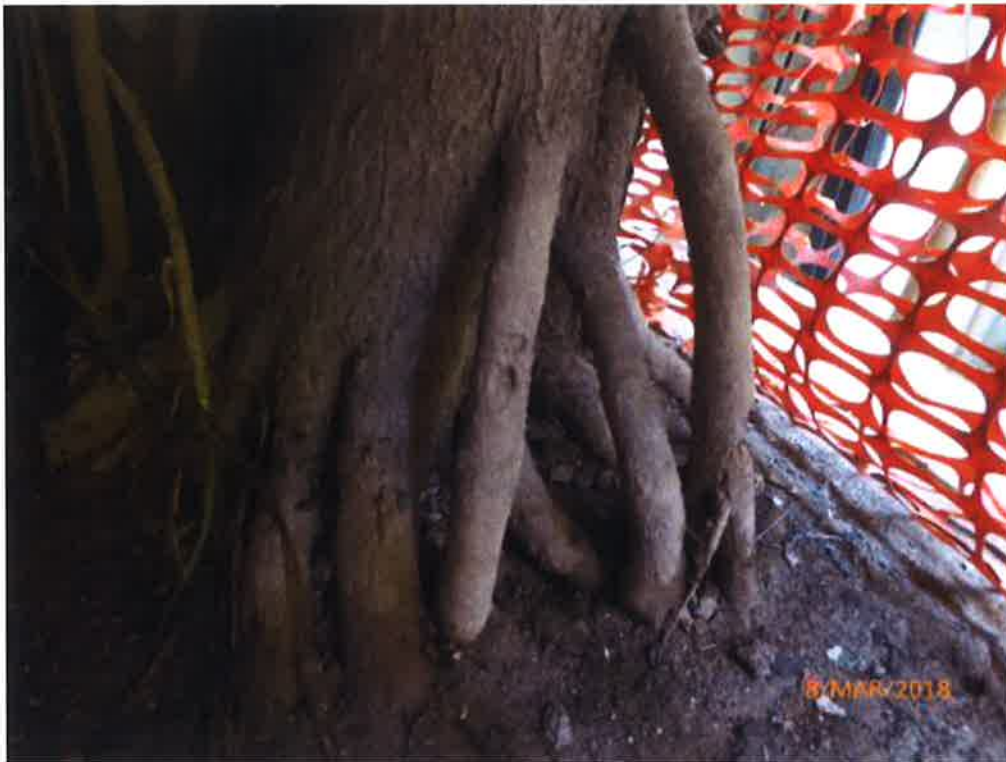
Fig. 2 Root collar is normal.

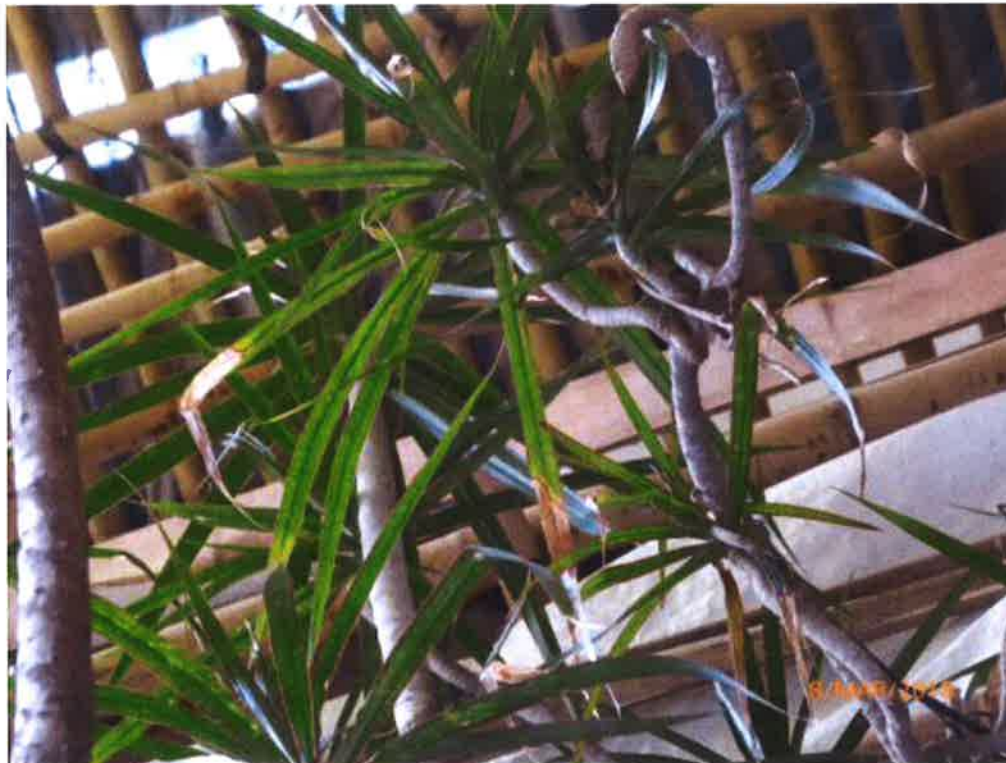
Fig. 7 Withered leaves still appear on the upper branches of Tree-11.

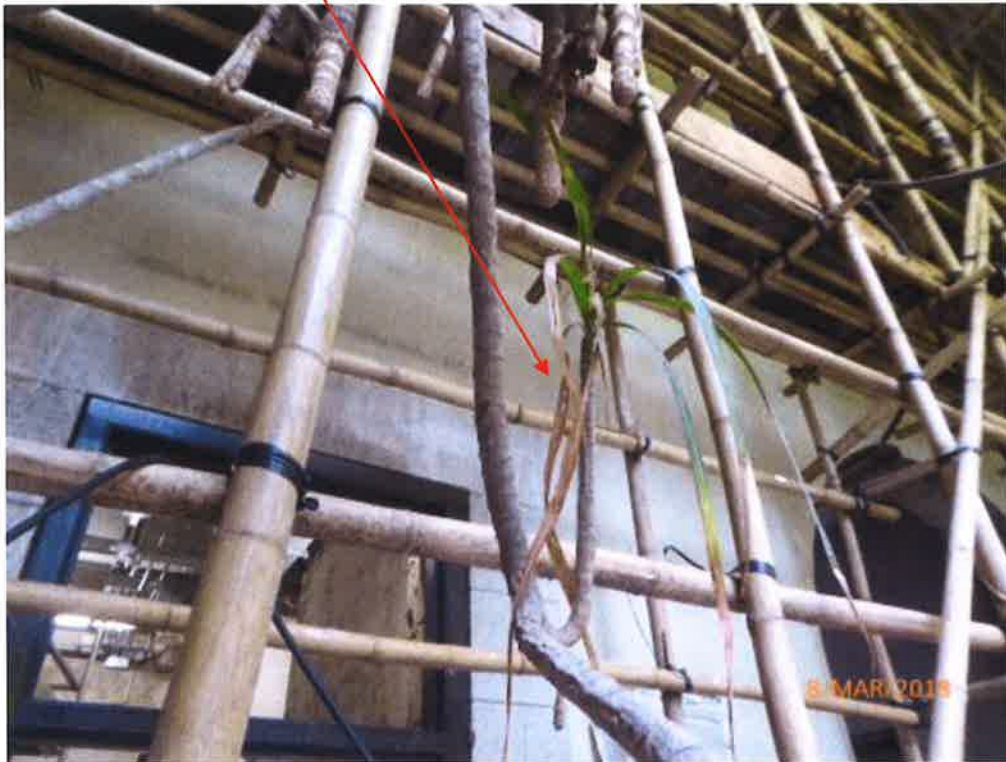
Fig. 8 Withered leaves also appear on the lower branches of Tree-11.

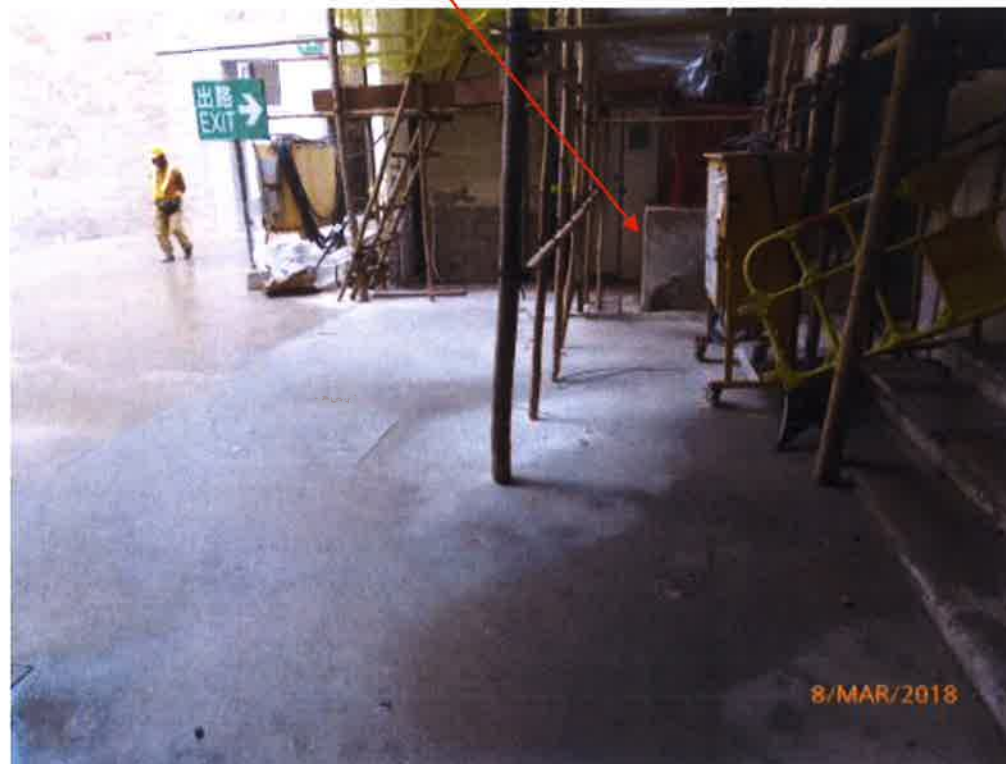
Fig. 11 The site near the planter appears clean and tidy.

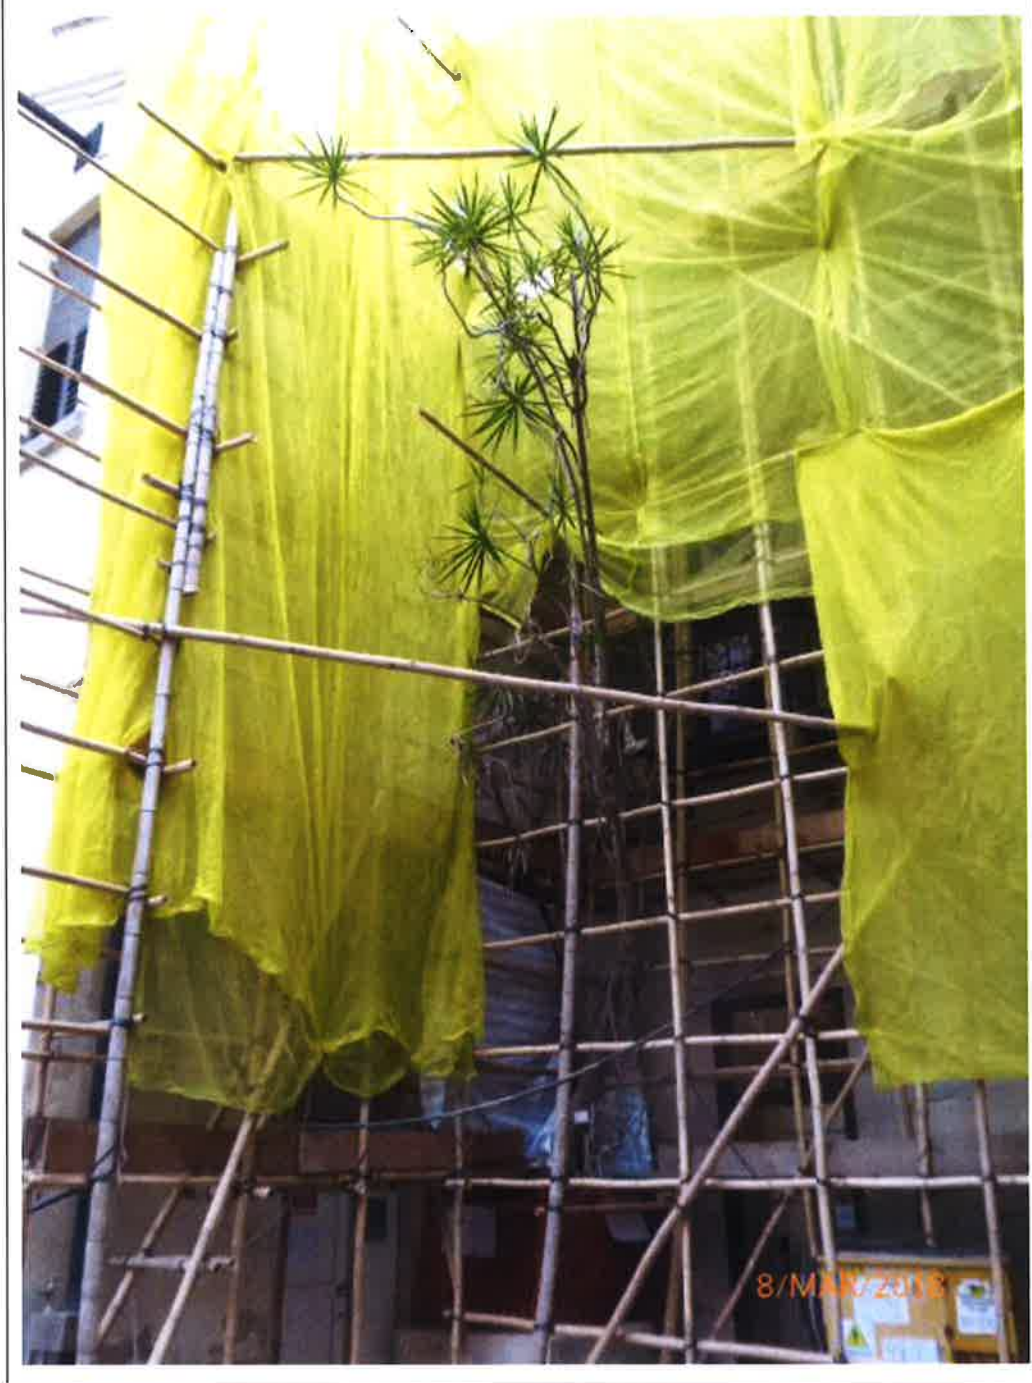
Fig. 12 Overall view of Tree-11 during inspection on 8th March 2018.
