Central Police Station Conservation
and Revitalisation Project:
63rd Monthly EM&A Report
(1 January to 31 January 2017)

Issue Date: February 2017

Environmental Resources Management

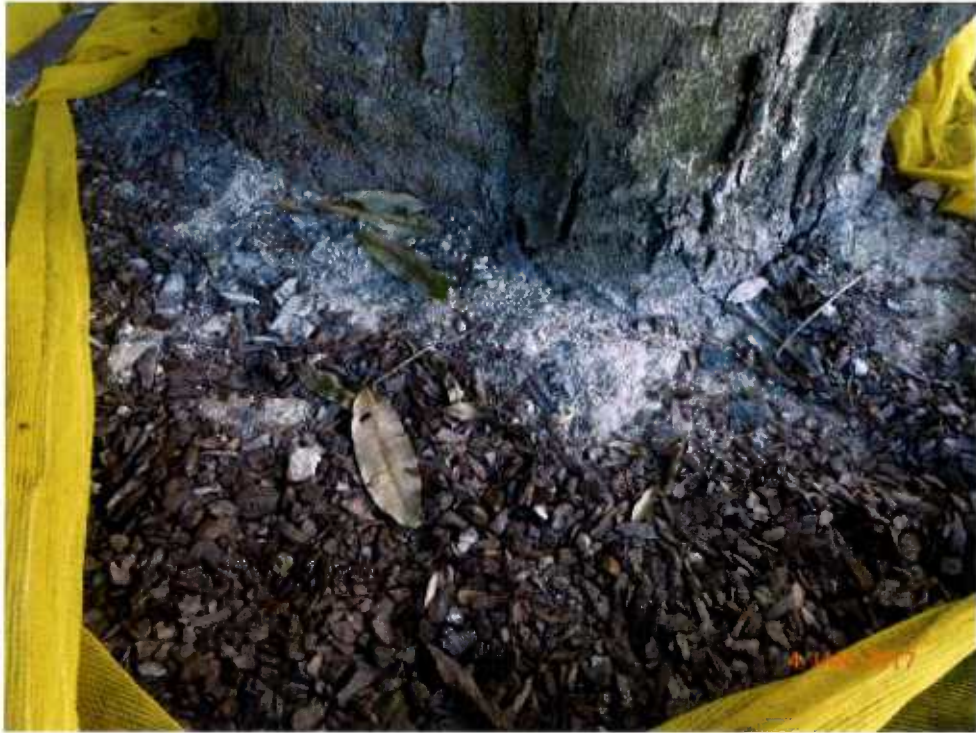
Fig. 3 Health condition of the lower trunk is fair.

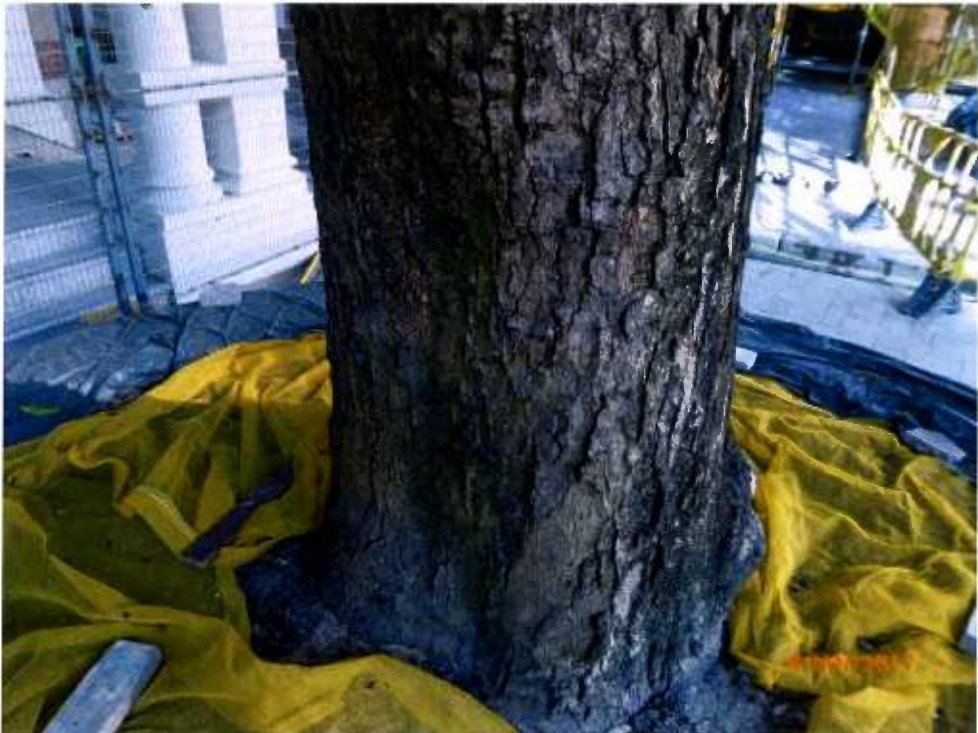
Fig. 4 Health condition of the mid trunk is fair.

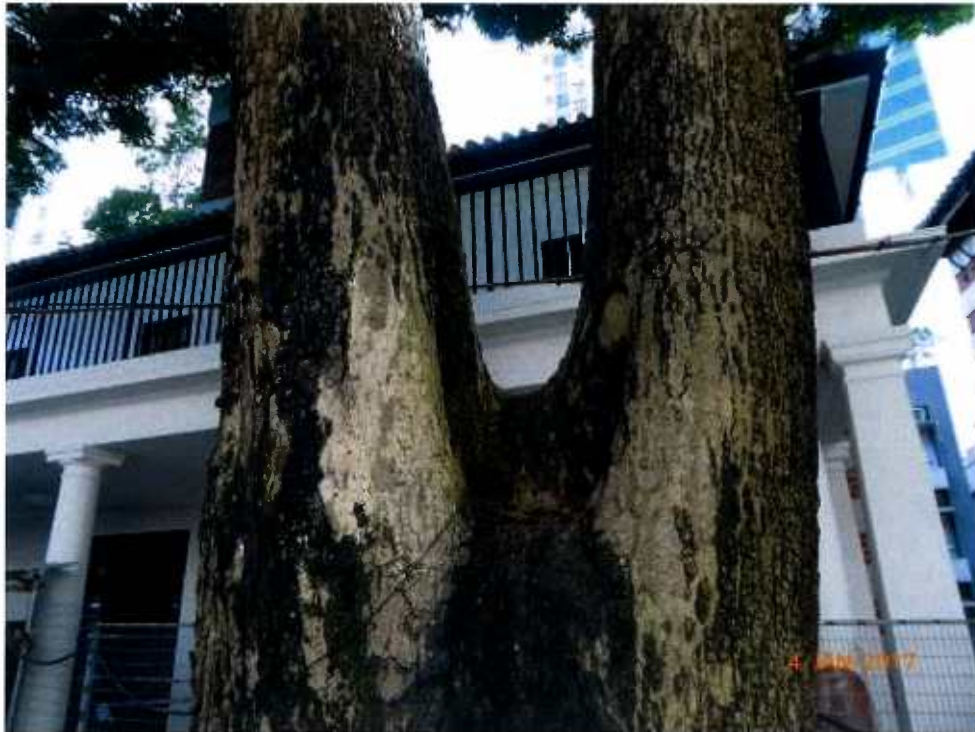
Fig. 5 Health condition of the upper trunk also is fair.

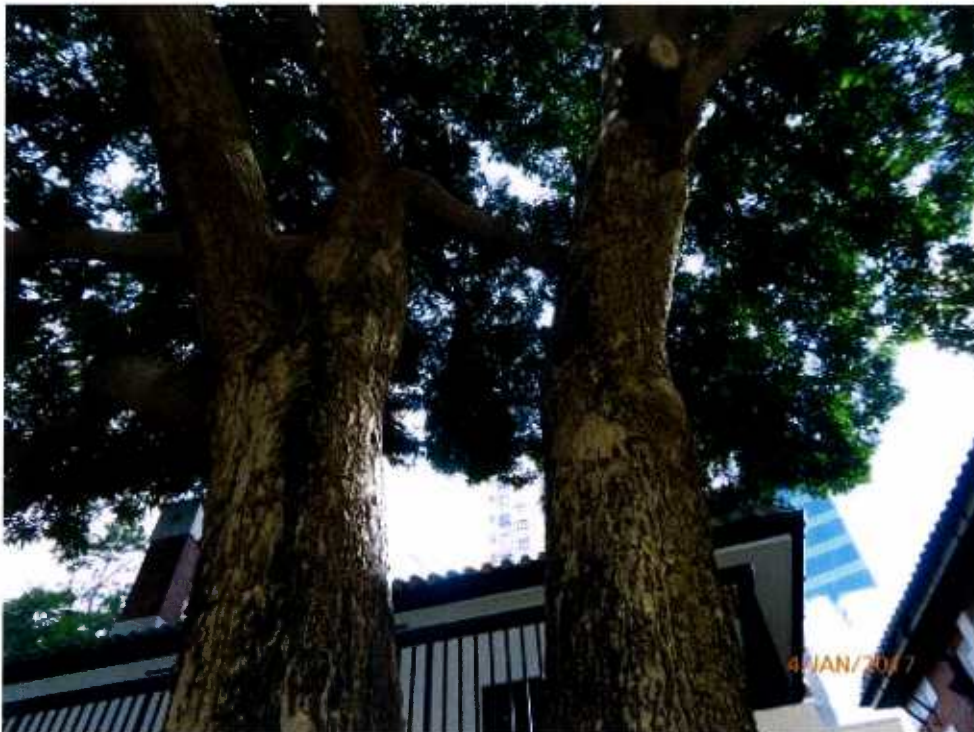
Fig. 6 The crown is full of vigorous and green leaves.

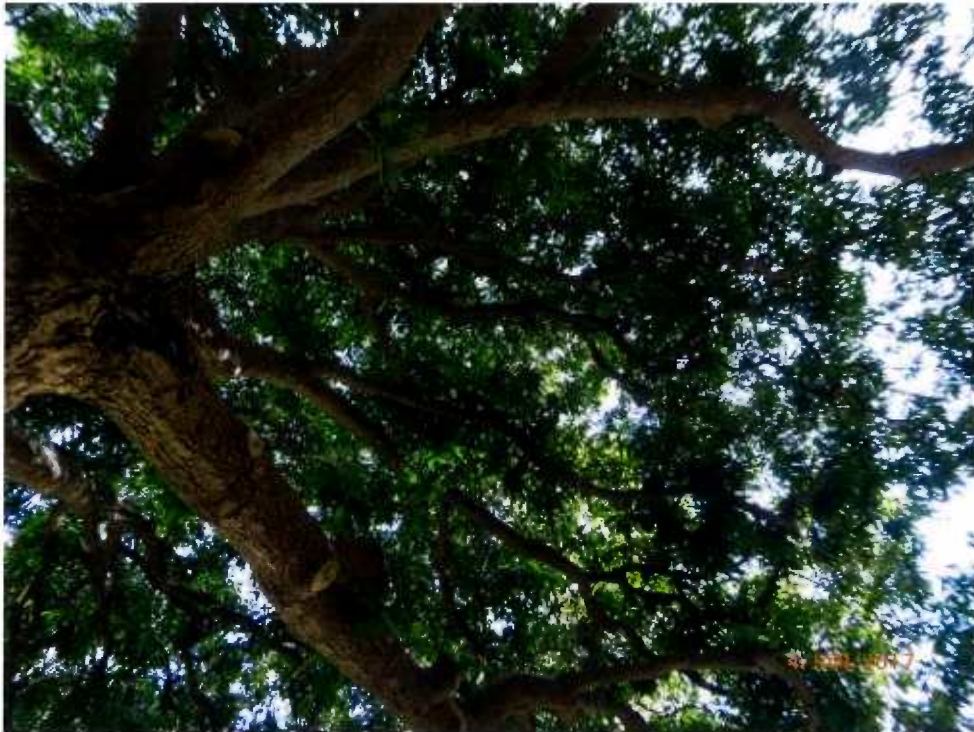
Fig. 7 Vigorous and green leaves also are growing on the lower branches.

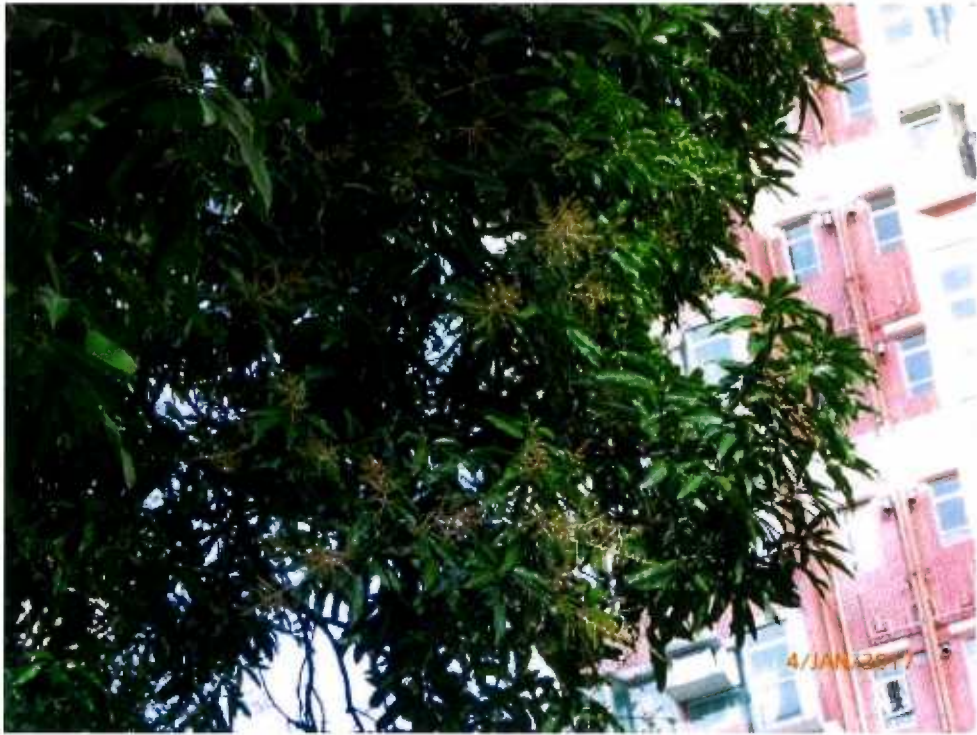
Fig. 9 The mango is still hanging on the tree.

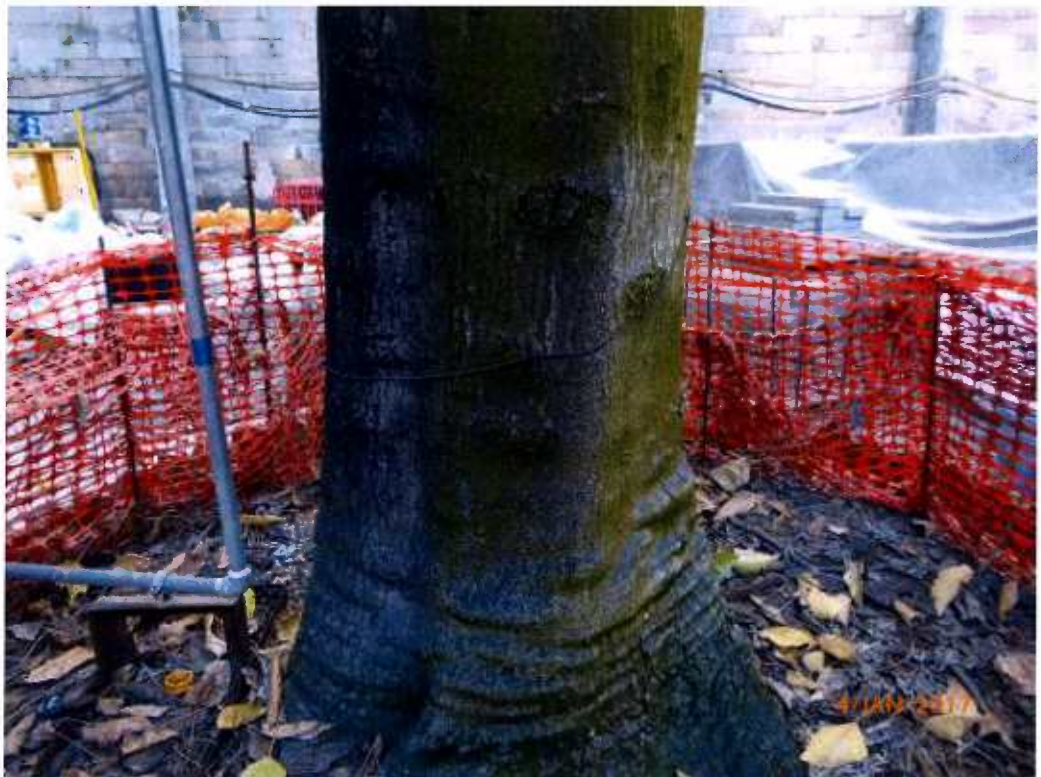
Fig. 4 Health condition of the mid trunk is fair.

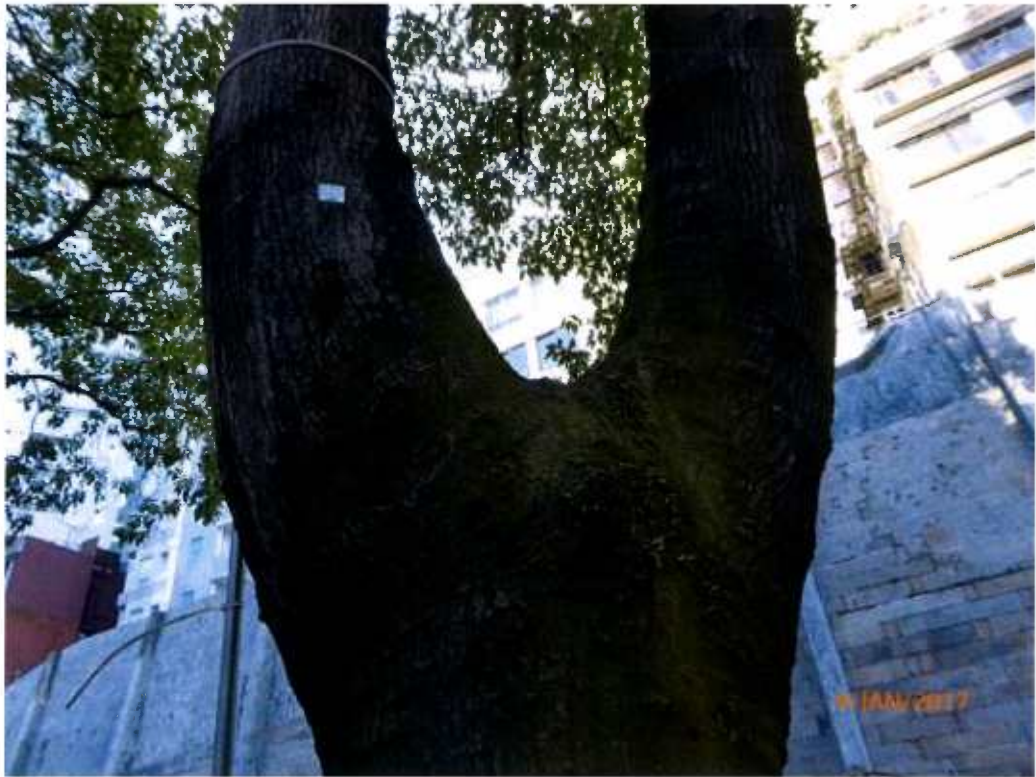
Fig. 5 Health condition of the upper trunk also is fair.

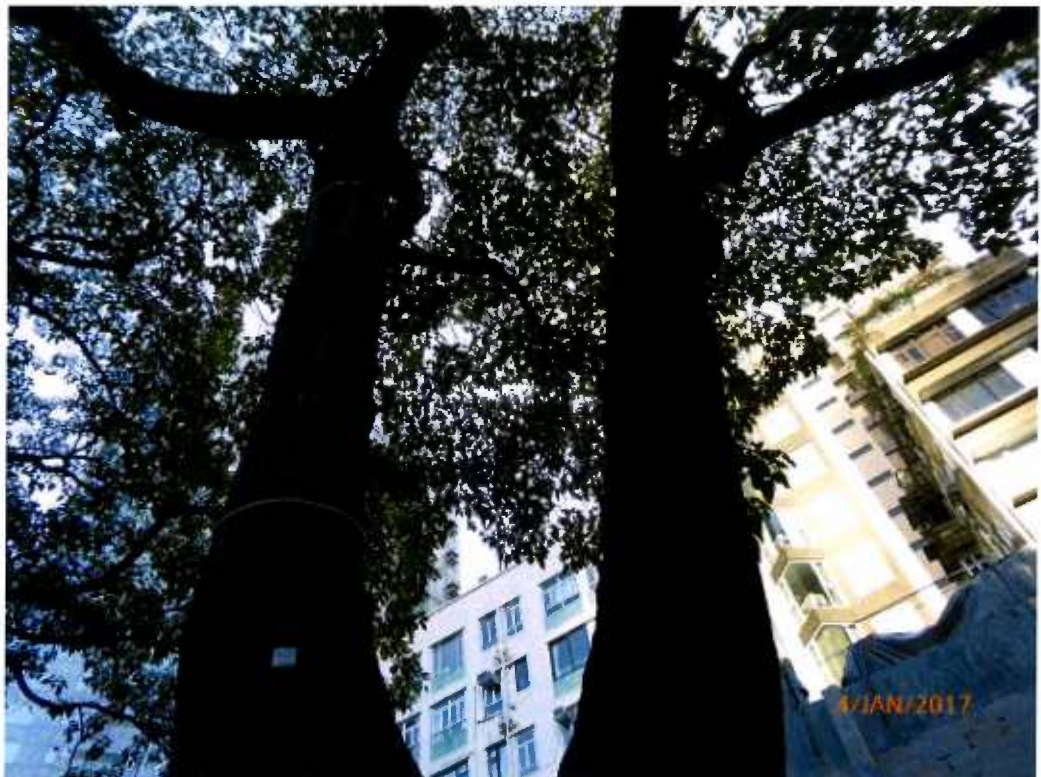
Fig. 6 The crown is full of vigorous and green leaves.

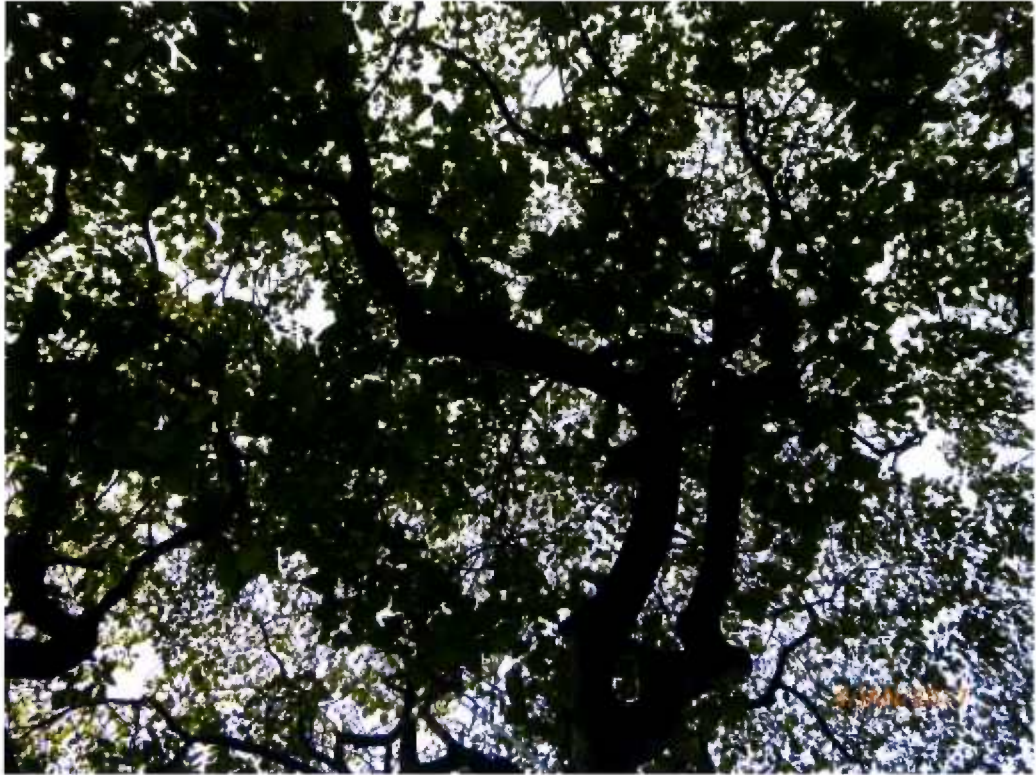
Fig. 7 Vigorous and green leaves also are growing on the lower branches.

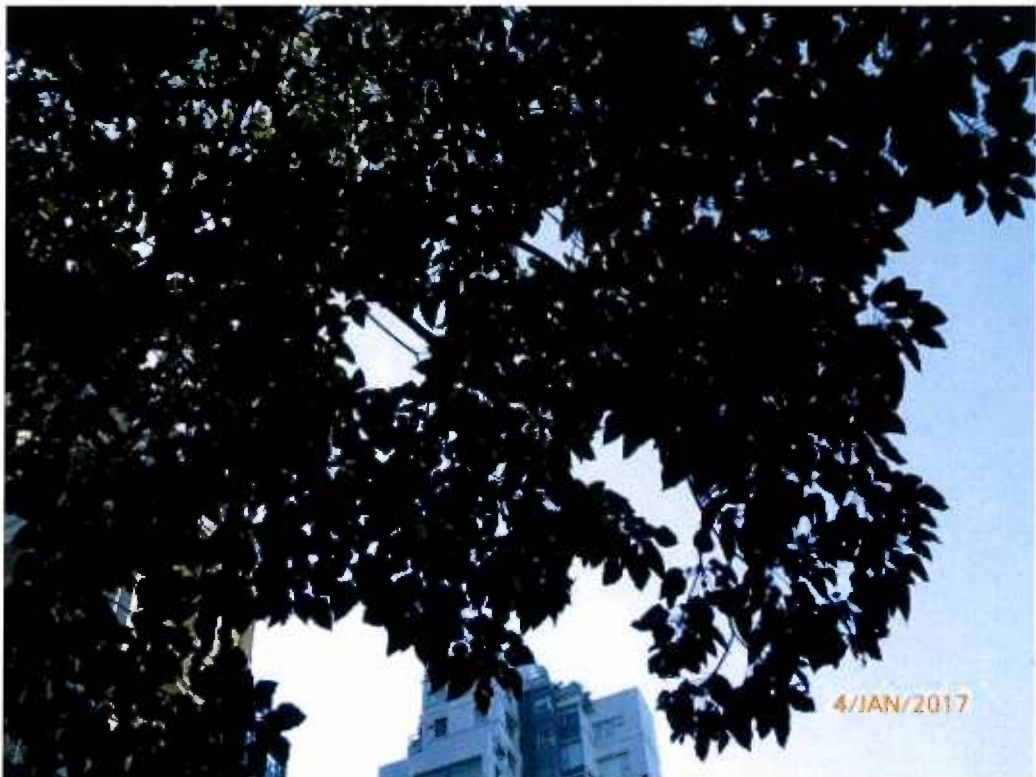
Fig. 8 As winter has come, some leaves on the tree become faded.

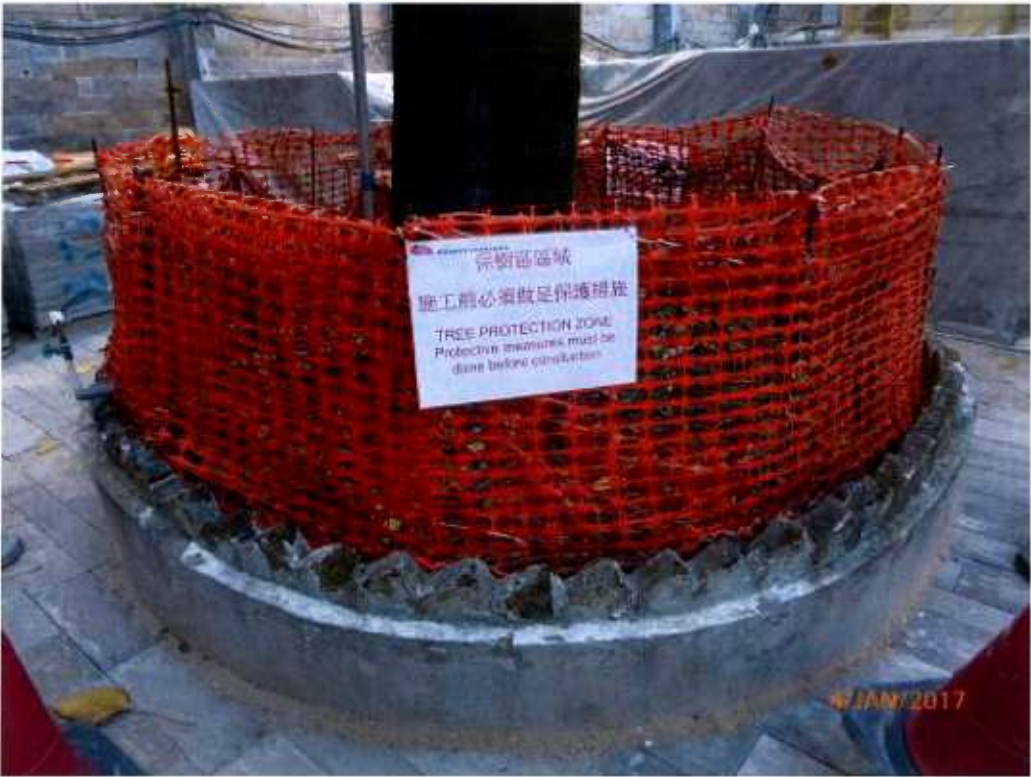
Fig. 11 The site near the planter is clean and tidy.

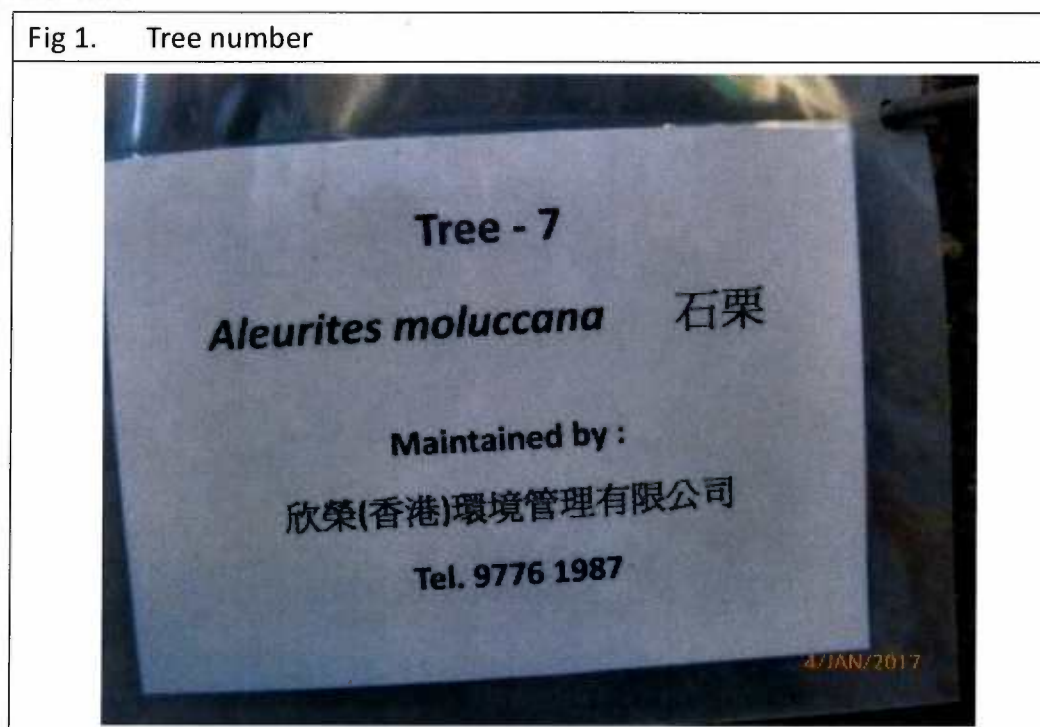
Fig 2. Root collar is normal. The planter is covered with mulch and leaves.

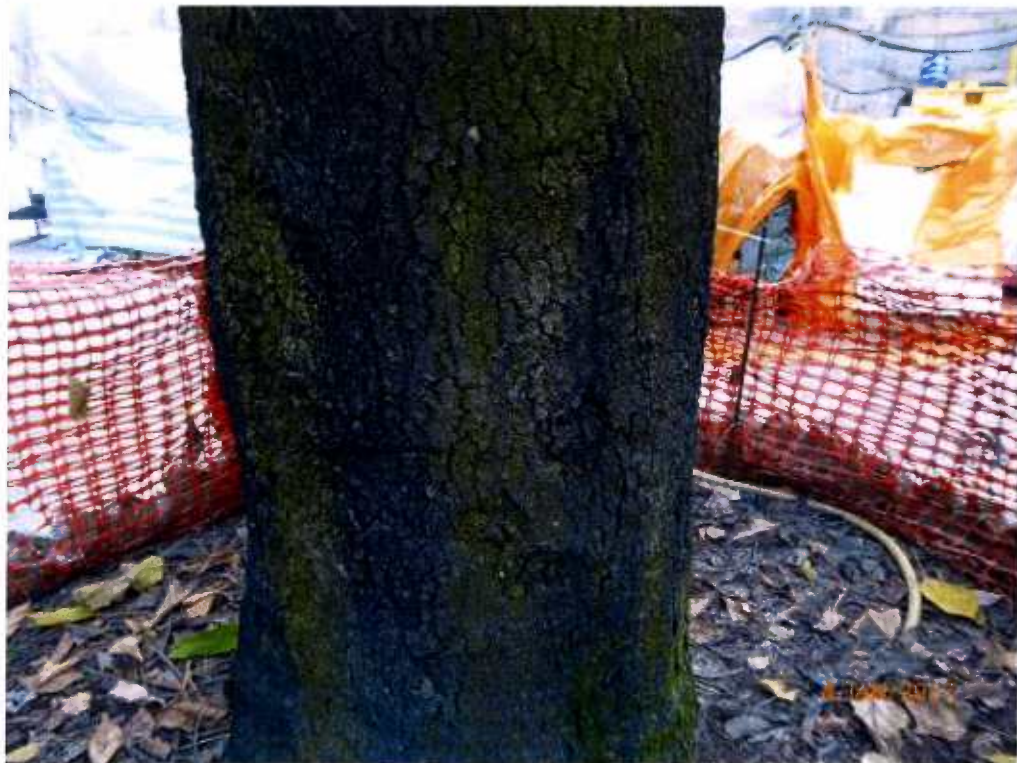
Fig. 4 Health condition of the mid trunk is fair.

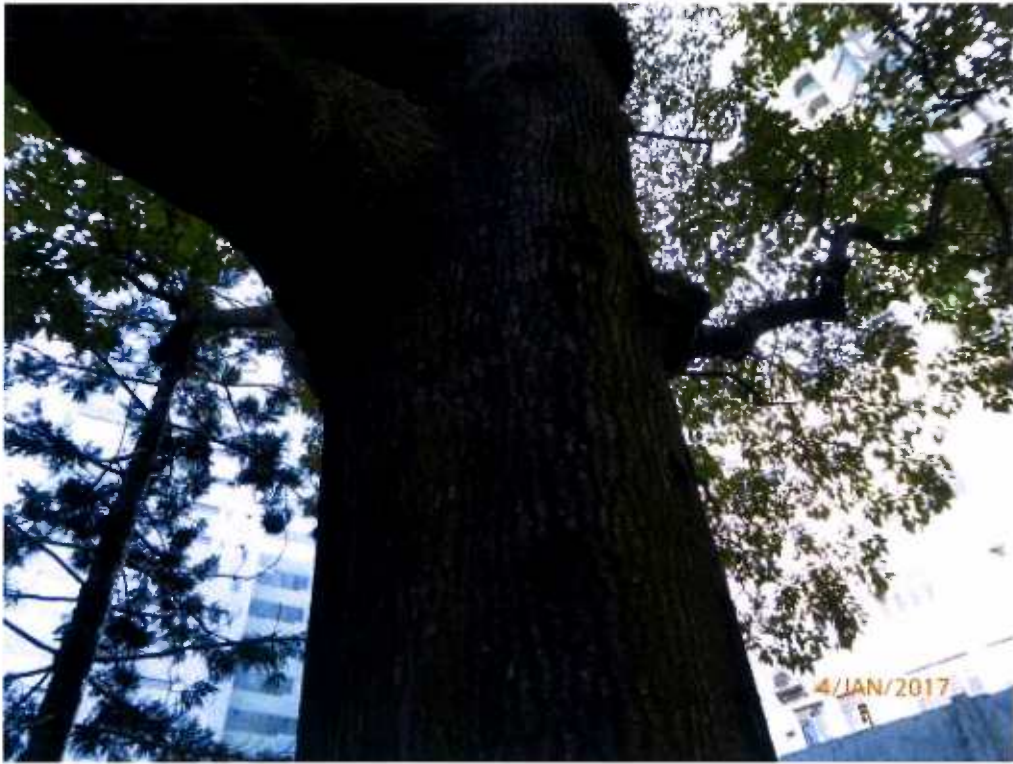
Fig. 5 Health condition of the upper trunk also is fair.

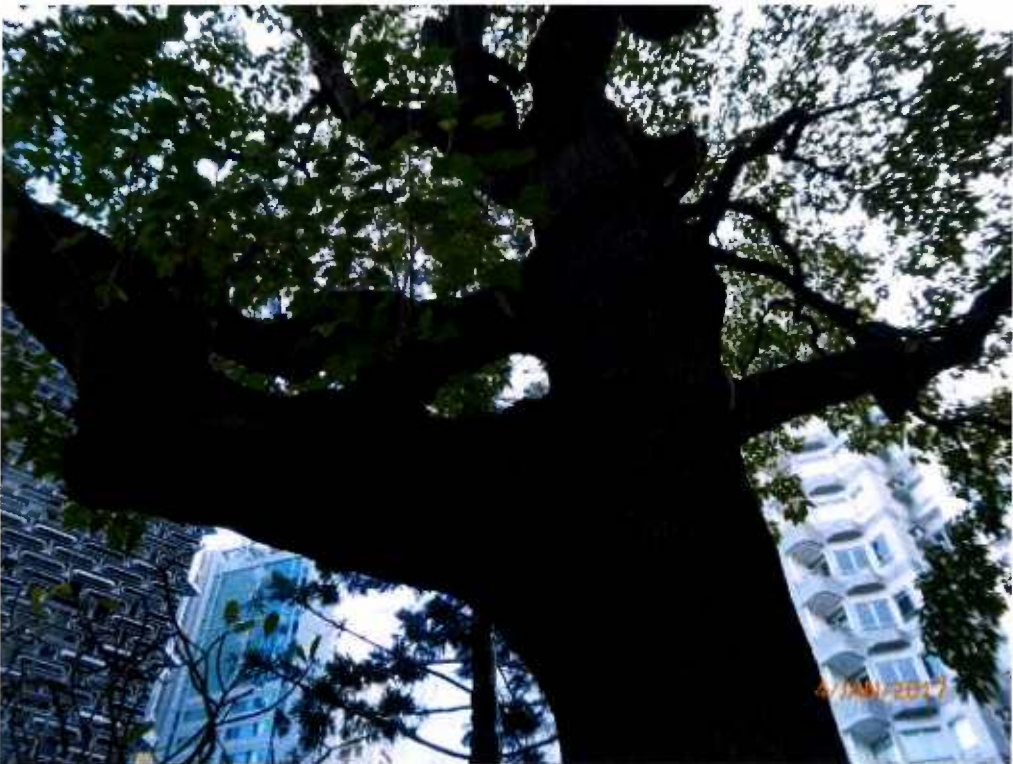
Fig. 6 The crown is full of vigorous and green leaves.

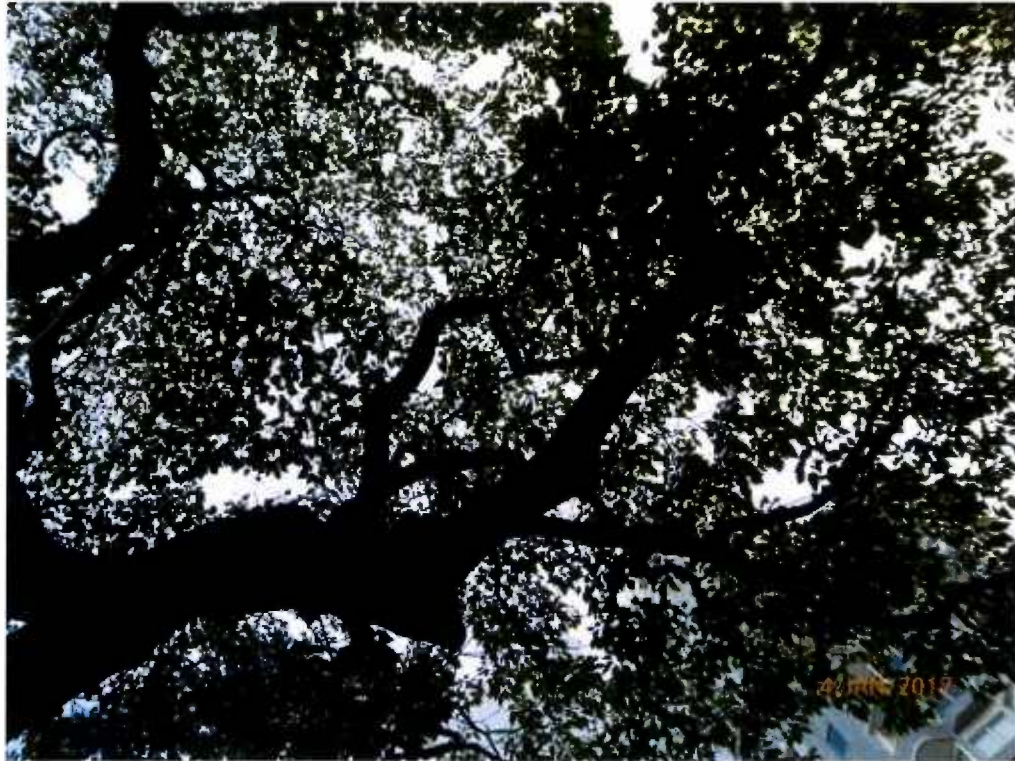
Fig. 7 Vigorous and green leaves also appear on the lower branches.

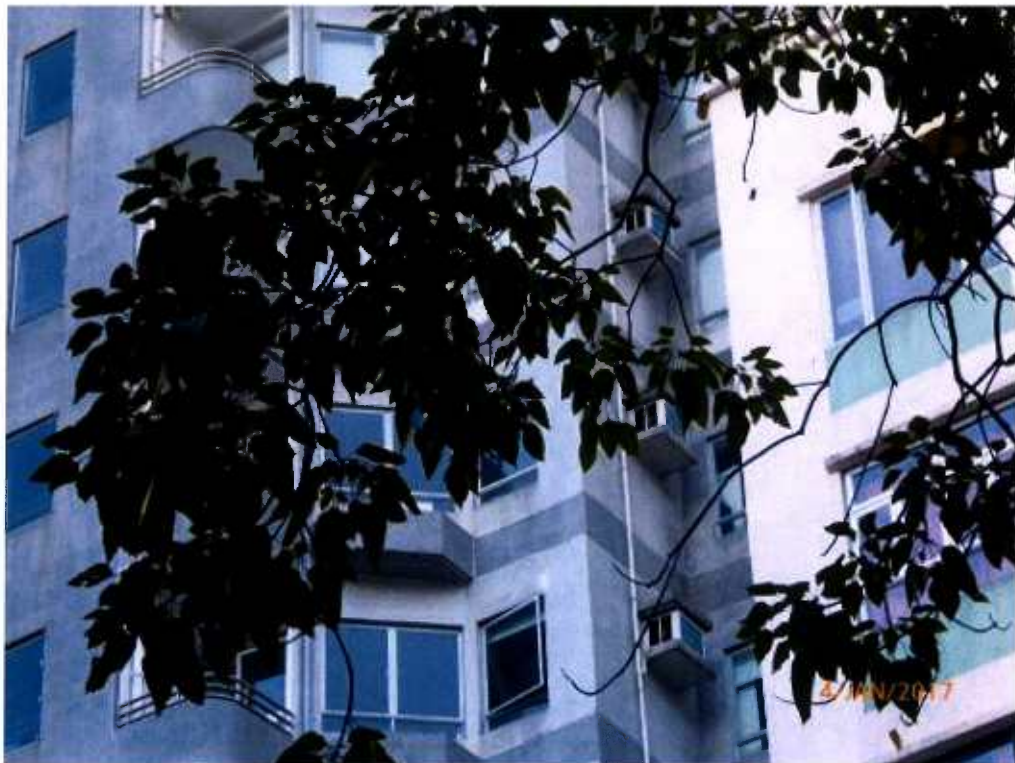
Fig. 8 As winter has come, some leaves on the tree become faded.

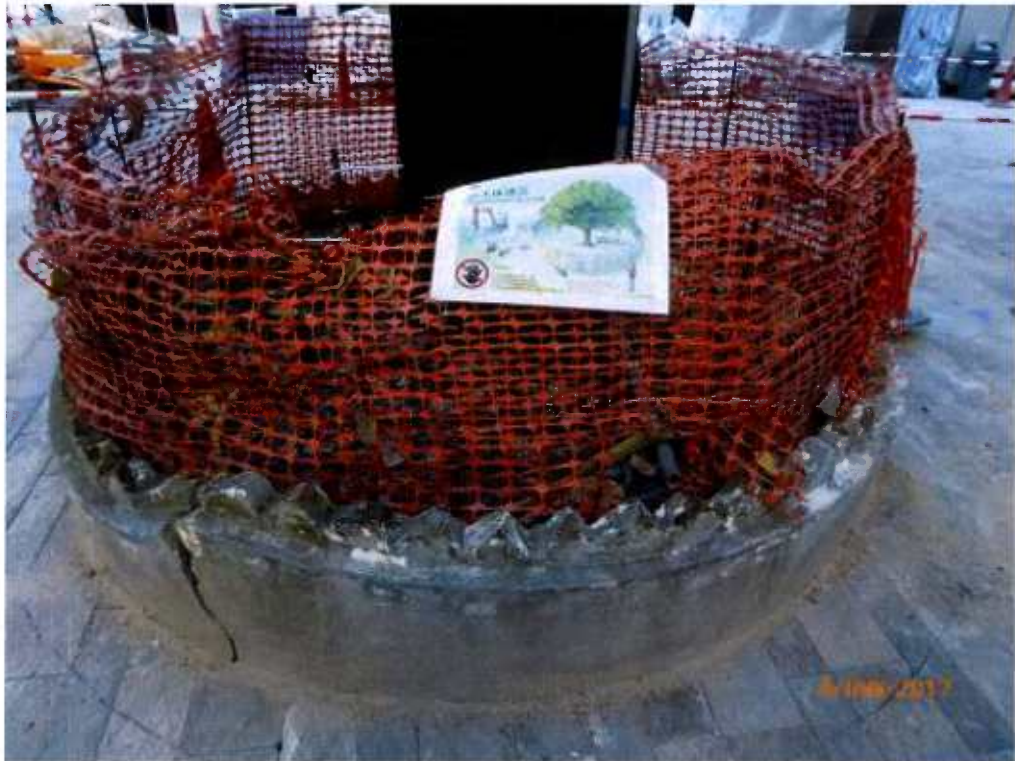
Fig. 11 The site near the tree appears clean and tidy.

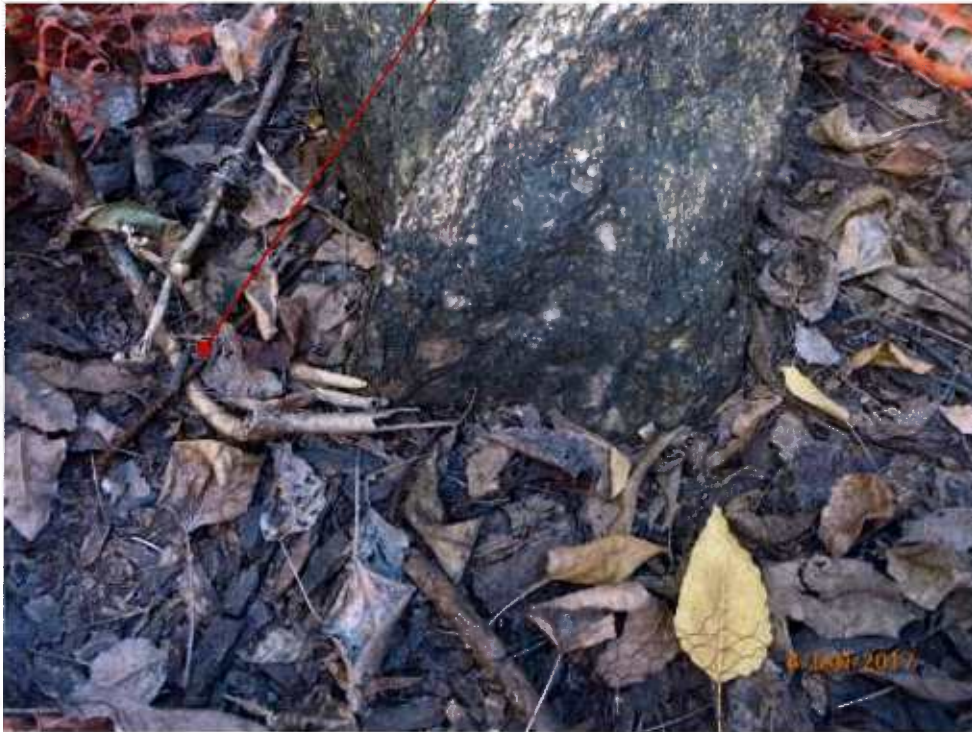
Fig 3 Health condition of the lower trunk is fair.

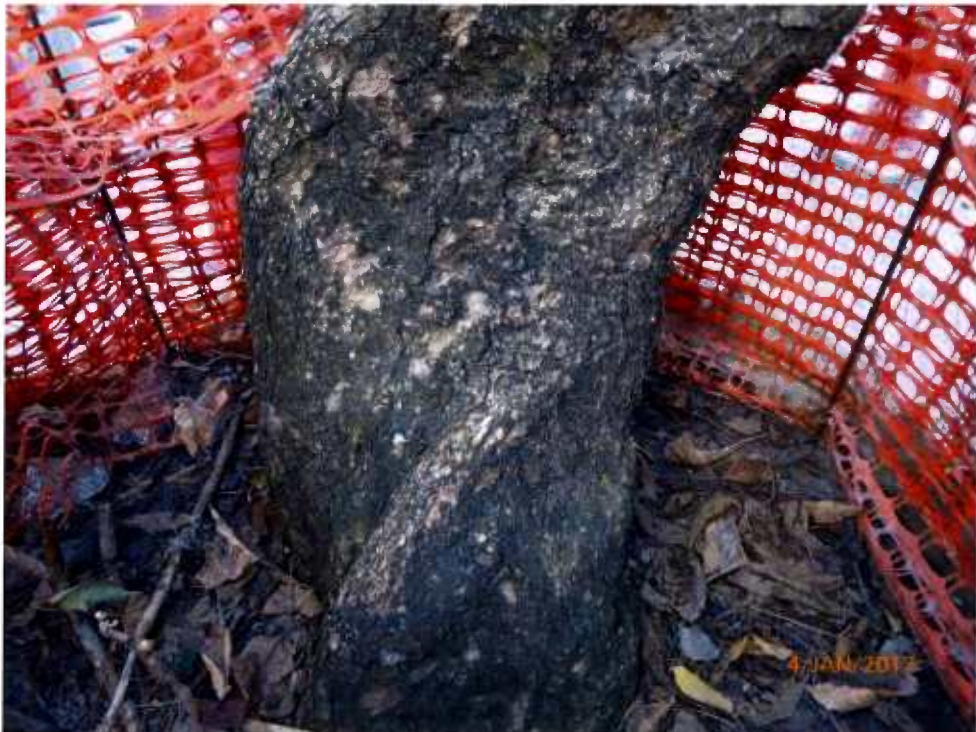
Fig. 4 Health condition of the mid trunk is fair.

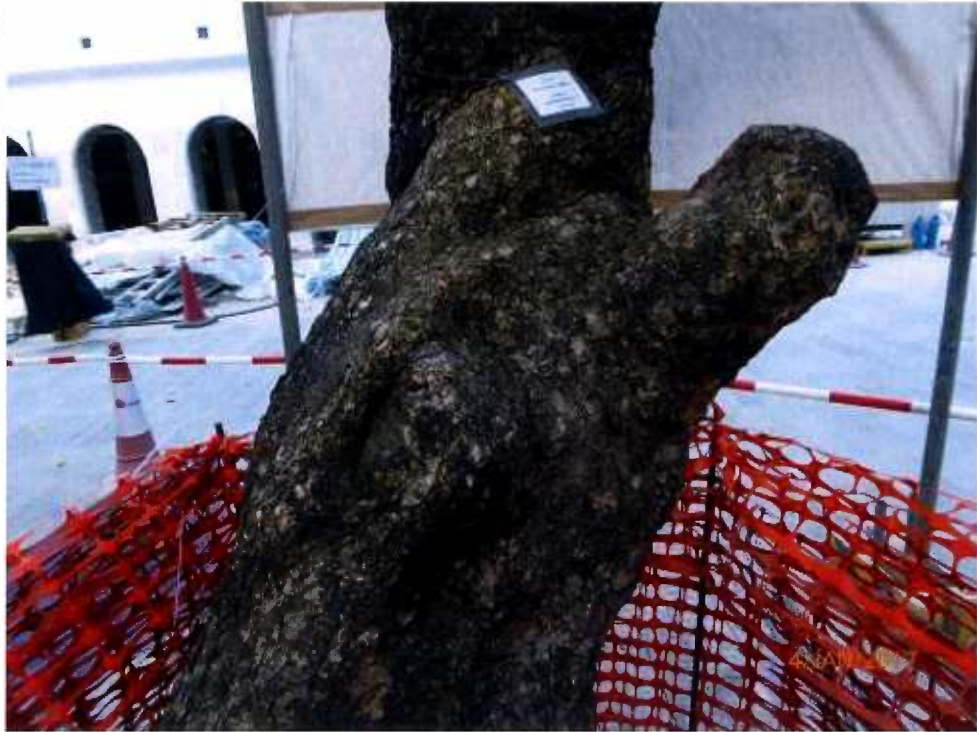
Fig. 5 Health condition of the upper trunk is fair..

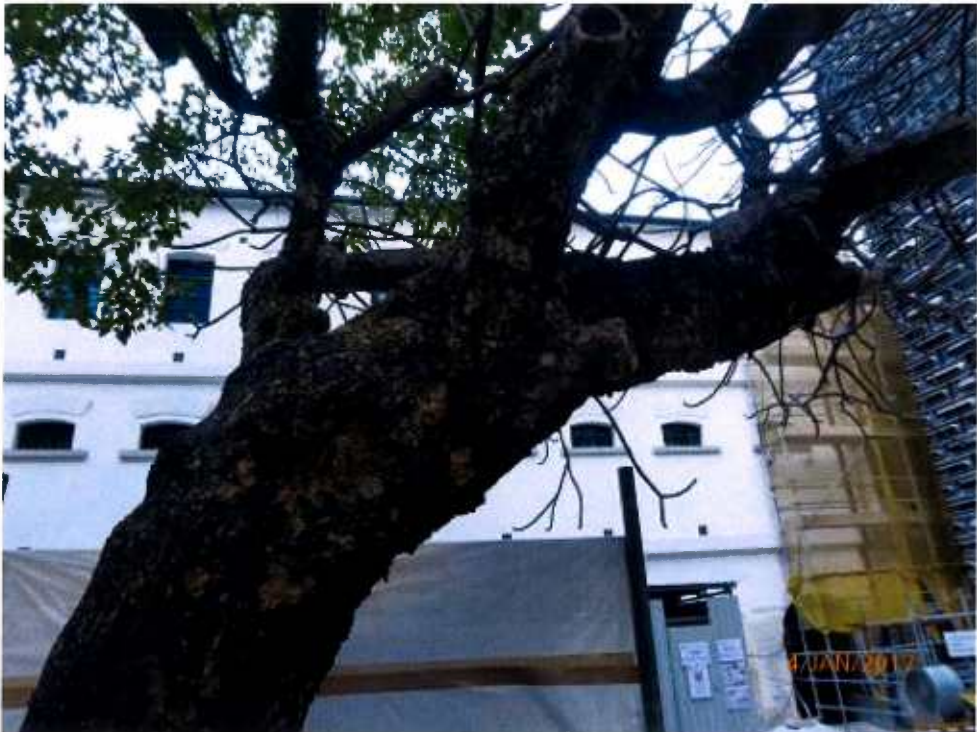
Fig. 6 As winter has come, leaves on Tree-8 become sparse.

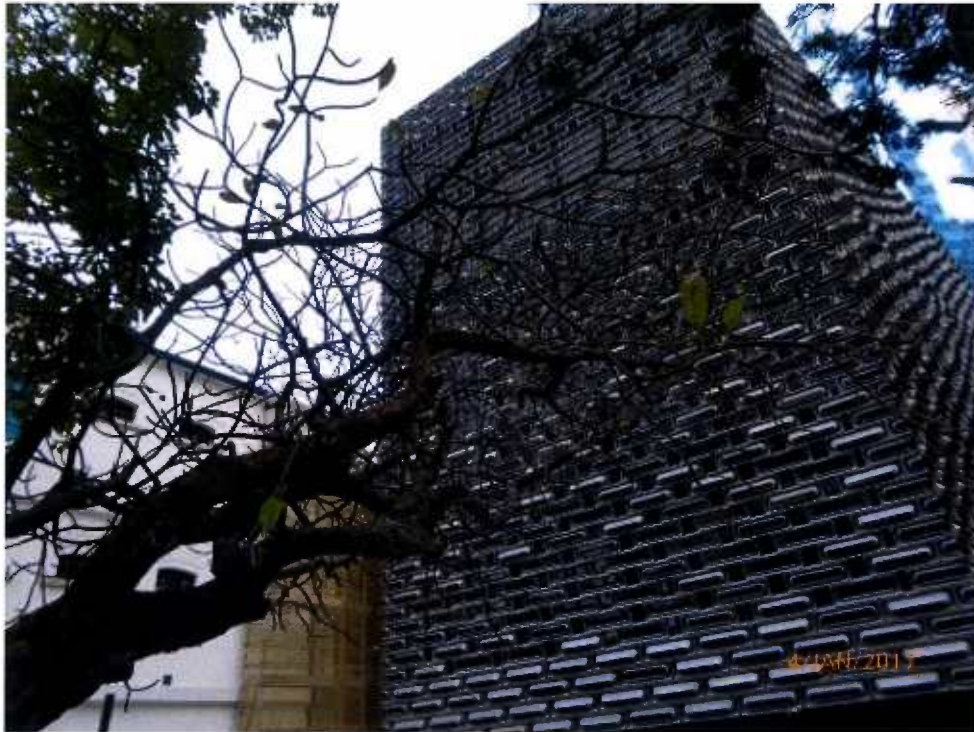
Fig. 7 Only a few leaves still remain on the tree.

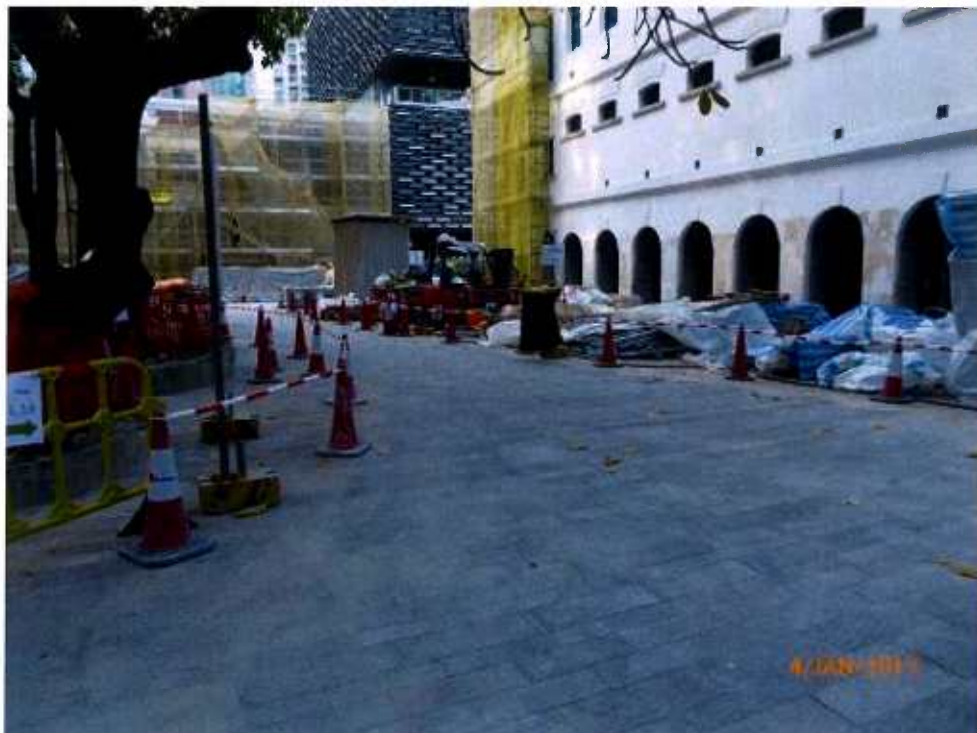
Fig. 10 Overall view of Tree-8 during inspection on 4th January 2017.

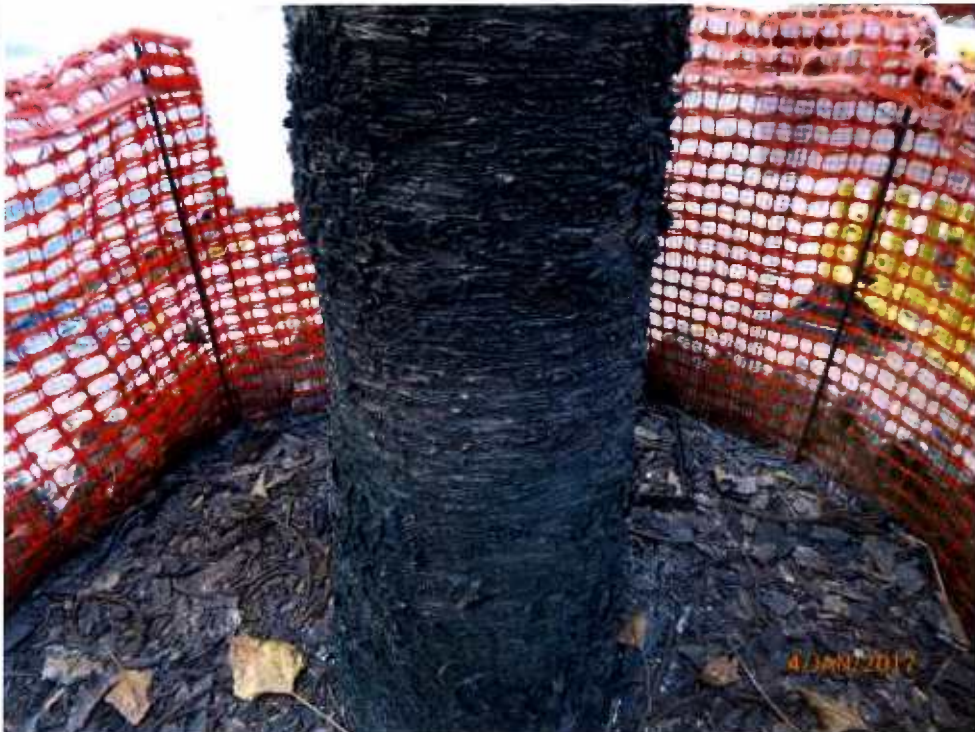
Fig. 4 Health condition of the mid trunk is fair.

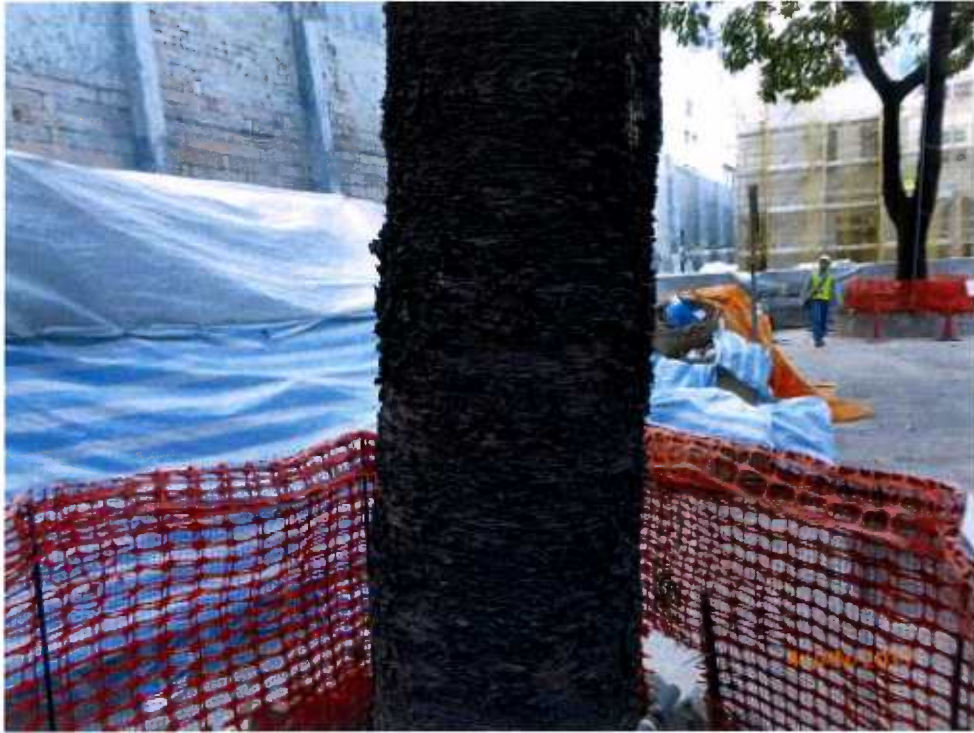
Fig. 5 Health condition of the upper trunk also is fair.

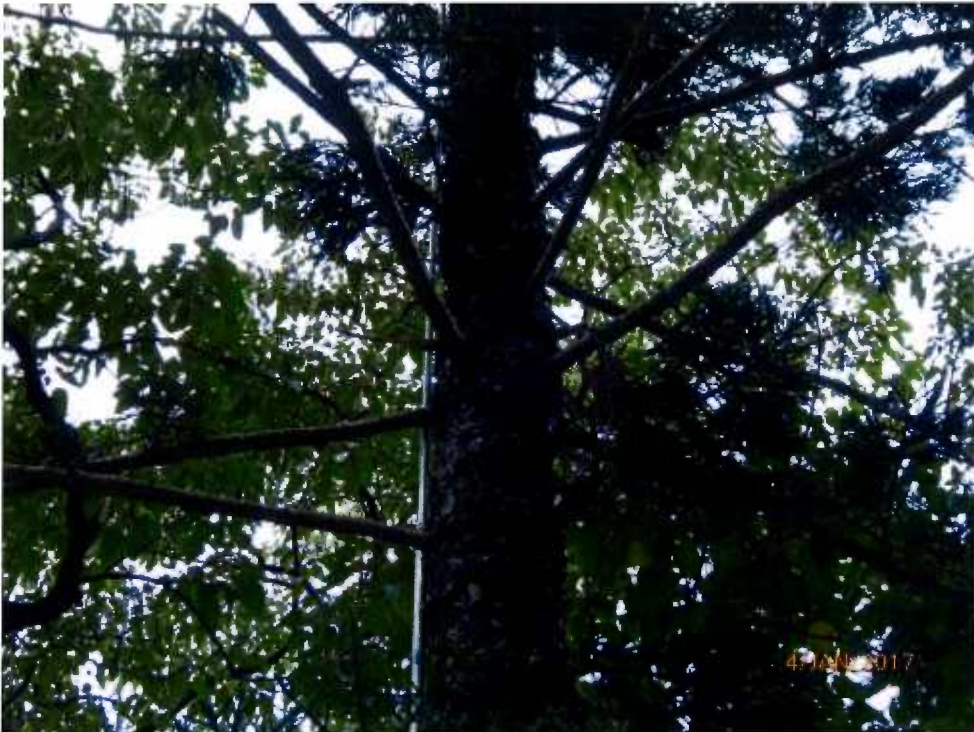
Fig. 6 The crown is full of vigorous and green leaves.

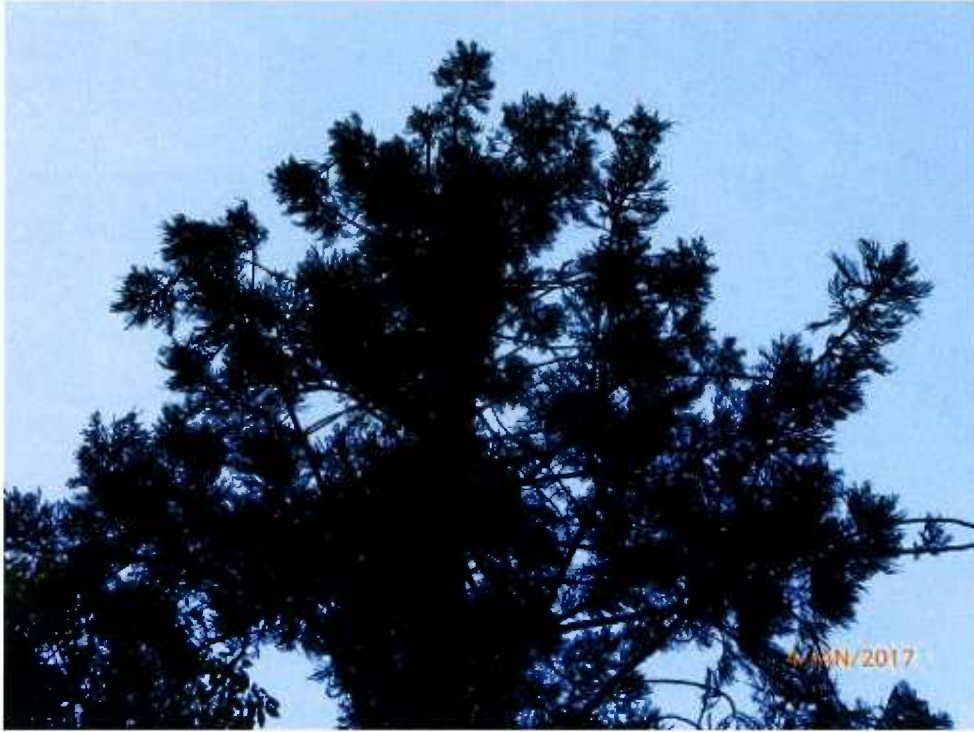
Fig. 7 Vigorous and green leaves also are growing on the lower branches.

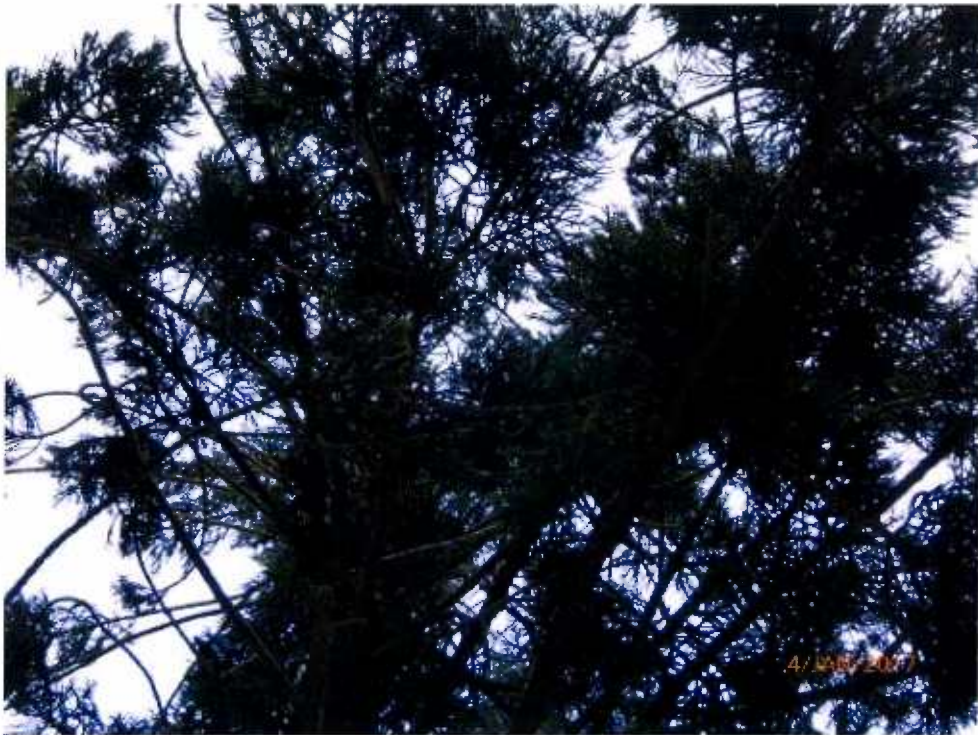
Fig. 8 The fresh fruit still appears on the tree.
