Central Police Station Conservation
and Revitalisation Project:
63rd Monthly EM&A Report
(1 January to 31 January 2017)

Issue Date: February 2017

Environmental Resources Management

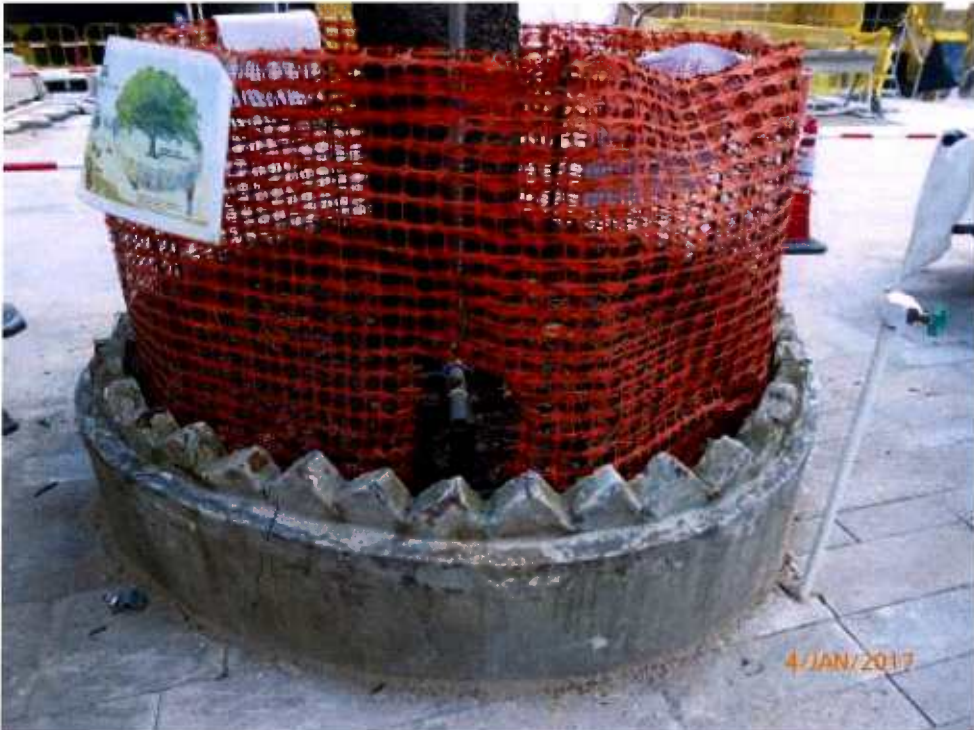
Fig. 10 The site near the planter is clean and tidy.

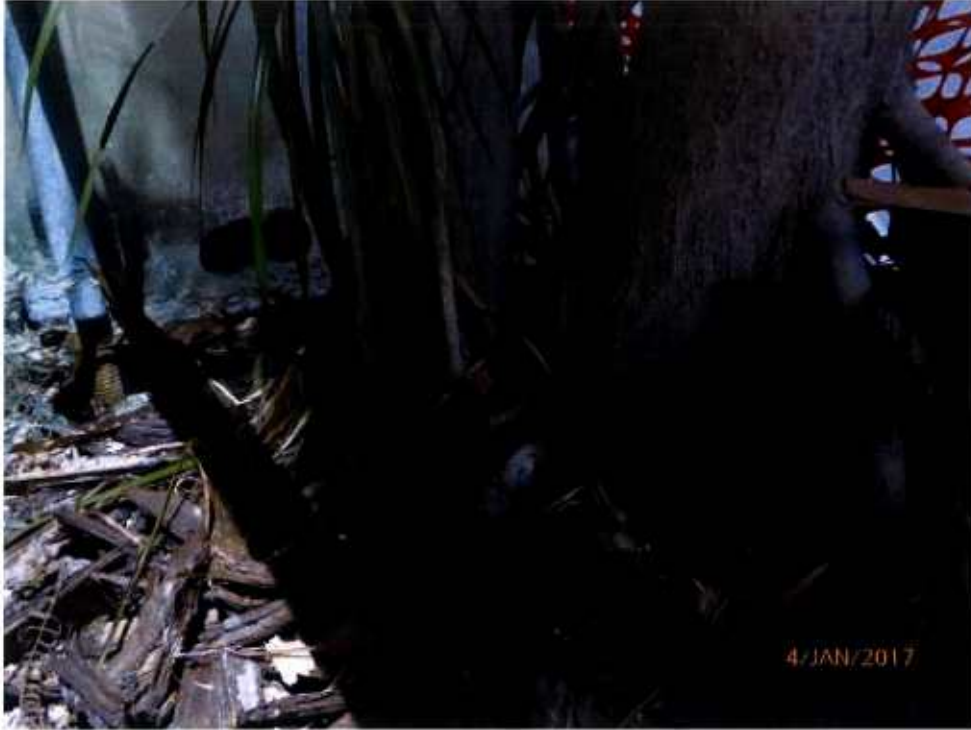
Fig. 3 Health condition of the lower trunk is fair.

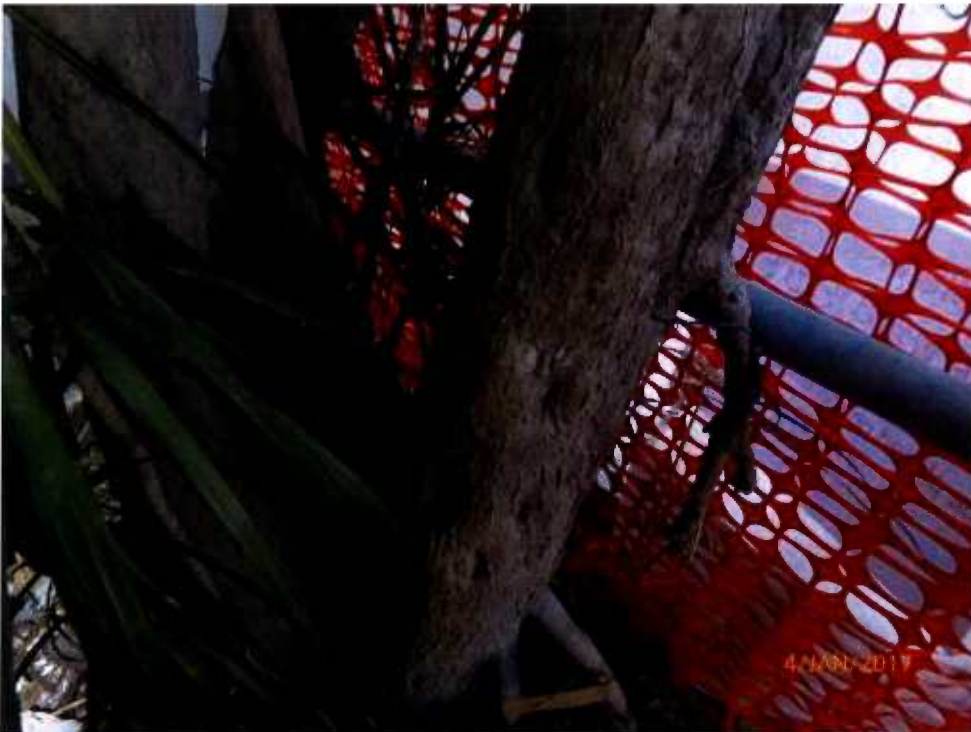
Fig. 4 Health condition of the mid trunk is fair.

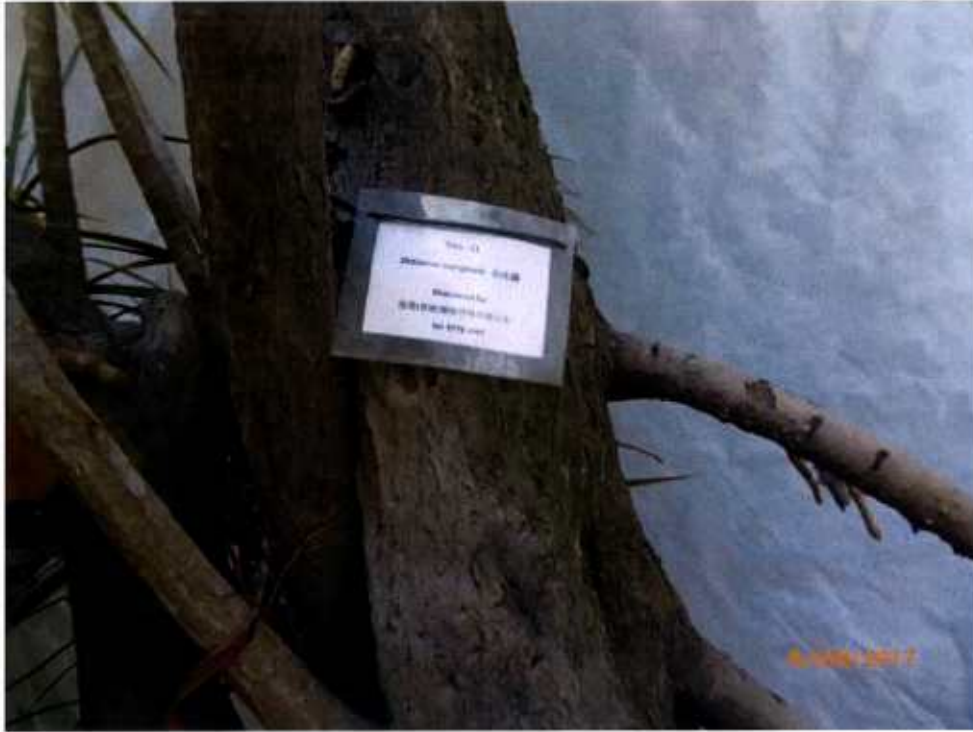
Fig. 5 Health condition of the upper trunk also is fair..
