The Jockey Club CPS Limited

Central Police Station Conservation  
and Revitalisation Project:  
*70<sup>th</sup> Monthly EM&A Report*  
*(1 August to 31 August 2017)*

Issue Date: September 2017

**Environmental Resources Management**

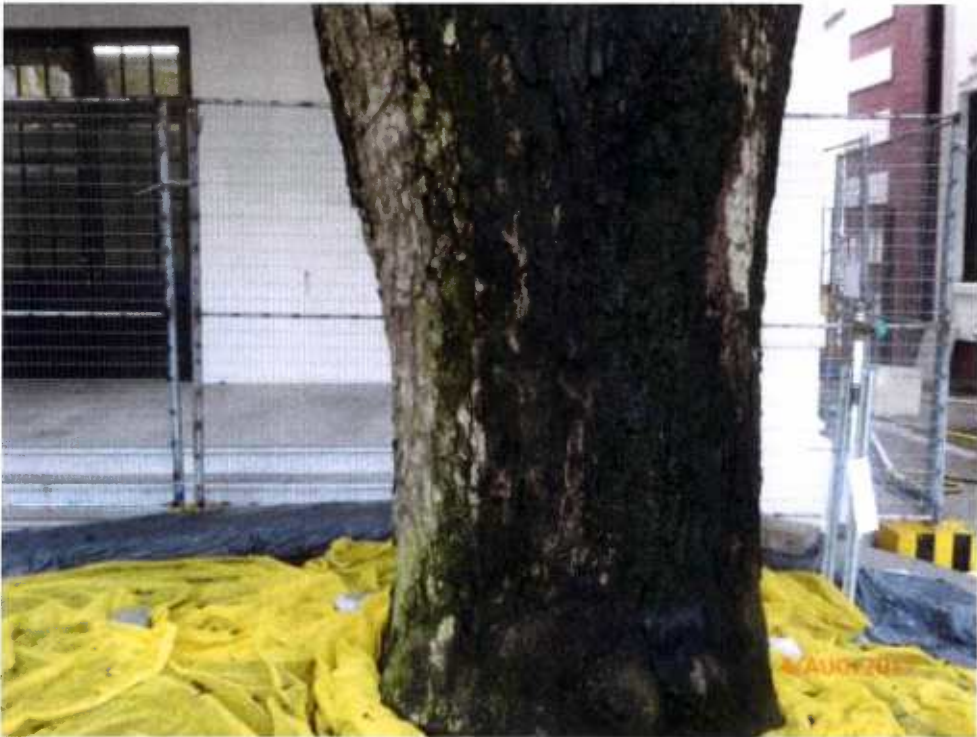
Fig. 3 Health condition of the lower trunk is fair.

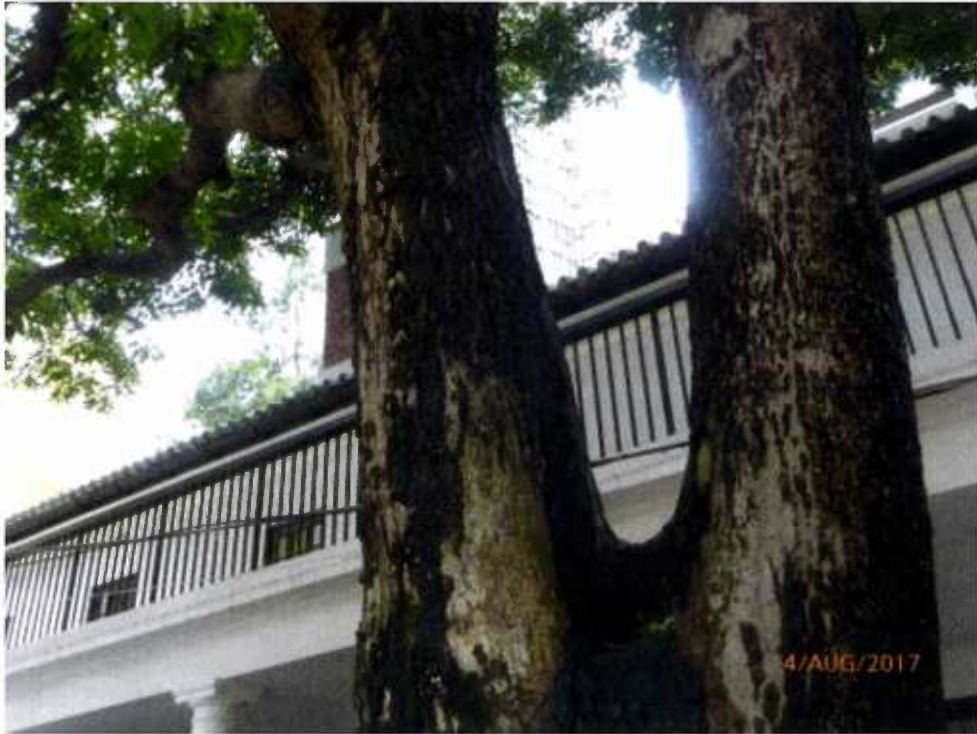
Fig. 4 Health condition of the mid trunk is fair.

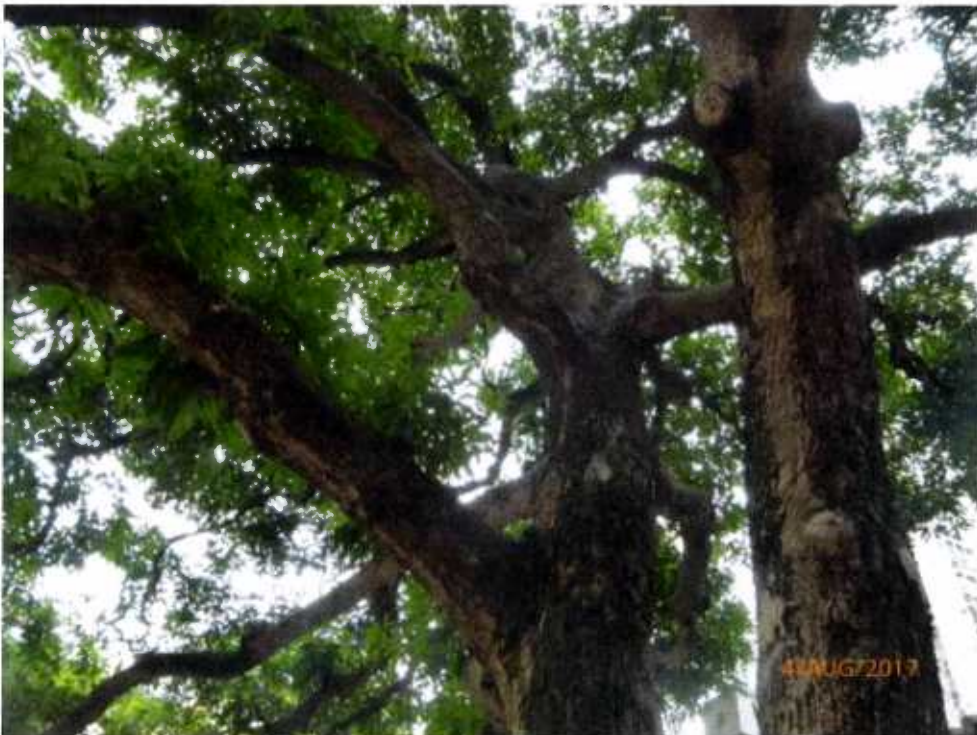
Fig. 5 Health condition of the upper trunk also is fair.

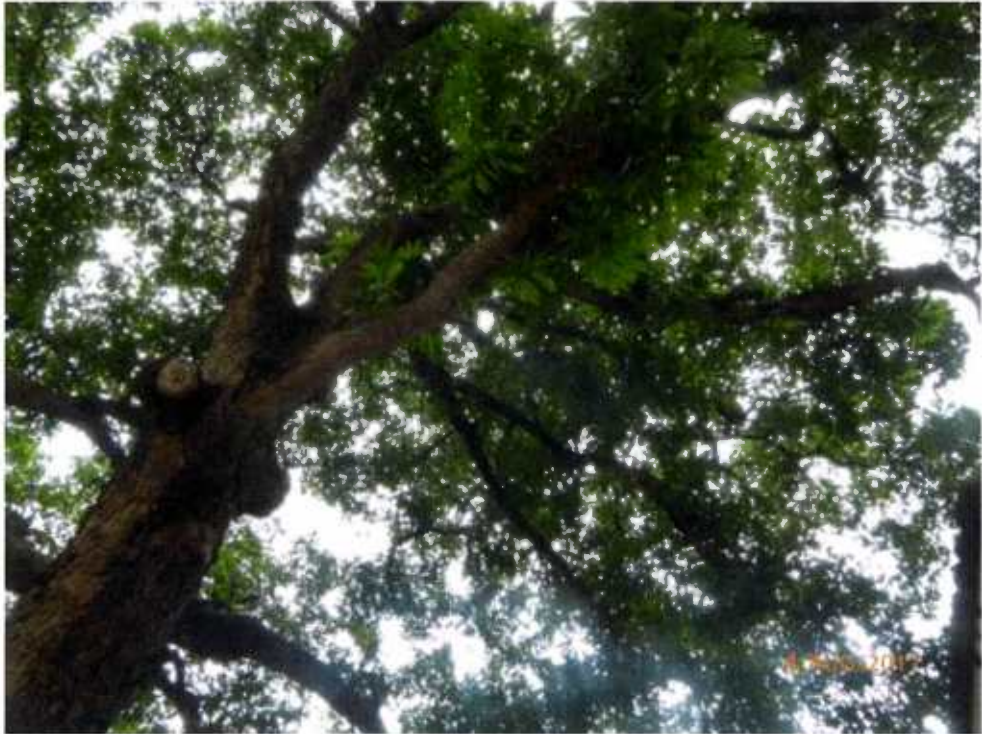
Fig. 6 The crown is full of vigorous and green leaves.

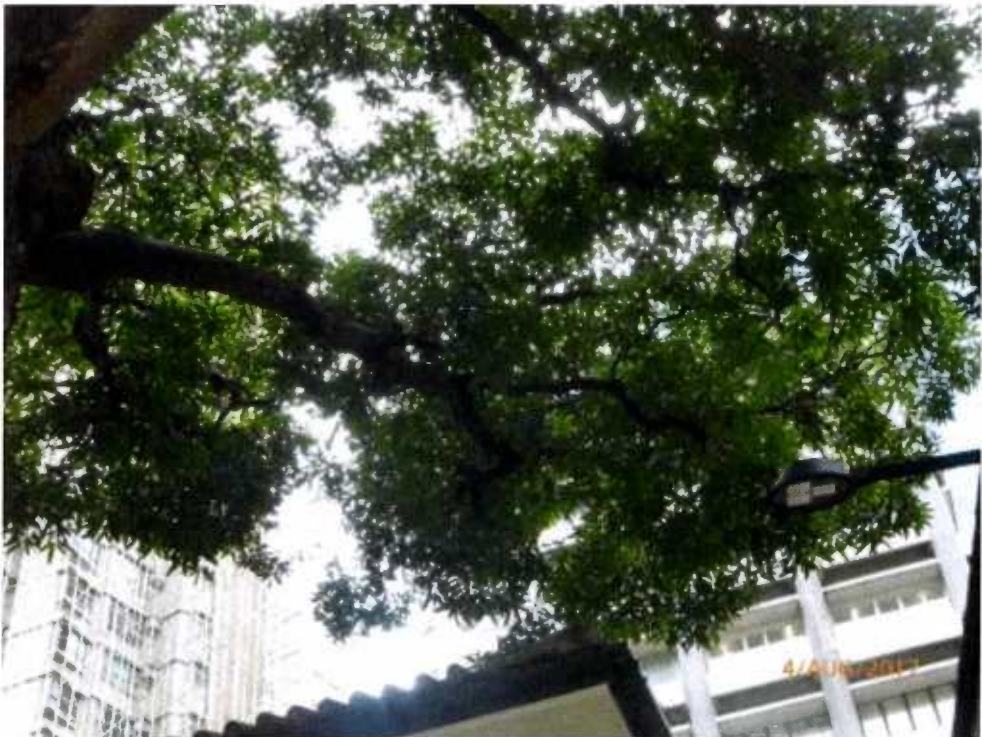
Fig. 7 Vigorous and green leaves also are growing on the lower branches.

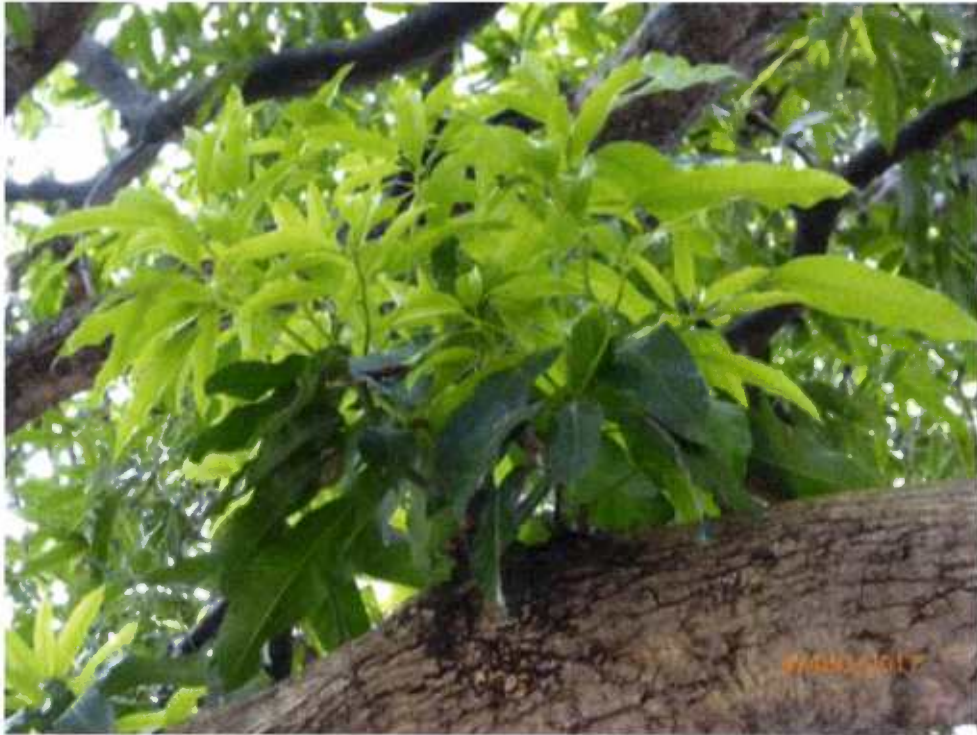
Fig. 8 Young and green leaves appear on the tree.

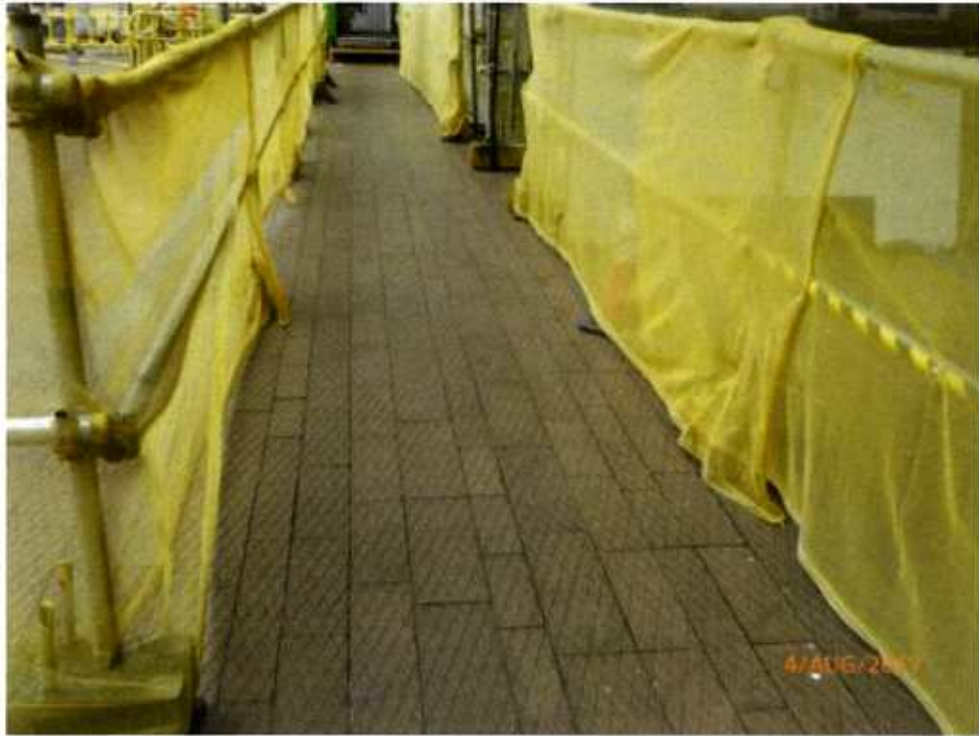
Fig. 10 The access near the planter is clean and tidy.

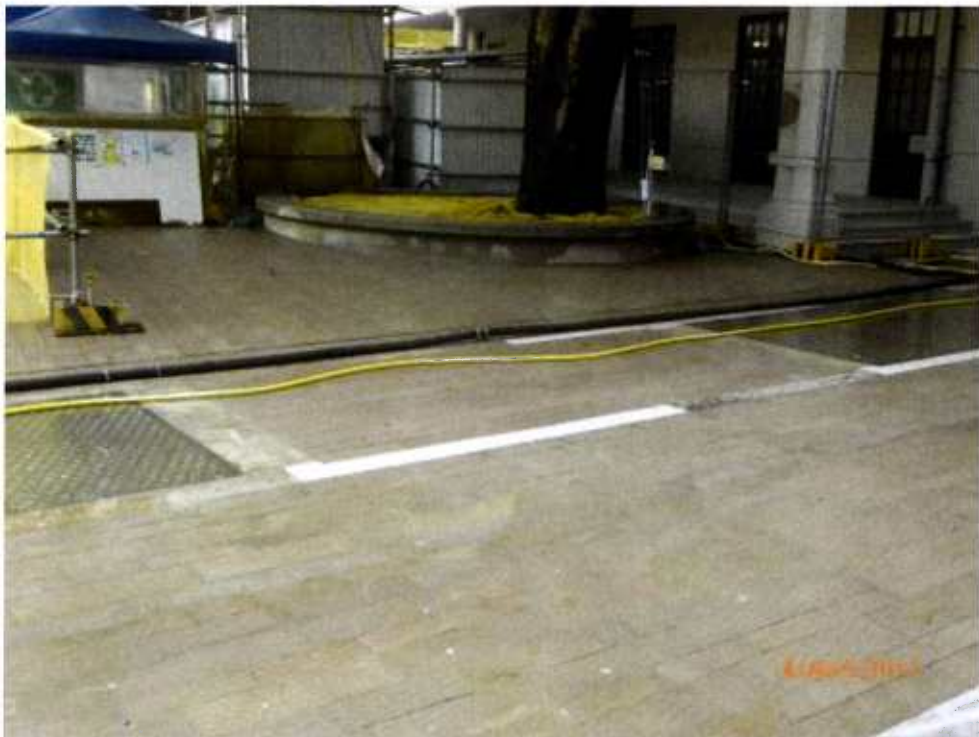
Fig. 11 The site near Tree-5 also is clean and tidy.

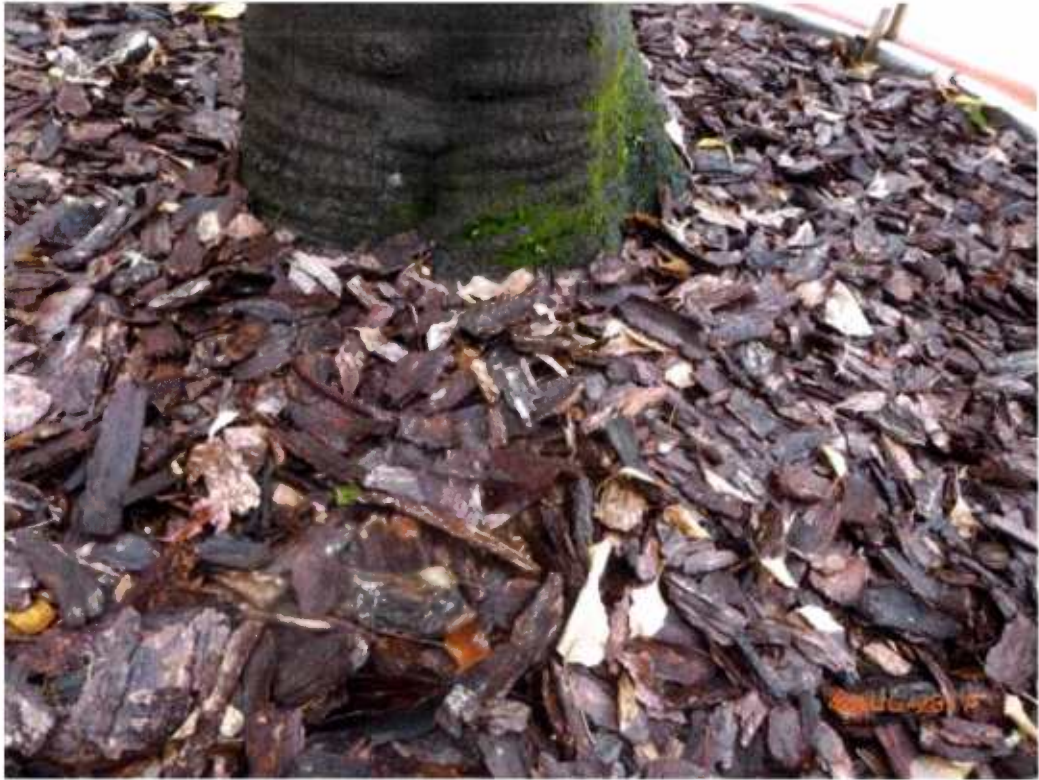
Fig 2. Root collar is normal. The planter is covered with reasonable mulch.

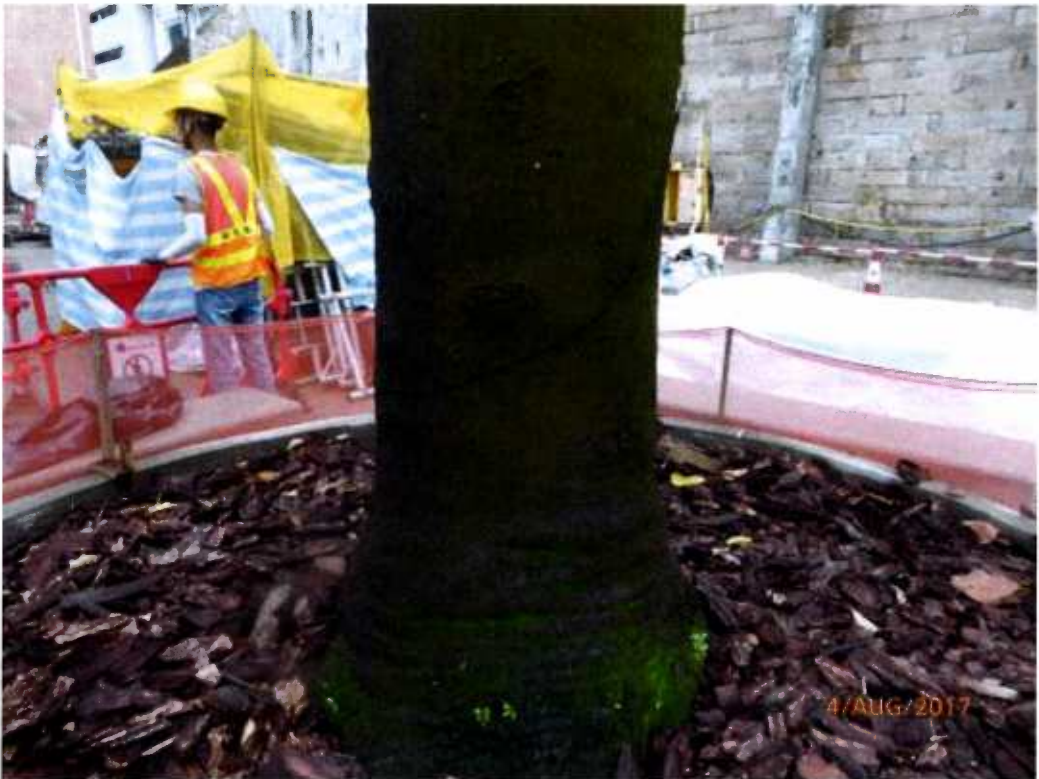
Fig 3. Health condition of the lower trunk is fair.

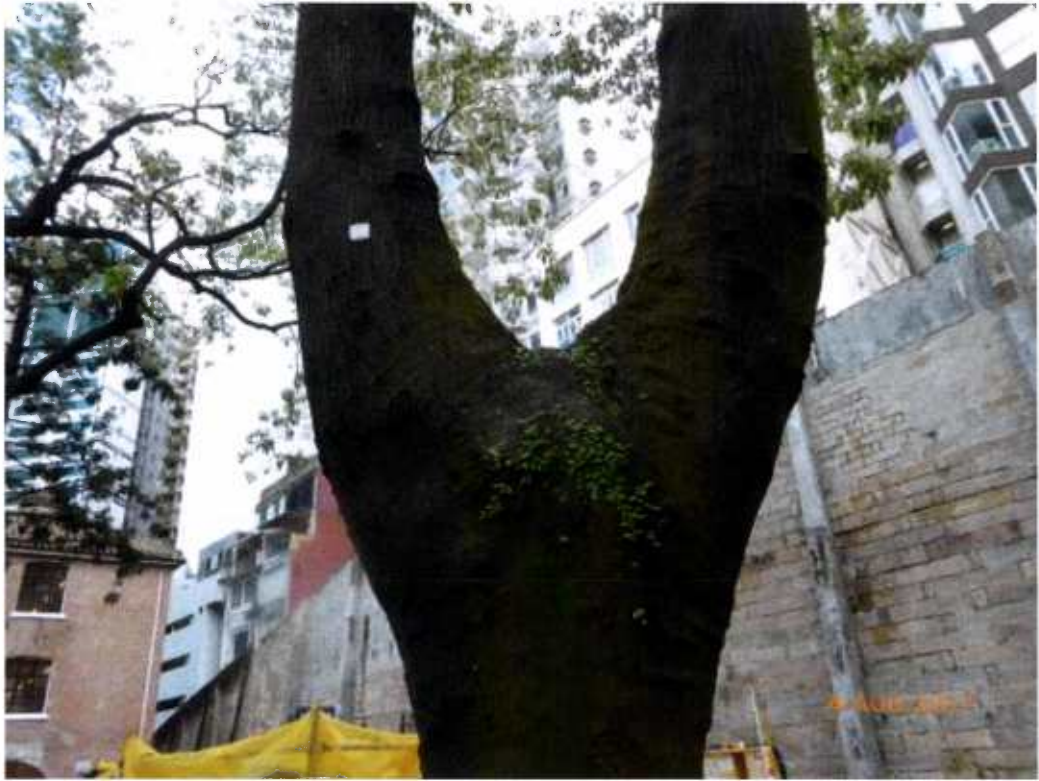
Fig. 4 Health condition of the mid trunk is fair.

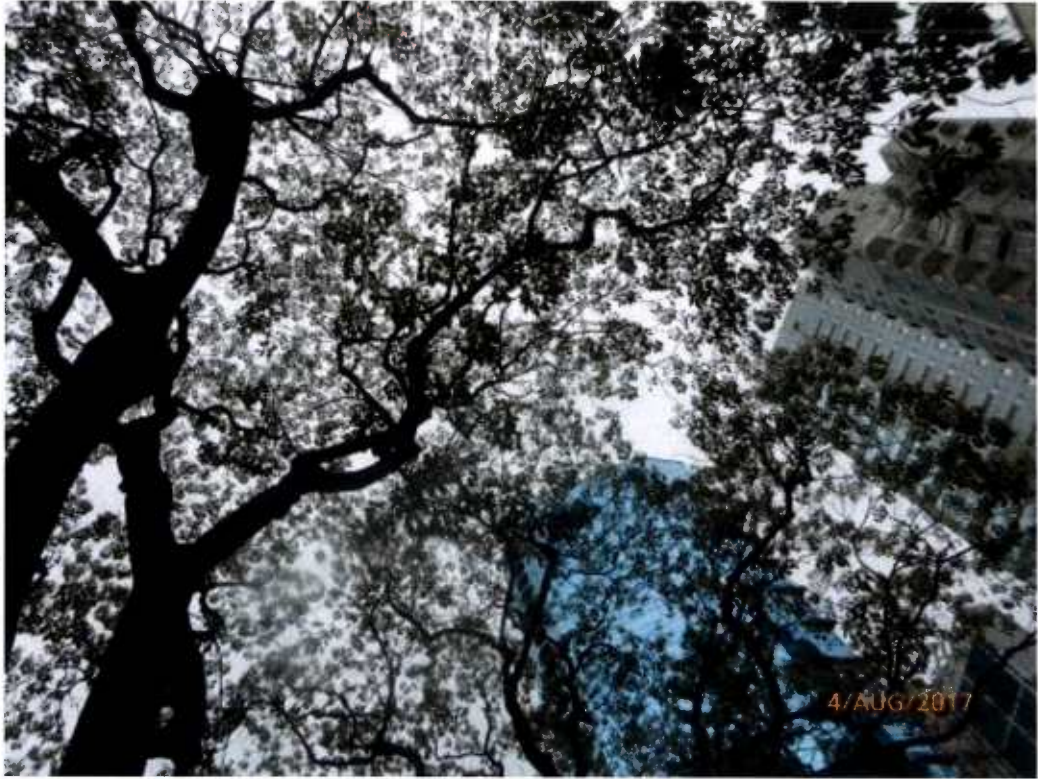
Fig. 6 Leaves on the crown are rather sparse.

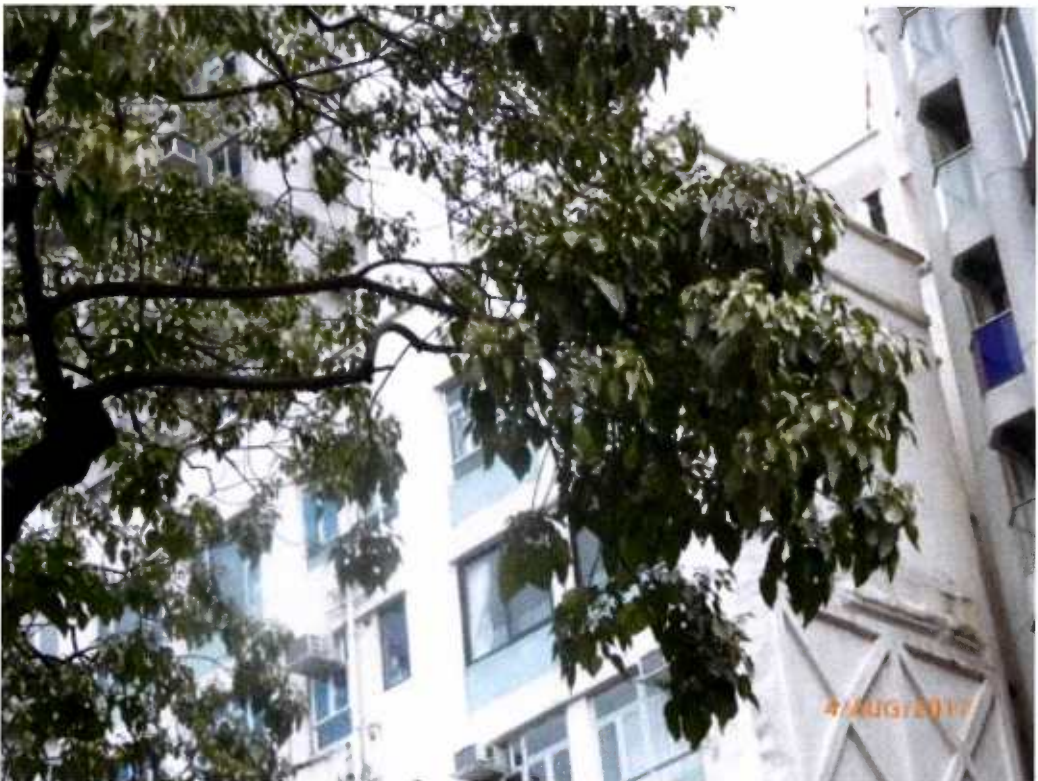
Fig. 7 Leaves on the lower branches are normal.

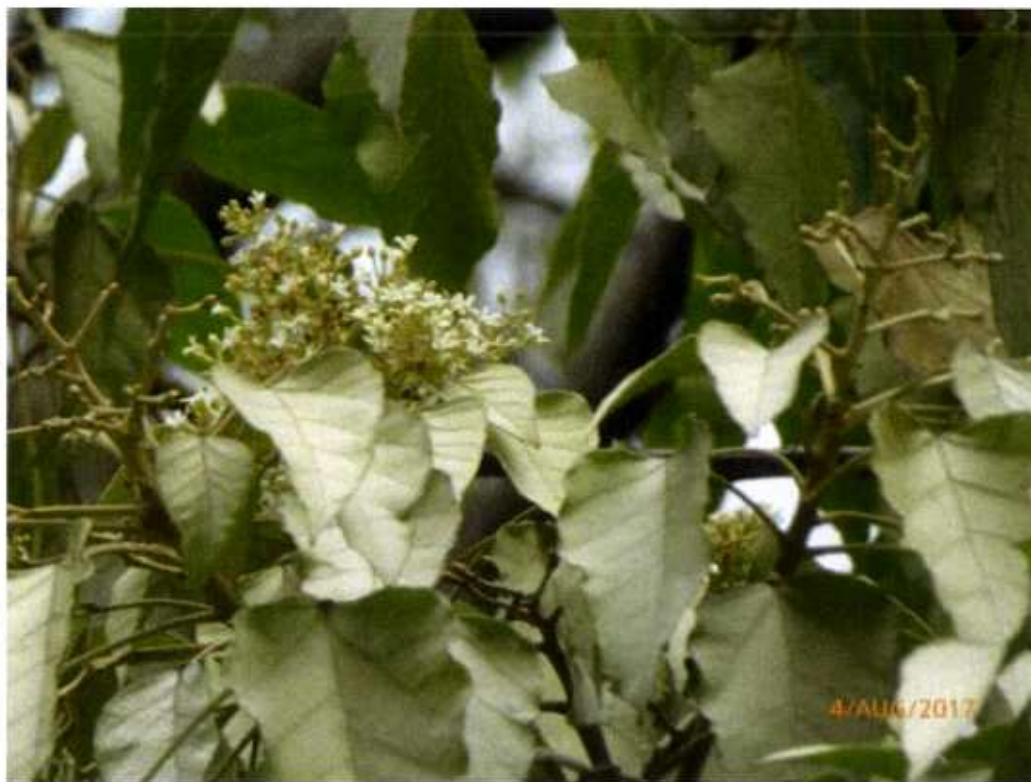
Fig. 8 Many flowers still remain on the tree.

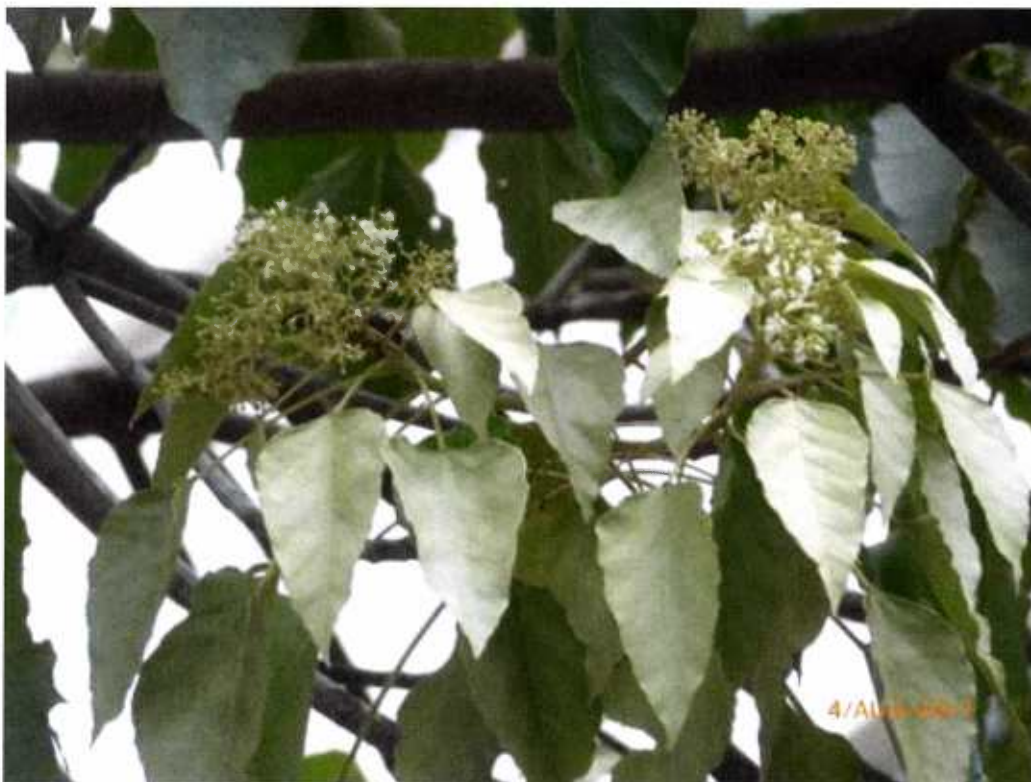
Fig. 9 Signs of Pest “白粉蝨 (*Trialeurodes vaporariorum*)” have apparently reduced due to Pest Control Operation on 3<sup>rd</sup> & 4<sup>th</sup> Aug. 2017.

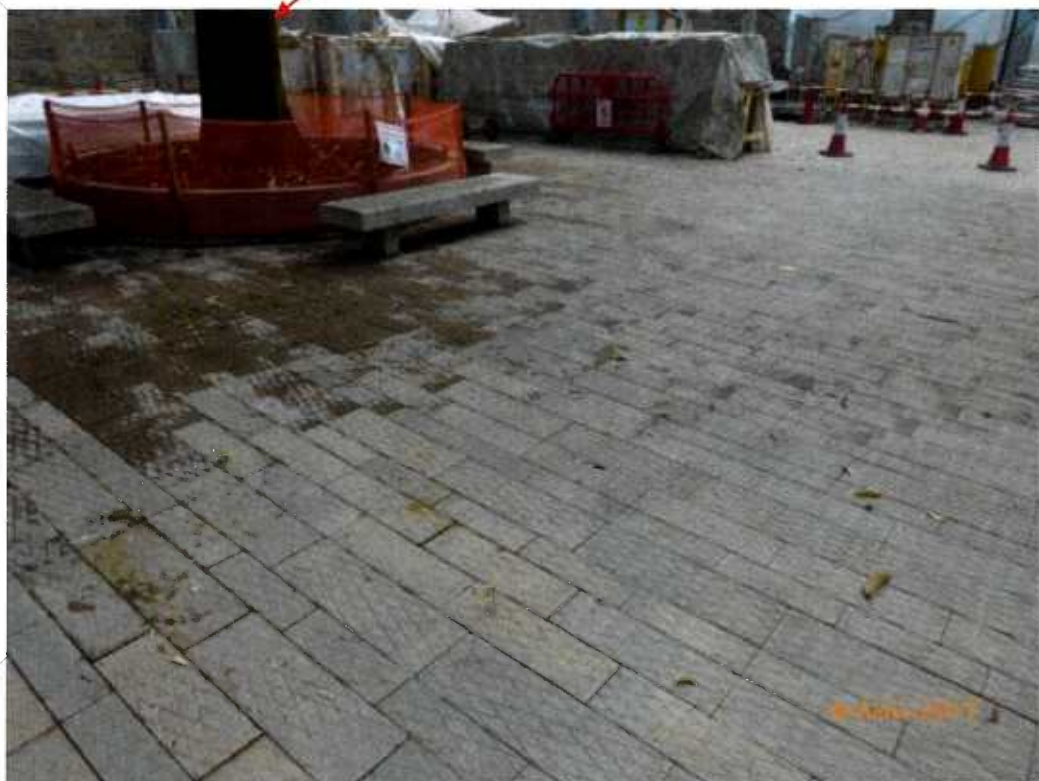
Fig. 11 The site near Tree-6 is clean and tidy.

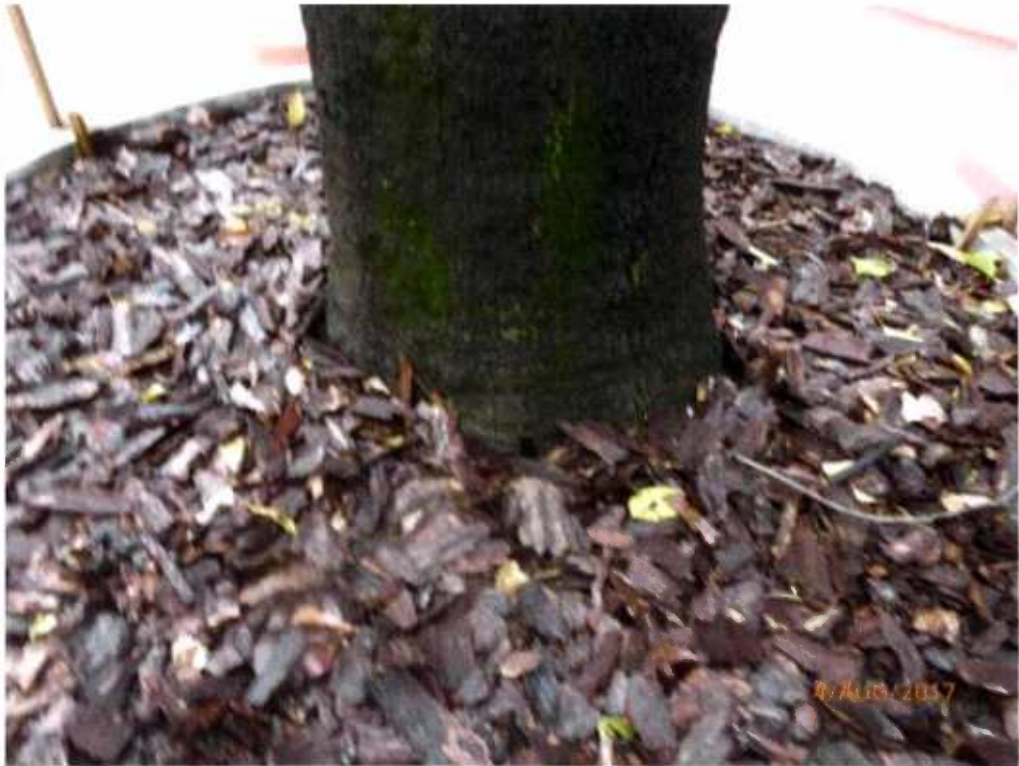
Fig. 2 Root collar is normal. The planter is covered with reasonable mulch.

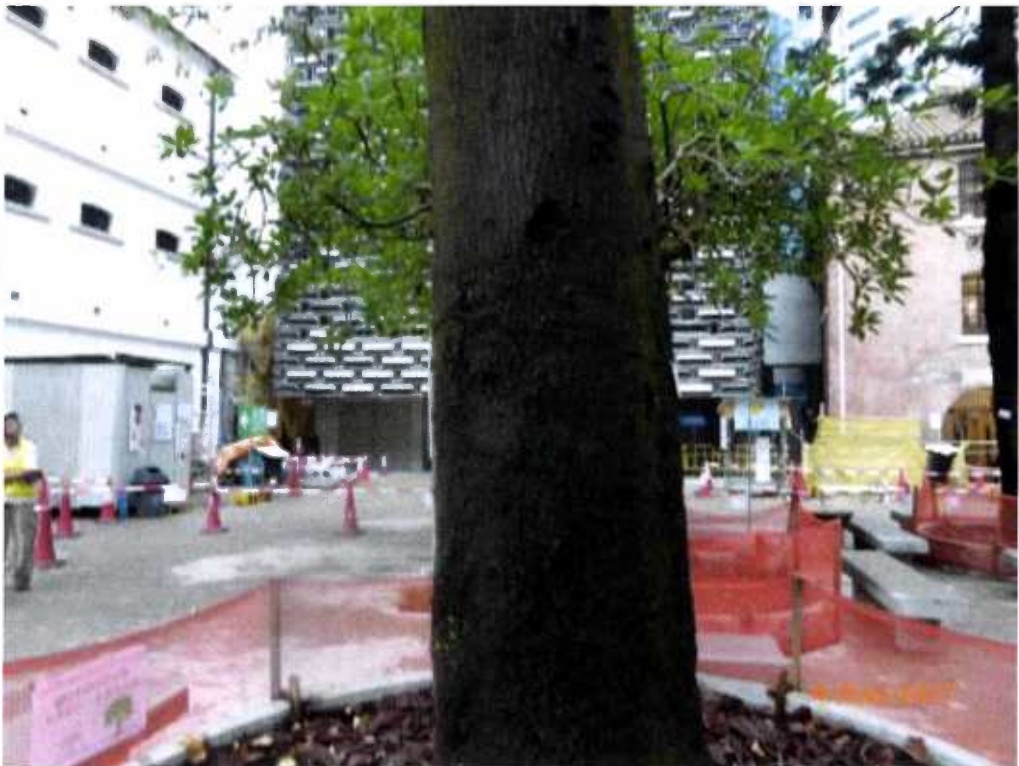
Fig 3. Health condition of the lower trunk is fair.

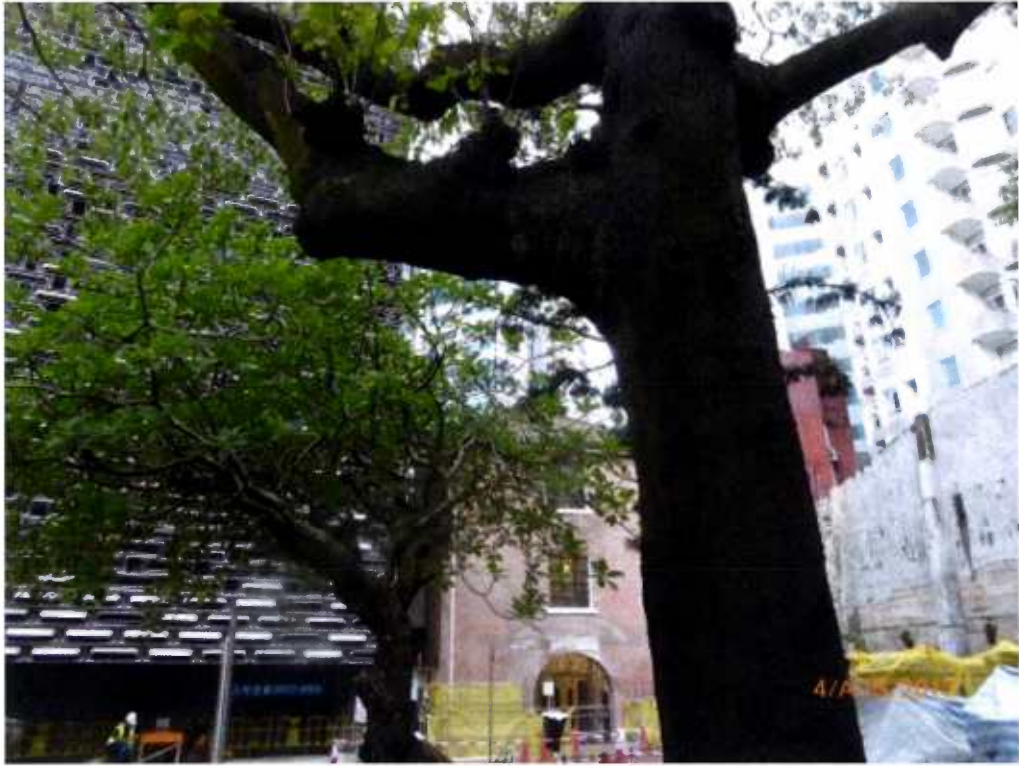
Fig. 4 Health condition of the mid trunk is fair.

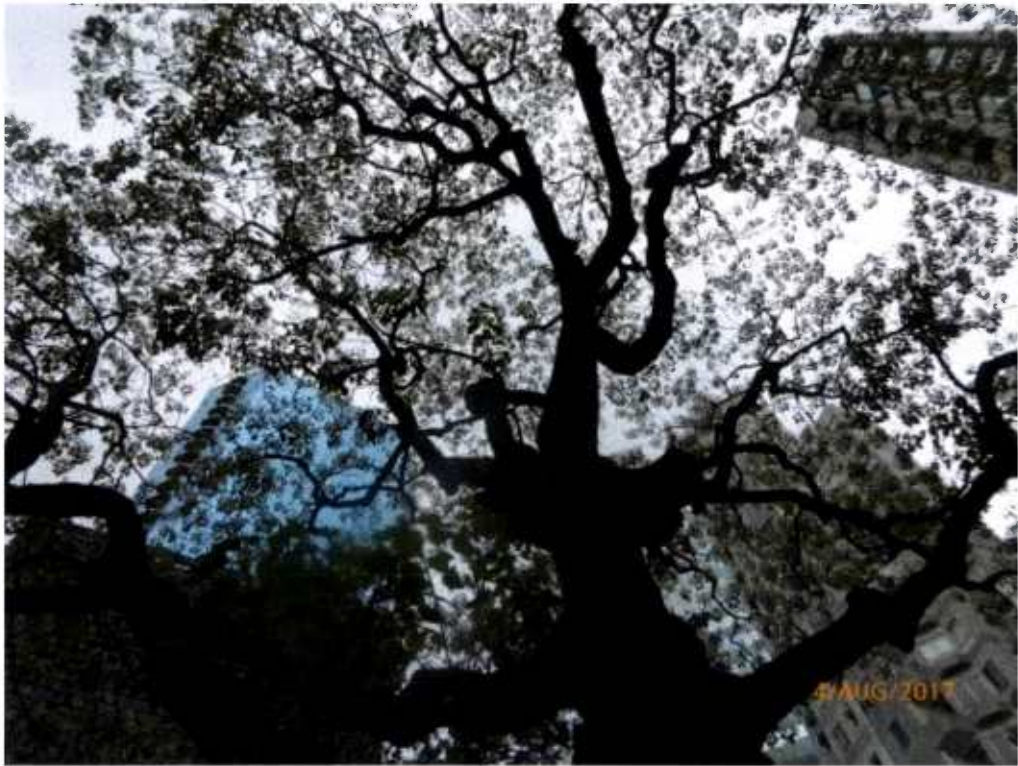
Fig. 6 Leaves on the crown are rather sparse.

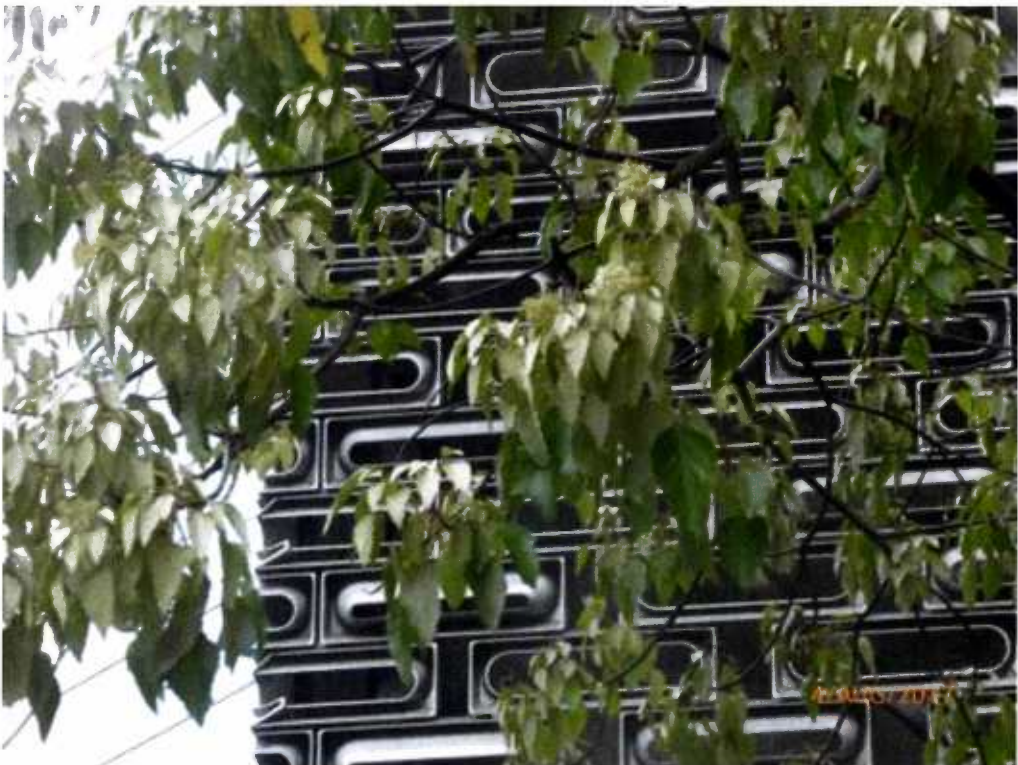
Fig. 7 Signs of Pest “白粉蝨 (*Trialeurodes vaporariorum*)” have apparently reduced due to Pest Control Operation on 3<sup>rd</sup> & 4<sup>th</sup> Aug. 2017.

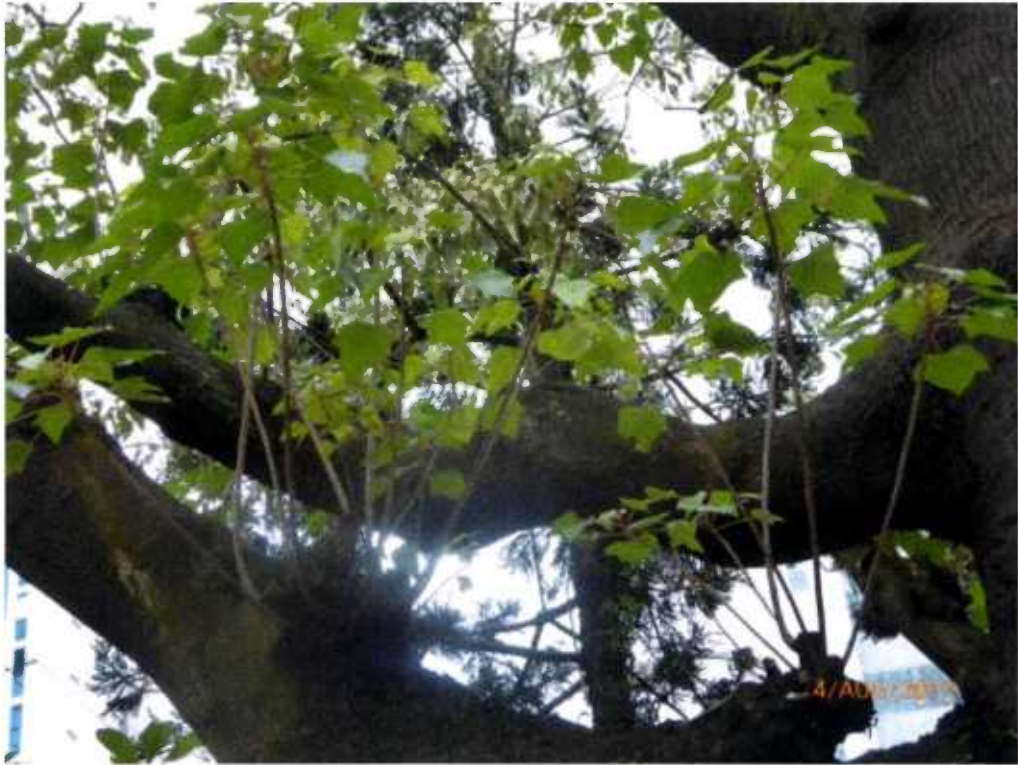
Fig. 8 Young and green leaves appear on the lower branches of Tree-7.

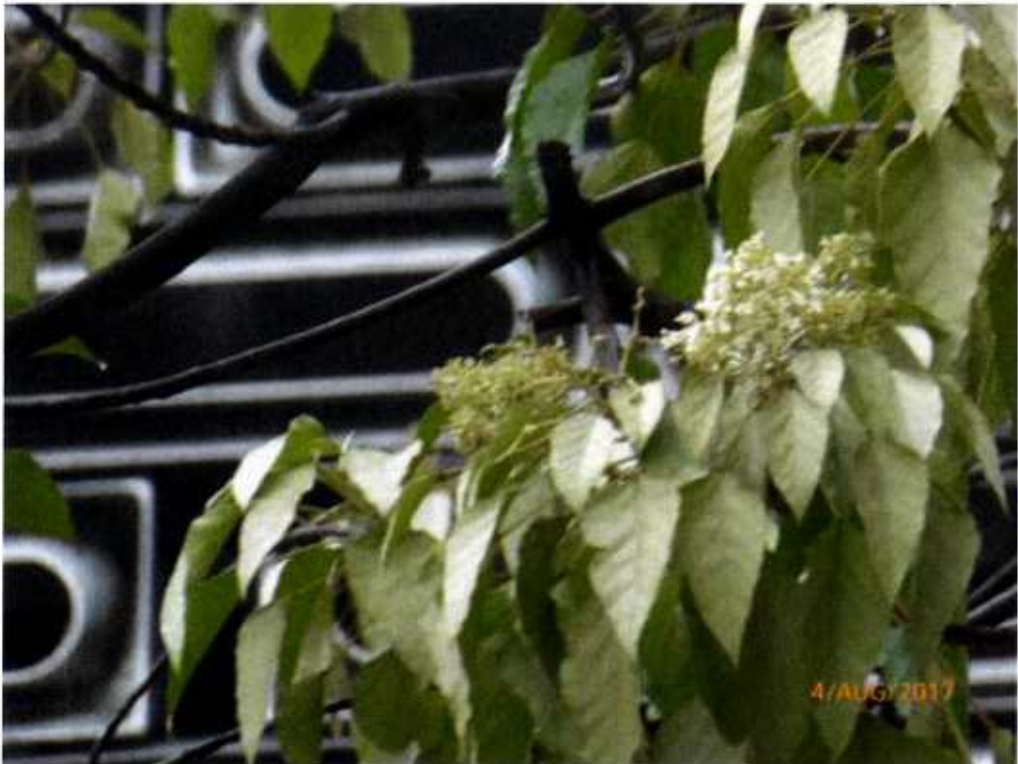
Fig. 9 Flowers still remain on the tree.

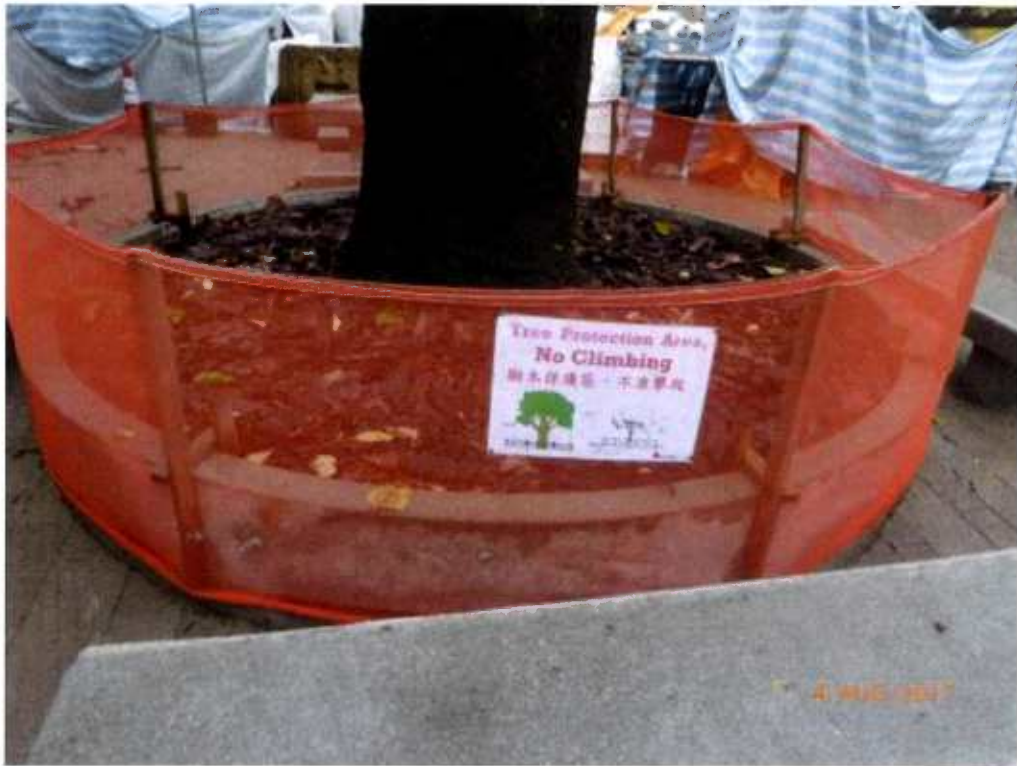
Fig. 10 The Tree Protection Zone is in good order.

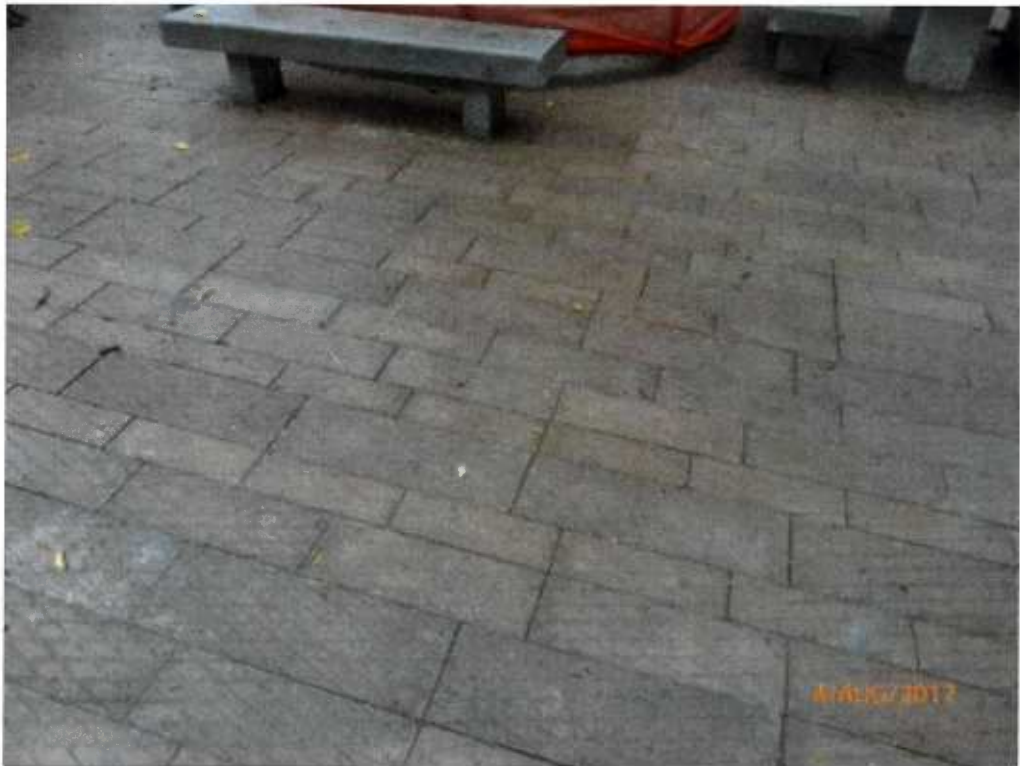
Fig. 11 The site near Tree-7 is clean and tidy.

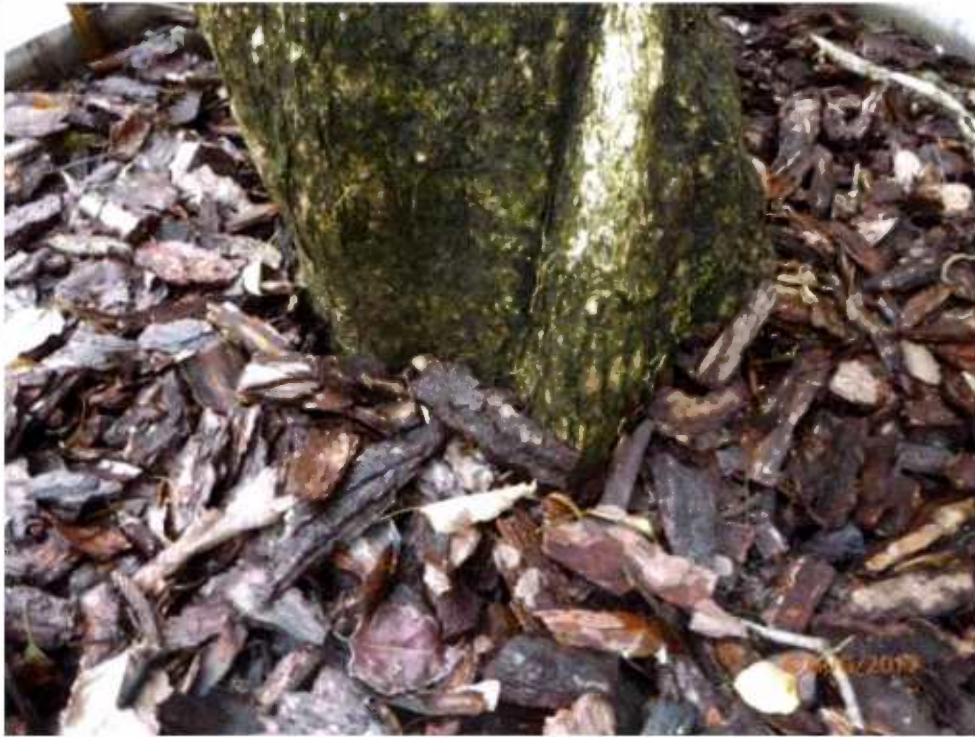
Fig. 2 Root collar is normal. The planter is covered with reasonable mulch.

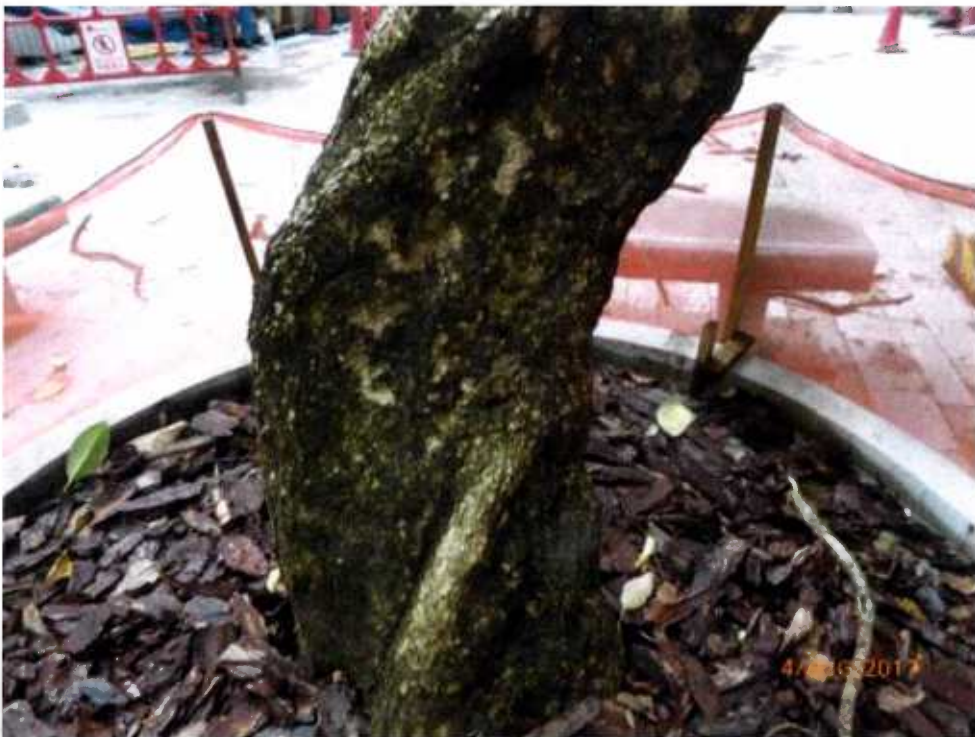
Fig. 3 Health condition of the lower trunk is fair.

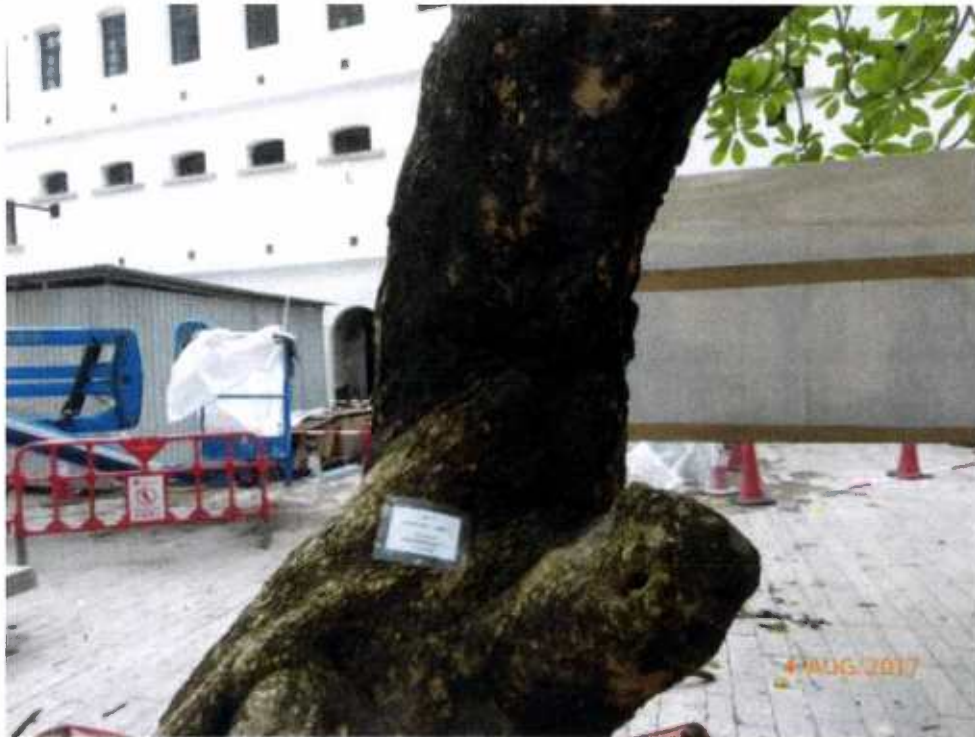
Fig. 4 Health condition of the mid trunk is fair.

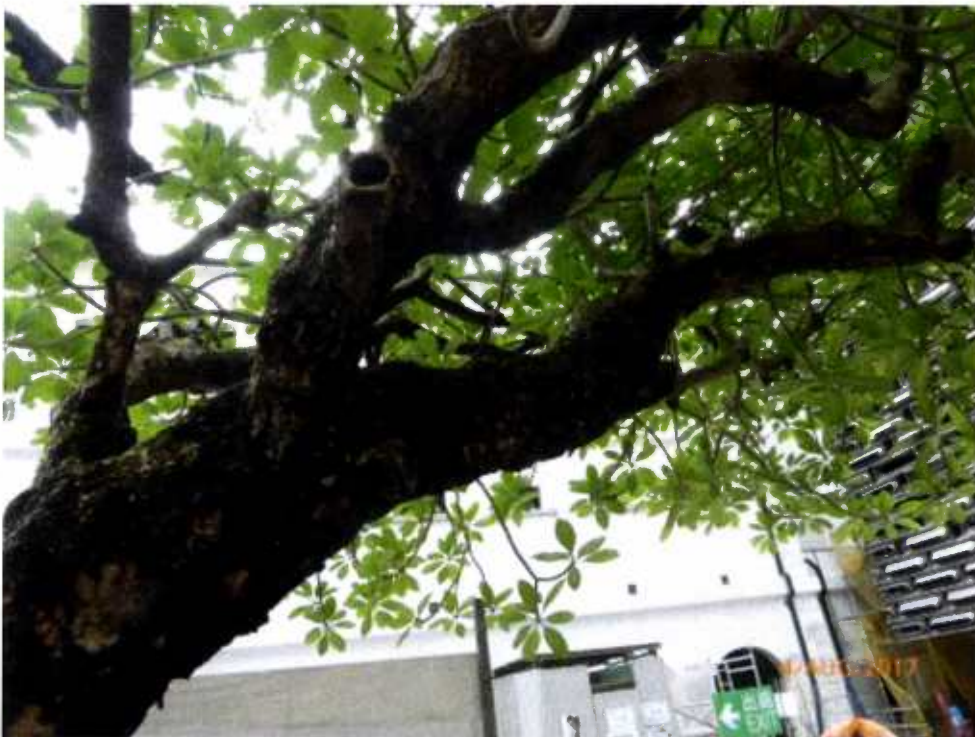
Fig. 5 Health condition of the upper trunk also is fair.

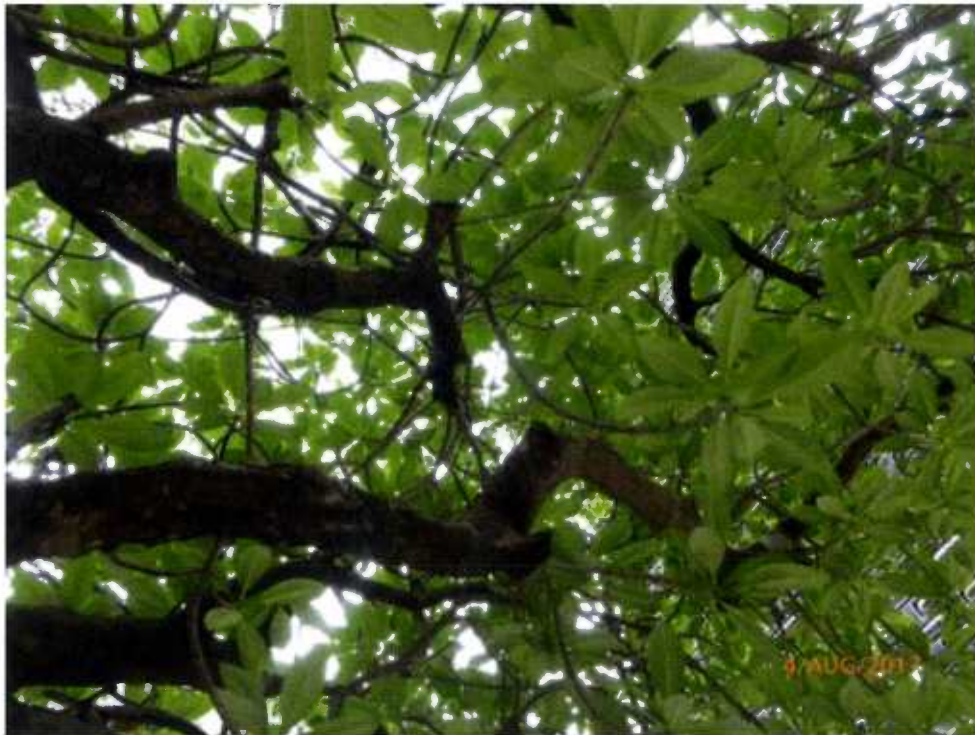
Fig. 6 The crown is full of vigorous and green leaves.
