The Jockey Club CPS Limited

Central Police Station Conservation  
and Revitalisation Project:  
*70<sup>th</sup> Monthly EM&A Report*  
*(1 August to 31 August 2017)*

Issue Date: September 2017

**Environmental Resources Management**

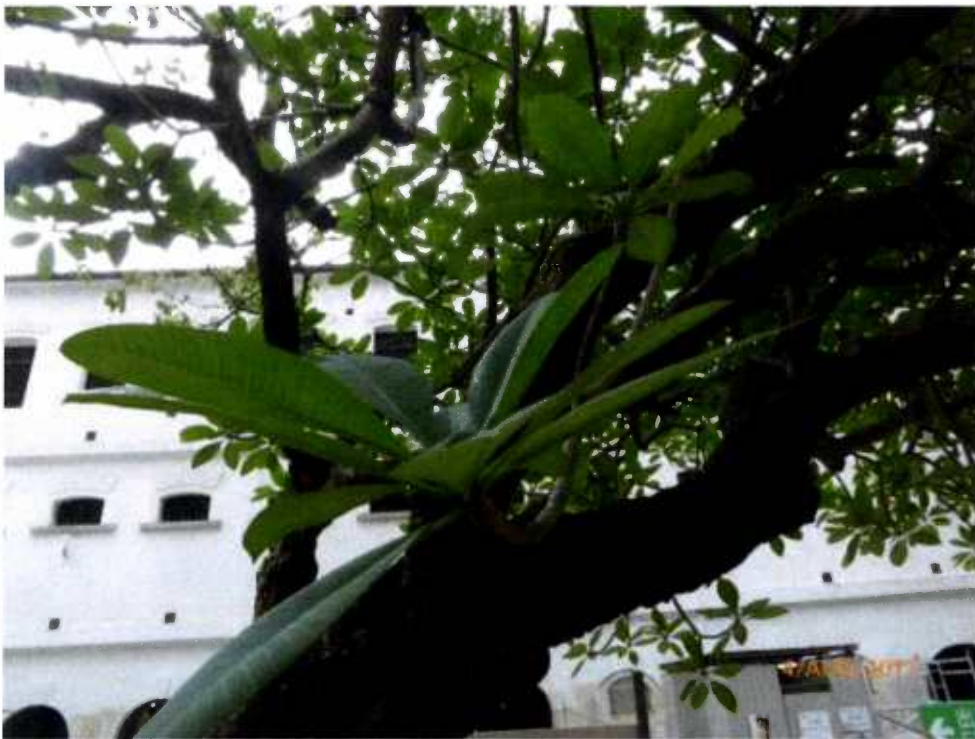
Fig. 7 Vigorous and green leaves also are growing on the lower branches.

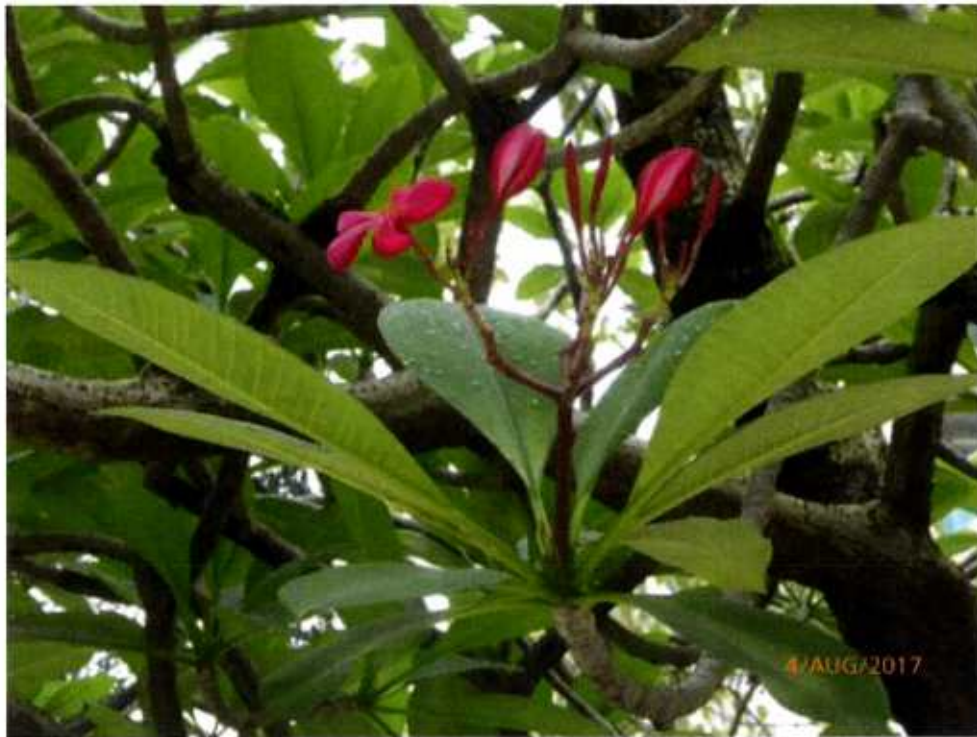
Fig. 8 Flowers still remain on the tree.

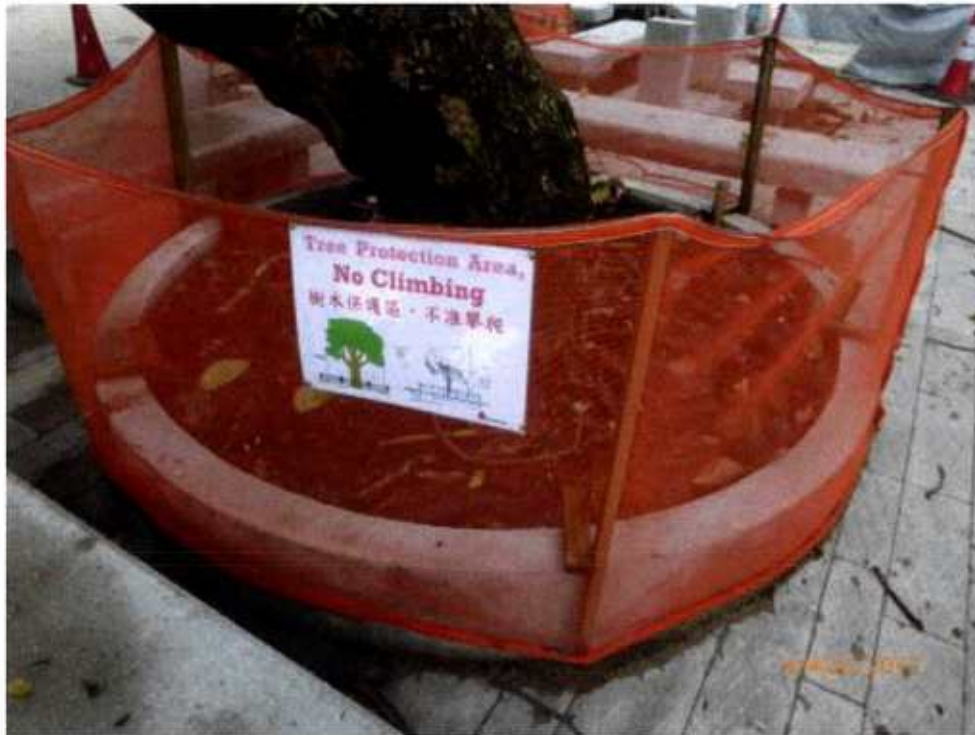
Fig. 10 The Tree Protection Zone is in good order.

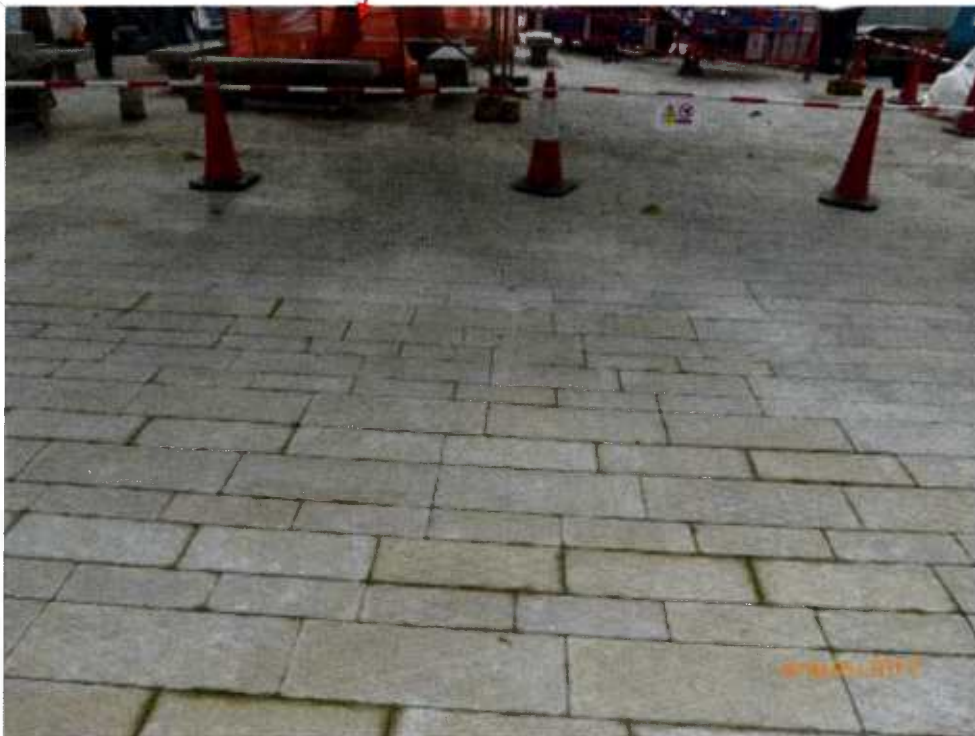
Fig. 11 The site near Tree-8 is clean and tidy.

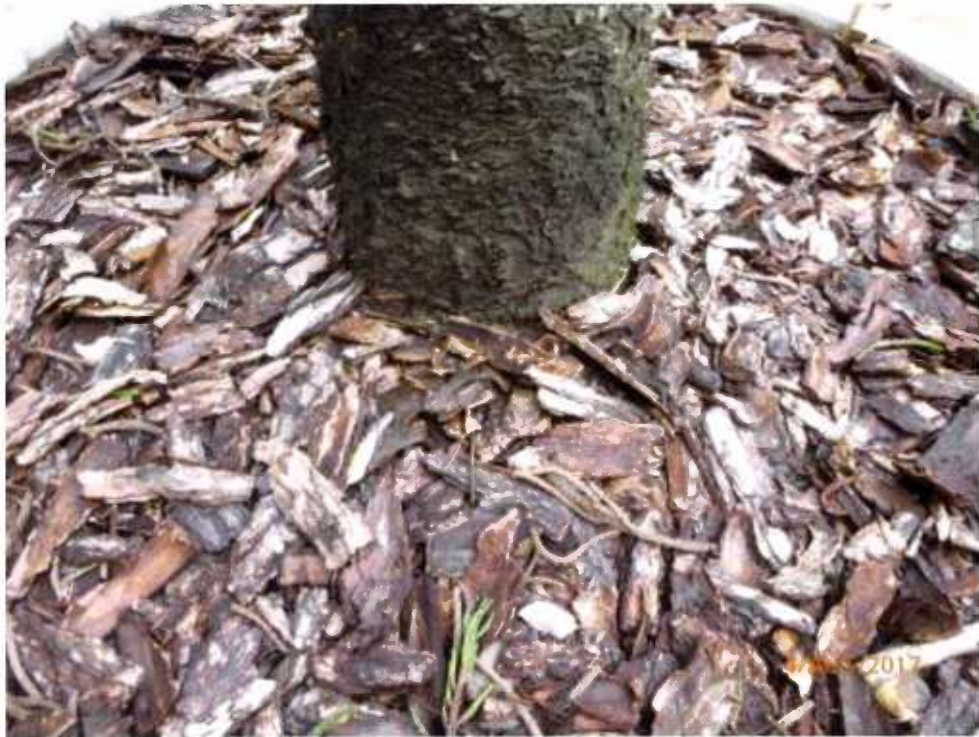
Fig. 2 Root collar is normal. The planter is covered with reasonable mulch.

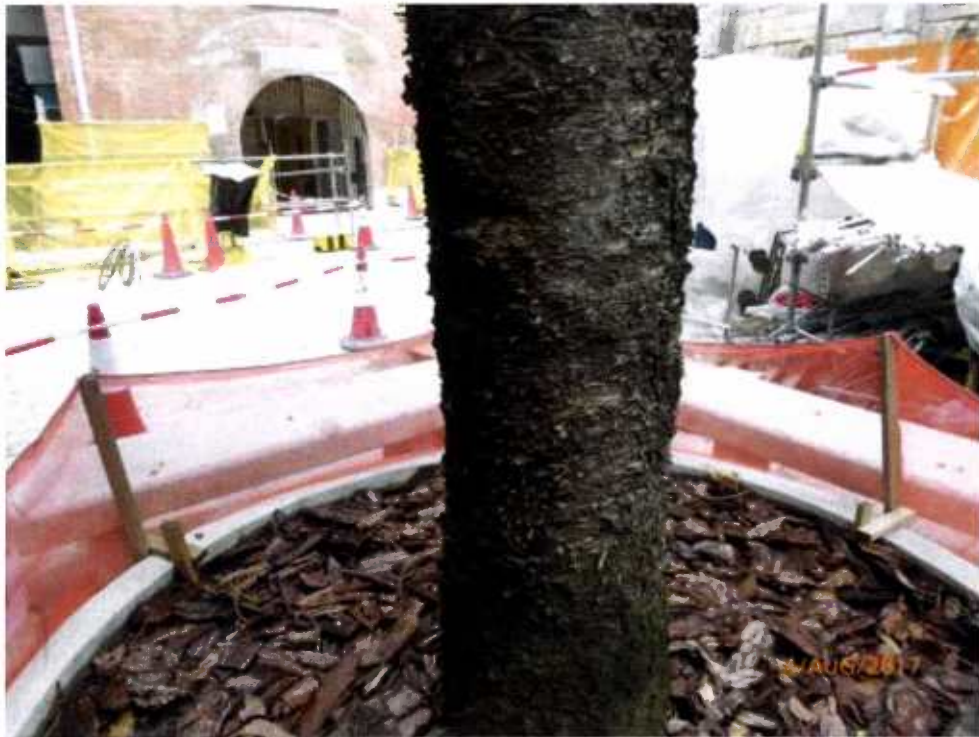
Fig. 3 Health condition of the lower trunk is fair.

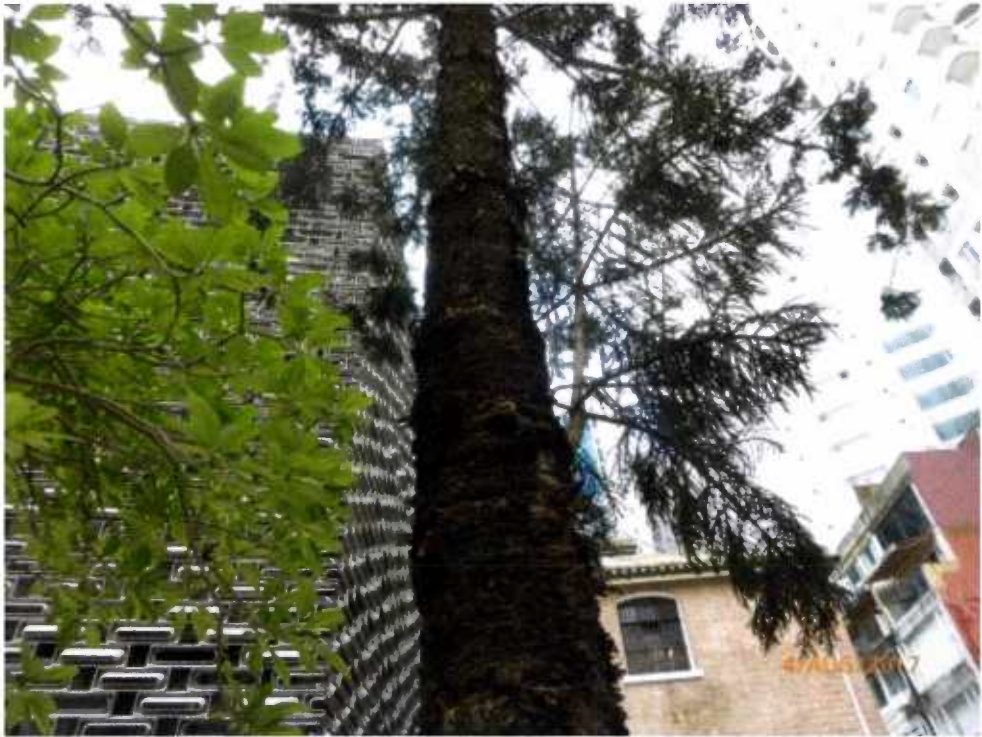
Fig. 4 Health condition of the mid trunk is fair.

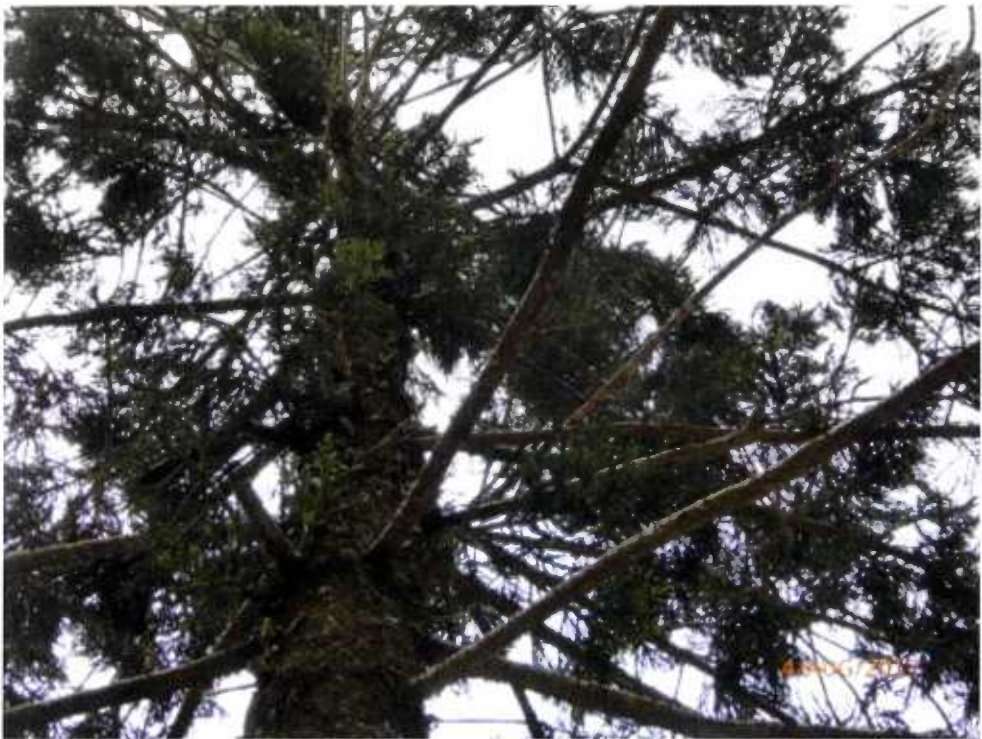
Fig. 5 Health condition of the upper trunk also is fair.

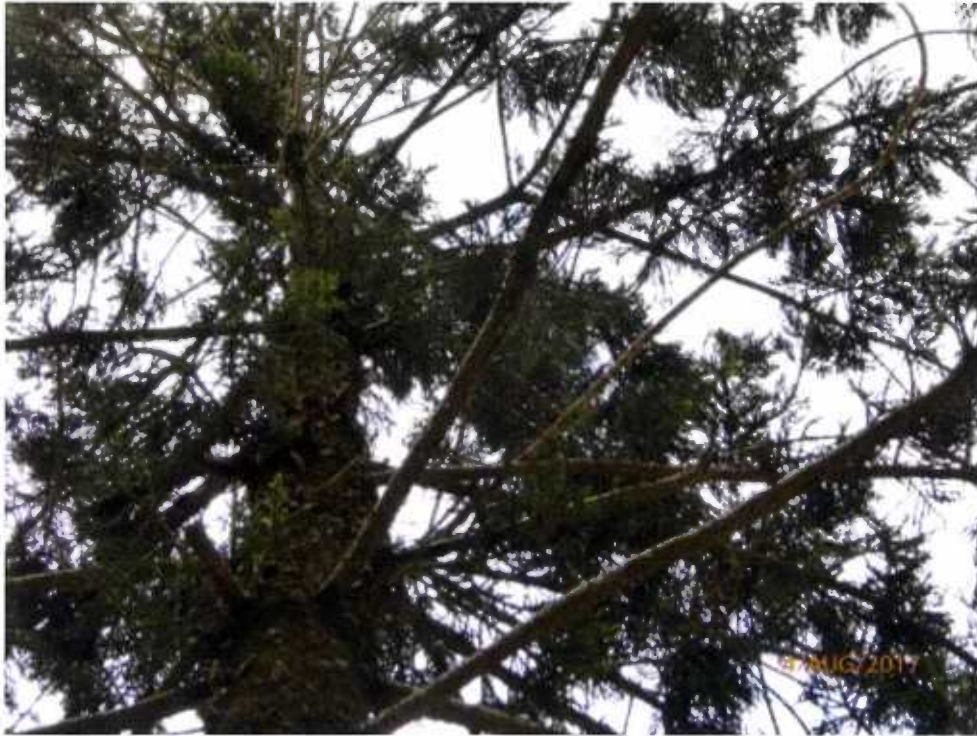
Fig. 6 The crown is full of vigorous and green leaves.

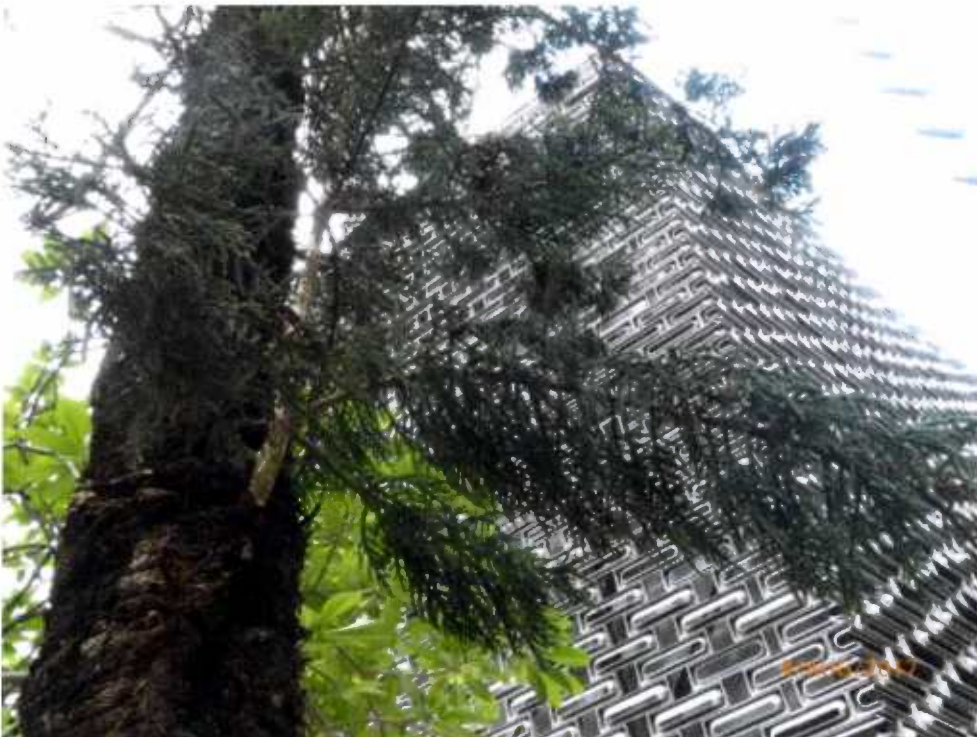
Fig. 7 Vigorous and green leaves also are growing on the lower branches.

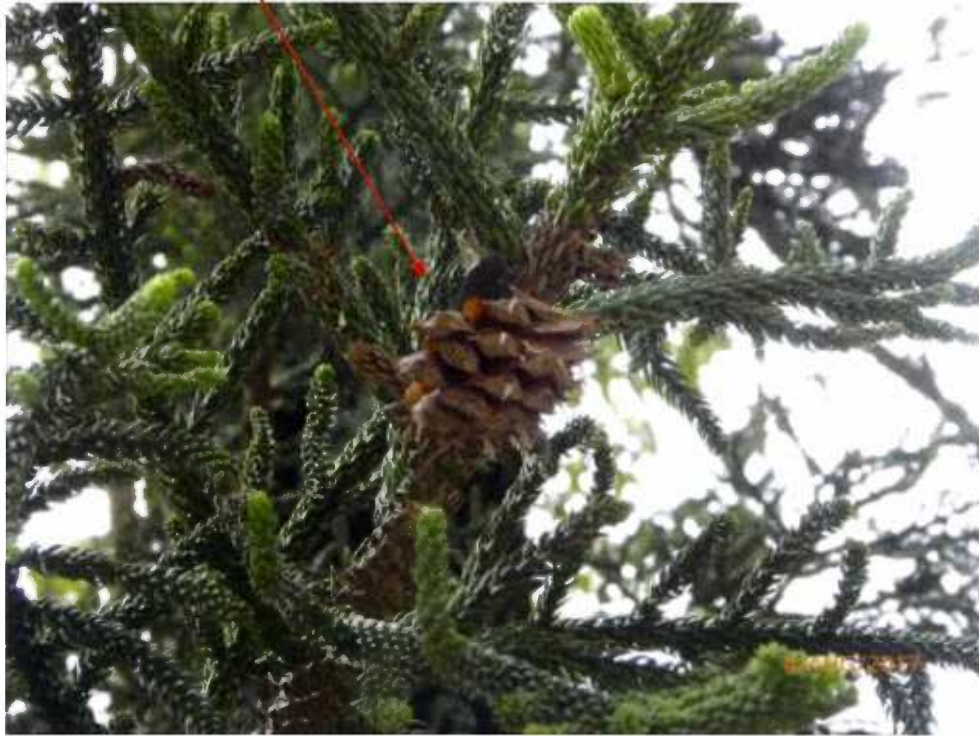
Fig. 8 The fruit still remains on the tree.

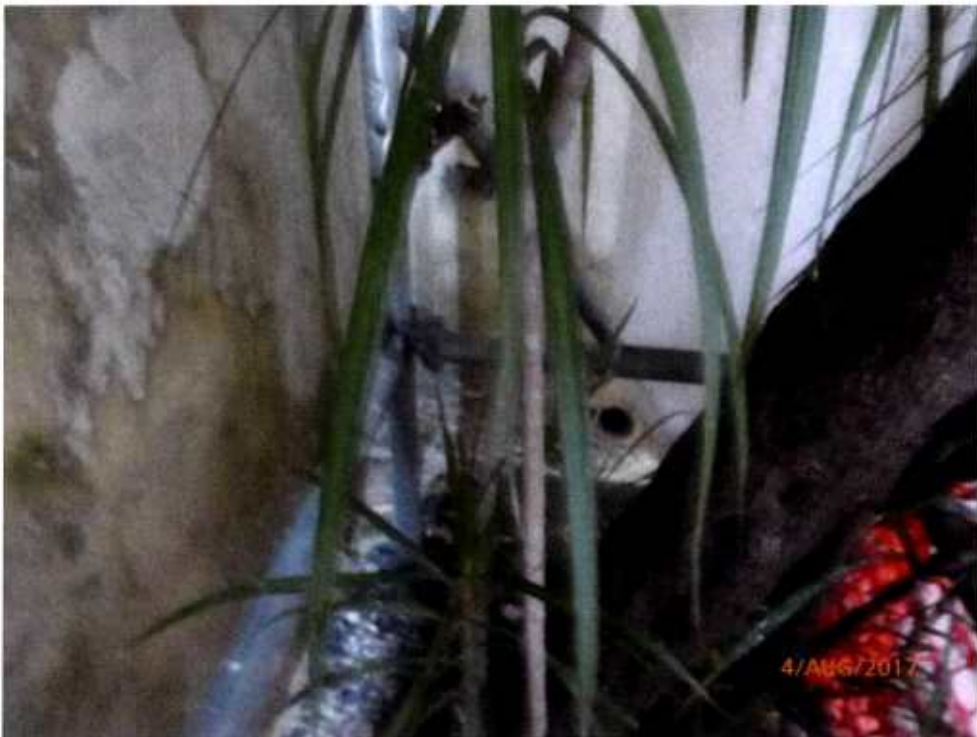
Fig. 4 Health condition of the mid trunk is fair.

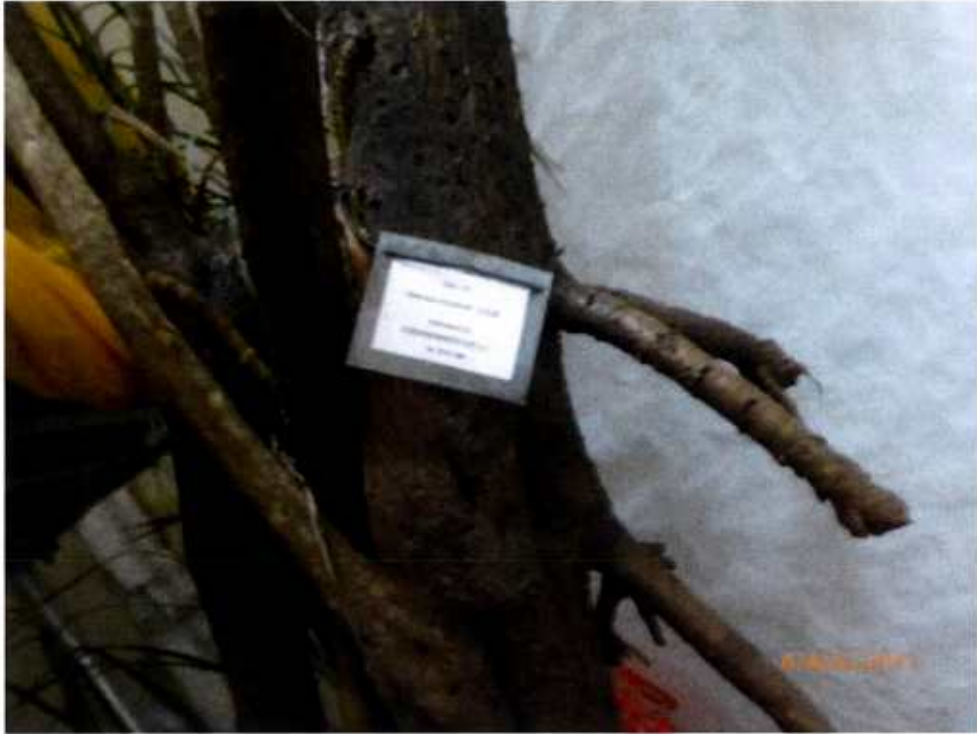
Fig. 5 Health condition of the upper trunk also is fair.

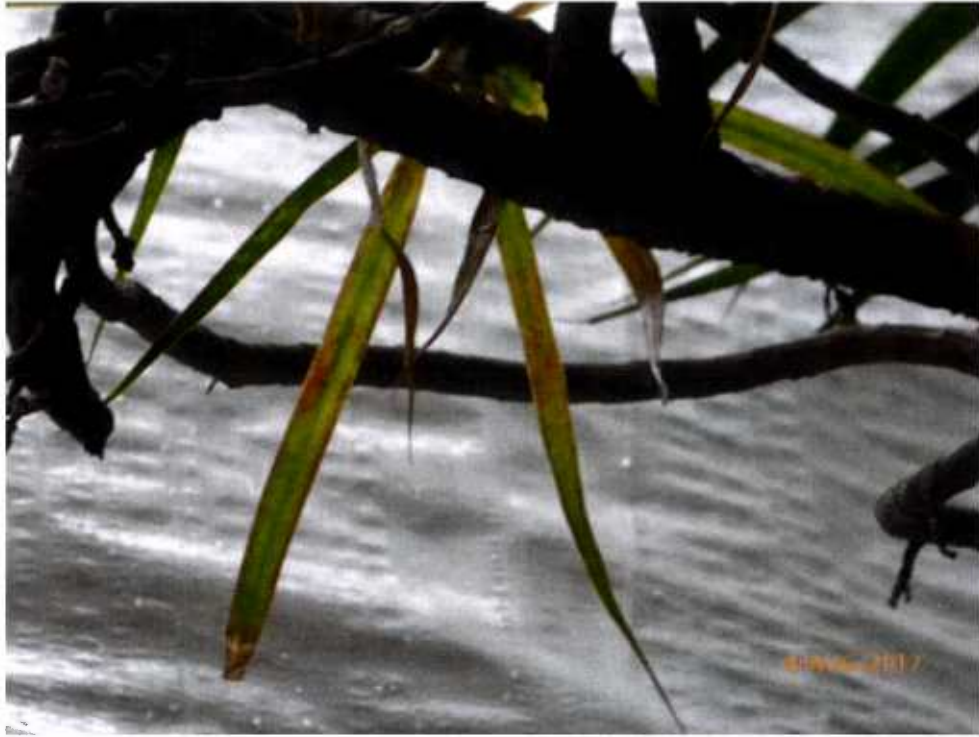
Fig. 7 Withered leaves also appear on the lower branches.

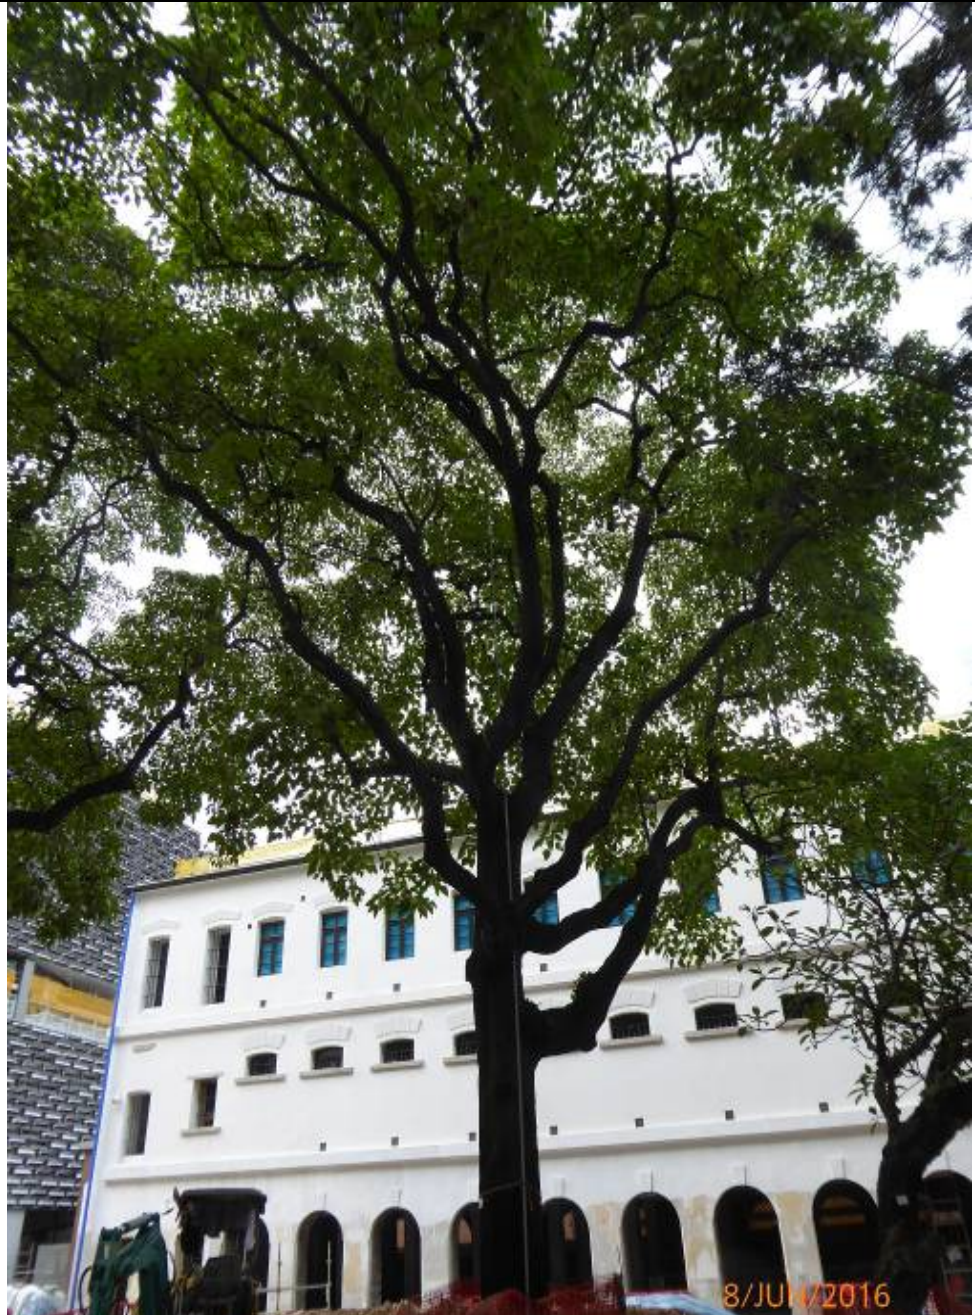
8 June 2016

i) Presence of pests – Besides the pests (*Trialeurodes vaporariorum*) which were recently discovered during the tree inspection on 10 July 2017, Tree 6 and Tree 7 have also been infected with the pest Mealy Bugs in April 2016. Pests present on the leaves take up nutrients from the trees, causing loss of leaves and potential deterioration of the health of the trees. Subsequent application of pesticides and pruning of affected leaves and branches were performed on 25 April 2016 and proved effective with signs of pests apparently reduced and hardly found after the application. Although the trees were clear of pests after the pest application on 25 April 2016, gradual loss of leaves at Tree 6 and Tree 7 can be observed since around May 2016.
