# Central Police Station Conservation and Revitalisation Project

*EIA Report:  
Volume II - Annexes*

**Built Heritage Resources within CPS –  
Detailed Baseline Studies and Impact Assessments**

**Annex A1**  
Built Heritage Resources: Baseline Studies and Impact Assessments

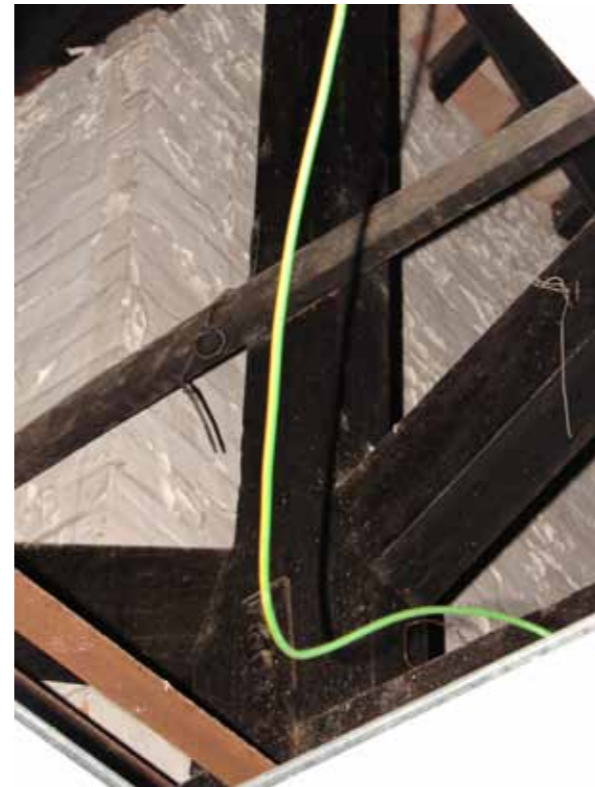
Figure 9 - Roof truss

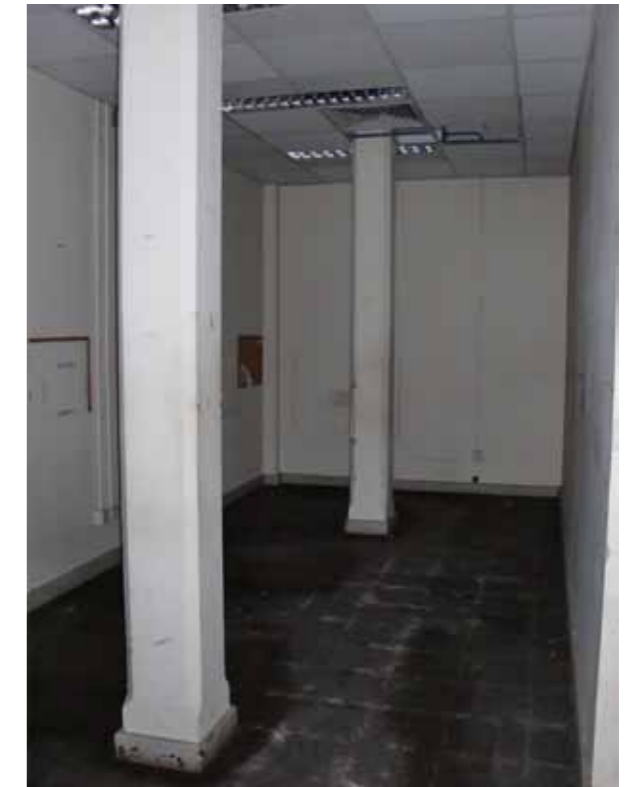
Figure 11 - Original columns in 02/G/09

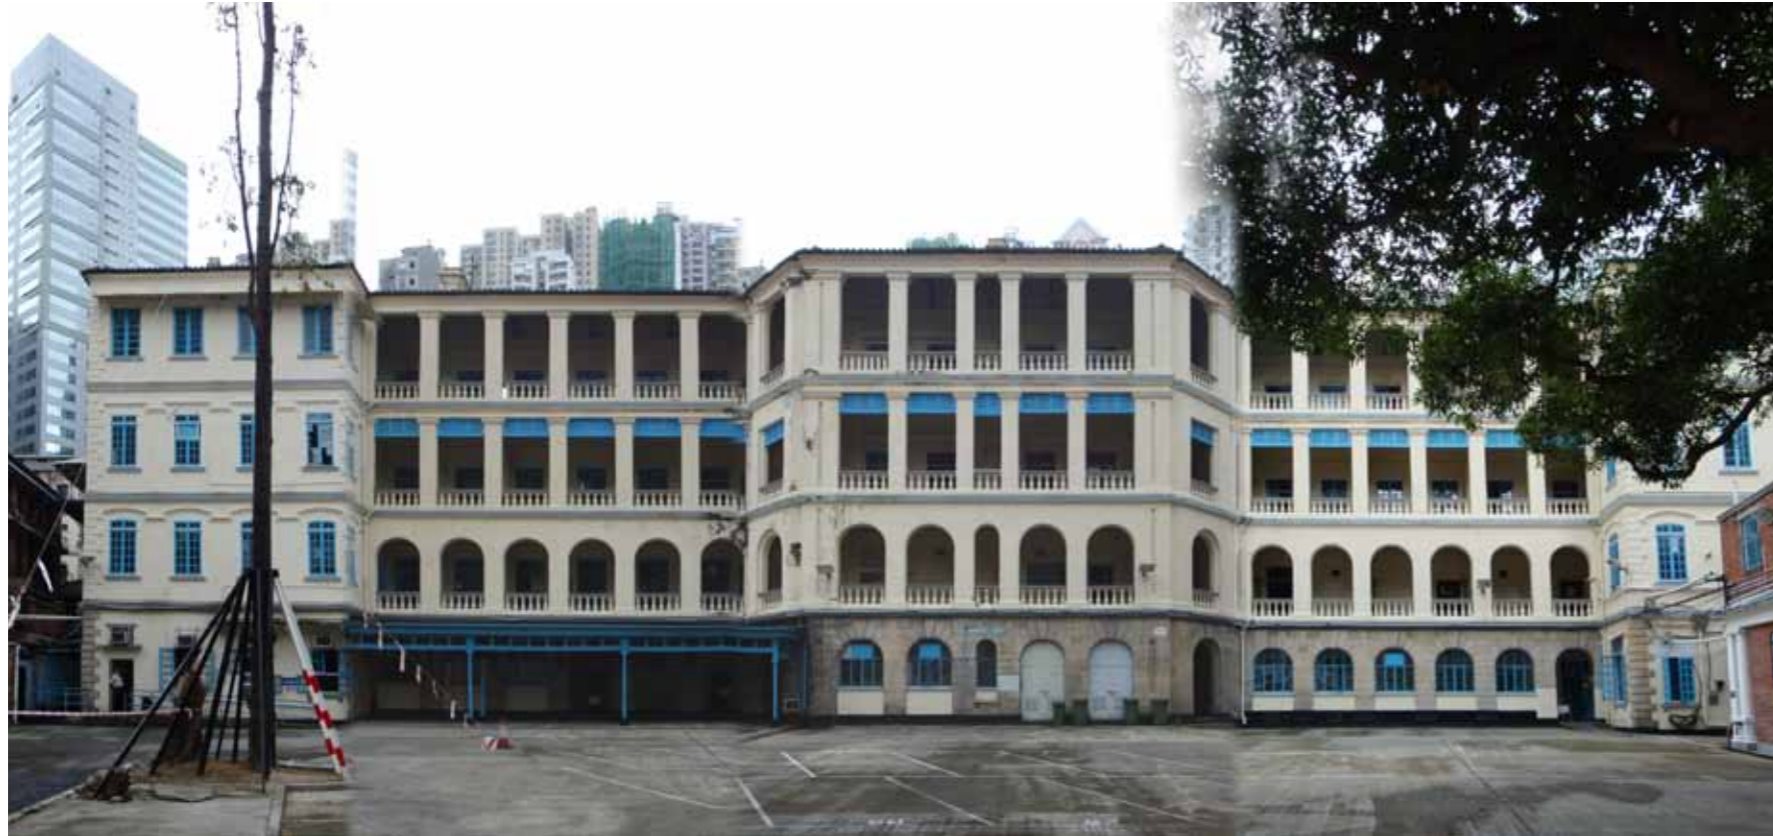
Figure 1 - Composite photograph of the north elevation

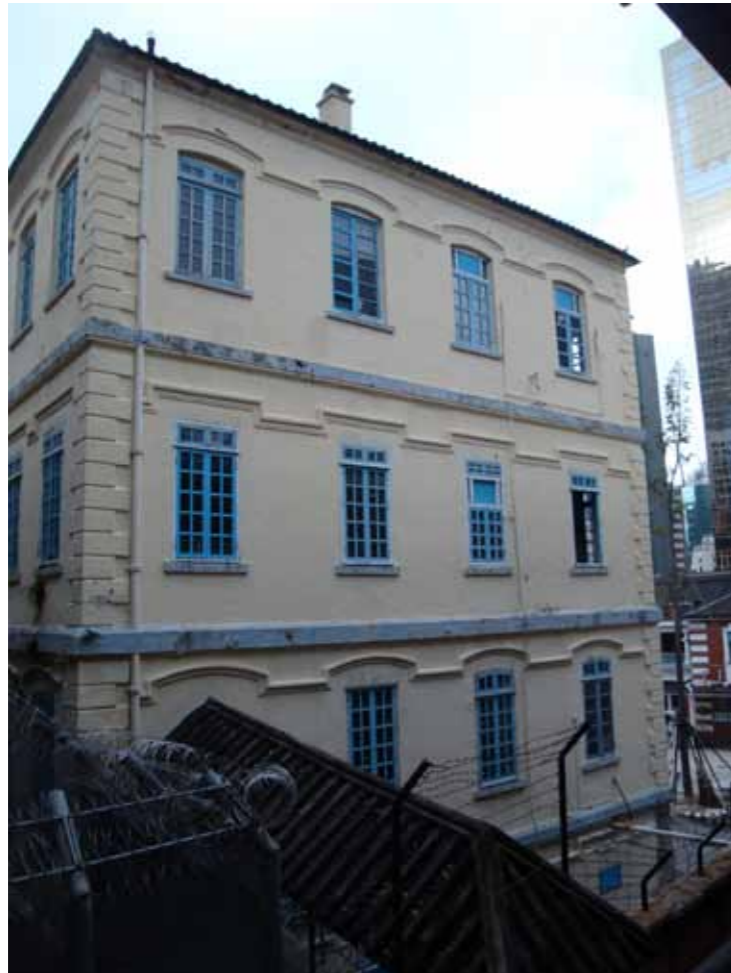
Figure 2 - East elevation

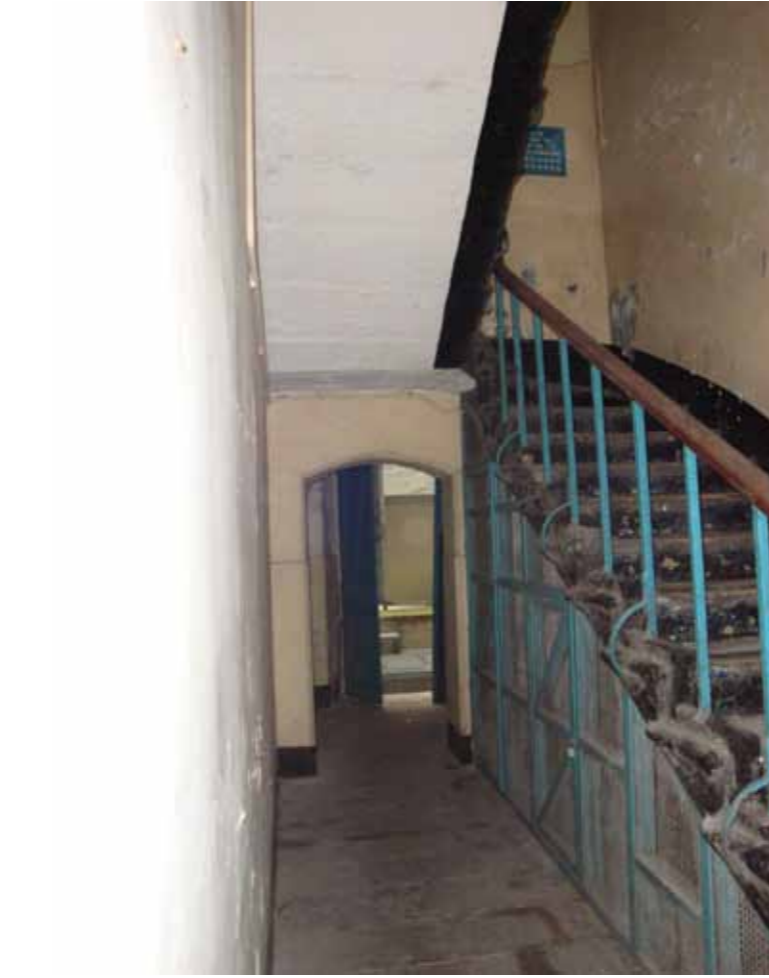
Figure 6 - Ground floor staircase
