Central Police Station Conservation
and Revitalisation Project:
Thirty-sixth Monthly EM&A Report
(1 October to 31 October 2014)

Issue Date: November 2014

Environmental Resources Management

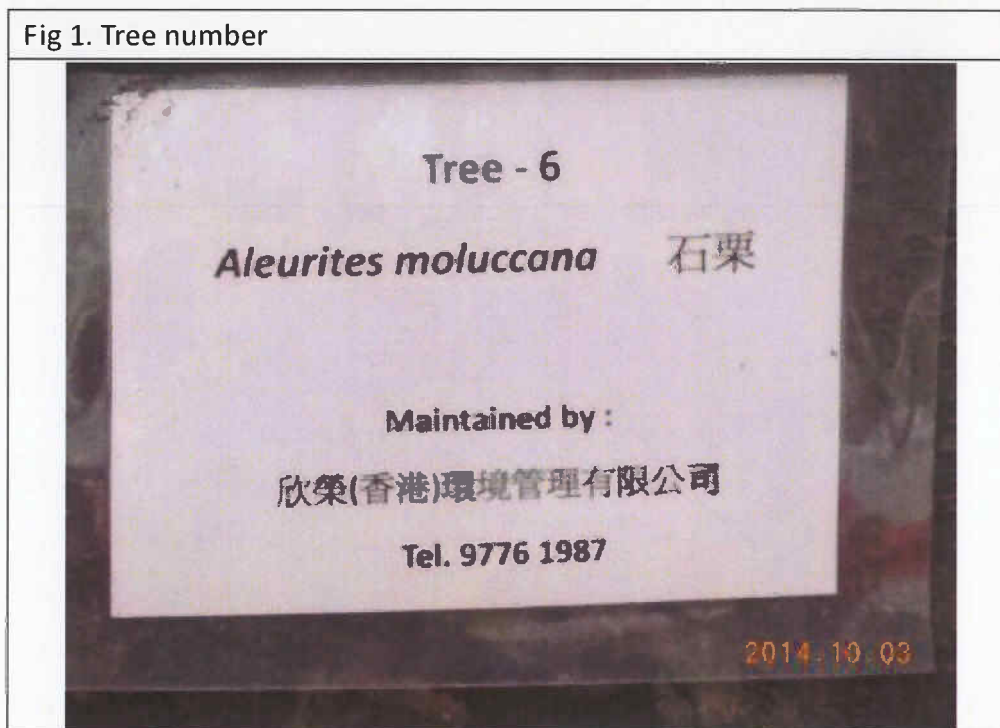
Fig 2. The root collar is normal. The planter is full of mulch.

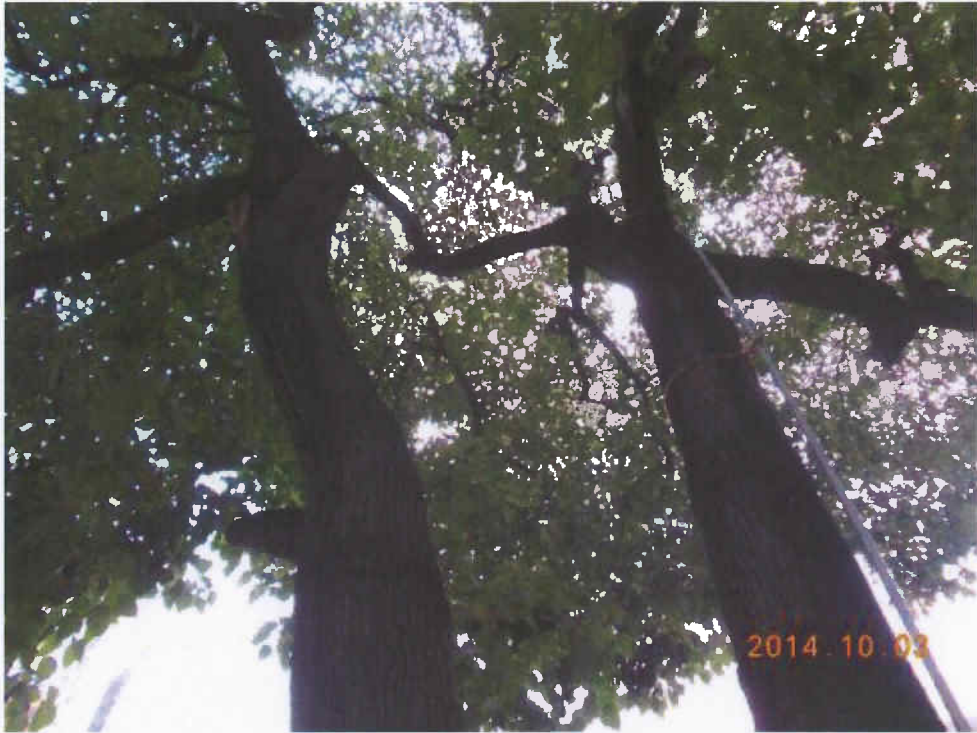
Fig. 5 The crown is full of green and dense leaves.

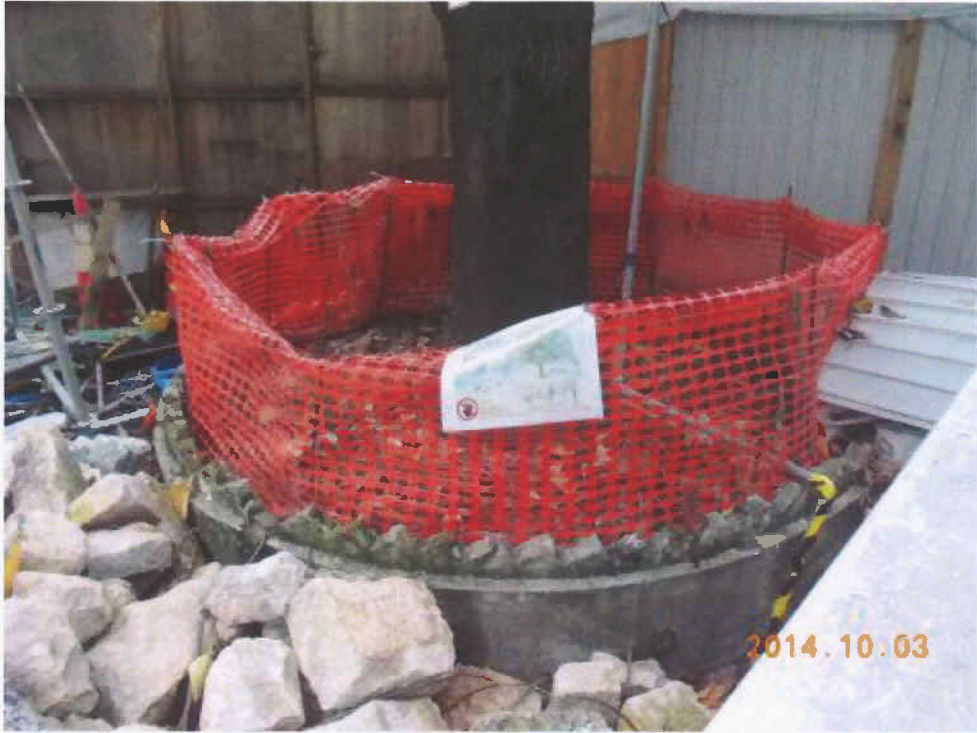
Fig. 7 Many construction items are placed near the planter. Tree-6

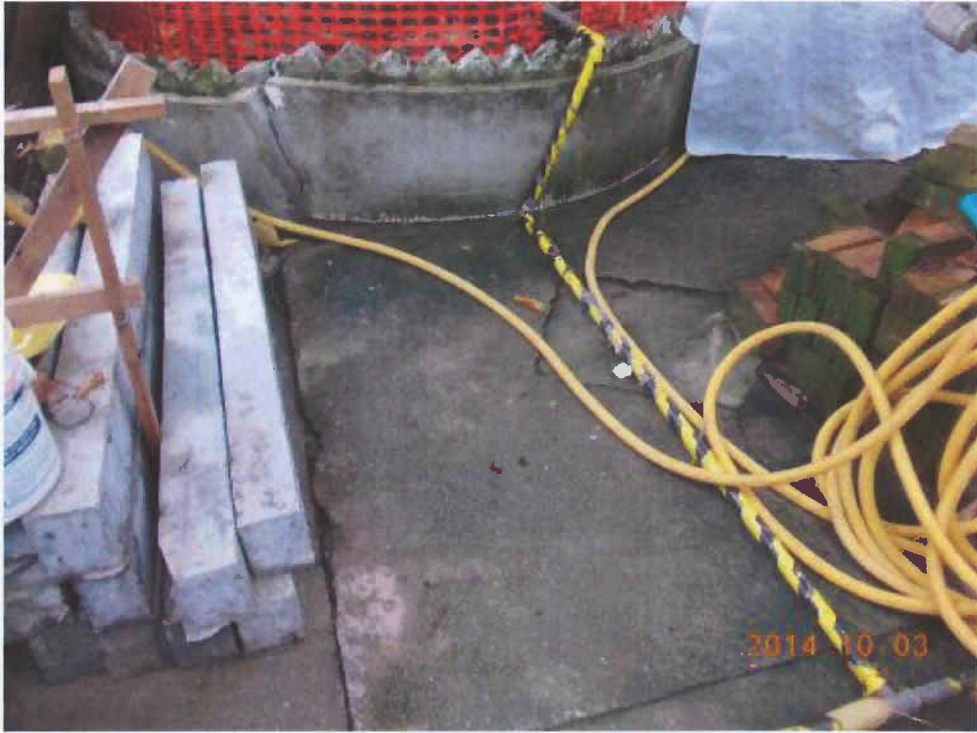
Fig. 9 Construction works are in progress outside the cordon zone.

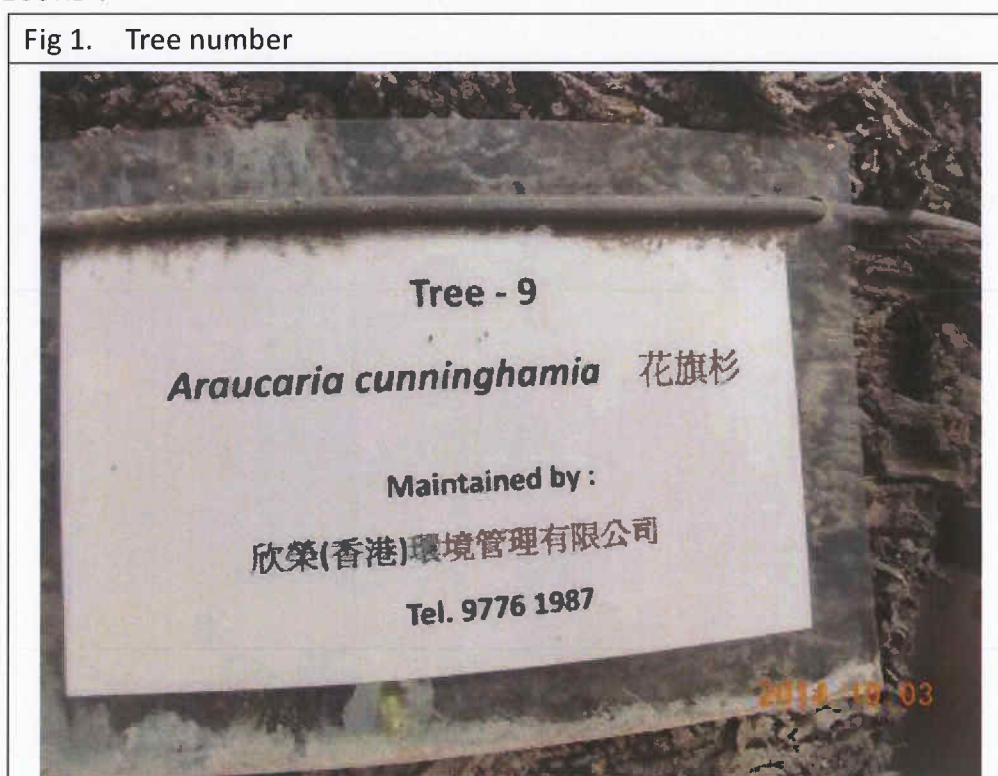
Fig 2. Root collar of Tree-9 is normal. The planter is full of mulch.

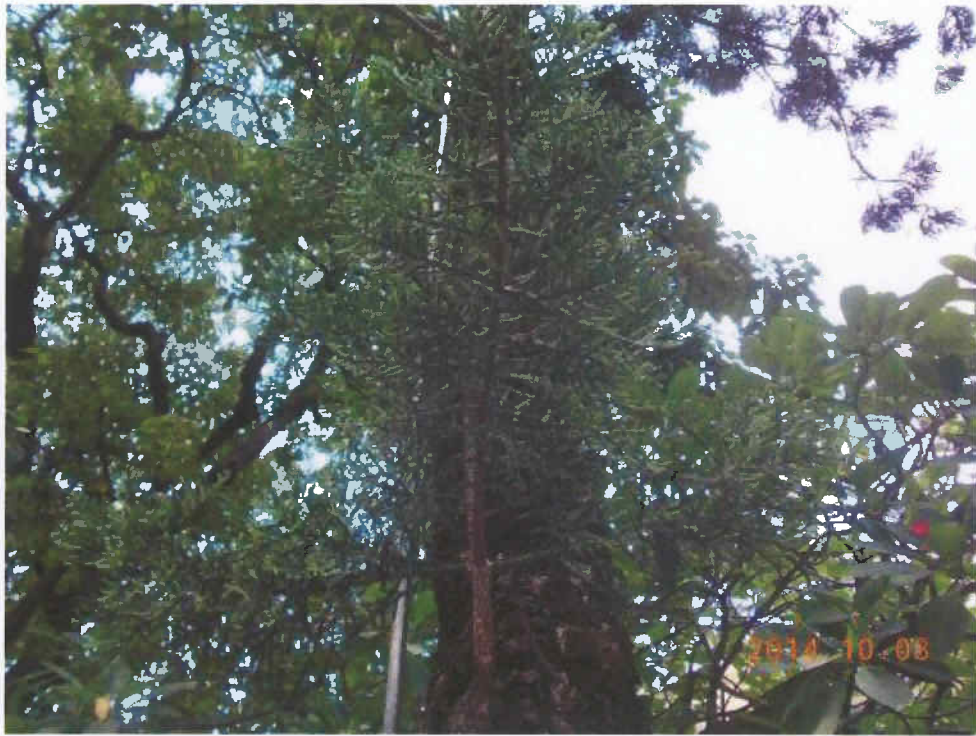
Fig. 5 A pipe leads water to the crown for irrigation.

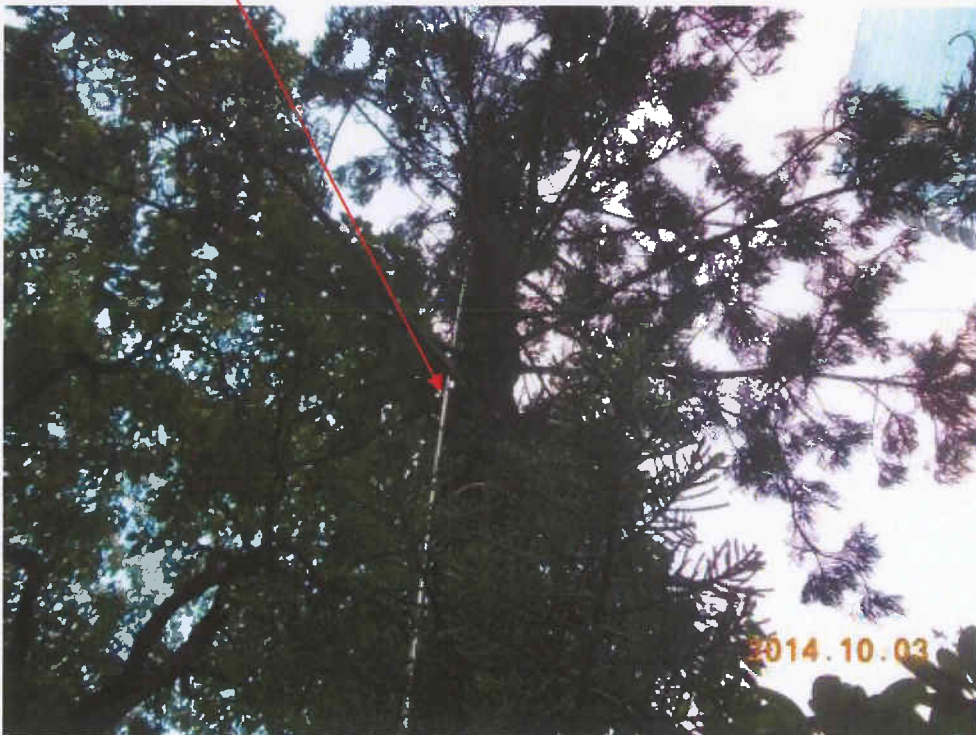
Fig. 6 Health condition of the crown is fair.

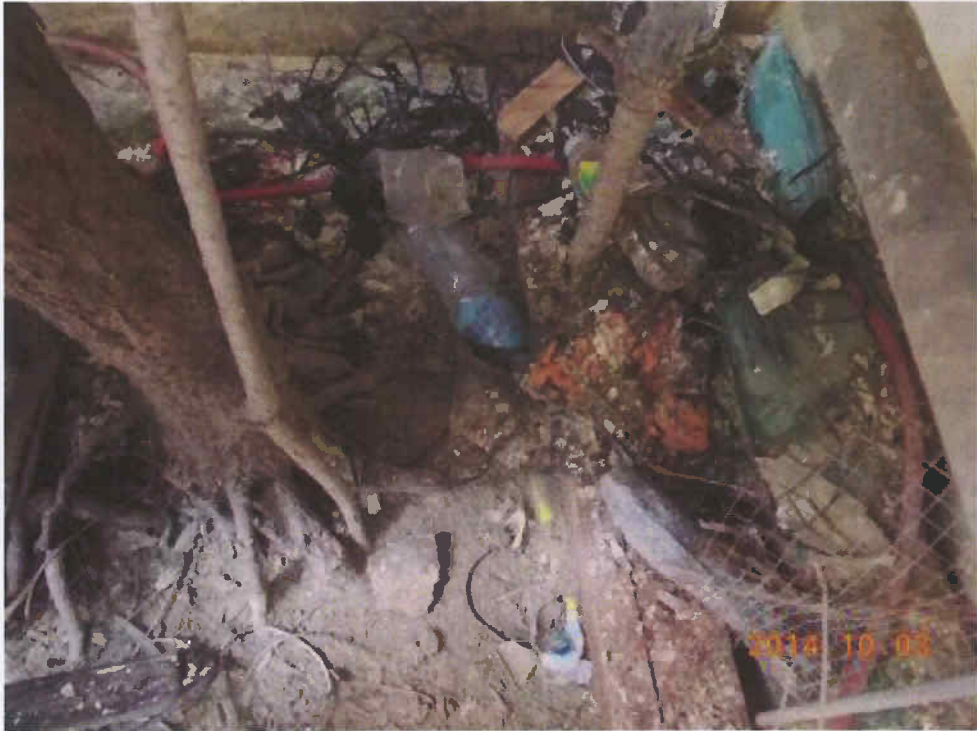
1. Overall health condition of the tree is poor.
2. The soil inside the planter has been polluted by construction debris and litter.
3. Withered leaves appear on the tree.
4. The small cordon zone is not in good order.
5. Renovation work is in progress near the tree.
6. The above incident has been reported to Ms. Oley C.T. WONG on 6/10/2014 morning.

Fig. 3 Other side view of the planter. The top-soil near Tree-11 has been seriously polluted by the construction debris and litter.

Mitigation measures have been carried out immediately. Tree Risk Assessment is not required for the time being.
(4)	Trees growing in very stressful site conditions with failure potential 生長於非常擠壓環境而有倒塌風險的樹木 (Note 1)	NII
