The Jockey Club CPS Limited

Central Police Station Conservation
and Revitalisation Project:
66th Monthly EM&A Report
(1 April to 30 April 2017)

Issue Date: May 2017

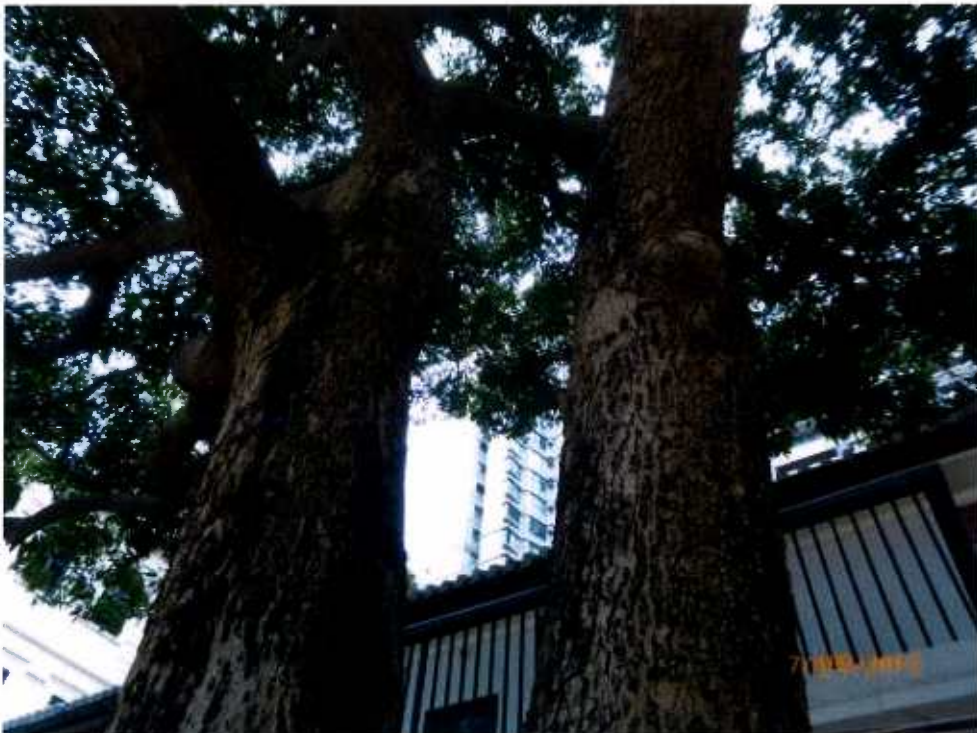
Fig. 6 The crown is full of vigorous and green leaves.

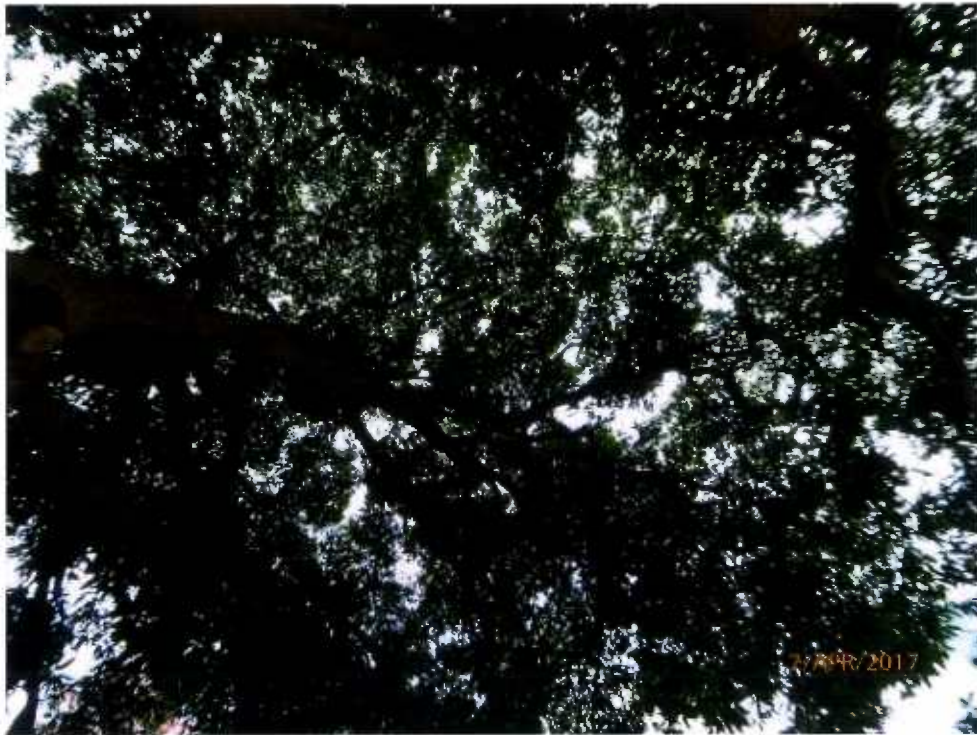
Fig. 7 Vigorous and green leaves also appear on the lower branches.

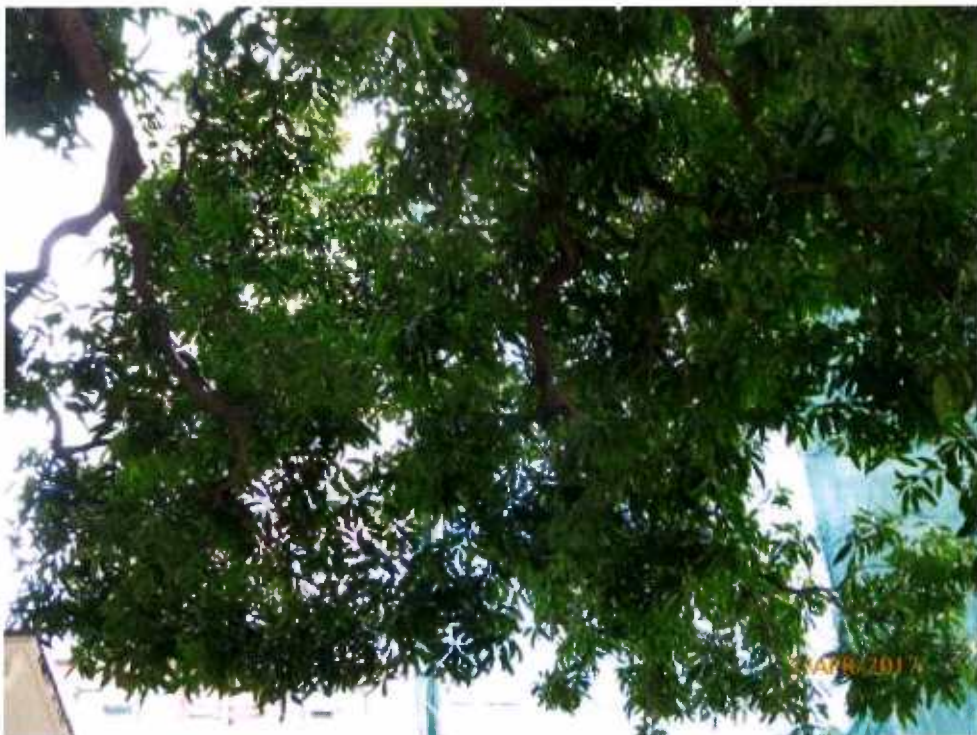
Fig. 8 Many flowers appear on the tree.

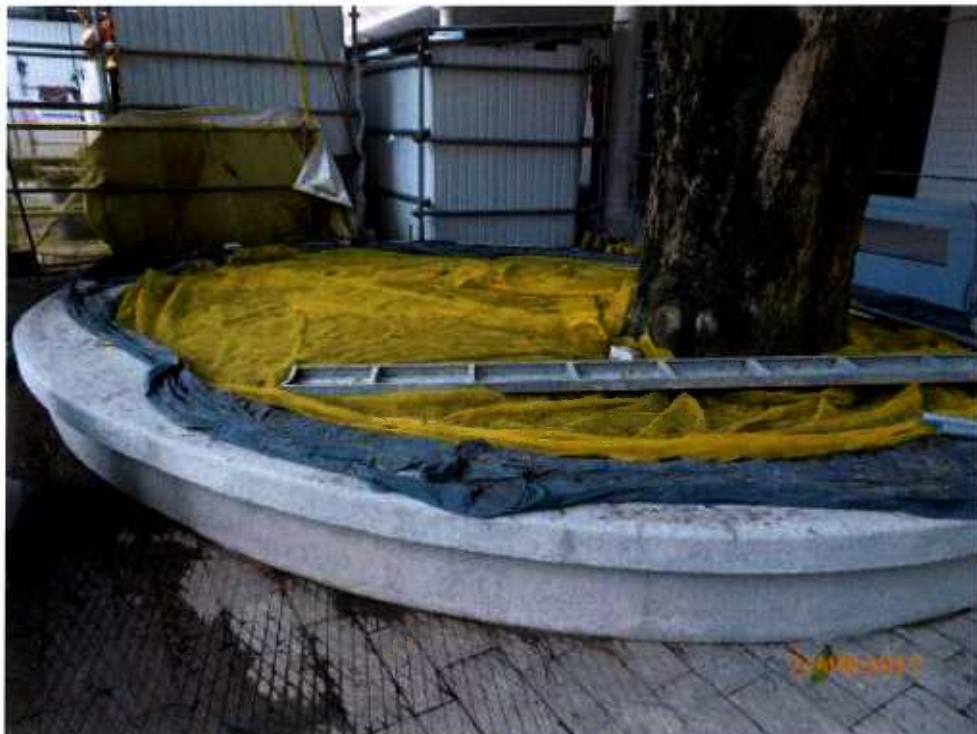
Fig. 10 The site near Tree-5 is clean and tidy.

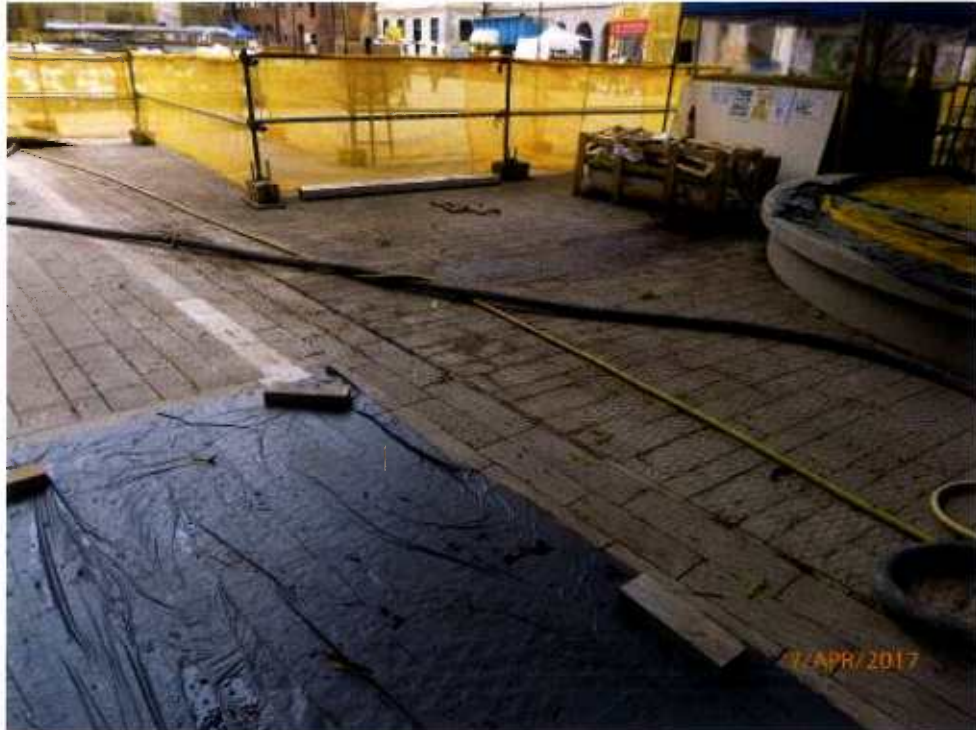
Fig. 11 The access near Tree-5 also is clean and tidy.

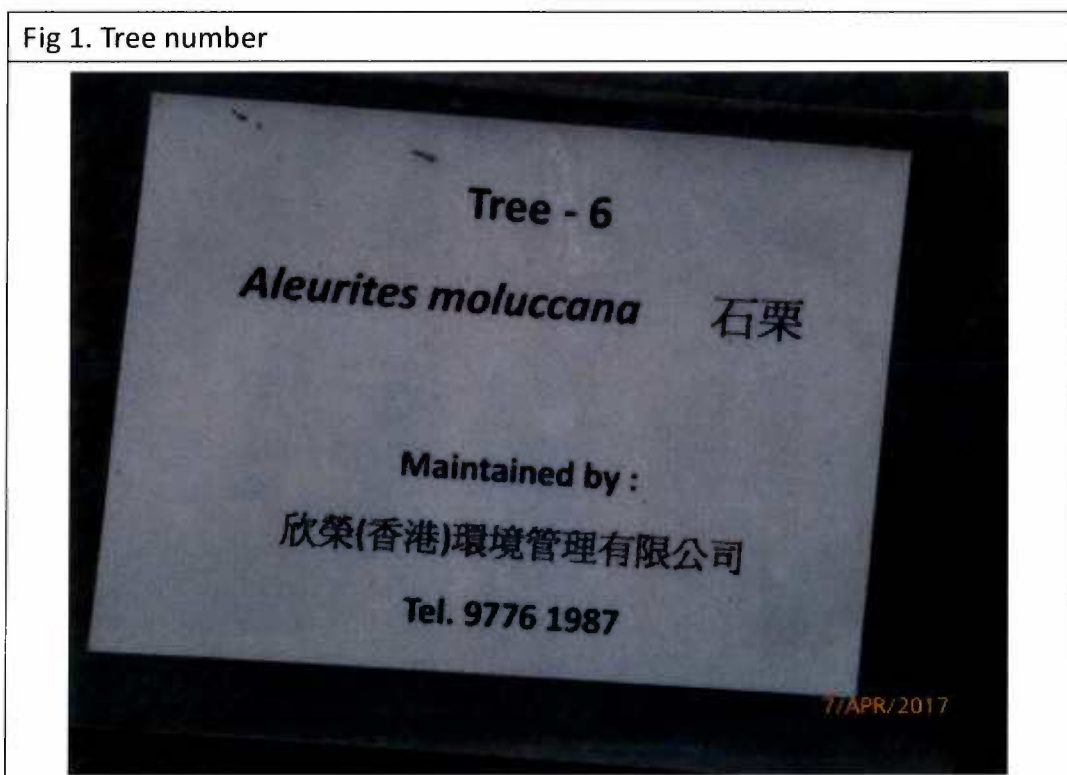
Fig 2. Root collar is normal. The planter is covered with mulch and dry leaves.

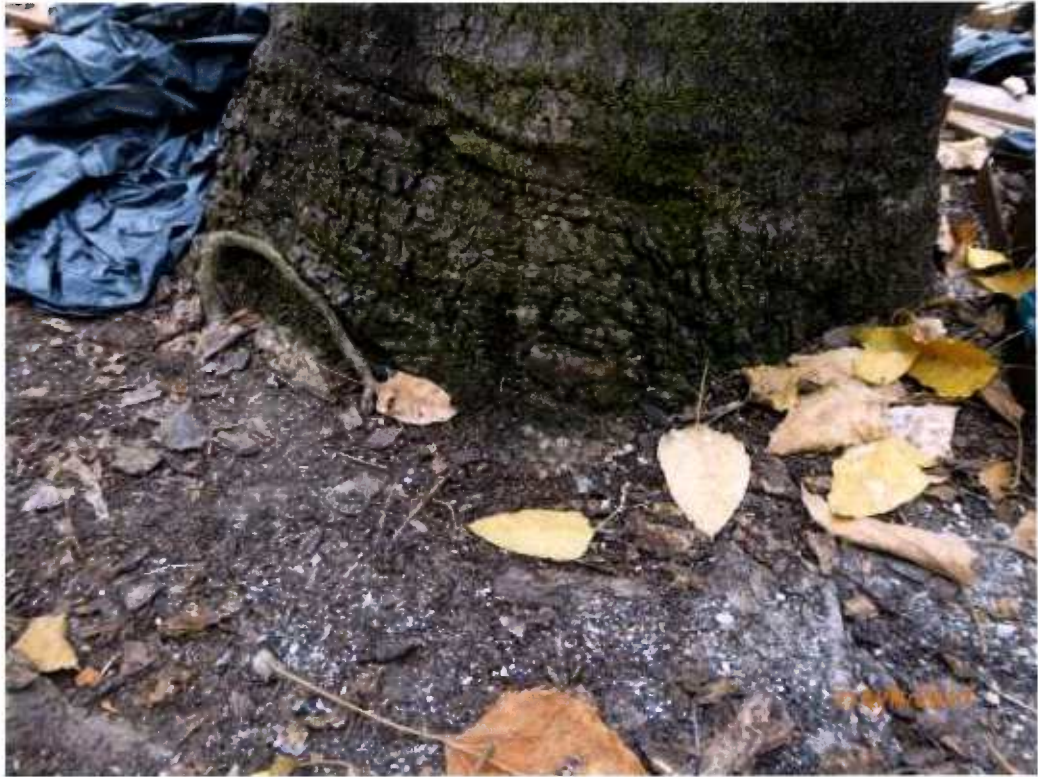
Fig 3. Health condition of the lower trunk is fair.

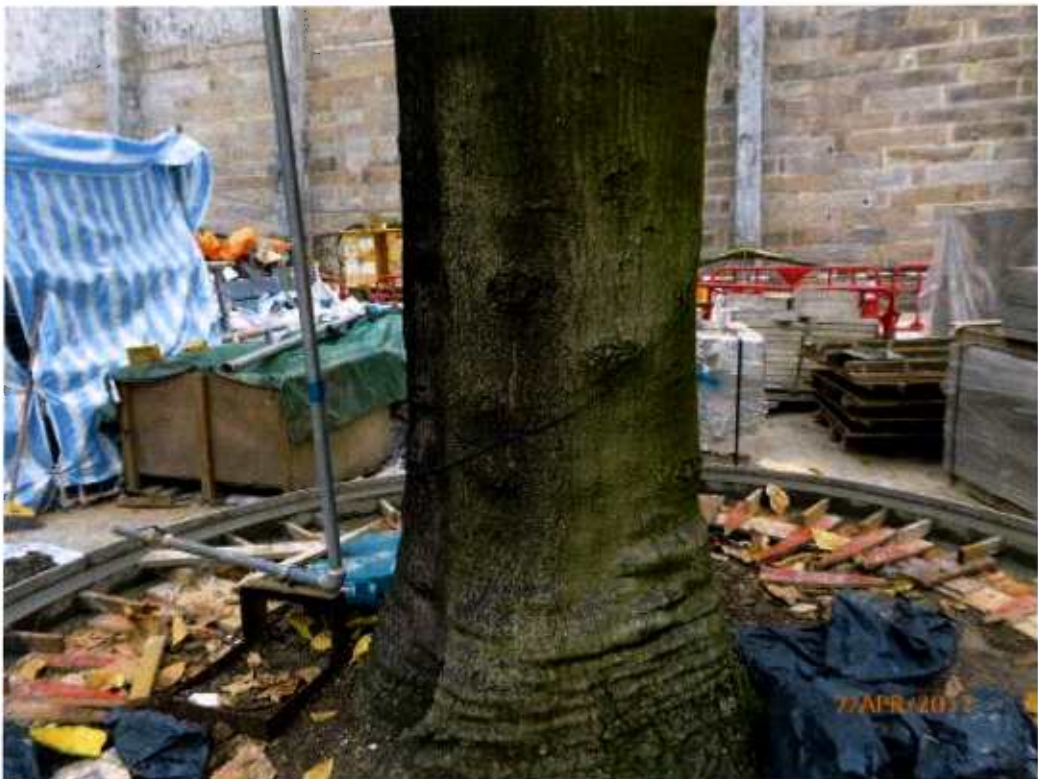
Fig. 4 Health condition of the mid trunk is fair.

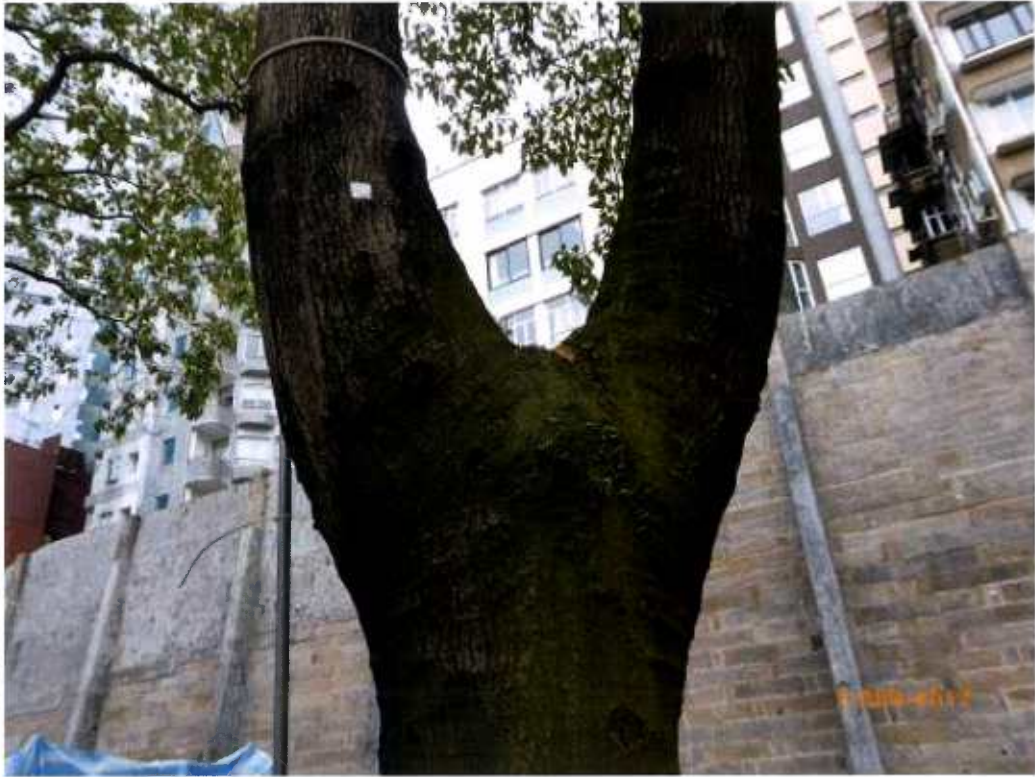
Fig. 5 Health condition of the upper trunk also is fair.

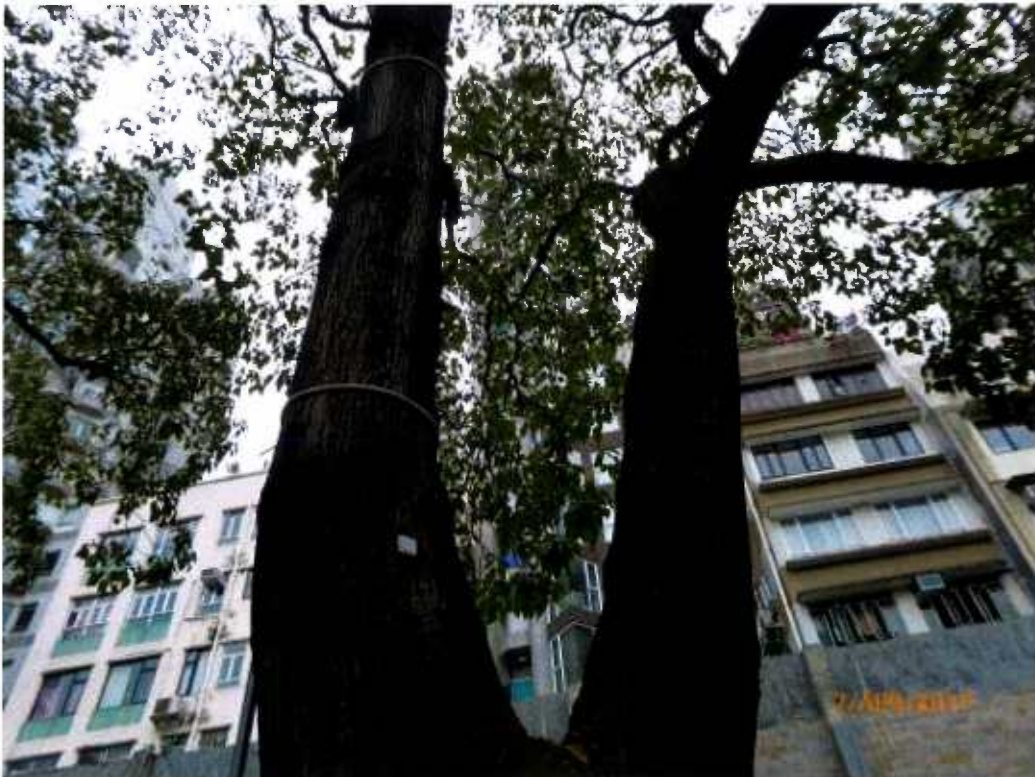
Fig. 6 The crown is full of vigorous and green leaves.

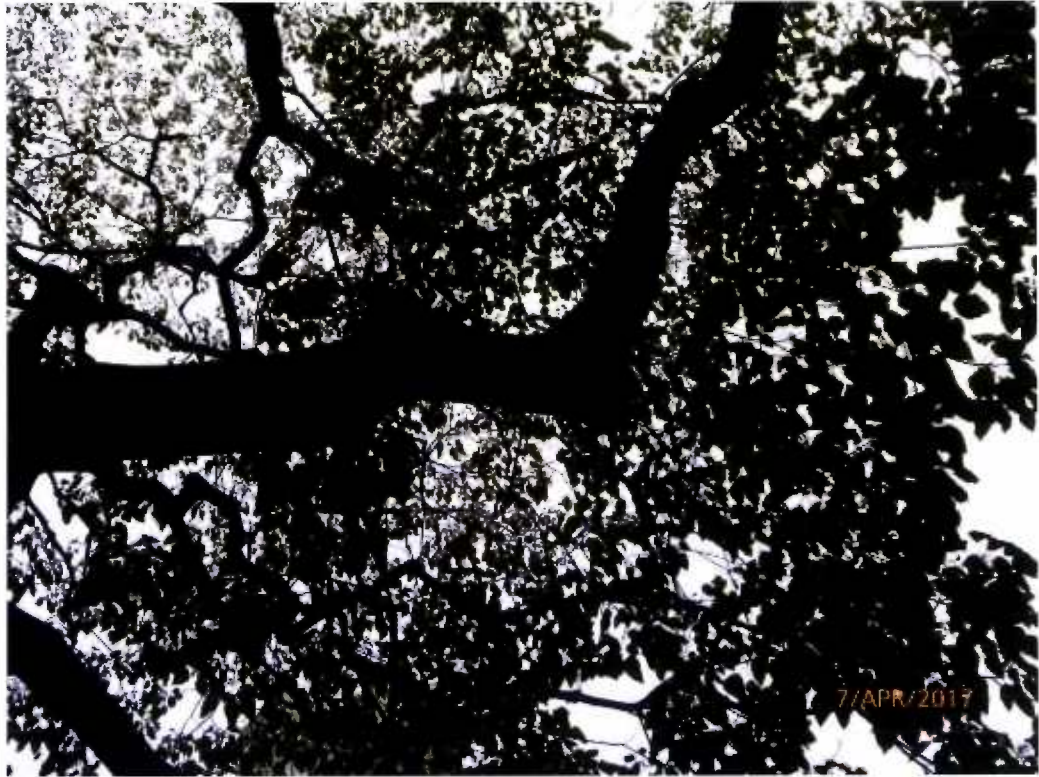
Fig. 7 Vigorous and green leaves also are growing on the lower branches.

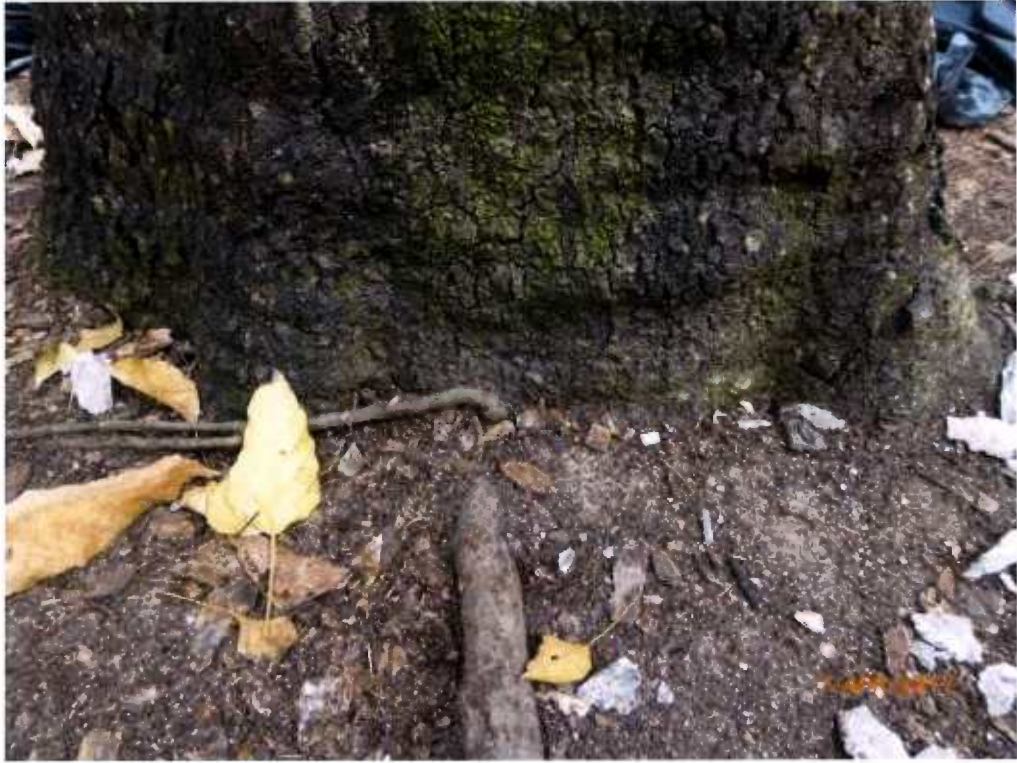
Fig 3. Health condition of the lower trunk is fair.

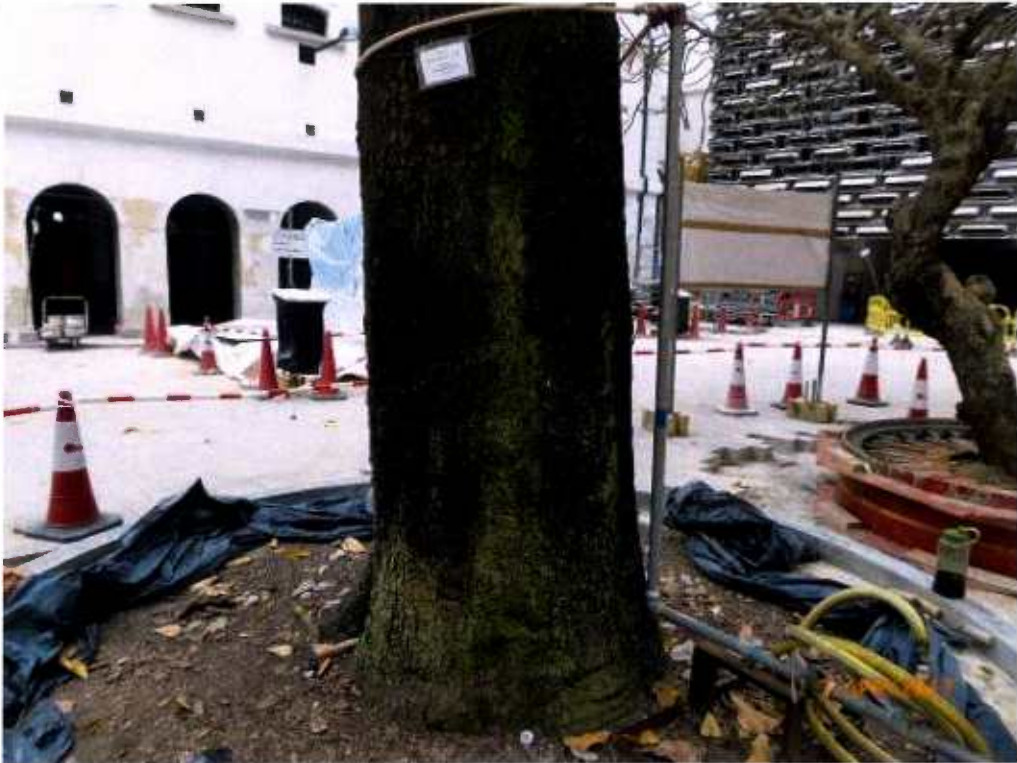
Fig. 4 Health condition of the mid trunk is fair.

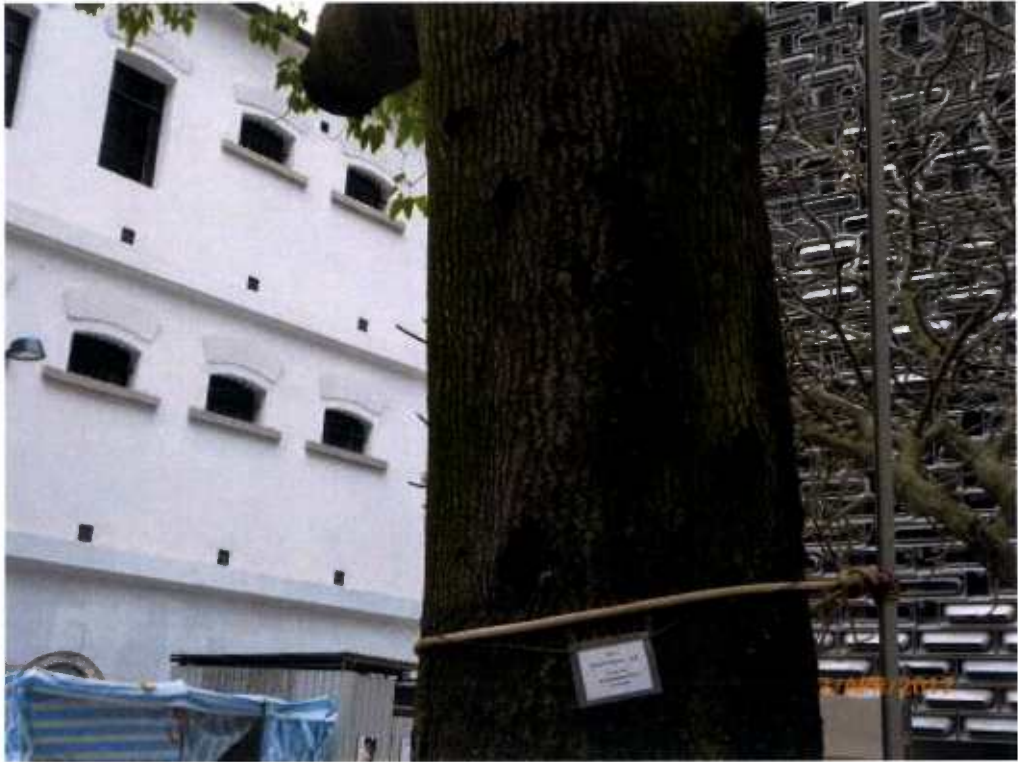
Fig. 5 Health condition of the upper trunk also is fair.

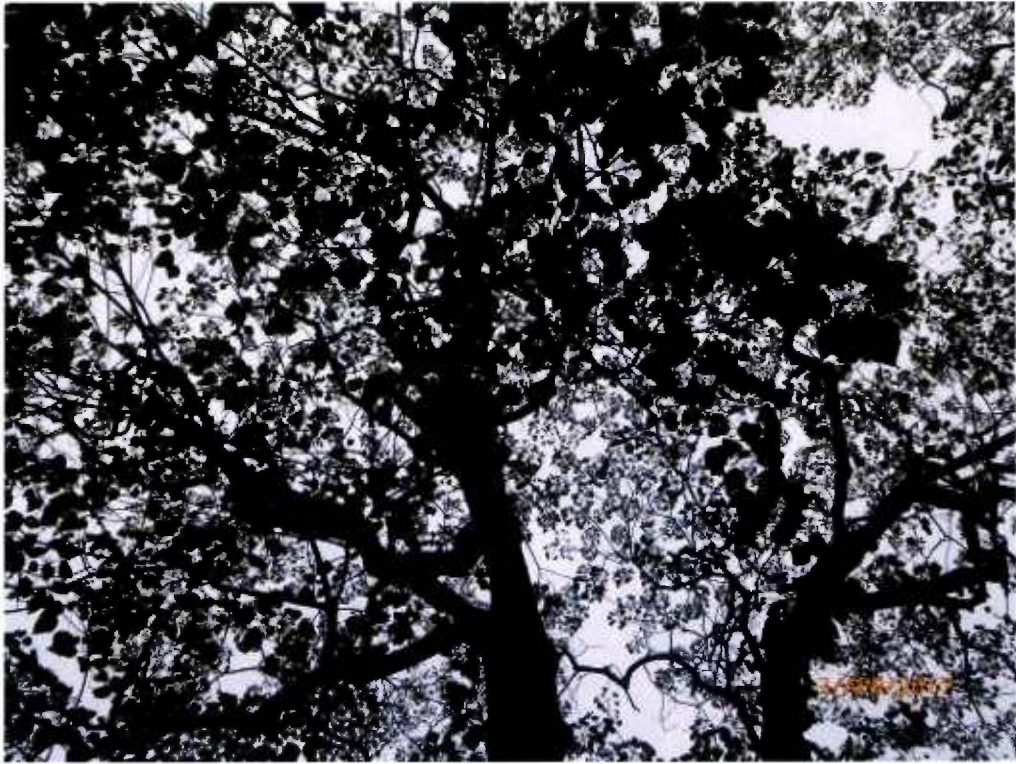
Fig. 7 Vigorous and green leaves also appear on the lower branches.

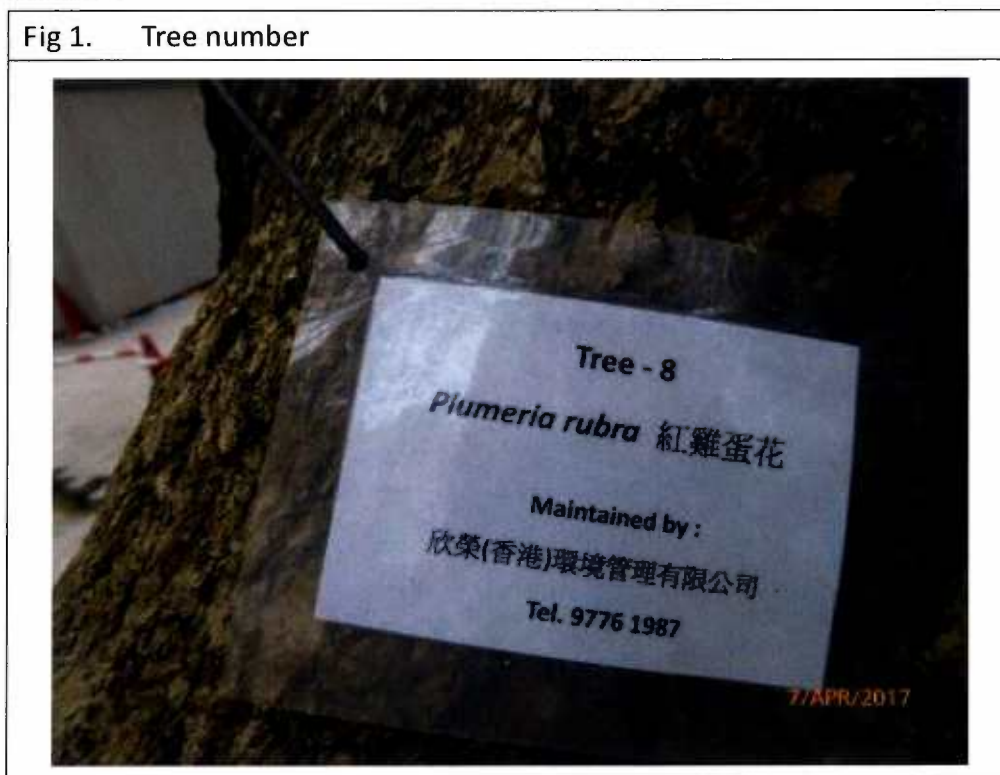
Fig 2. Root collar is normal.

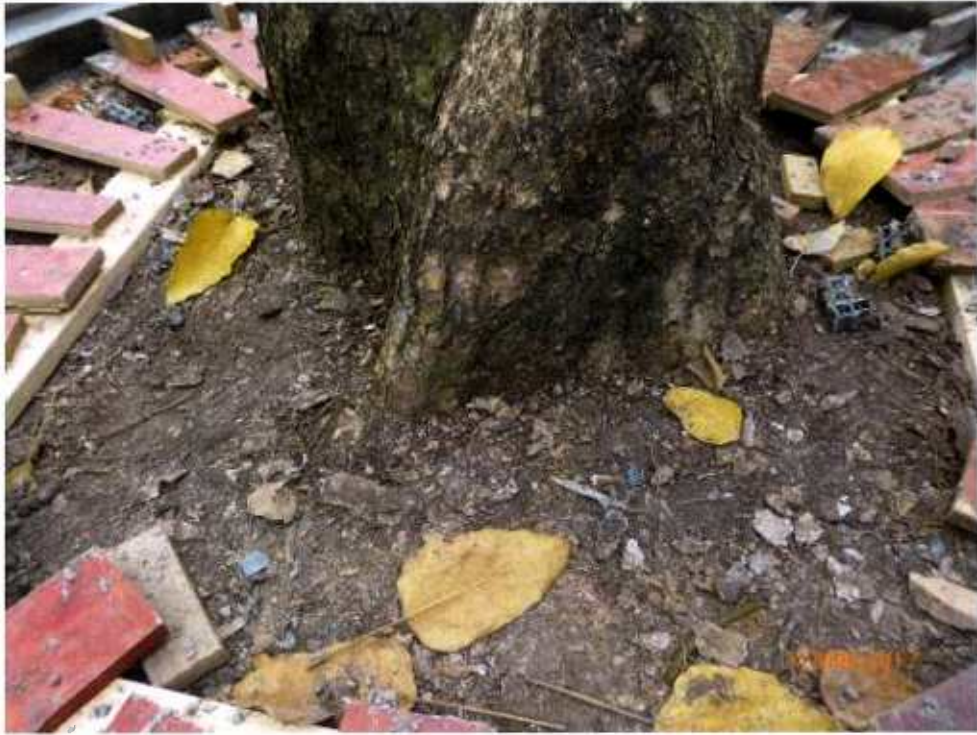
Fig. 3 Health condition of the lower trunk is fair.

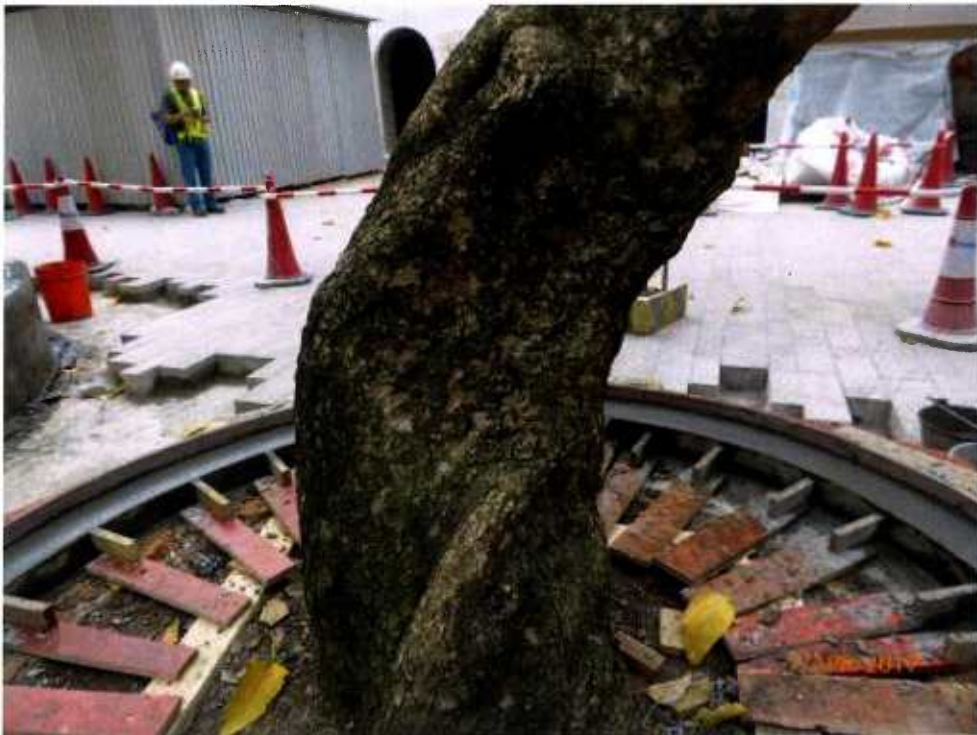
Fig. 4 Health condition of the mid trunk is fair.

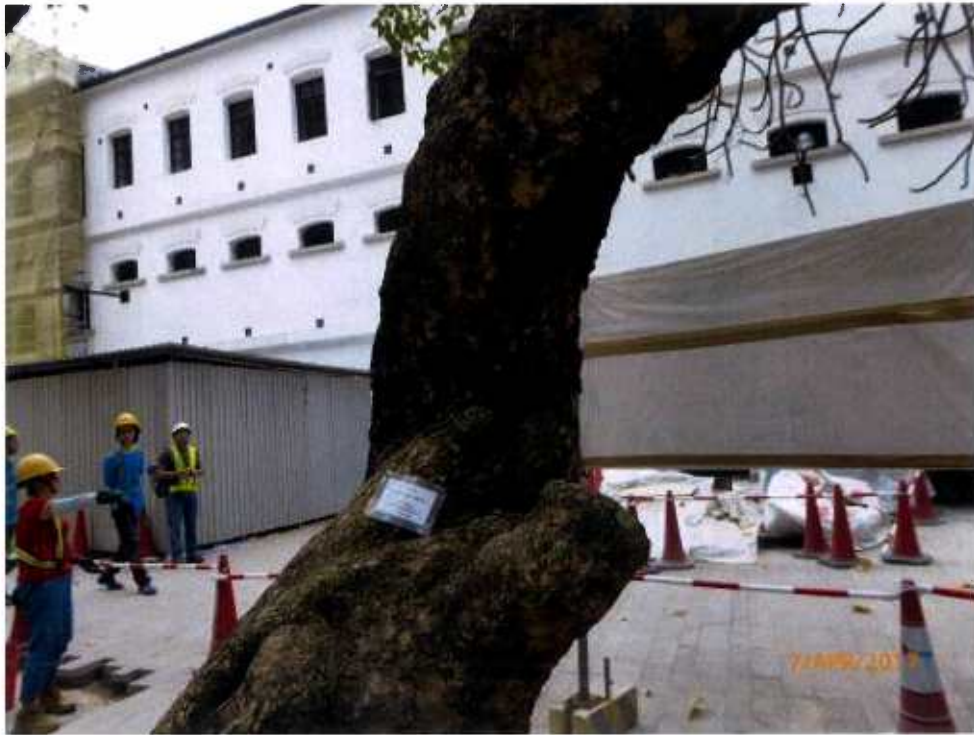
Fig. 5 Health condition of the upper trunk is fair..

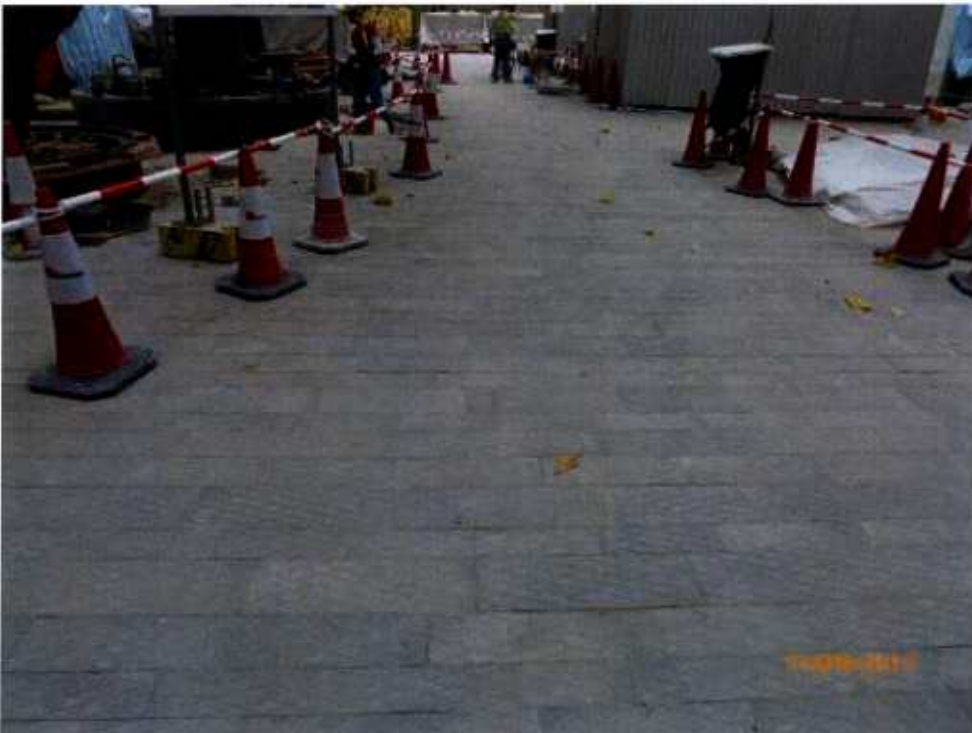
Fig. 10 Overall view of Tree-8 during inspection on 7th April 2017.

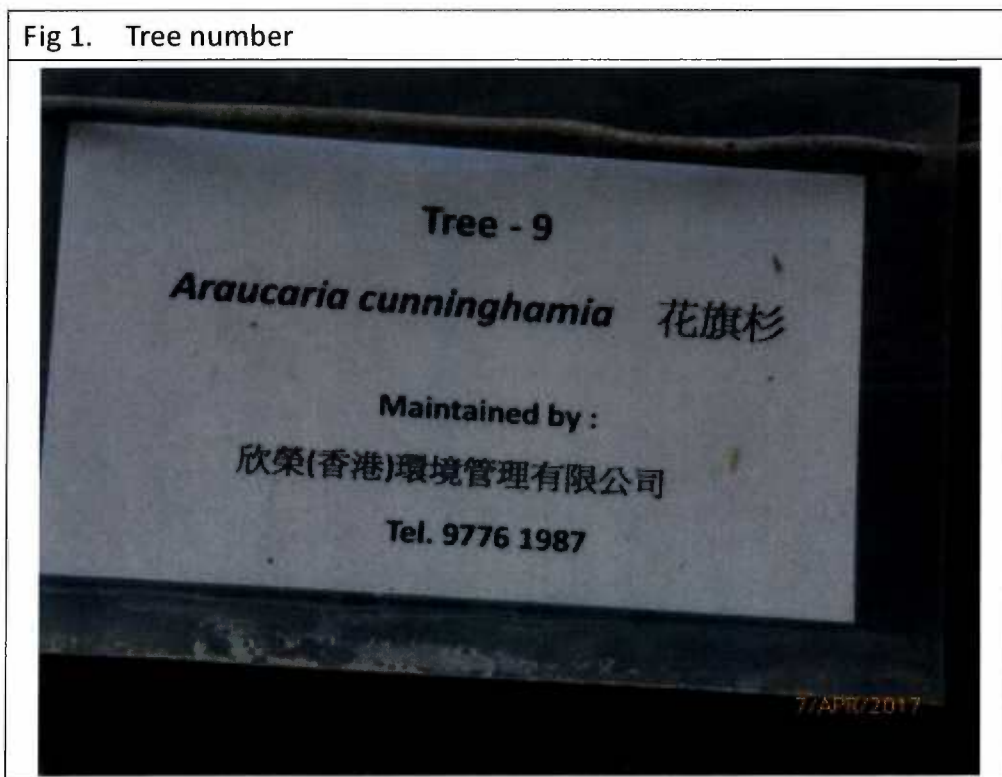
Fig 2. Root collar is normal. The planter is covered with mulch and leaves.

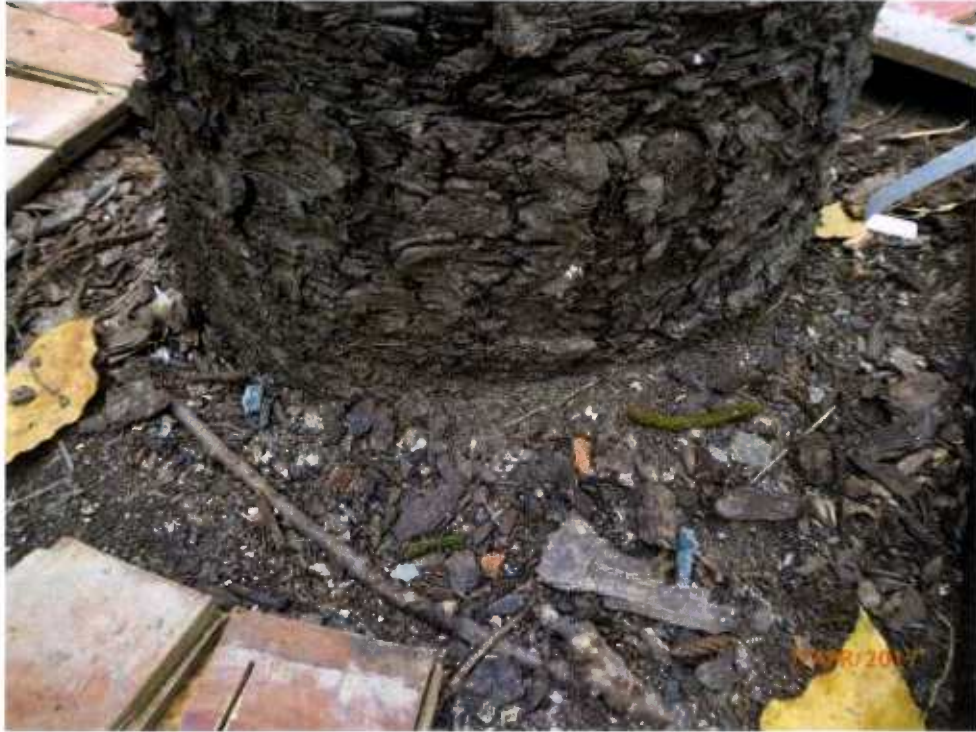
Fig. 3 Health condition of the lower trunk is fair.

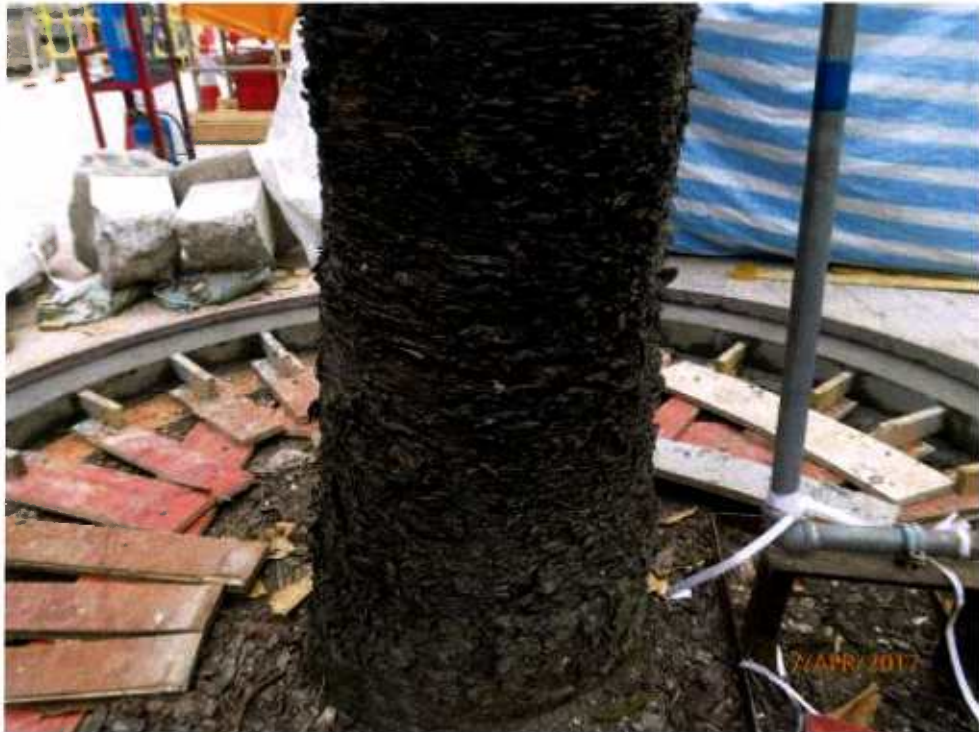
Fig. 4 Health condition of the mid trunk is fair.

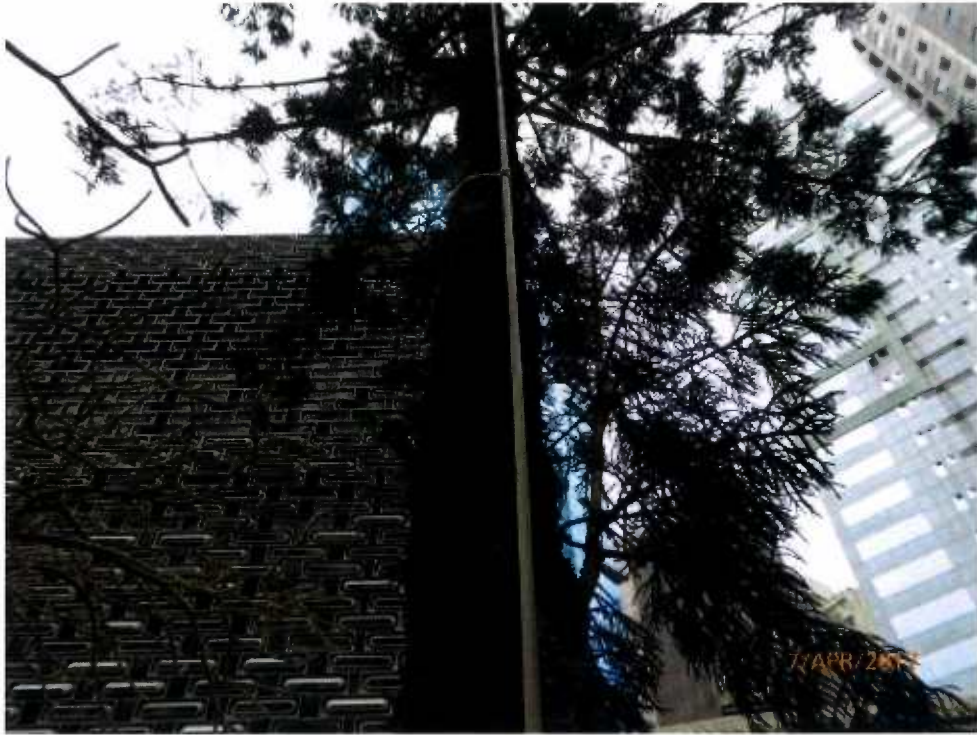
Fig. 5 Health condition of the upper trunk also is fair.

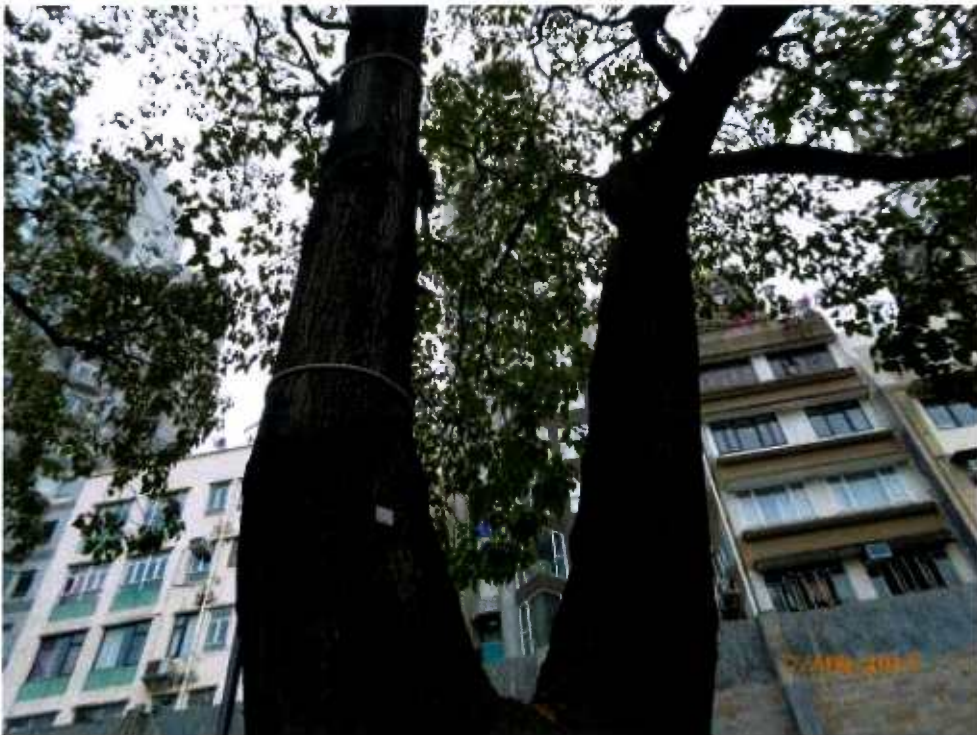
Fig. 6 The crown is full of vigorous and green leaves.

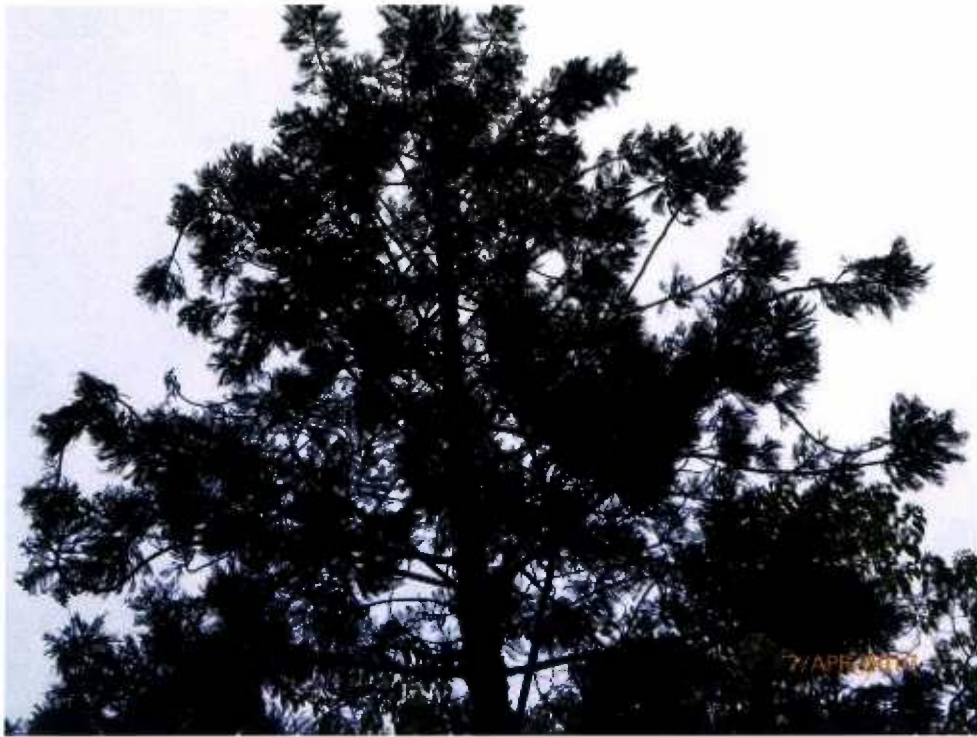
Fig. 7 Vigorous and green leaves also are growing on the lower branches.

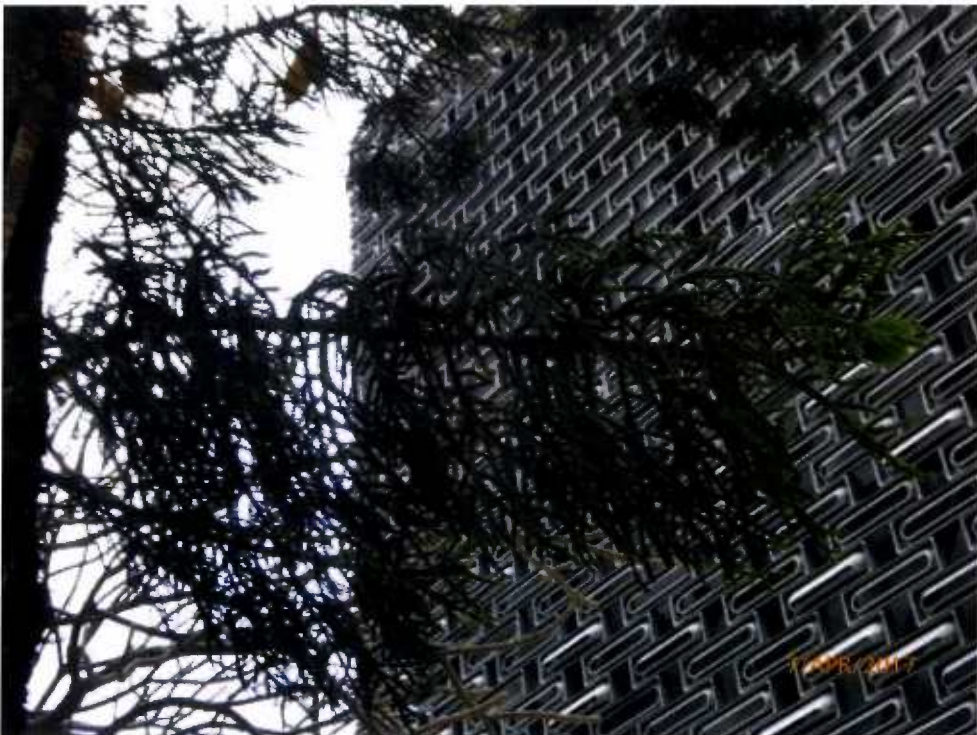
Fig. 8 The fresh fruit still appears on the tree.

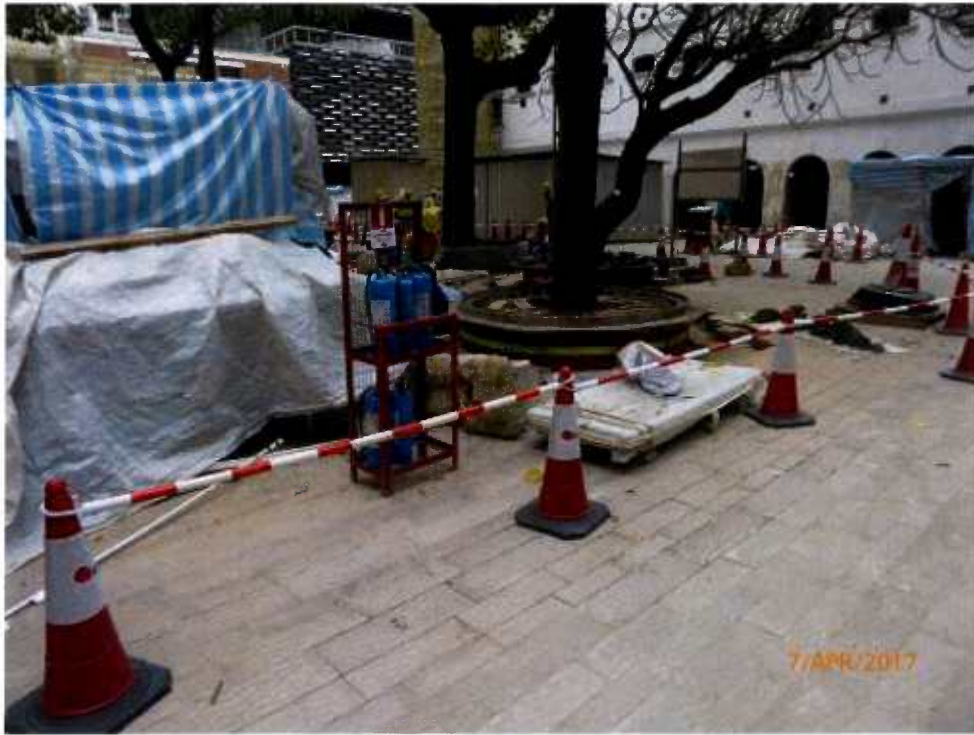
Fig. 11 The site near the tree appears clean and tidy.

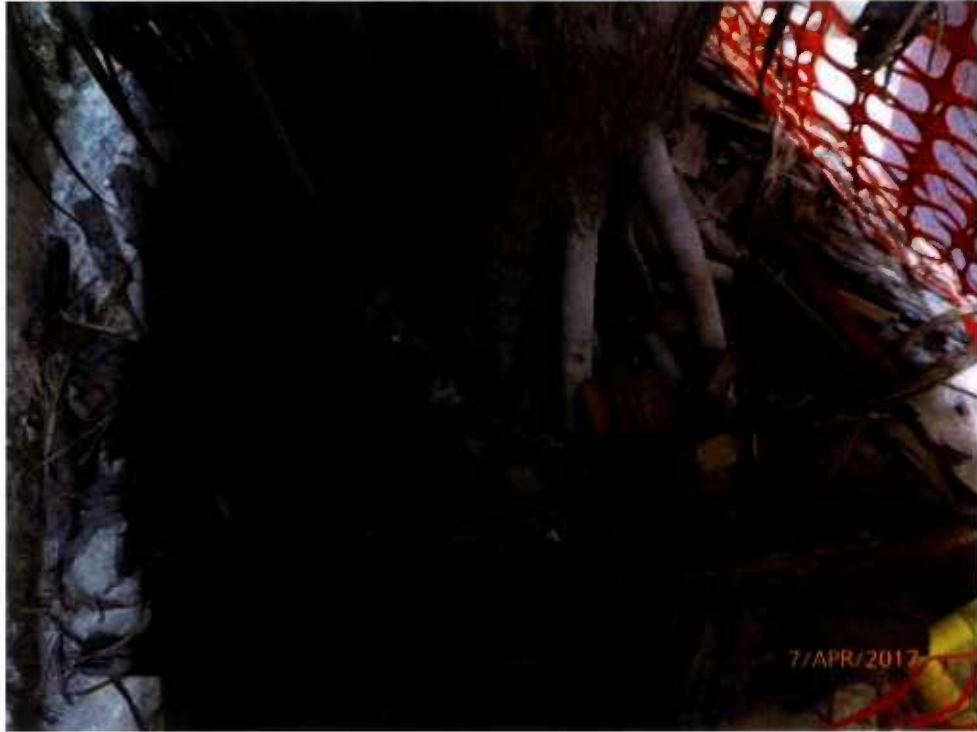
Fig. 3 Health condition of the lower trunk is fair.

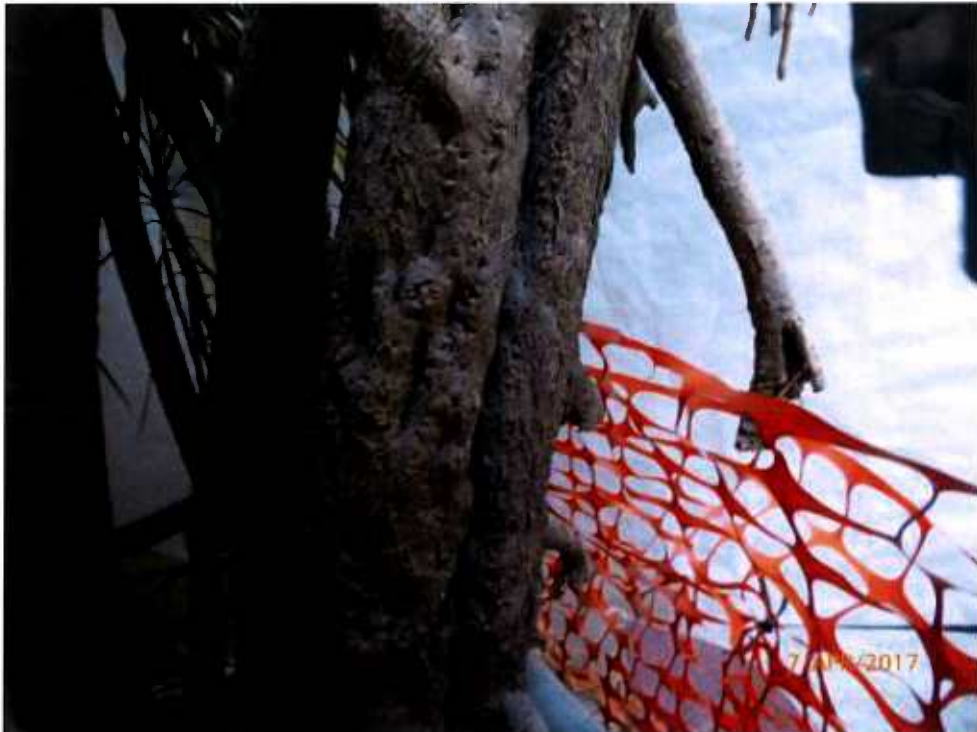
Fig. 4 Health condition of the mid trunk is fair.
