The Jockey Club CPS Limited

Central Police Station Conservation
and Revitalisation Project:
66th Monthly EM&A Report
(1 April to 30 April 2017)

Issue Date: May 2017

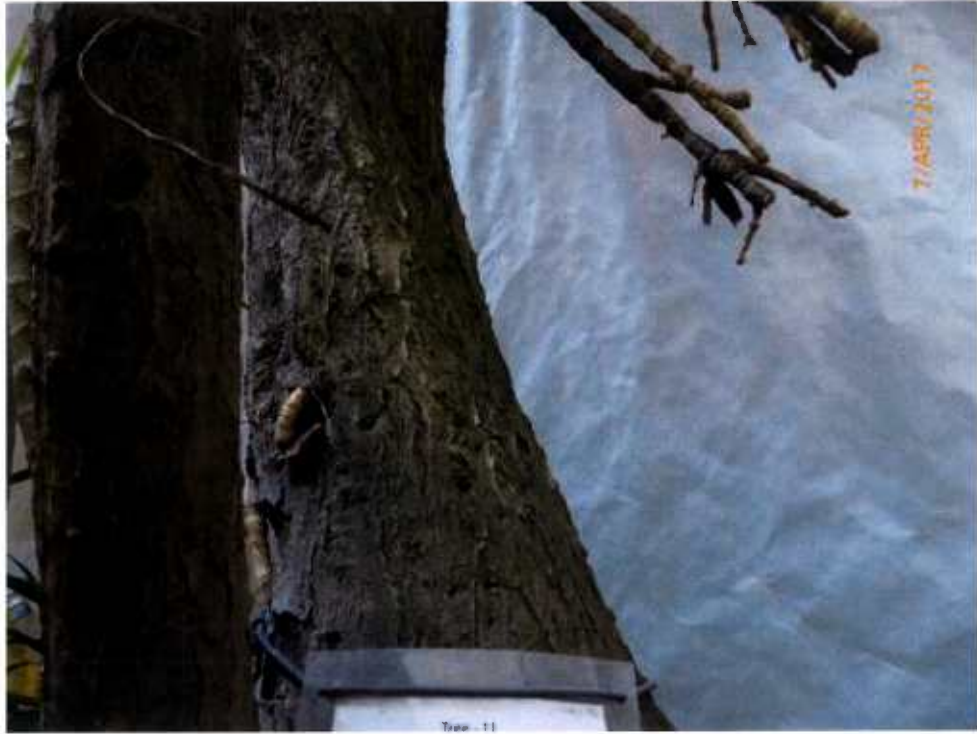
Fig. 5 Health condition of the upper trunk also is fair.

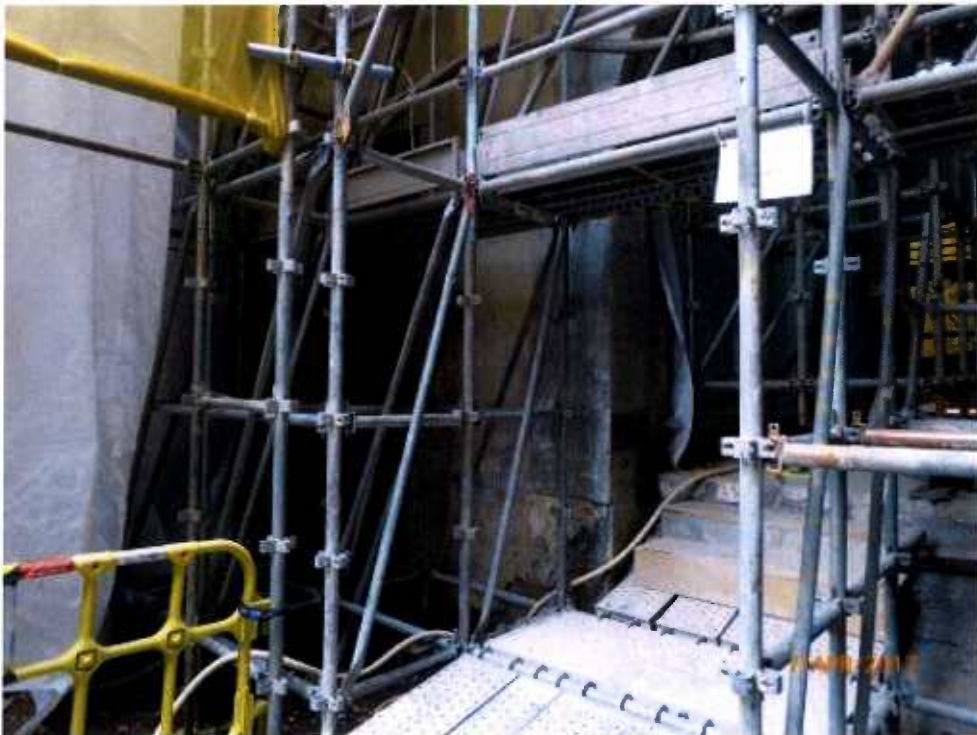
Fig. 12 Overall view of Tree-11 during inspection on 7th April 2017.
